Rail Accident Investigation Branch

Rail Accident Report

Derailed at Porthkerry, South Wales 2 October 2014

Report 10/2015
August 2015

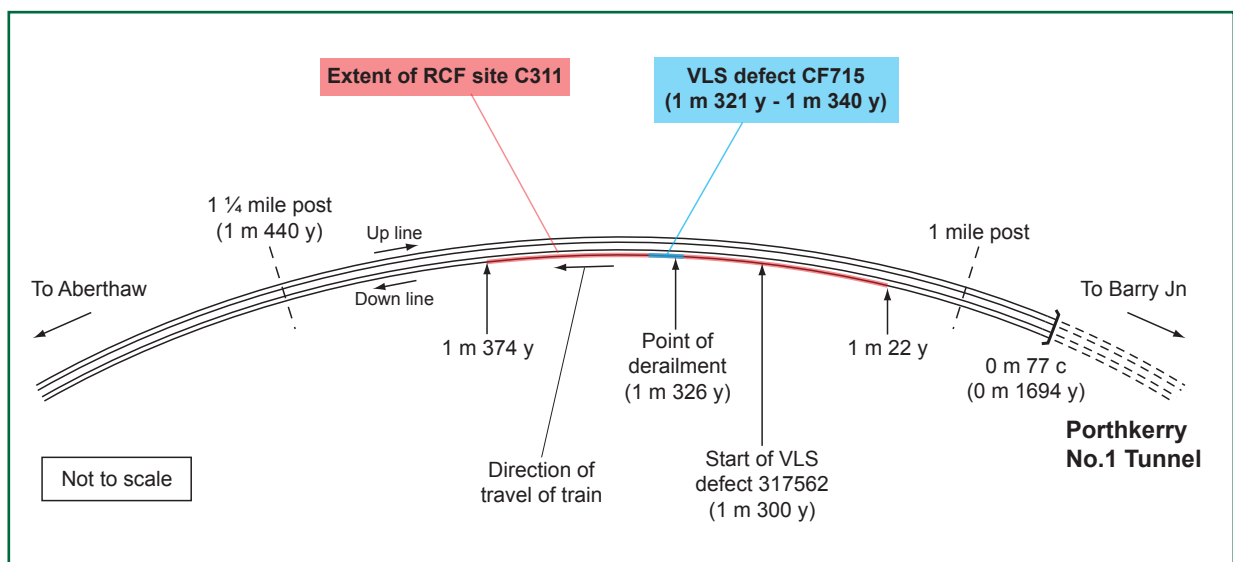
Figure 3: The layout of the key features at the derailment site (see text for meaning of features)

- 6 The line on which the derailment occurred has two tracks. The 'up' line carries trains in the direction of Barry and the 'down' line carries trains heading towards Aberthaw and Bridgend (figure 3). It is used by heavy freight trains and by passenger trains. Passenger trains can achieve higher speeds than the loaded freight trains, because of the rising gradient on this section of track. The track was designed to have 130 mm of *cant* to cater for passenger trains travelling at 50 mph (80 km/h).

- 7 The derailment occurred as the train was travelling on the down line round a left-hand curve on a rising gradient. The point of derailment was at mileage 1 mile 326 yards, measured from a zero datum at Barry Junction. The maximum permitted speed at this location is 50 mph (80 km/h).

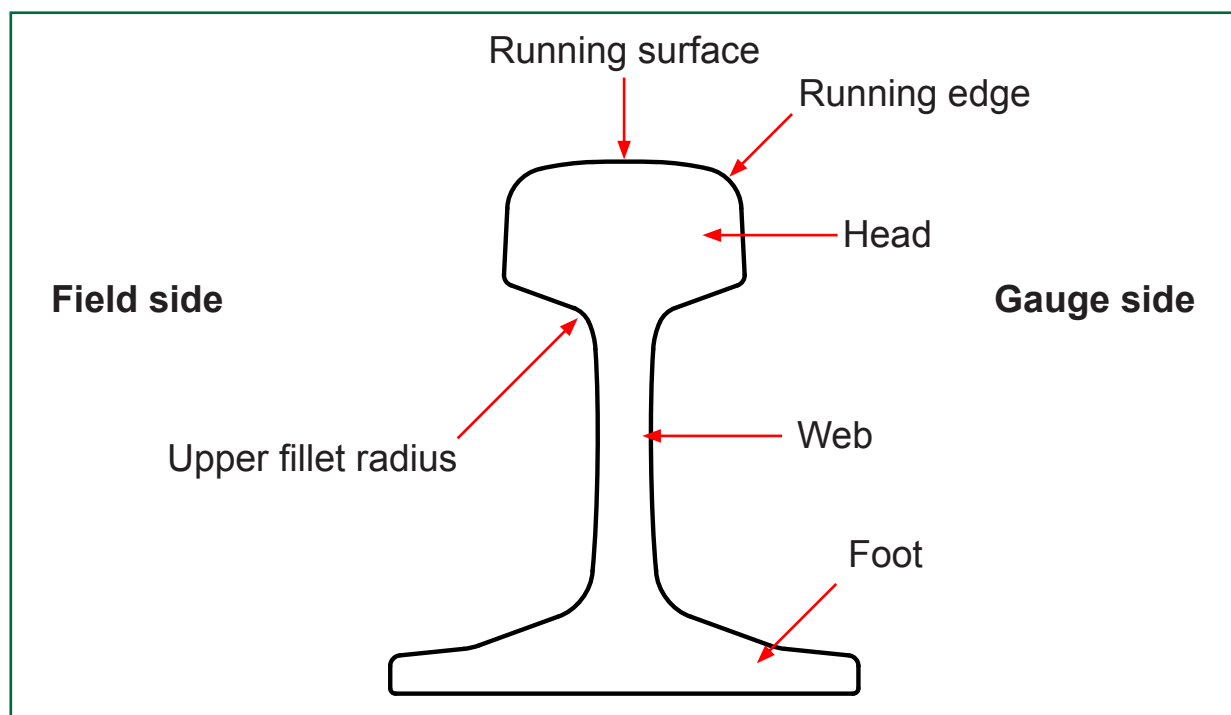
Figure 5: Nomenclature of rail

- 24 The front of the train passed the site of the derailment travelling at 16.5 mph (26.5 km/h) and the locomotive and the first 19 wagons passed over the defective rail without incident.
- 25 As the 20th wagon ran onto the defective left rail, the *field side* of the rail head (figure 5) broke away from the rest of the rail. The weight of the wheels pressed the *gauge side* of the head down so that the wheels ran on the web of the rail. When examined by the RAIB after the derailment, the wheels on the left side of the 20th wagon (rear bogie) and 21st wagon (leading bogie) had marks on the tread consistent with them having run on a sharp edge, such as would be presented by the broken top surface of the rail web.

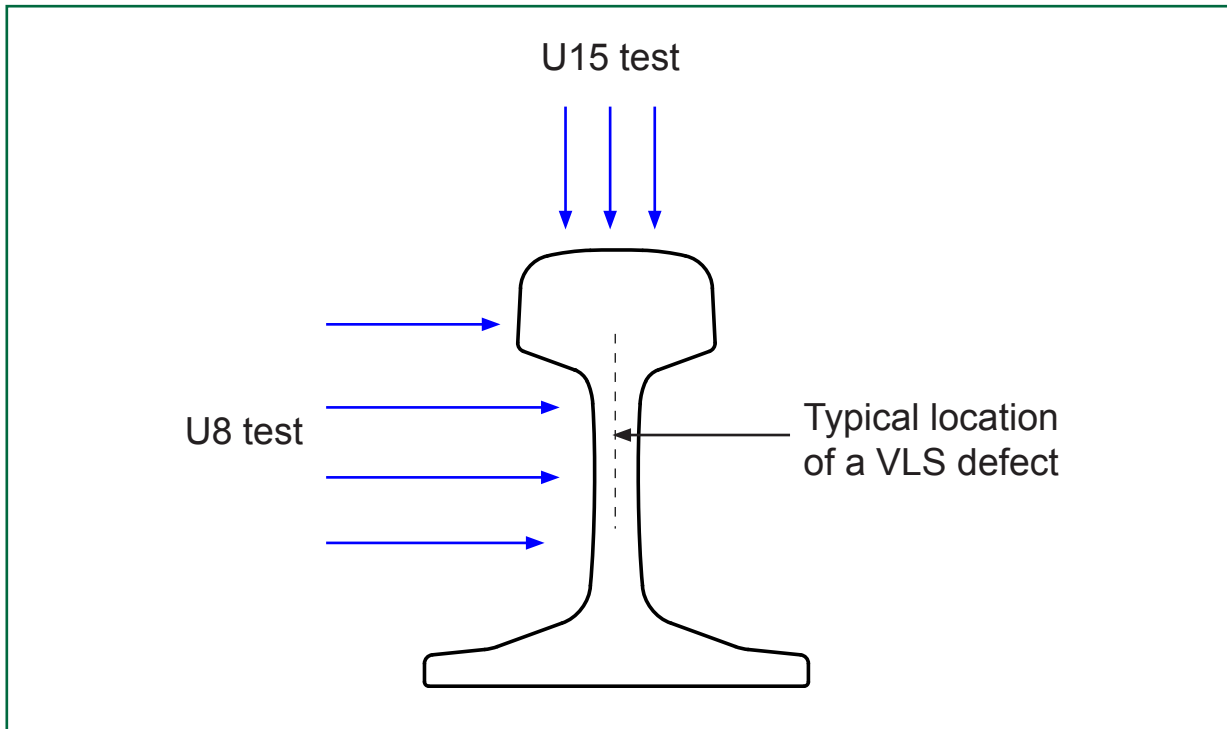
Figure 7: Direction of ultrasound in U8 and U15 tests

- 48 The standard ultrasonic test for rails is known as U15¹, and is carried out with a set of ultrasonic probes on top of the rail looking at various angles down into the rail (figure 7). This test can be done from the UTU or by pedestrian testing. As the U15 test looks down from the top of the rail, VLS defects can be difficult to spot as they are aligned with their smallest dimension, their width, facing the ultrasonic beams. If a VLS defect is suspected, another test can be performed, U8, from the side of the rail. This test uses a hand-held probe to look sideways through the rail head and web. Any VLS defect would be perpendicular to this direction making it easy to spot in the ultrasonic response. As it requires a probe on the side of the rail, U8 testing cannot be performed from a UTU.

- 49 Since the VLS defect is difficult to identify from the UTU or U15 pedestrian test, Network Rail standard NR/L2/TRK/001 mod06 'Visual inspection and ultrasonic testing of rails' specifies that rails rolled in 1976 or earlier should be visually inspected to look for [signs of] VLS and other defects that cannot be detected by the UTU (such as excessive rail corrosion). The interval between these inspections varies according to the track category and for the track at Porthkerry the interval was 2 years.

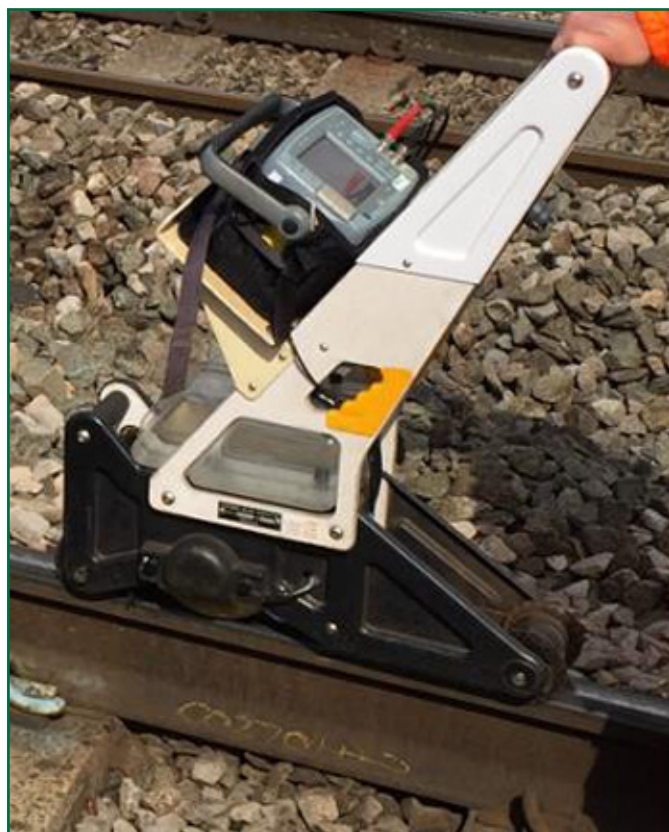
Figure 8: Sperry ultrasonic 'walking stick'

- 58 The RCF inspections involved the use of pedestrian ultrasonic test equipment, known as the Sperry 'walking stick' (figure 8). This is fitted with double flanged wheels to guide the ultrasonic test wheel along the head of the rail.

- 59 During some of the RCF inspections the rail was found to be deformed such that a lip had developed on the field side. This lip made the rail head wider and, in some locations, prevented the walking stick from being pushed over it, as the flanges on each side of its wheels were not far enough apart to cope with the width of the lipped rail. When this was found to be the case the tester reported on the test report sheet that the rail was ultrasonically untestable due to head profile. The rail defects standard, NR/L2/TRK/001 mod07 defines the action that must be taken in these circumstances, which is to replace the rail or reprofile the rail head (by grinding) and retest it within 4 weeks.

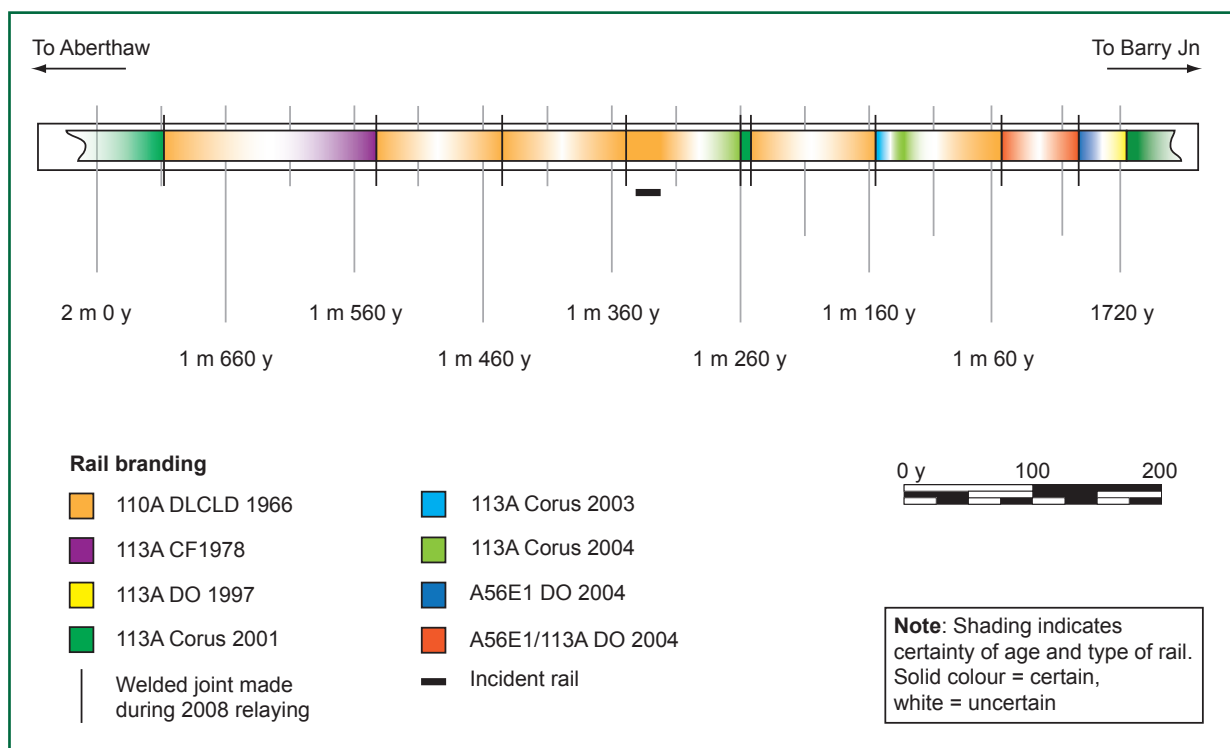
Figure 14: Plan of left-hand rail at Porthkerry showing rail type and age

77 The health and safety file also contained copies of weld inspection certificates for the rail welds made during the relaying work. These gave details of the type and profile of the rails joined along with the position of the weld along the track. The RAIB used the information on these certificates to produce a graphical representation of the age and profile of the left (low) rail (figure 14). This showed that the predominant rail type was normal grade BS110A rolled in 1966. There was only one grade of rail specified in the British Standard for rail (BS11:1959, 'Flat Bottom Railway Rails') in 1966, and this corresponded to the modern 'normal' grade, but amendment 2 to that standard in January 1964 stated that the chemical composition and properties required from the steel should be agreed between the manufacturer and customer. It is possible that British Railways agreed improved properties with Dorman Long for these rails because, when tested by the metallurgist, the chemical composition was found to be close to the modern 'wear resisting A' grade.

78 In addition to the BS110A rail, the weld certificates also recorded lengths of newer rail of normal grade BS113A section. Contrary to what was declared on the plain line GEOFIS/Construction details form (paragraph 76), no lengths of 1977 rail were recorded on the welding certificates.

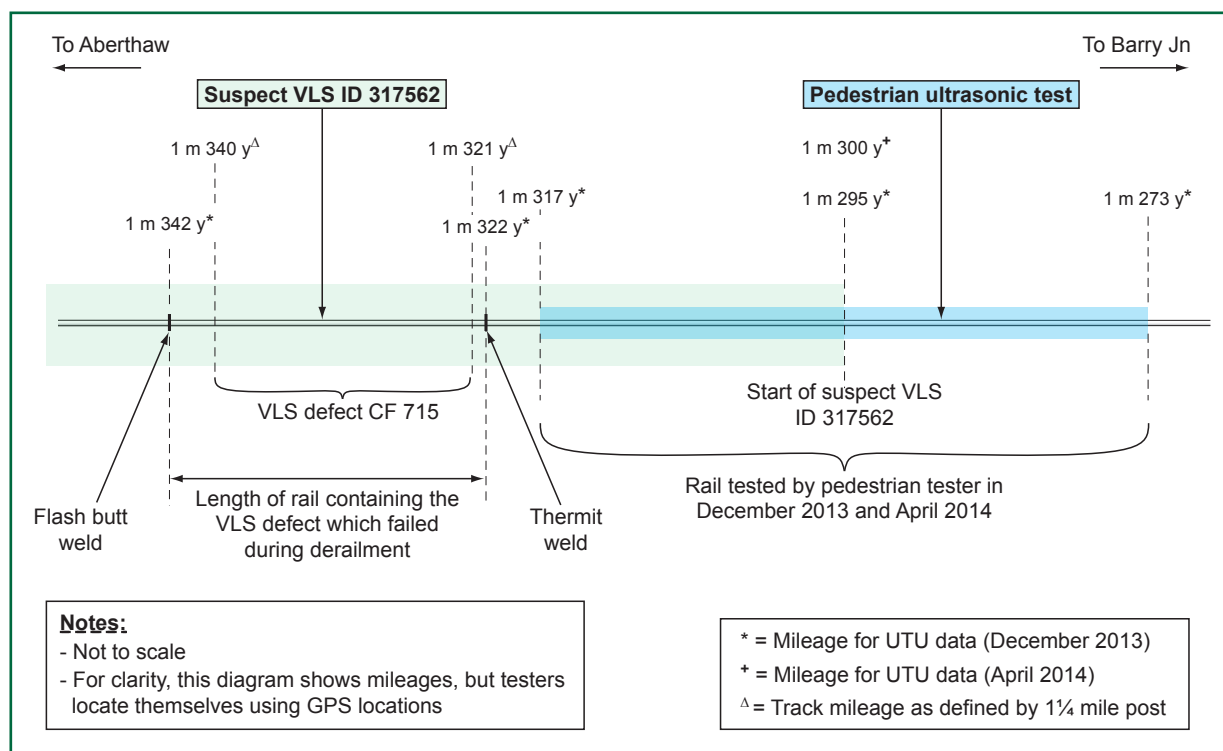
Figure 15: Diagram showing relative position of features on left-hand rail of down line

- 105 The process which Network Rail usually employs to identify VLS defects in rail is by dedicated visual inspection (paragraph 91). However, when the down line at Porthkerry was declared an RCF site in August 2012 (paragraph 57), an additional series of regular inspections was begun with the aim of monitoring the progression of the RCF. These included both visual and ultrasonic inspection of the rail. They were carried out by the ultrasonic inspection team, who reported via the section manager (rail testing and lubrication) to the rail management engineer until May 2014, and the Newport track maintenance engineer from then on.

106 The RCF inspection on 30 July 2014 found the VLS defect (paragraph 62) and assigned it identity 'CF715'. Details of it were input to the rail defect management system. Standard NR/L2/TRK/001 mod07 specifies the minimum action to be taken on discovery of rail defects. The action for a VLS in the head or web of the rail depends on whether the rail shows signs of the split widening; if there are signs, defined as the head spreading by 2 mm or more or there being visible cracking on the surface of the rail, the minimum action is '1B'. Action 1B means that an immediate 20 mph emergency speed restriction should be imposed and the rail should be replaced within 7 days. If there are no signs of the split widening, the action is less urgent and depends on the track category; for the track at Porthkerry the minimum action was '3M', which, for category 4 track, is to retest the rail at 104 week intervals. However, Wales Route had a policy of not leaving defects in track indefinitely (paragraph 51) and, where the minimum action was '3M', applied the next highest action, '3L', which is to remove the defect within 52 weeks.

107 The RCF inspection on 30 July 2014 did not identify any spreading of the head or cracking of the rail due to the VLS, so the action assigned was '3L'. The poor condition of the rail head due to the RCF and the lipping on the field side of the rail head would have obscured visual evidence of head widening. The metallurgical examination of the rail (paragraph 68) revealed that the VLS crack had not reached the rail head, but had broken through to the surface at the upper fillet radius (figure 5). The inspector stated that he used calipers to measure the head width below the lipping and he did not find it was spread by as much as 2 mm. The inspector also stated that he looked for cracking beneath the head of the rail and did not see any evidence of this. The cracking at this position was difficult to identify without conducting non-destructive testing (paragraph 113).
