Rail Accident Investigation Branch

Rail Accident Report

Freight train derailment at Heworth, Tyne and Wear 23 October 2014

Report 16/2015
September 2015

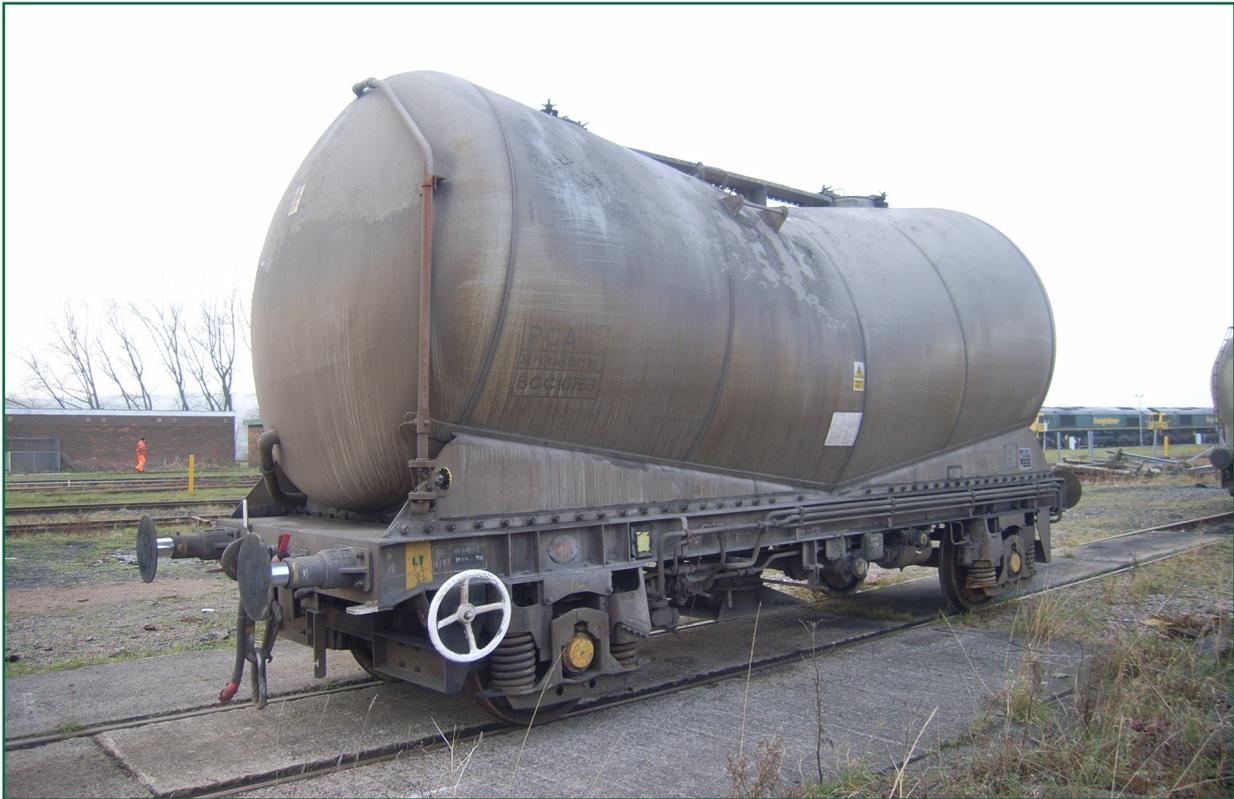
Figure 4: PCA wagon 10769 that derailed at Heworth

- 11 The freight train that derailed, reporting number 6S26, was the 14:47 hrs service from Seaham Harbour, near Sunderland, to Dunbar cement works at Oxwellmains. It consisted of a class 66 diesel-electric locomotive, 66 616, hauling 25, two-axle, PCA cement tank wagons (the PCA wagon type is described in more detail in paragraphs 24 and 25). All of the wagons were empty. The wagon that derailed was number 10769 (figure 4).

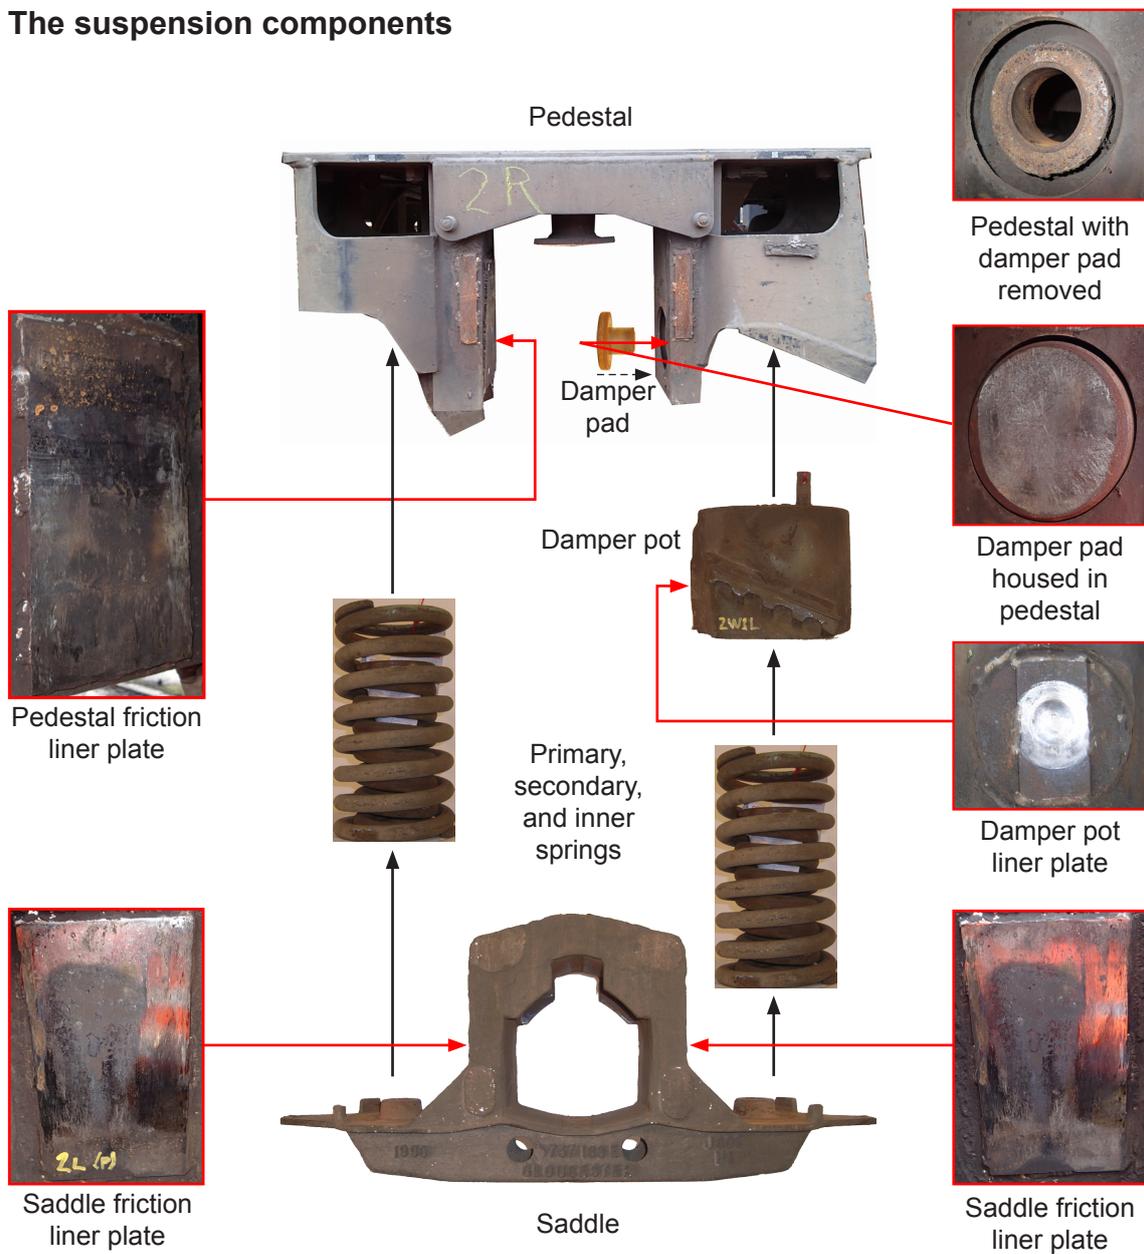
Figure 7: The 'Mark 2' Gloucester pedestal suspension

- 26 The 'Mark 2' Gloucester pedestal suspension was fitted to the PCA wagon that derailed at Heworth (figure 7). It was designed and manufactured by the Gloucester Railway Carriage and Wagon Company. This suspension unit has a *pedestal* (also known as an axle horn guide) bolted to the underside of the frame. A *saddle* houses the axle bearing and slots into the pedestal.

- 28 On the inner side of the saddle, a *damper pot* is located between the top of the springs and the pedestal. The weight of the wagon and its payload at each corner acts upon a pair of wedges between the pedestal and the damper pot. The downwards force acting on the damper pot creates a horizontal force through the wedge which pushes a *damper pad*, housed inside a hole in the pedestal, against a friction liner plate on the saddle, to damp the vertical movement of the saddle. The damping force thus changes according to the load on that corner of the wagon.

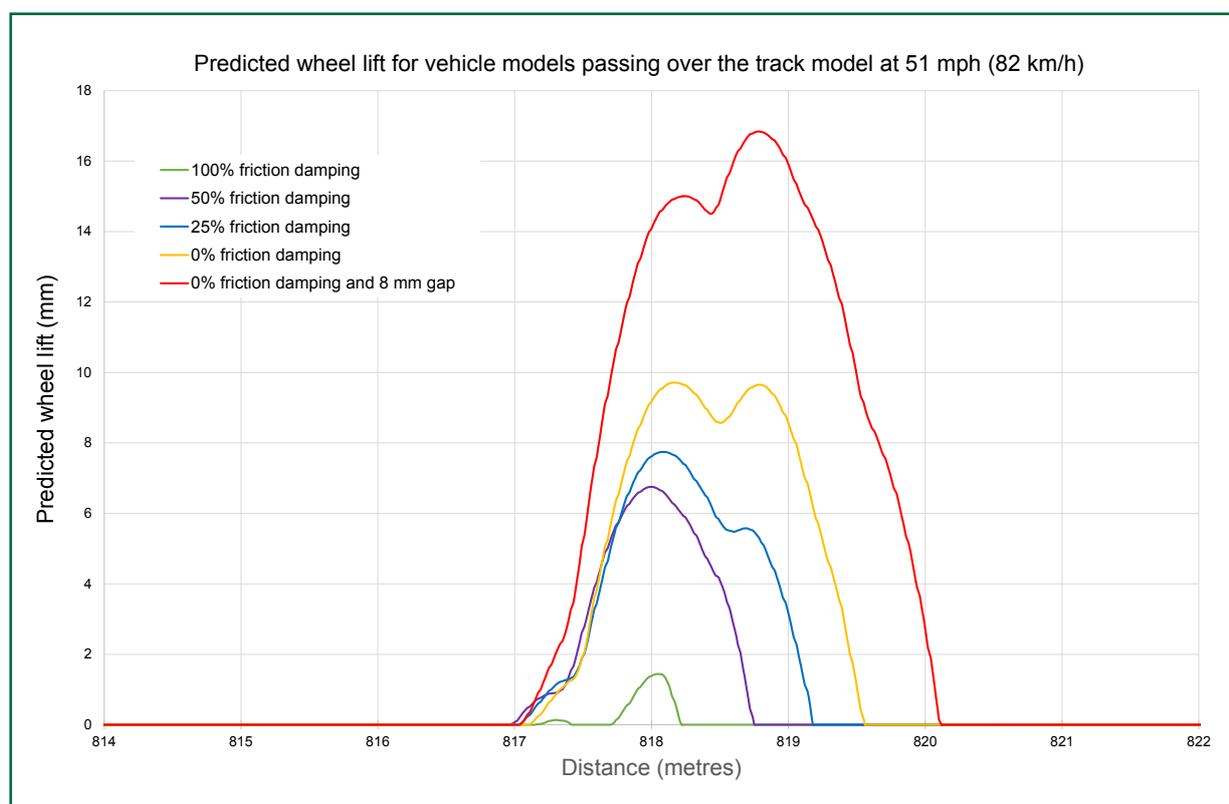
Figure 11: Simulation results for the leading left-hand wheel of vehicle models passing over the track model at 51 mph (82 km/h)

- 52 The dynamic modelling predicted that when a wagon with a working suspension (ie no loss of damping at all) passed over the track at the same speed that train 6S26 was travelling at when it derailed (paragraph 17), the leading left-hand wheel was fully unloaded due to the vertical track geometry, and the wheel lifted off the rail a small amount (1.4 mm). None of the other wheels were predicted to be fully unloaded. Figure 11 shows that as the amount of damping on the leading right-hand corner was reduced, the wagon's ride performance at its leading left-hand wheel worsened, with this wheel lifting higher and for longer (up to 17 mm over a distance of 3.1 metres). Further simulations to understand the sensitivity of the wagon's ride performance to changes in speed showed the worst ride performance occurred at 50 mph (80 km/h), when there was no damping and a gap between the friction liner plates. These conditions matched those at the time of the derailment. Further details about the results from the dynamic modelling are provided in appendix D.

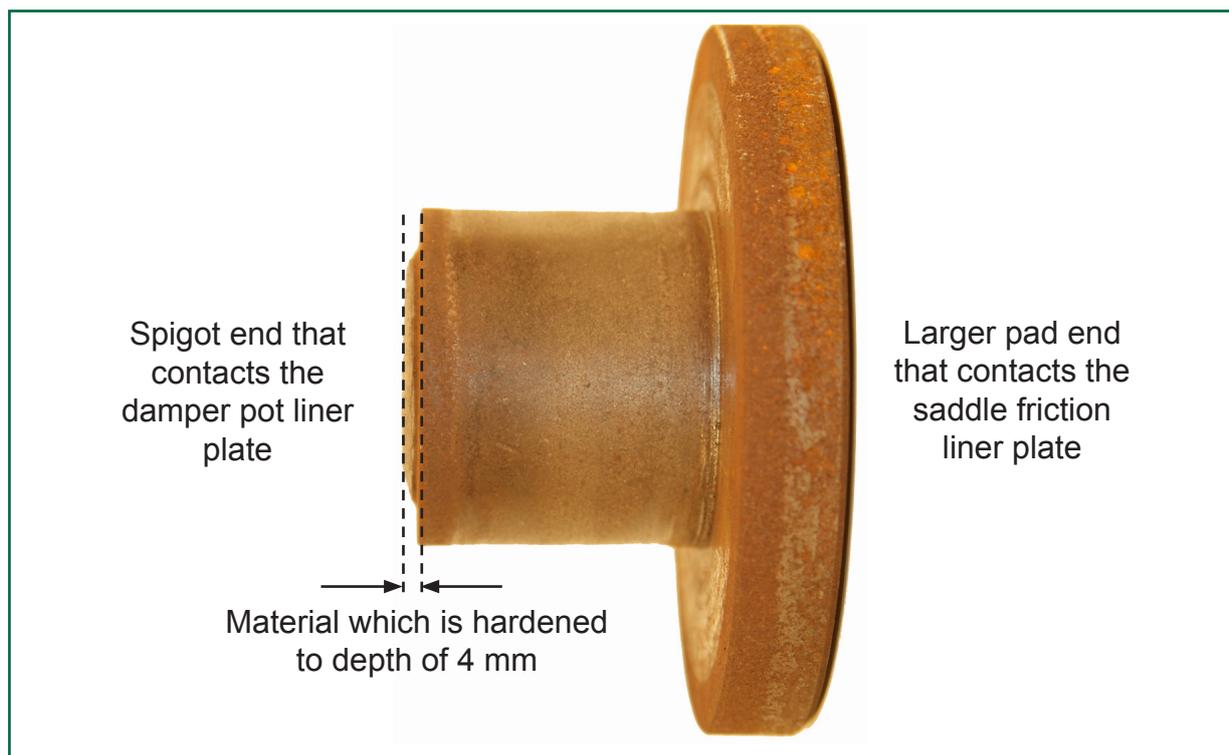
Figure 12: A damper pad used in a 'Mark 2' Gloucester pedestal suspension

- 56 Figure 12 shows a damper pad used in a 'Mark 2' suspension. When in situ within the suspension, the larger diameter end rubs up and down against a friction liner plate welded onto the saddle. The smaller diameter spigot end is in contact with a liner plate welded onto the damper pot.

- 58 The damper pad specification calls for the smaller spigot end to be hardened to a depth of 4 mm (figure 12). Once this hardened material is worn away, the underlying material that is exposed is softer and will wear much quicker. The depth of hardening on a new damper pad, which has an overall length of 69 mm, corresponds with the wear limit of 65 mm in Freightliner's vehicle maintenance instruction.

- 59 The damper pad from the leading left-hand corner was tested and the hardness recorded on the tip of the spigot end exceeded the value required by the specification. It was hardened to a depth of about 3.5 mm, but allowing for 1 mm of wear that was noted, it is likely that the depth of hardening when new would have met the specification.

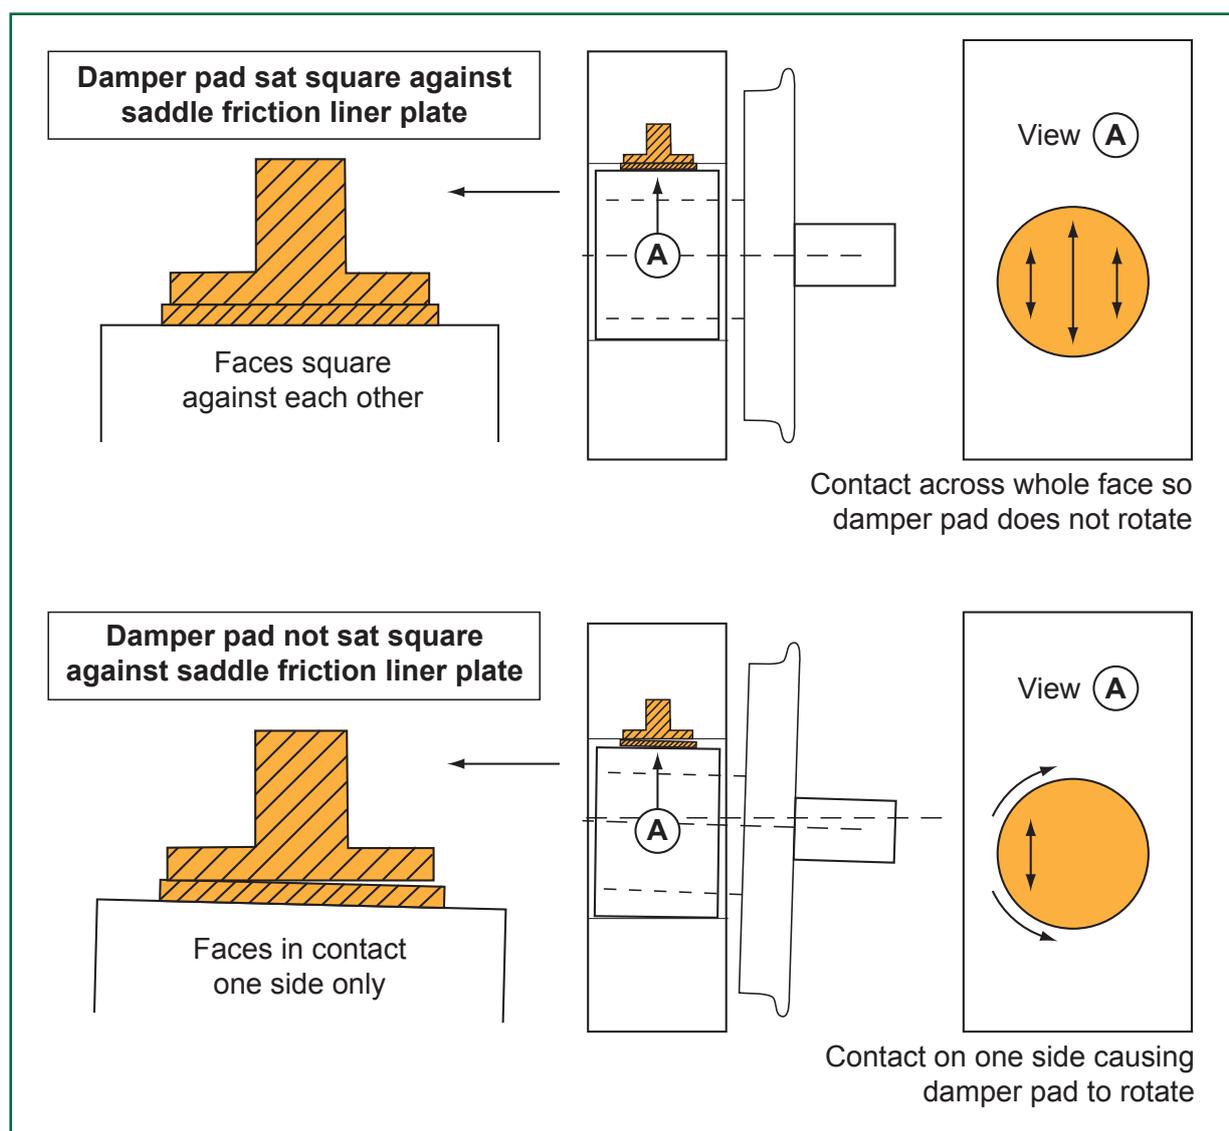
Figure 14: Mechanism for damper pad rotation within the suspension

68 The marks on the wear faces of the damper pad (figure 13) indicate that it had been rotating while in service (paragraph 61). Normally, the larger diameter face of the damper pad will be sitting square against the friction liner plate on the saddle and move up and down against it. If the damper pad is not square against the saddle friction liner plate, the up and down movement will act on just one side of the wear face causing the damper pad to rotate (figure 14). The damper pad sits in a round bush in the pedestal and there is nothing to prevent it from rotating.

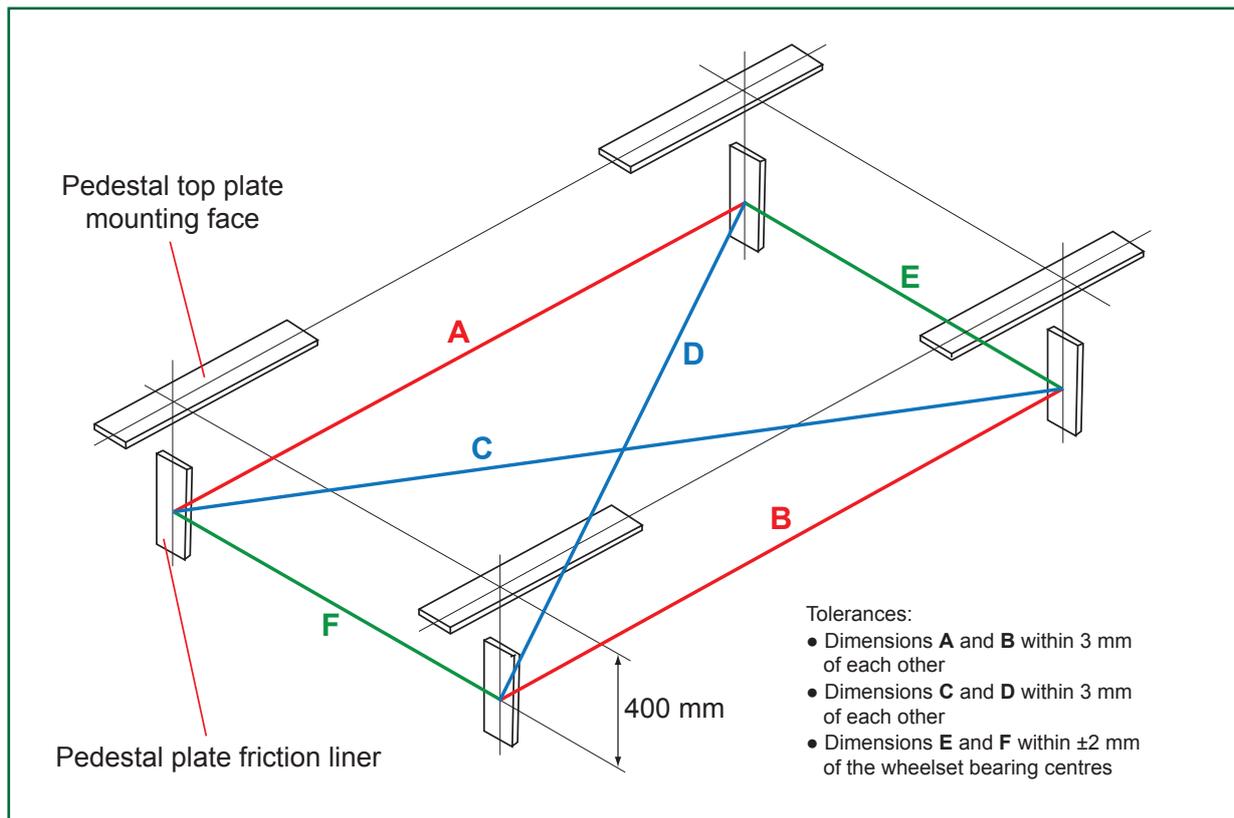
Figure 15: Tolerances for the positions of the pedestals (extracted from the maintenance manual for the 'Mark 2' Gloucester pedestal suspension)

69 The maintenance manual for the 'Mark 2' Gloucester pedestal suspension defines tolerances for the positions of the pedestals when bolted to the wagon's underframe. These dimensions are shown in figure 15. They are not normally measured; they would only be measured when the wagon was manufactured or if a pedestal on one corner was replaced.

- 70 The RAIB surveyed wagon 10769 after the accident to measure these dimensions and found the results did not fall within the defined tolerances². This was probably due to the amount of damage that the pedestals had sustained while the wagon ran derailed. The trailing right-hand pedestal was the most damaged (figure 16). Further measurements taken at the top of the pedestal friction liner plates, where there was less damage to the pedestals, showed dimensions A and B and dimensions C and D (figure 15) were within about 1 mm of each other, which is within the specified tolerance. The measurement for dimension E (leading end) was in tolerance at 1.9 mm but dimension F (trailing end) was outside the tolerance at 3.8 mm.

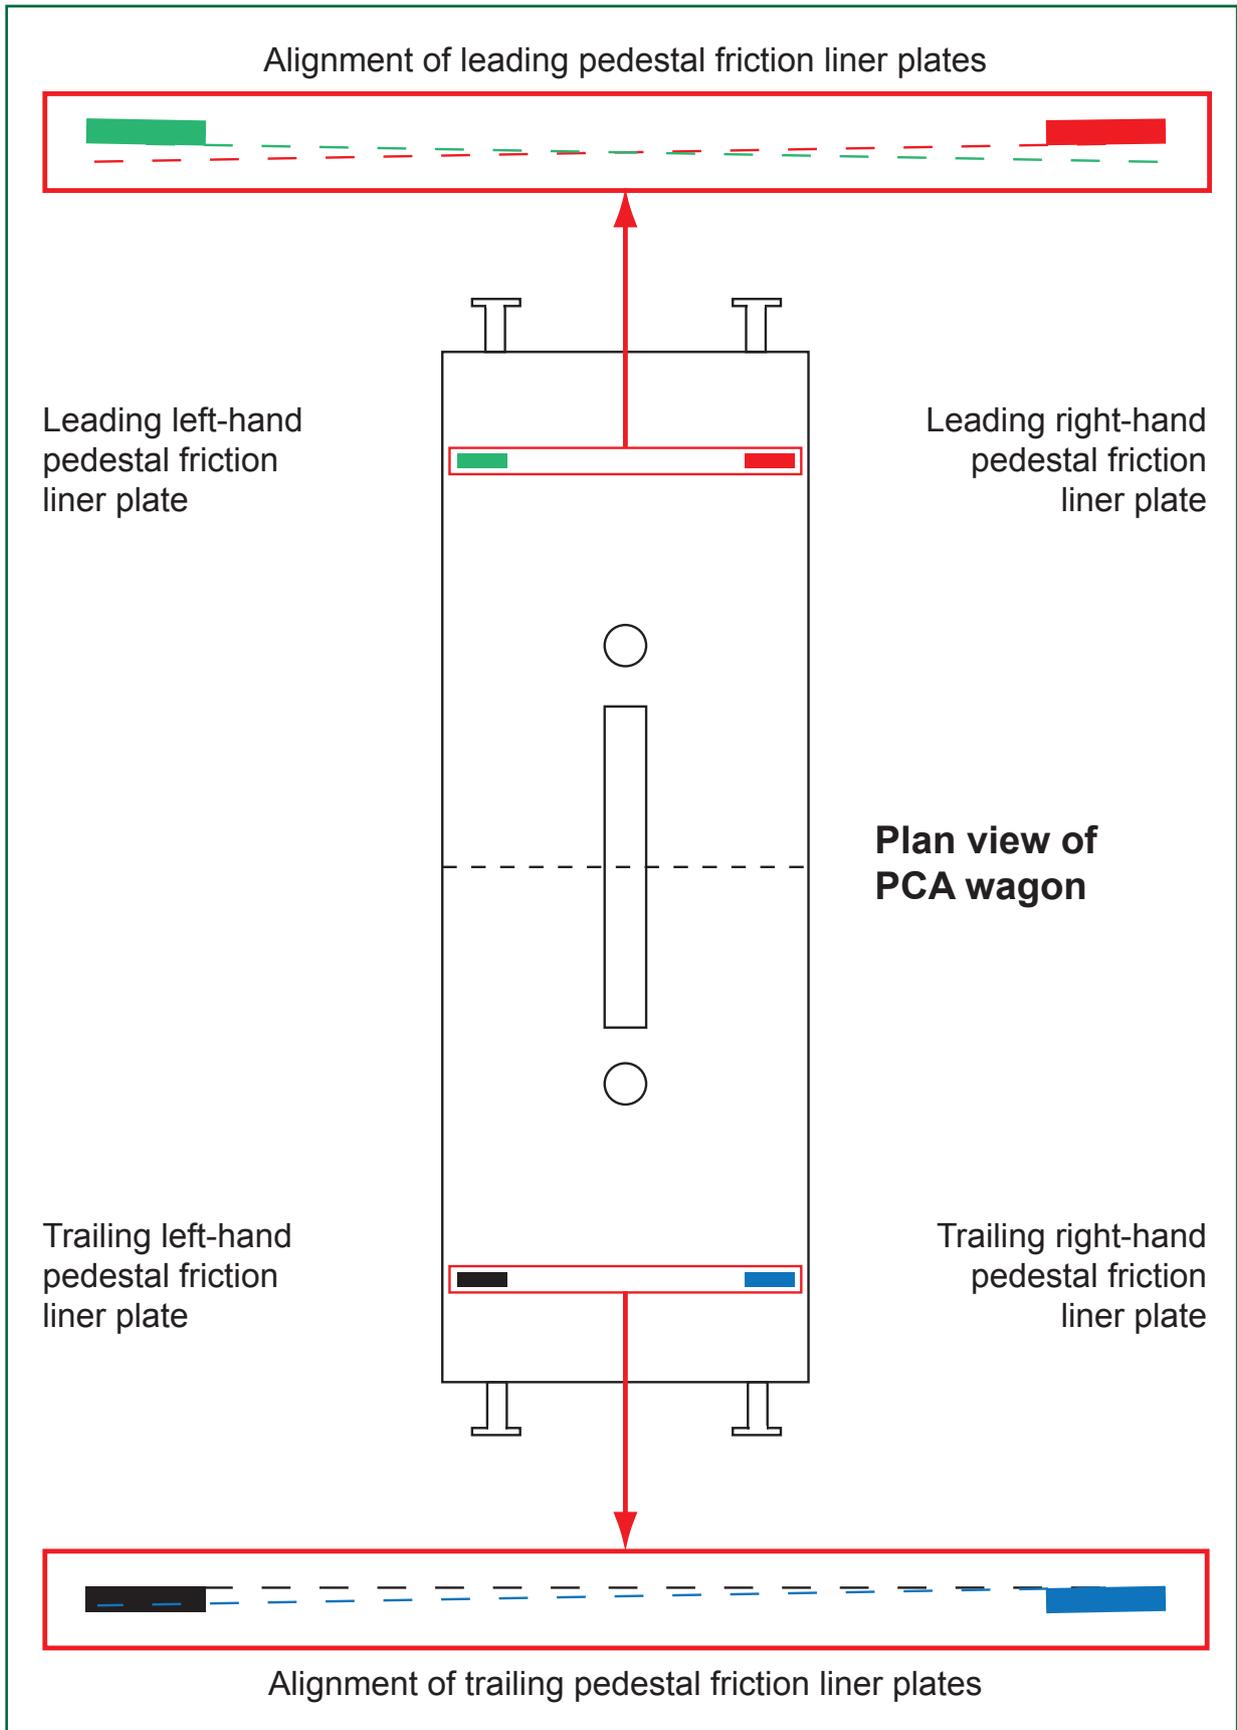
Figure 17: Leading and trailing wheelset alignment

- 71 The alignment of the leading and trailing pedestals was plotted using the measurements taken at the top of the pedestal friction liner plates. The results are shown in figure 17. The measurements for the trailing pedestals indicate that the left-hand pedestal is perpendicular to the wagon's frame but the right-hand pedestal turns inwards. However, this pedestal was damaged in the accident (figure 16). The measurements for the leading pedestals indicate both pedestals turn a very small amount inwards towards each other. If the wheelset was running aligned with the left-hand side pedestal, the saddle would not be squarely aligned within the pedestal on the right-hand side. As discussed earlier (paragraph 68), this would allow the damper pad to rotate and cause its spigot end to wear away.

- 72 It is probable that the alignment of the leading wheelset in its pedestals on wagon 10769 caused the excessive wear to the damper pad found on the leading right-hand corner. However, this small amount of misalignment was not enough to cause the wheels to wear quickly or unusually. Maintenance records showed this wheelset was placed under wagon 10769 in October 2012 and wheel profile measurements taken after the derailment did not show high levels of wear or any unusual tread or flange wear.

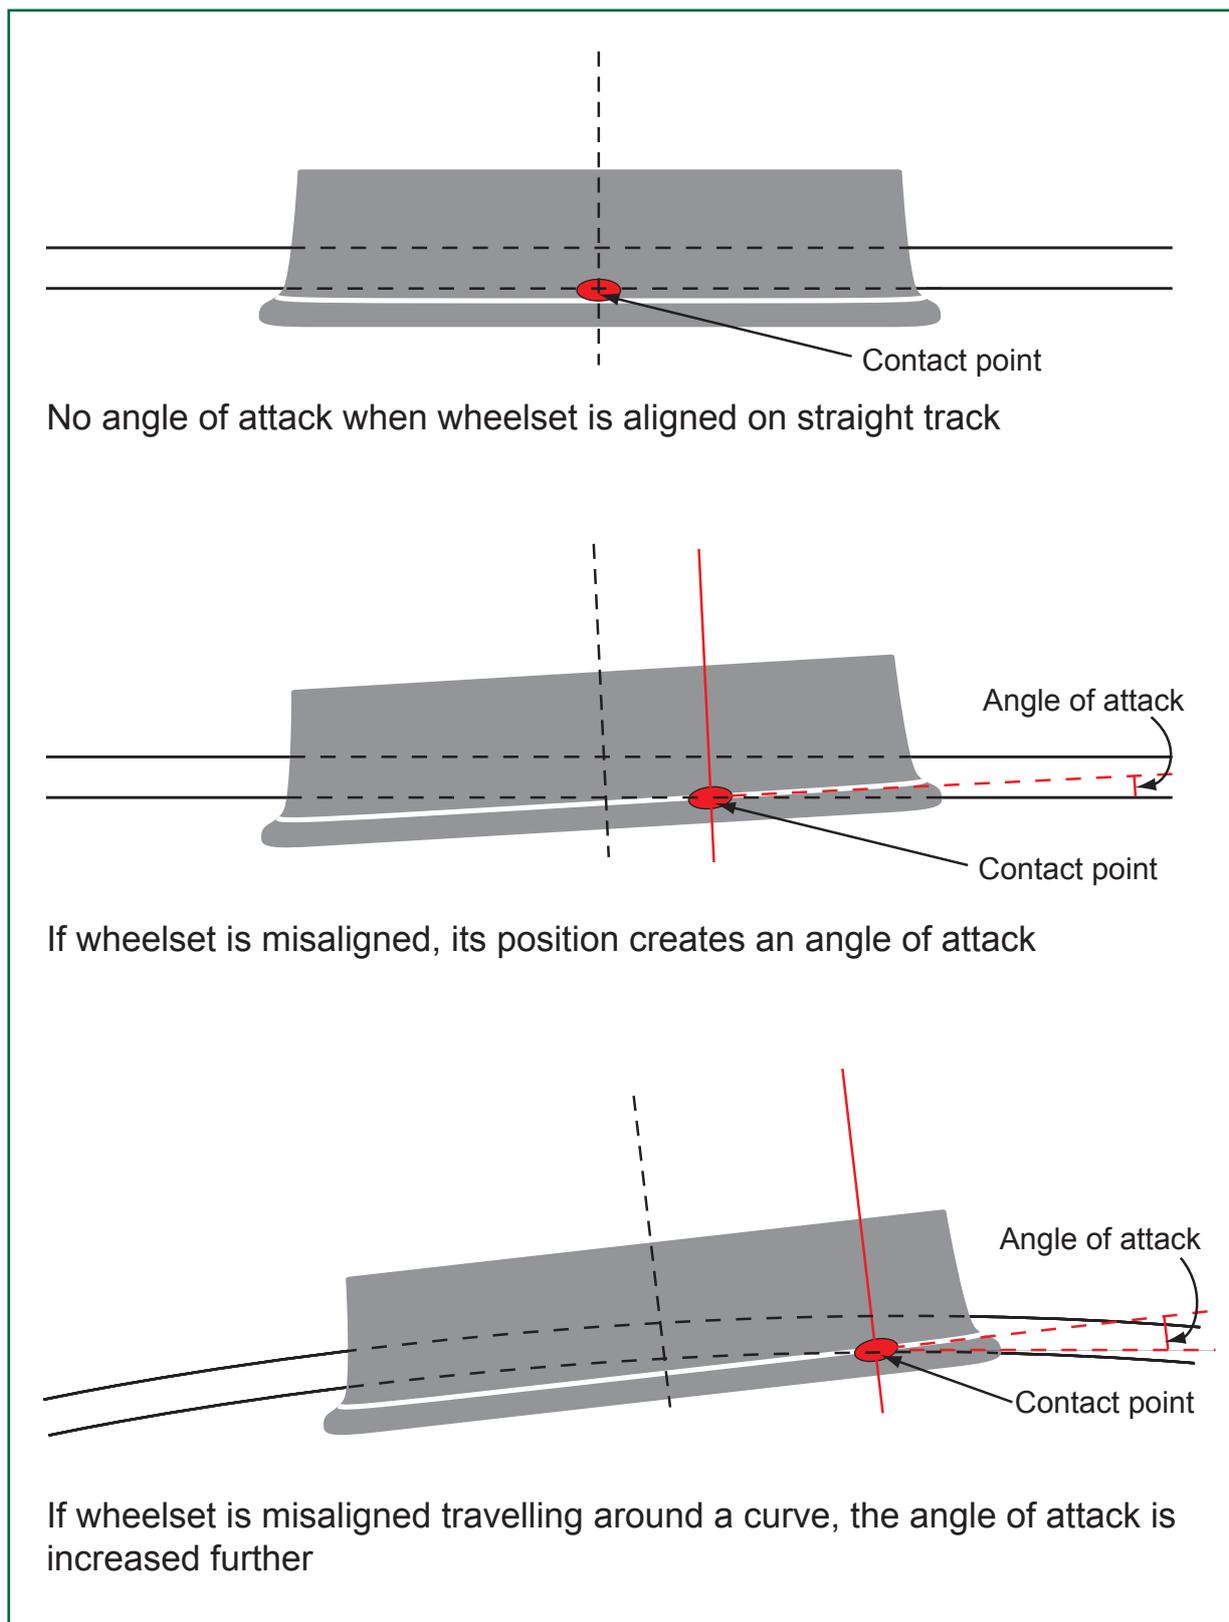
Figure 18: Wheelset angle of attack

- 73 If the leading wheelset was misaligned within the suspension, this would alter its position while running. This would become more significant while travelling around a curve because it would increase the wheelset's angle of attack; this is the angle between the running edge of the rail and the plane of the wheel flange (figure 18). Changing the wheelset's angle of attack alters the amount of lateral force where the wheel is in contact with the rail, which could give rise to the conditions required for a derailment as indicated by the vehicle dynamics study (appendix D, paragraph D6).

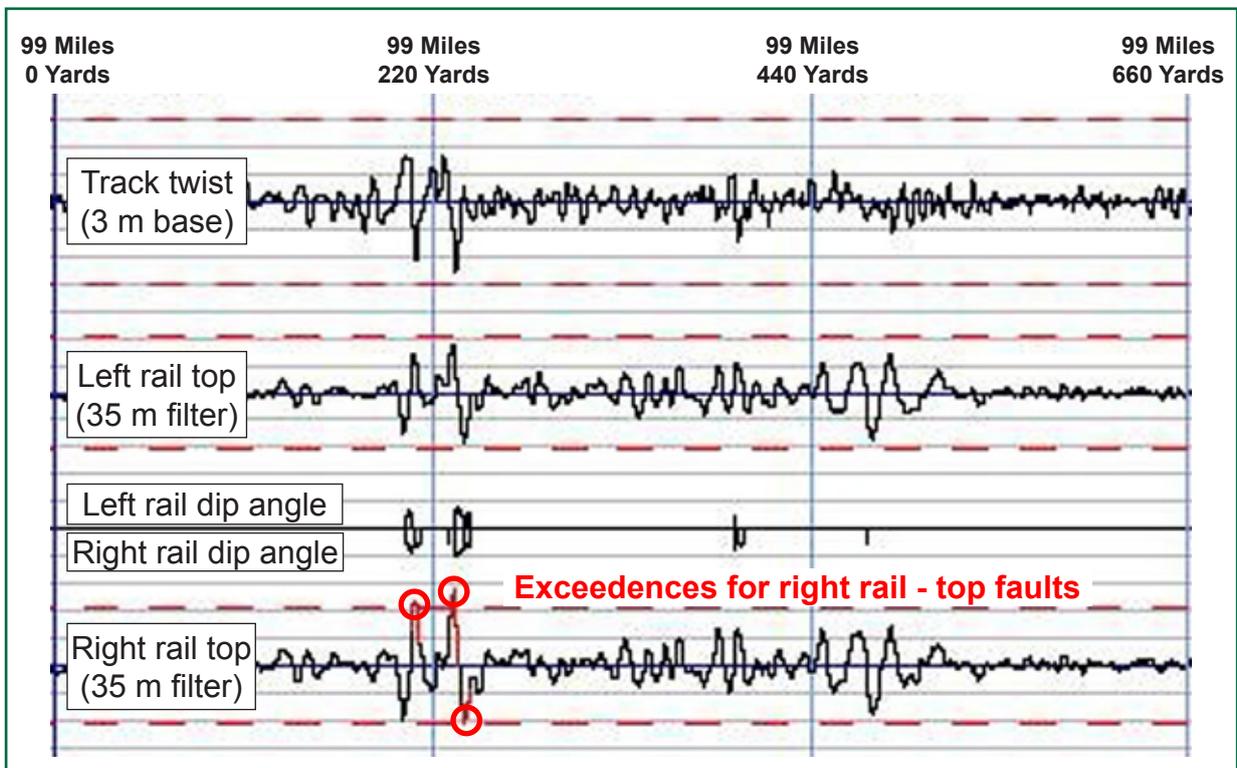
Figure 21: Extract from the track geometry trace recorded on 11 October 2014

- 76 Track geometry recording trains had measured these variations in the vertical track geometry. Track geometry data is plotted on a trace and the trace from the last run prior to the derailment (paragraph 37) shows the variations in the level (or top) of the left-hand and right-hand rails (figure 21). The trace for the right-hand rail shows three changes in top in short succession exceeding the intervention limit for track maintenance in NR/L2/TRK/001/mod11³. The trace shows that the differences in level between the two rails were not enough to cause a *track twist* that required maintenance action. It also shows rates of change in the height of the rails were large enough for dip angles to be recorded. Dip angles are normally observed at joints or welds in the track rather than on sections of continuously welded rail.

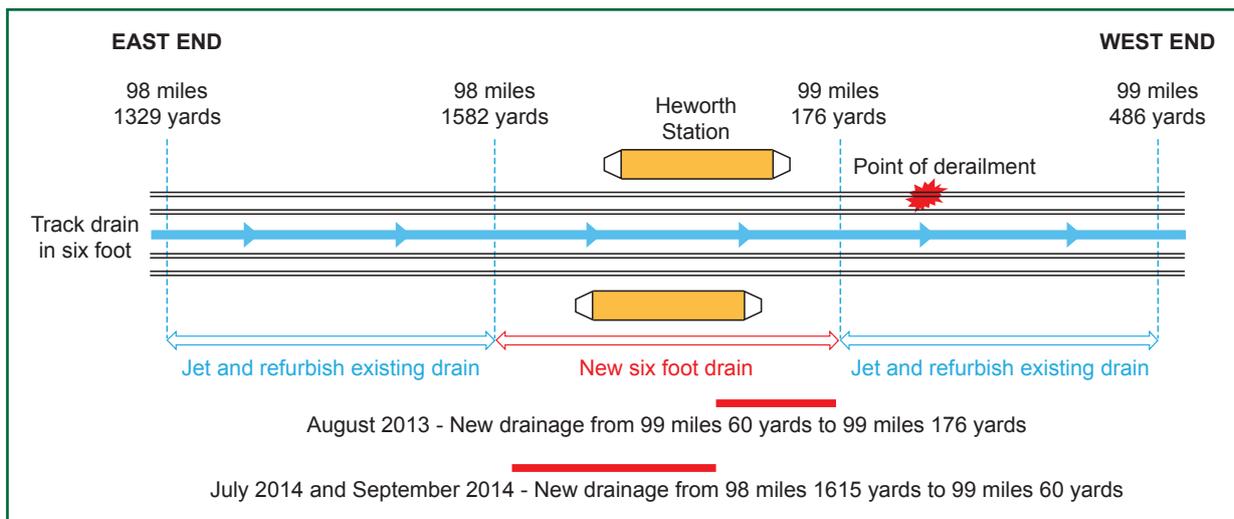
Figure 22: The scope of the proposed track drainage improvements at Heworth

- 86 The point of derailment is in a small cutting and on a falling gradient (in the direction of travel) on the Down Sunderland line, starting at Pelaw at 98 miles 484 yards. These features channel water towards and under the railway lines. Track drainage is installed in the six foot between the Up and Down Sunderland lines to take this water away.
- 87 Network Rail's Route Asset Manager (track) (the RAM (track))⁴ was allocated budget for track drainage improvements on LNE Route and the Track Maintenance Engineers were asked to propose locations where such improvements could be made. The Heworth station area was one of the proposed locations.
- 88 Network Rail's Works Delivery organisation was used to deliver this work and during 2013 it planned to make drainage improvements at Heworth. The scope of work proposed by Works Delivery is shown in figure 22.

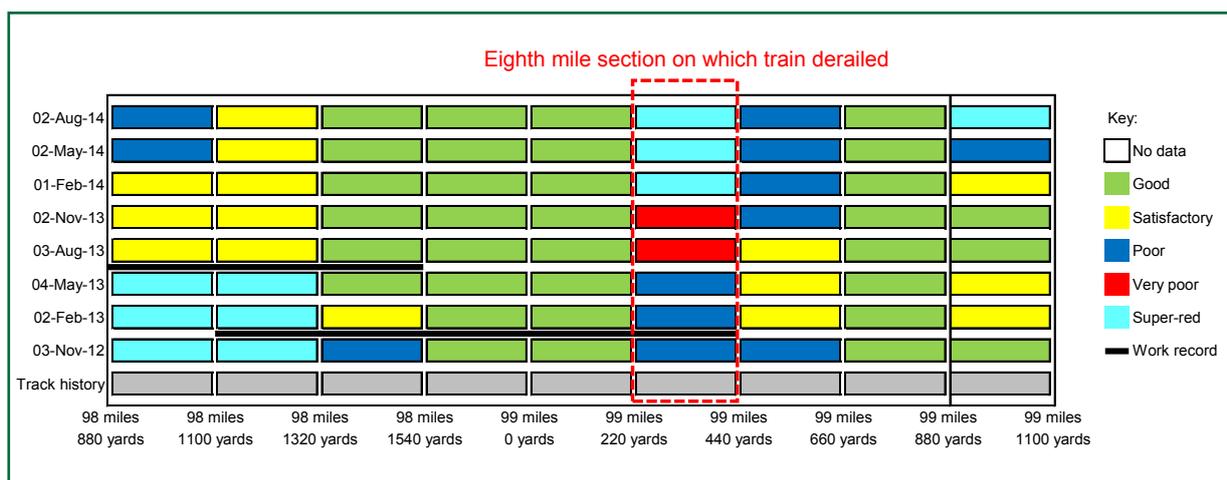
Figure 26: Chart showing the SD values recorded on the Down Sunderland line

101 The track geometry recording trains that ran over the Down Sunderland line also recorded a *standard deviation* (SD) value for the overall quality of the vertical track geometry for each eighth of a mile section (appendix E, paragraphs E3 to E4). A chart showing how the SD values for the eighth of a mile section in which the train derailed have changed over the previous 10 recordings is shown in figure 26. It shows that the SD value for the portion of track from 99 miles 220 yards to 99 miles 440 yards had worsened over that time, falling into the very poor band in August 2013. In 2014, each run recorded a SD value which fell in the *super-red* band (appendix E, paragraph E4).

- 102 When the SD value fell into the very poor band, NR/L2/TRK/001/mod11 required TSM2 to inspect this track by no later than the next supervisor inspection. The aim of this inspection is to identify the actions needed to address the underlying causes of the very poor track geometry, improve the condition of the track components and rectify track geometry defects. However, there is no evidence that this inspection took place.

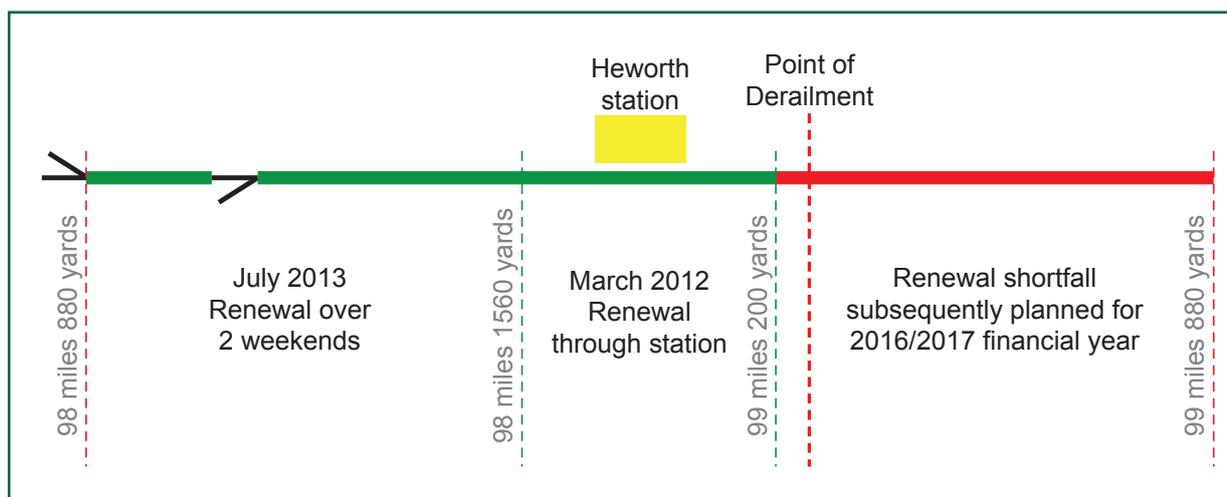
Figure 27: Track renewals on the Down Sunderland line

- 120 The long term solution at Heworth required the track to be renewed. The need for replacing the ballast on the Down Sunderland line at Heworth due to contamination had first been identified back in 2006 (paragraph 94). In 2008 the RAM (track) team inspected the site, accepted this work needed to be done and expanded its scope to a plain line track renewal, ie replacing the ballast, sleepers and rails, as this was just as cost effective to do as replace the ballast. The track renewal was planned to take place through Heworth station (figure 27).

- 121 The RAM (track) team included the plain line renewal in the track renewals programme and initially proposed that it would take place during the financial year 2011/2012. Later in 2008, the RAM (track) team reprioritised it to take place in 2012/2013. This decision was reviewed in 2010 and the track renewal was brought forward again for delivery in 2011/2012. It was subsequently delivered by Network Rail Investment Projects in March 2012, with the track on the Down Sunderland line renewed from 98 miles 1560 yards to 99 miles 200 yards. This work stopped just short of where train 6S26 derailed at 99 miles 253 yards.

- 122 Due to ongoing issues with the track quality on the Down Sunderland line in the Heworth area, the RAM (track) team decided in 2012 to extend the track renewal mileage either side of the station so that it now covered from 98 miles 880 yards to 99 miles 880 yards (figure 27). The track from 98 miles 880 yards to 98 miles 1560 yards had a long standing 30 mph (48 km/h) speed restriction on it for poor top and cyclic top defects, which were due to contaminated ballast and wet beds. This part of the renewal was initially planned to take place in the financial year 2012/2013.

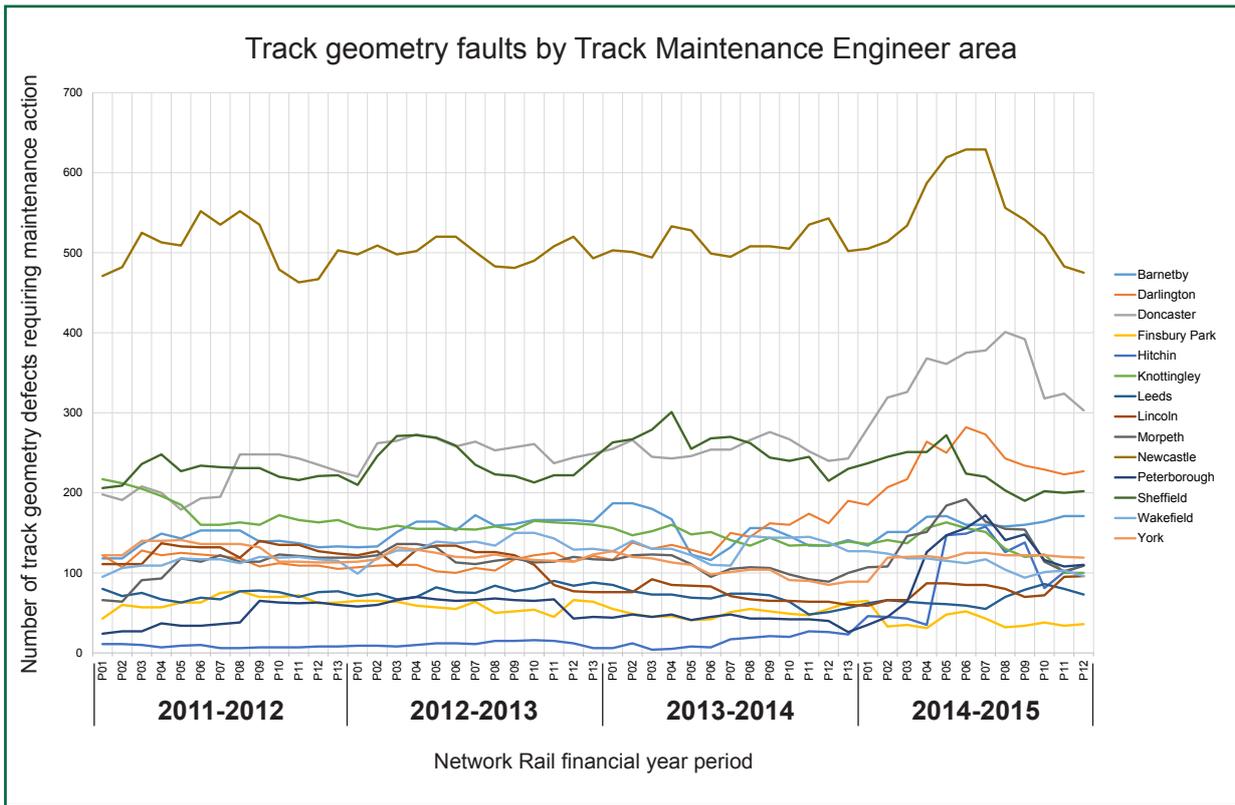
Figure 28: Numbers of reportable track geometry faults by Track Maintenance Engineer area on LNE Route

- 129 The track geometry recording trains running over the track assets in the whole of the area covered by the Newcastle Track Maintenance Engineer (figure 8) were consistently reporting a high number of track geometry defects. Figure 28 shows that over the past four years, this area has had the highest number of reportable track geometry defects on LNE Route. The number of track geometry defects was consistently much higher than the other LNE Track Maintenance Engineer areas.
- 130 Figure 29 shows that over the past four years the Newcastle Track Maintenance Engineer's area has had the highest percentage of eighth of a mile sections of track with a SD value in the super-red band on LNE Route. Again, the numbers for this Track Maintenance Engineer area were consistently higher than those for other LNE Track Maintenance Engineer areas.

- 131 The Newcastle Track Maintenance Engineer area is the sixth largest of the fourteen Track Maintenance Engineer areas on LNE Route, in terms of its number of track miles. If the number of track geometry defects for each Track Maintenance Engineer area is normalised by using its number of track miles, the Newcastle Track Maintenance Engineer area has a consistently higher number of track geometry defects per mile than any of the other areas on LNE Route. Witness evidence indicated that while, in geographical terms, the Newcastle Track Maintenance Engineer area is not the largest, it is a difficult area to manage. In 2008 Network Rail had changed the Track Maintenance Engineer boundaries so the Newcastle Track Maintenance Engineer was responsible for the Newcastle and Middlesbrough Track Section Manager areas (paragraph 32). Witnesses explained that each of these areas has track assets which are challenging to maintain; the Middlesbrough area includes a lot of older track and points which are in a poor condition and generate a high number of track geometry faults, and the Newcastle area includes some old track assets plus others which are among the most complex on LNE Route, particularly in and around the Newcastle station area.

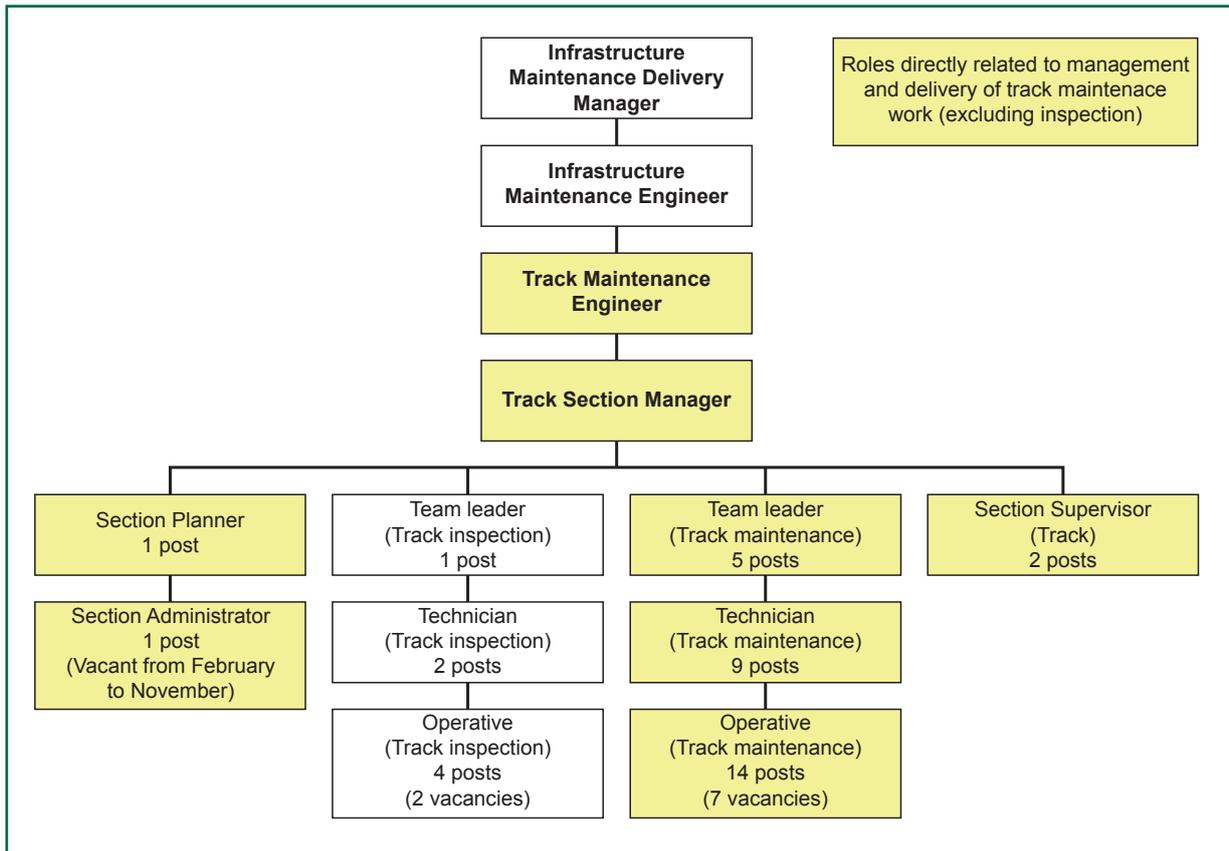
Figure 30: The Newcastle Track Section Manager organisation chart in 2014

134 The phase 2b/c template organisation for the Newcastle Track Section Manager organisation shows it had a total of 40 staff (figure 30). This comprised a Track Section Manager, 2 supervisors, a planner, a section administrator and 35 maintenance staff. Of these 35, 7 were allocated to track inspection and the remaining 28 to track maintenance. During 2014, the Newcastle Track Section Manager organisation had 2 vacancies in track inspection (ie 2 out of 7 posts were vacant) and 7 vacancies in track maintenance (ie 7 out of 28 posts were vacant).

135 The number of vacancies had increased since 2011 because posts had not been filled when staff had left. The Newcastle Infrastructure Maintenance Delivery Manager (IMDM) and the Newcastle Infrastructure Maintenance Engineer (IME) had been reluctant to recruit due to the introduction of PLPR (paragraphs 35 to 37) and the possible need to find roles for staff displaced from the track inspection team. However, since 2011 the timescale for introducing PLPR had been put back several times, which in turn had delayed any plans for recruiting staff. In addition to this, as work to introduce PLPR progressed, Network Rail reduced its estimates of how many staff would be displaced from inspection duties. By the start of 2015, Network Rail LNE route had decided that any reduction in the number of posts in track inspection, due to the introduction of PLPR, would result in a corresponding increase in the number of posts in the track maintenance teams.

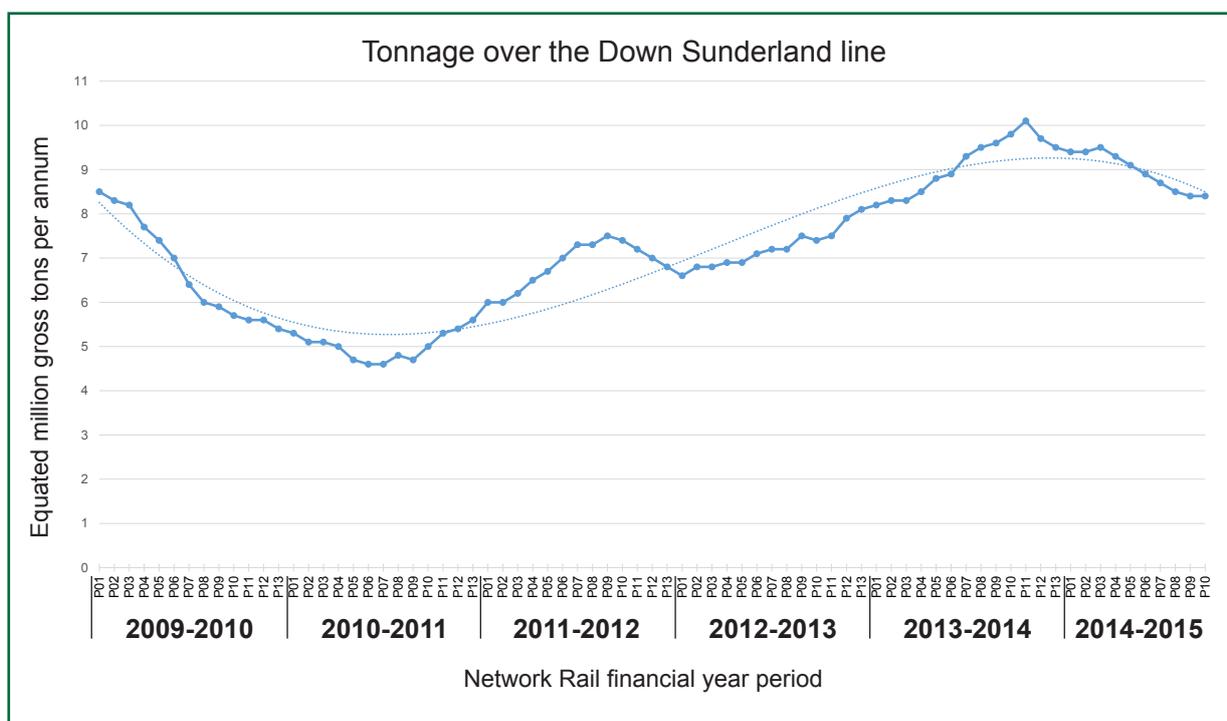
Figure 31: Tonnage over the Down Sunderland line

150 Network Rail's data for the amount of tonnage passing over the Down Sunderland line at Heworth shows that it doubled from about September 2010 to January 2014 (figure 31). This was due to a steady increase in the number of freight trains running into and out of Tyne Dock, particularly the loaded trains coming out onto the Down Sunderland line. The increased number of freight trains was not enough to trigger a change in the track's category, which would affect its inspection regime. However, the freight trains ran throughout the day and night and affected the maintenance team's ability to get access to the track.

151 Before the freight traffic out of Tyne Dock started, the track maintenance teams could take possession of the track between Pelaw and Newcastle during the night on most weeks when they needed to. After the amount of freight traffic increased, these possessions could only be taken once every six weeks, leaving less opportunity to do repairs that were planned at short notice.
