Rail Accident Investigation Branch

RAIB Bulletin 03/2015

Collision between a train and a wooden sleeper, near Somerleyton, Suffolk, 18 June 2015

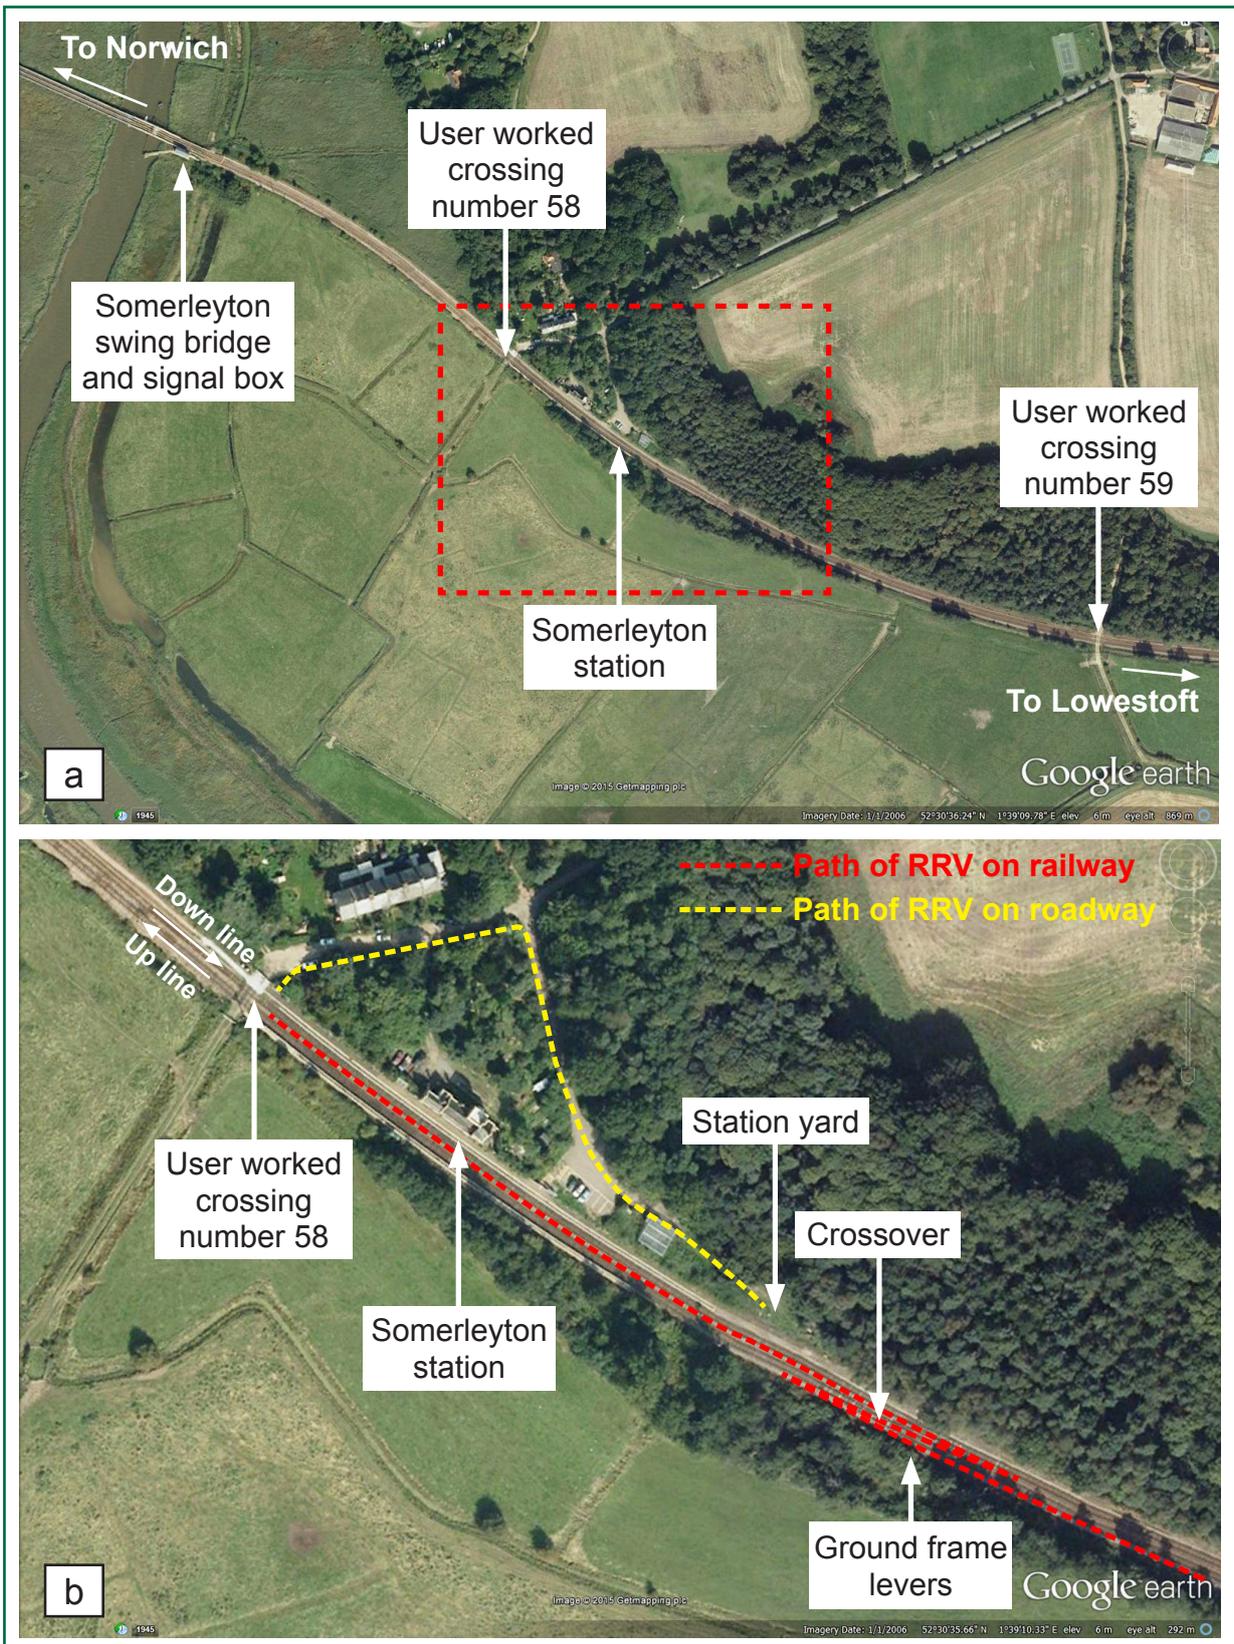
Figure 2: Layout at Somerleyton station

- 6 There is a station yard between the crossover and the station, which can be accessed from the down line (figure 2b). This yard is used by Network Rail to stable rail mounted equipment such as *road-rail vehicles* (RRVs) and trailers, and to store materials.

- 16 The MC reported that he walked in the cess, ahead of the leading trailer, alternating his gaze between looking ahead, maintaining visual contact with the MO and looking towards the rear trailer to monitor its load. As they approached Somerleyton, near to user worked crossing number 59 (figure 2a), the MC noticed some sleeper bundles that they had missed on the way out. They stopped by each one, picking it up and loading the sleepers onto the trailers.

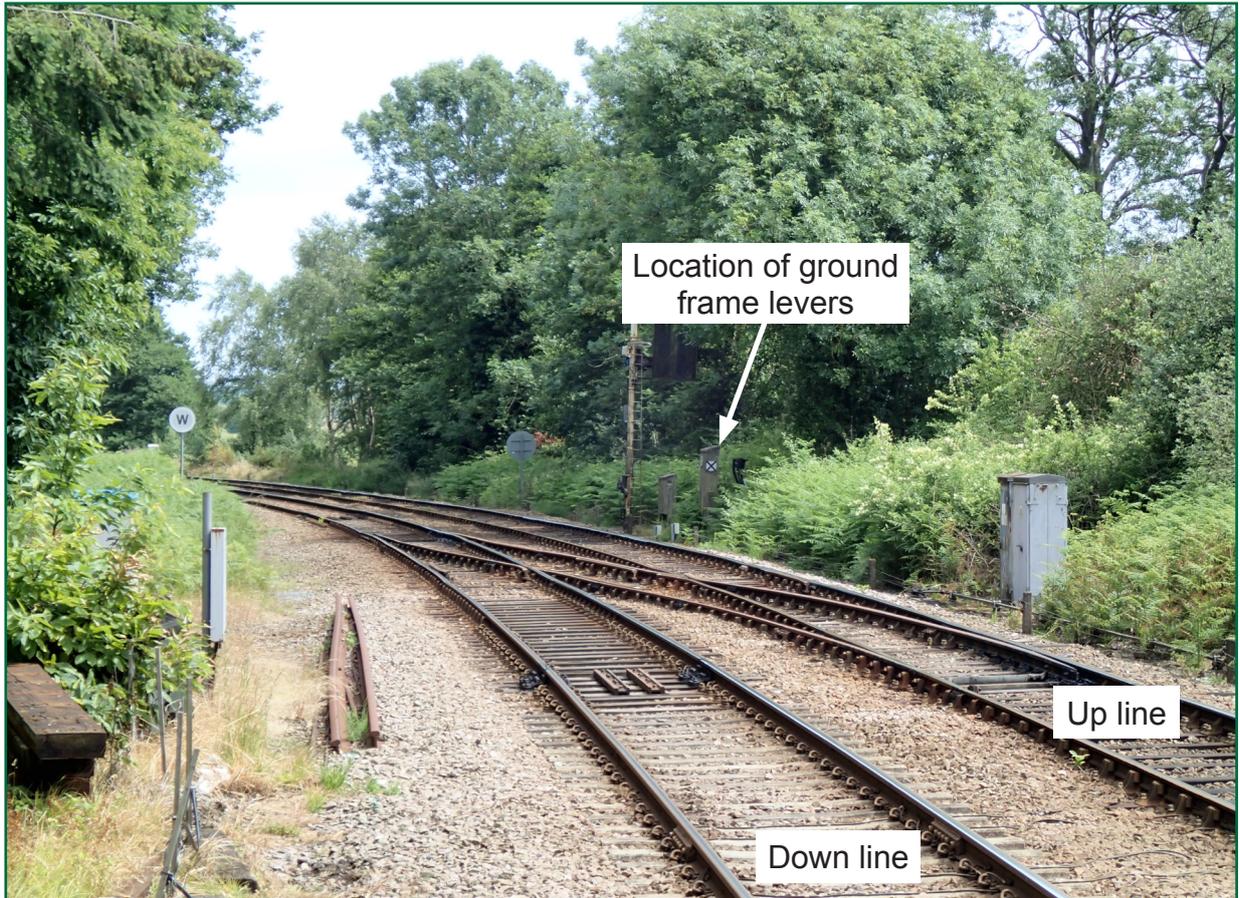
Figure 3: The crossover at Somerleyton station

- 5 A crossover between the up and down lines is located on the Lowestoft side of the station at 18 miles 7 chains (figure 3). The points of the crossover can be moved using levers in a *ground frame*, which is located adjacent to the crossover. The ground frame is locked and the levers cannot be moved unless the signaller at Somerleyton signal box (figure 2a) gives permission by releasing them.

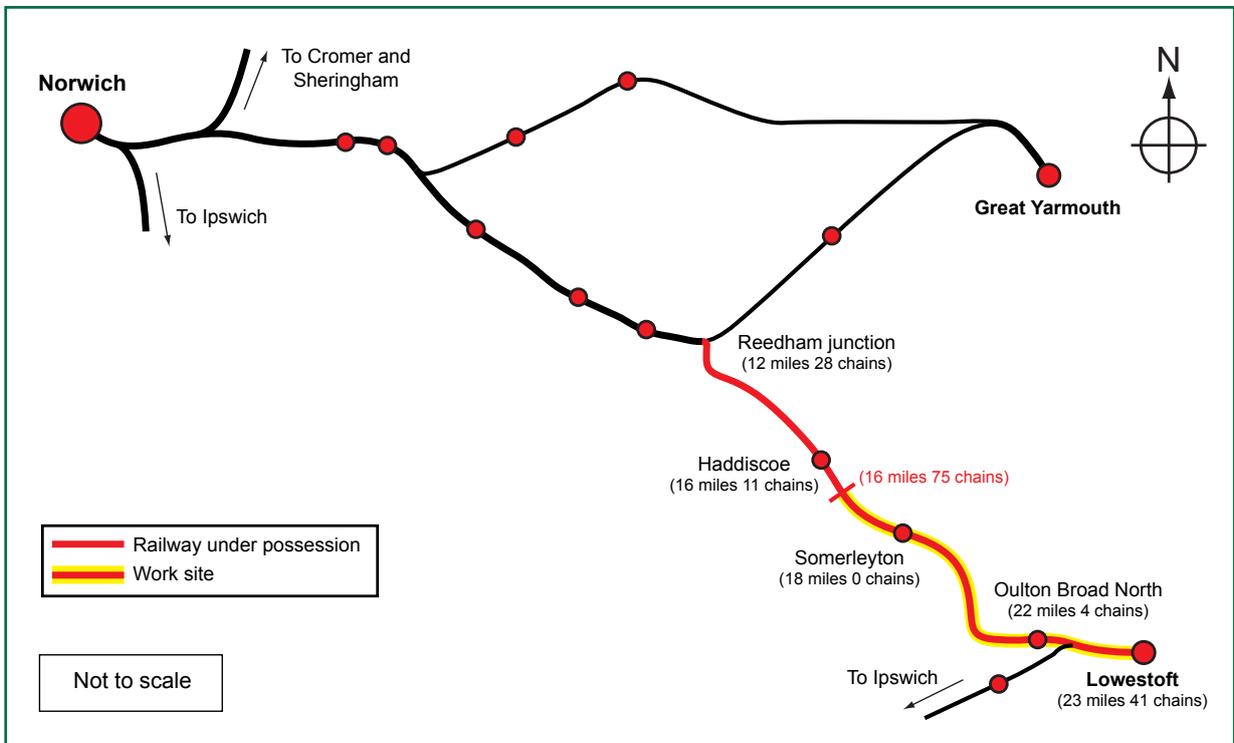
Figure 4: Map of area showing extent of possession and work site

- 7 Network Rail had planned a *possession* of the railway between Reedham junction (at 12 miles 28 chains) and Lowestoft (at 23 miles 41 chains) from 00:15 hrs to 04:50 hrs on 18 June 2015 (figure 4). The possession plan called for two *work sites* to be set up. One of these work sites included Somerleyton, extending from 16 miles 75 chains to 23 miles 41 chains, which is up to the buffer stops at Lowestoft station (figure 4). The planned activity within this work site was for members of the local track maintenance team, based at Network Rail's Norwich depot, to collect scrap material from alongside the railway.

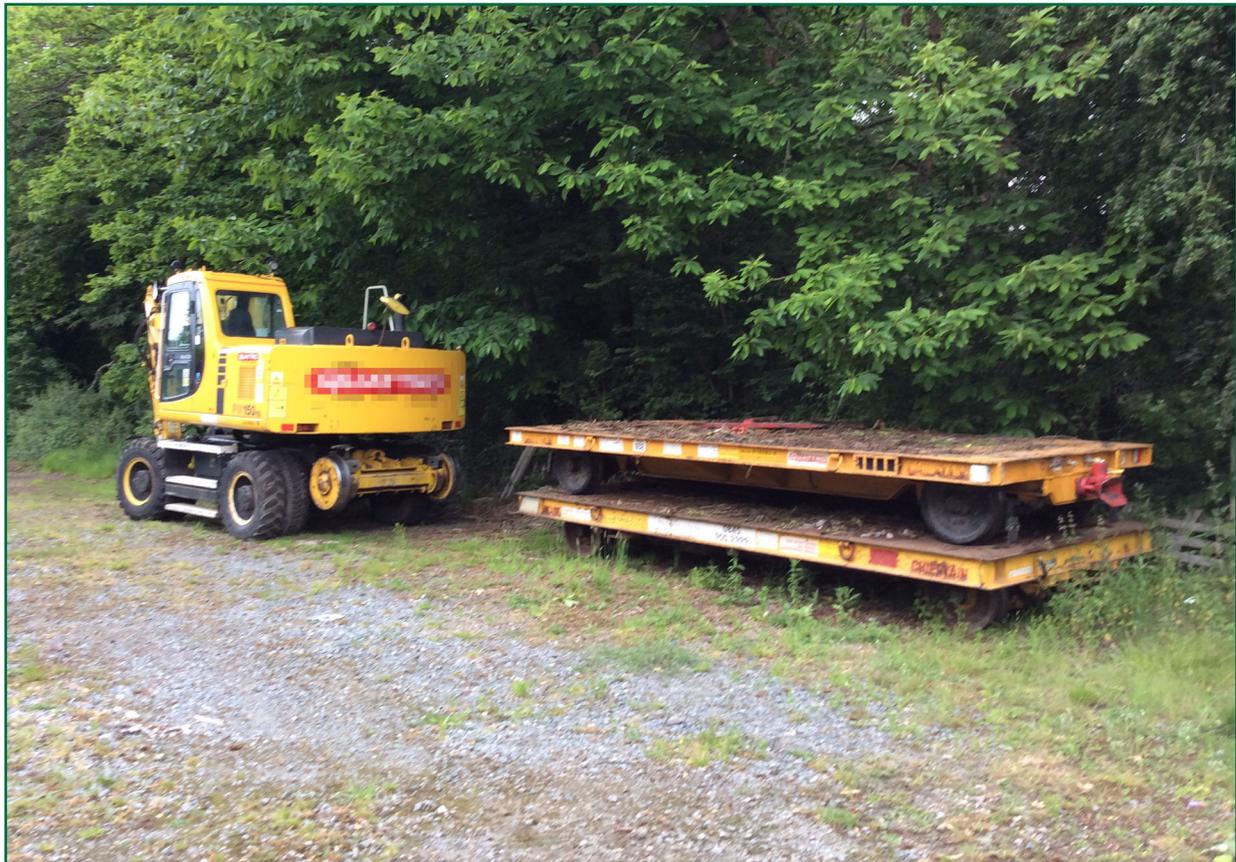
Figure 5: The RRV and trailers (image courtesy of Network Rail)

- 11 Network Rail hired in the RRV, trailers and the MO from a rail plant provider. The RRV was a 360° excavator with a single seat cab offset to the left (figure 5). It had a two-piece boom, to which various attachments could be connected for the lifting of materials. The RRV was supplied with a log grab for lifting the scrap sleepers that were being collected. Network Rail also hired two 20 tonne flatbed trailers (figure 5) which could be coupled to the RRV. These were for carrying the scrap sleepers back to Somerleyton.
