Report on the investigation of
a chief officer's fall from
a hatch cover on board the general cargo ship

Norjan

at Southampton, United Kingdom

18 June 2014

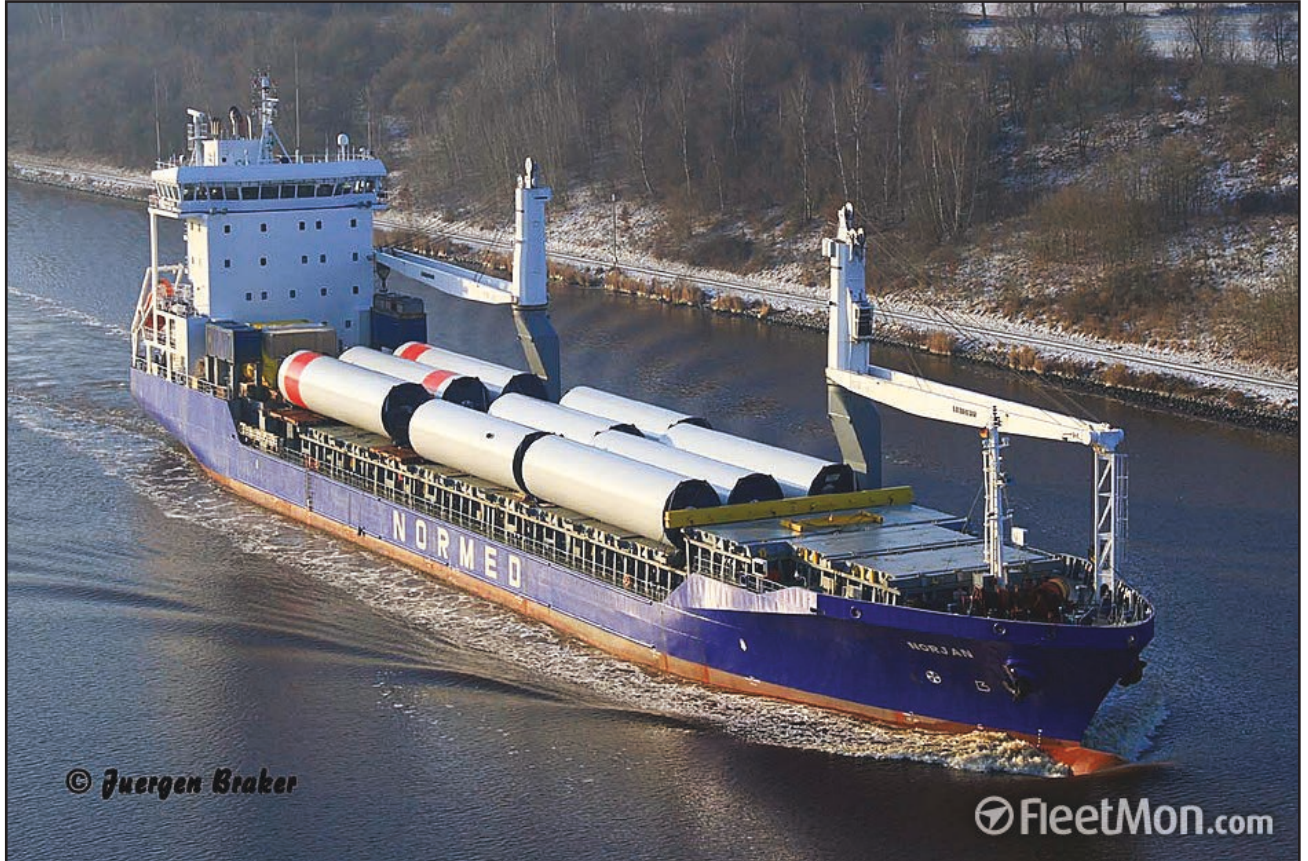
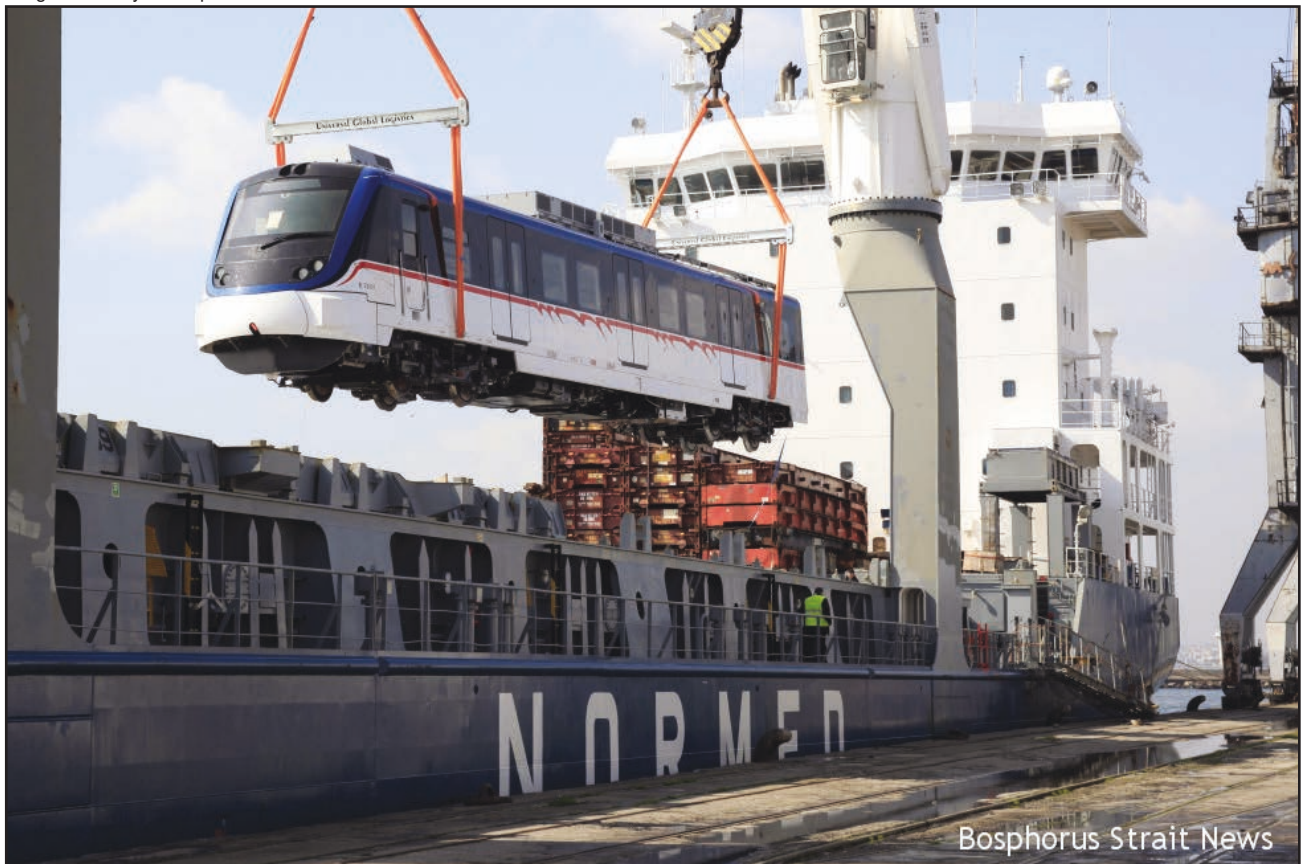
Figure 6: Examples of non-standardised cargoes on board *Norjan*

Non-standardised cargo such as yachts, locomotives and steel coils were regularly carried on *Norjan*'s deck and in its holds (**Figure 6**). The deck cargo was stowed on top of the vessel's hatch covers and container loading platforms. *Norjan*'s pontoon-type hatch covers had been strengthened to support heavy loads and were fitted with raised sockets and D-rings for the securing of containers. The D-rings were also used to secure non-standardised cargo.

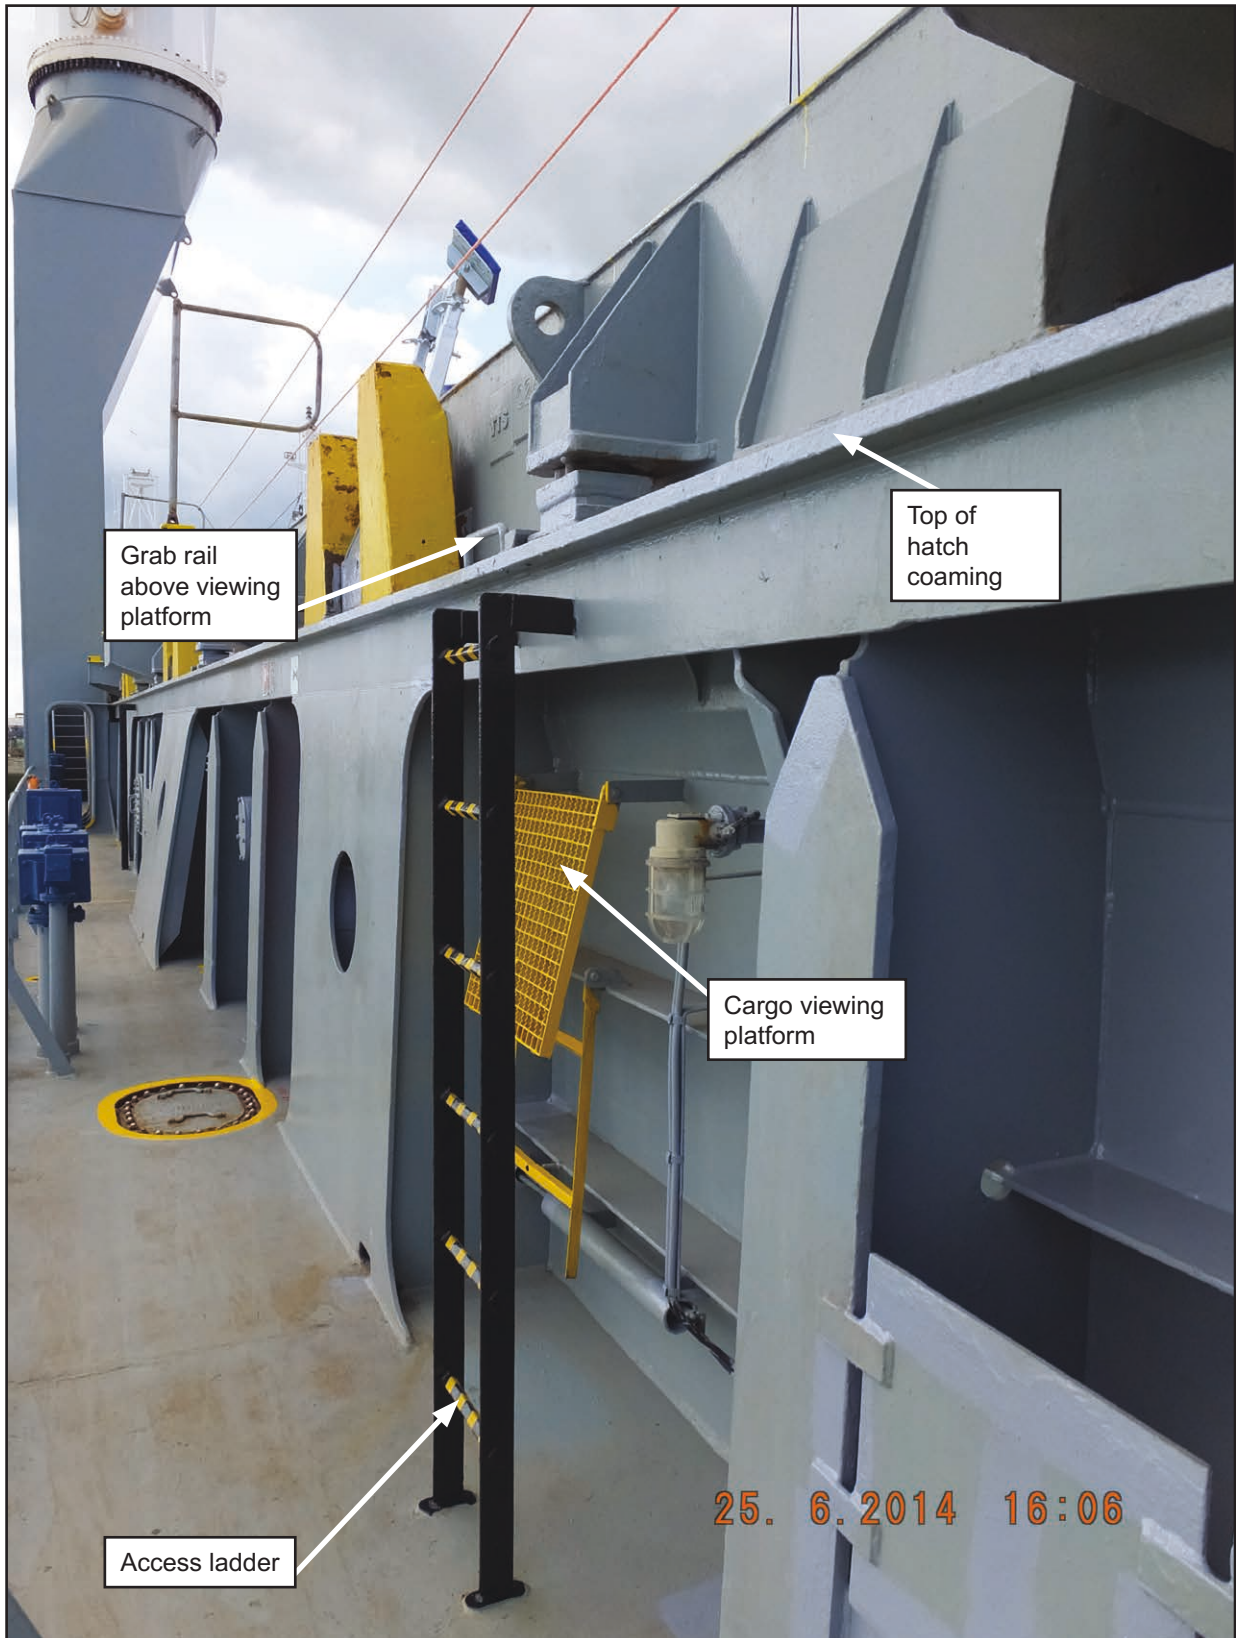
Figure 7: Access and egress route for hatch covers

The hatch covers were accessed from the main deck via the hatch coaming. Vertical ladders (**Figure 7**) were welded to the sides of the hatch coaming but no stanchions or grab rails had been provided above them to help people climb onto the hatch coaming or hatch covers. Fold-away cargo viewing platforms and grab rails were located adjacent to each of the vertical ladders.
