AAIB
Air Accidents Investigation Branch

AAIB Bulletin

12/2015

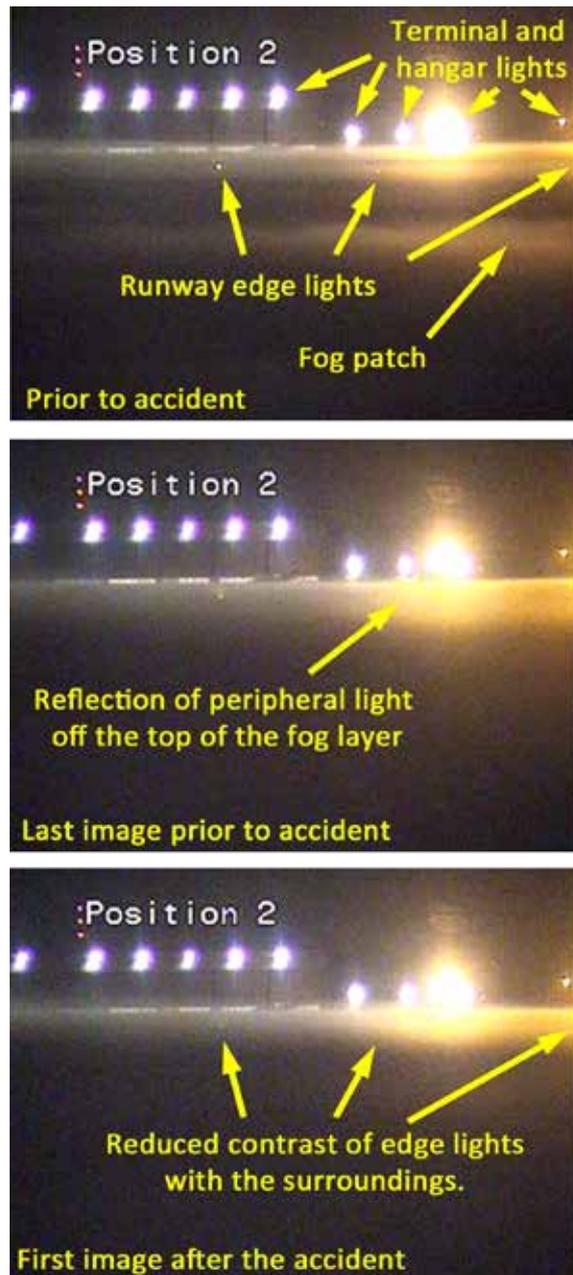
Figure 5 illustrates the low-level fog patches drifting across the airfield during the accident period, and the patches are also prevalent in the rest of the recording, in which their movement is seen more clearly. The CCTV snapshots were taken from the side of the runway, so only the low-intensity omnidirectional components of the runway edge lights were captured, and not the high-intensity directional component as viewed when looking along the runway.

CCTV images from Position 2 taken 1 minute 25 seconds apart

The lights associated with the hangars, terminal and apron areas are significantly brighter than the runway lights. The CCTV images do not fully represent the extent of this as the image brightness of the peripheral lights (such as those at the apron and the terminal) was recorded at the maximum brightness the image can represent. Therefore the contrast in actual brightness was greater than the images in Figure 5 indicate.

The UK AIP states that there is no centreline lighting on Runway 03, and that the pavement width at the beginning of the runway is twice the normal runway width. It recognises the potential for confusion and urges crews to ensure that they have lined up correctly. This information was not available to the crew on their aerodrome charts and both crew members believed that the runway had centreline lighting. Further, the light from those left-side runway edge lights covered in fog would have been scattered, making it harder for the crew to perceive them as a distinct line of lights. The situation is likely to have been made worse by the bright lights reflecting off the top of the fog layer, making the underlying runway lights even harder to see, or swamping them completely as shown in Figure 5.

The CCTV images in Figure 5 show that peripheral lighting can interact with low fog layers to reduce the visibility of underlying aerodrome lighting. Current standards associated with apron lighting only address the minimum light levels required to make the areas safe and there are no standards relating to light spilling into other areas.

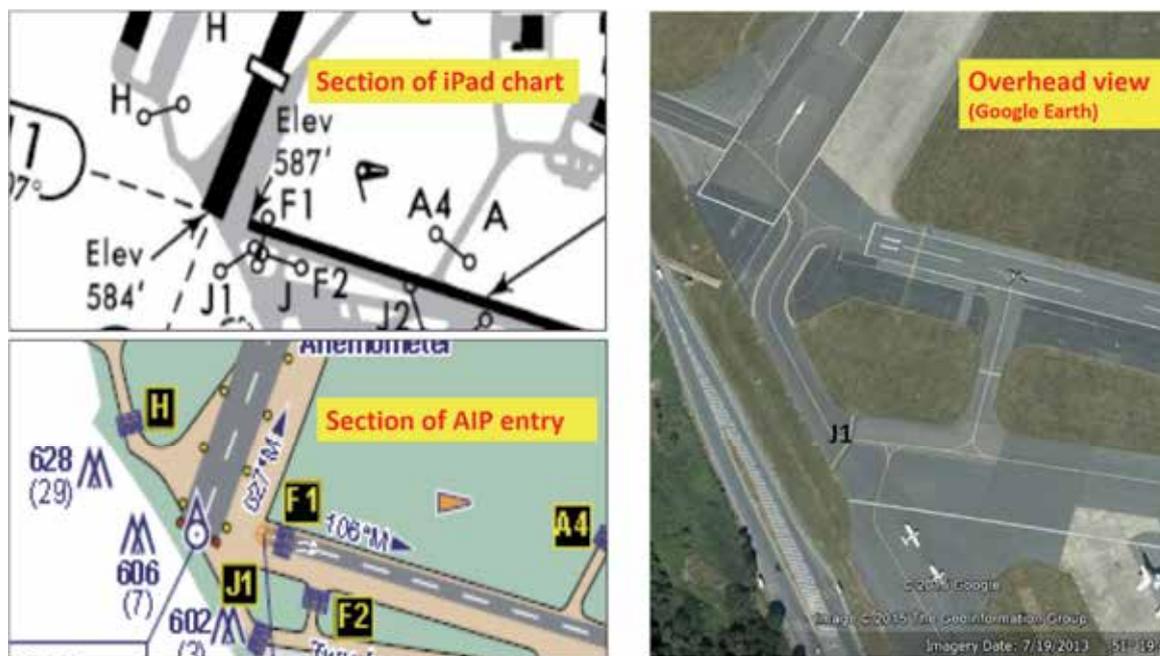
Figure 6

The aerodrome chart used by the crew was contained in an iPad app which was updated through a subscription service with the product supplier. The authoritative source for the aeronautical information contained within the app is the Biggin Hill Airport Aerodrome Chart contained in the UK Aeronautical Information Publication (AIP), maintained by NATS AIS. Sections of the iPad and AIP charts showing the area between Holding Point J1 and the beginning of Runway 03 are shown in Figure 6. The path that an aircraft must follow after passing Holding Point J1 is shown by the yellow taxiway markings in the 'Overhead view' within the figure.

Taxi route from J1 to Runway 03

Following this accident, reflective studs were installed as a temporary measure to delineate the taxiways and runway access points around the Runway 03 threshold. Blue taxiway edge markers were installed leading from Holding Point J1 to the runway, and alternating yellow/green studs were installed on the taxiway centreline. In addition, a bar of red studs was placed across the southern edge of the ORP, along with taxiway edge markings (see Figure 9), to reduce the risk that crews following the taxiway around the first right turn after J1 would proceed straight ahead, as the aircraft in this accident did.

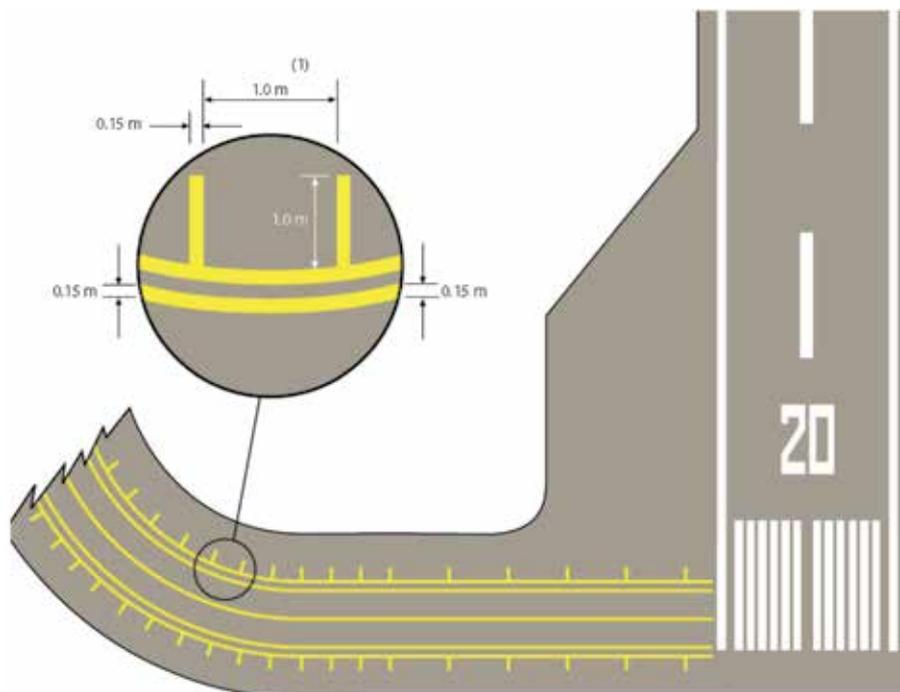
Extract of CAP 168 showing taxiway edge markings at a representative aerodrome

The eastern side of the ORP at the beginning of Runway 03 at Biggin Hill Airport is used as Taxiway C and the boundary between the southern end of the ORP and Taxiway J was not marked as shown in Figure 9 at the time of the accident.
