Rail Accident Investigation Branch

# Rail Accident Report

**Container detachments at Scout Green,  
Cumbria, 7 March 2015 and near Deeping St  
Nicholas, Lincolnshire, 31 March 2015**

Report 19/2015  
December 2015

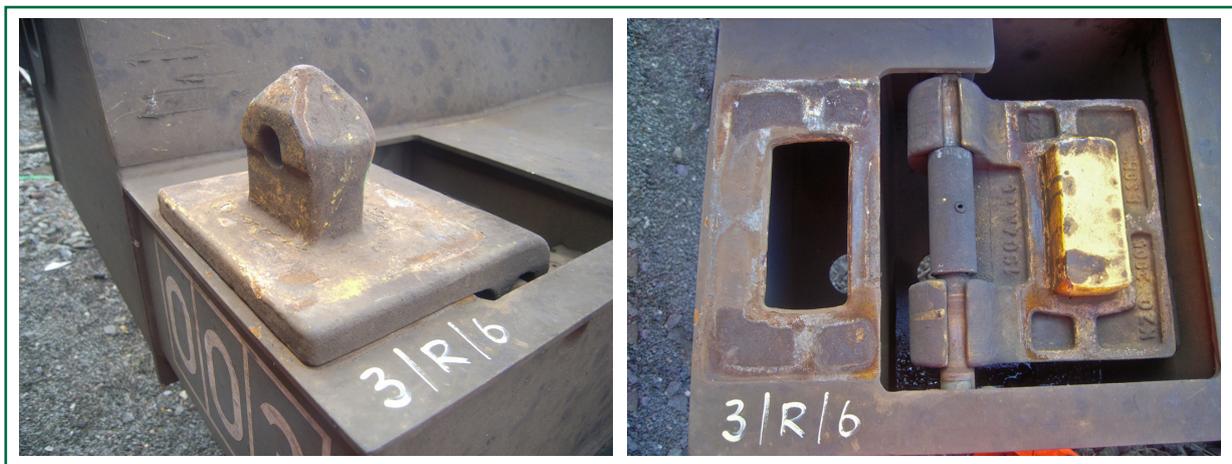
- 15 The FEA-B and FEA-S wagon types can carry various combinations of 20, 30, and 40 ft containers or a single 45 ft container. They are provided with ten pairs of spigots which can be deployed as required to carry, for example, three 20 ft containers or one 20 ft container and one 40 ft container. The containers carried on FEA-B and FEA-S wagons have corner castings which locate on the spigots. The spigots are designed with inboard hinges so that they can be rotated manually and stowed in recesses in the wagon bed when not in use (figure 4).

Figure 4: Fold-down spigot with inboard hinge, as fitted to FEA-B and FEA-S wagons, deployed (left), stowed (right)

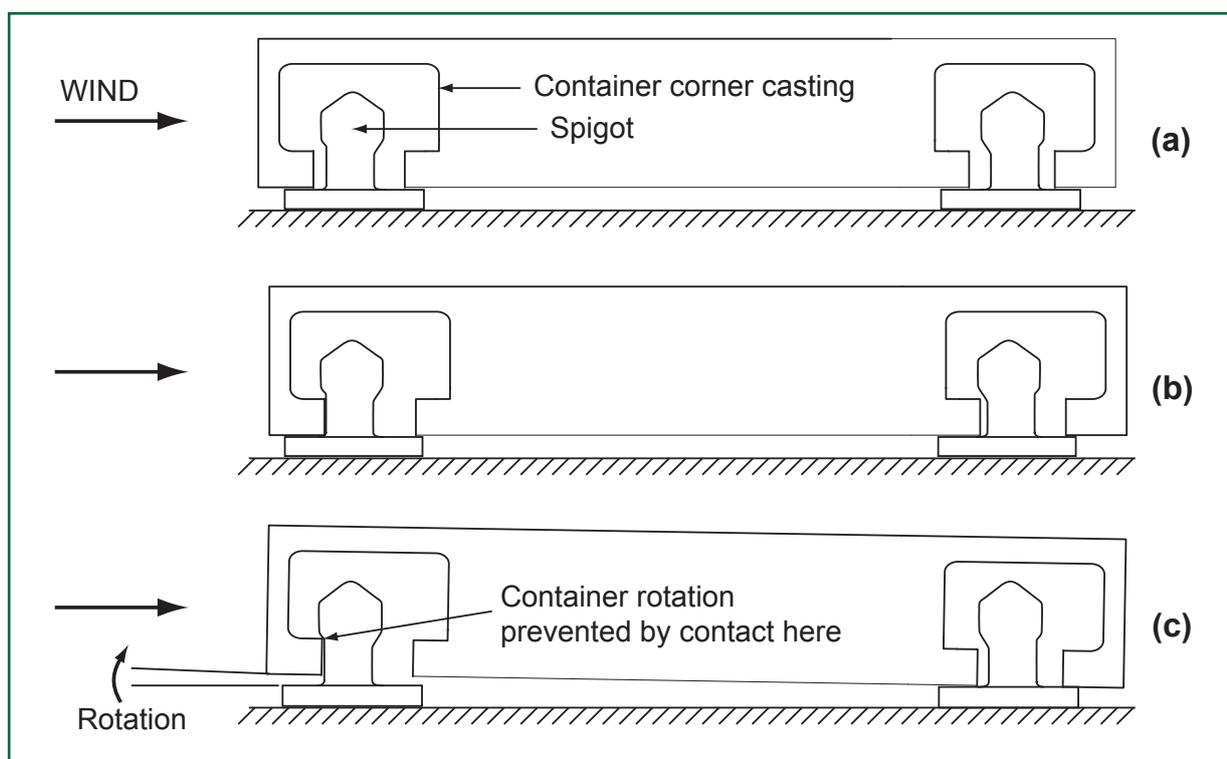
- 18 The head of a UIC spigot is shaped to guide the container corner casting on and off the spigot during loading and unloading. A UIC spigot that complies with UIC 571-4 also provides overturning restraint in windy conditions. The principal of operation of a UIC spigot is illustrated in figure 5. Studies<sup>5</sup> have shown that wind forces acting on the windward side of the empty container will first slide the container laterally from its central position relative to the spigots (figure 5a) until the windward corner castings contact the neck of the windward spigot (figure 5b). If the wind is strong enough to cause the windward side of the container to lift, the corner castings on the windward side of the container will engage with the underside of the spigot heads (figure 5c). This engagement provides the necessary vertical restraint to hold the container and stop it from lifting further.

Figure 5: Principle of operation of spigots in windy conditions

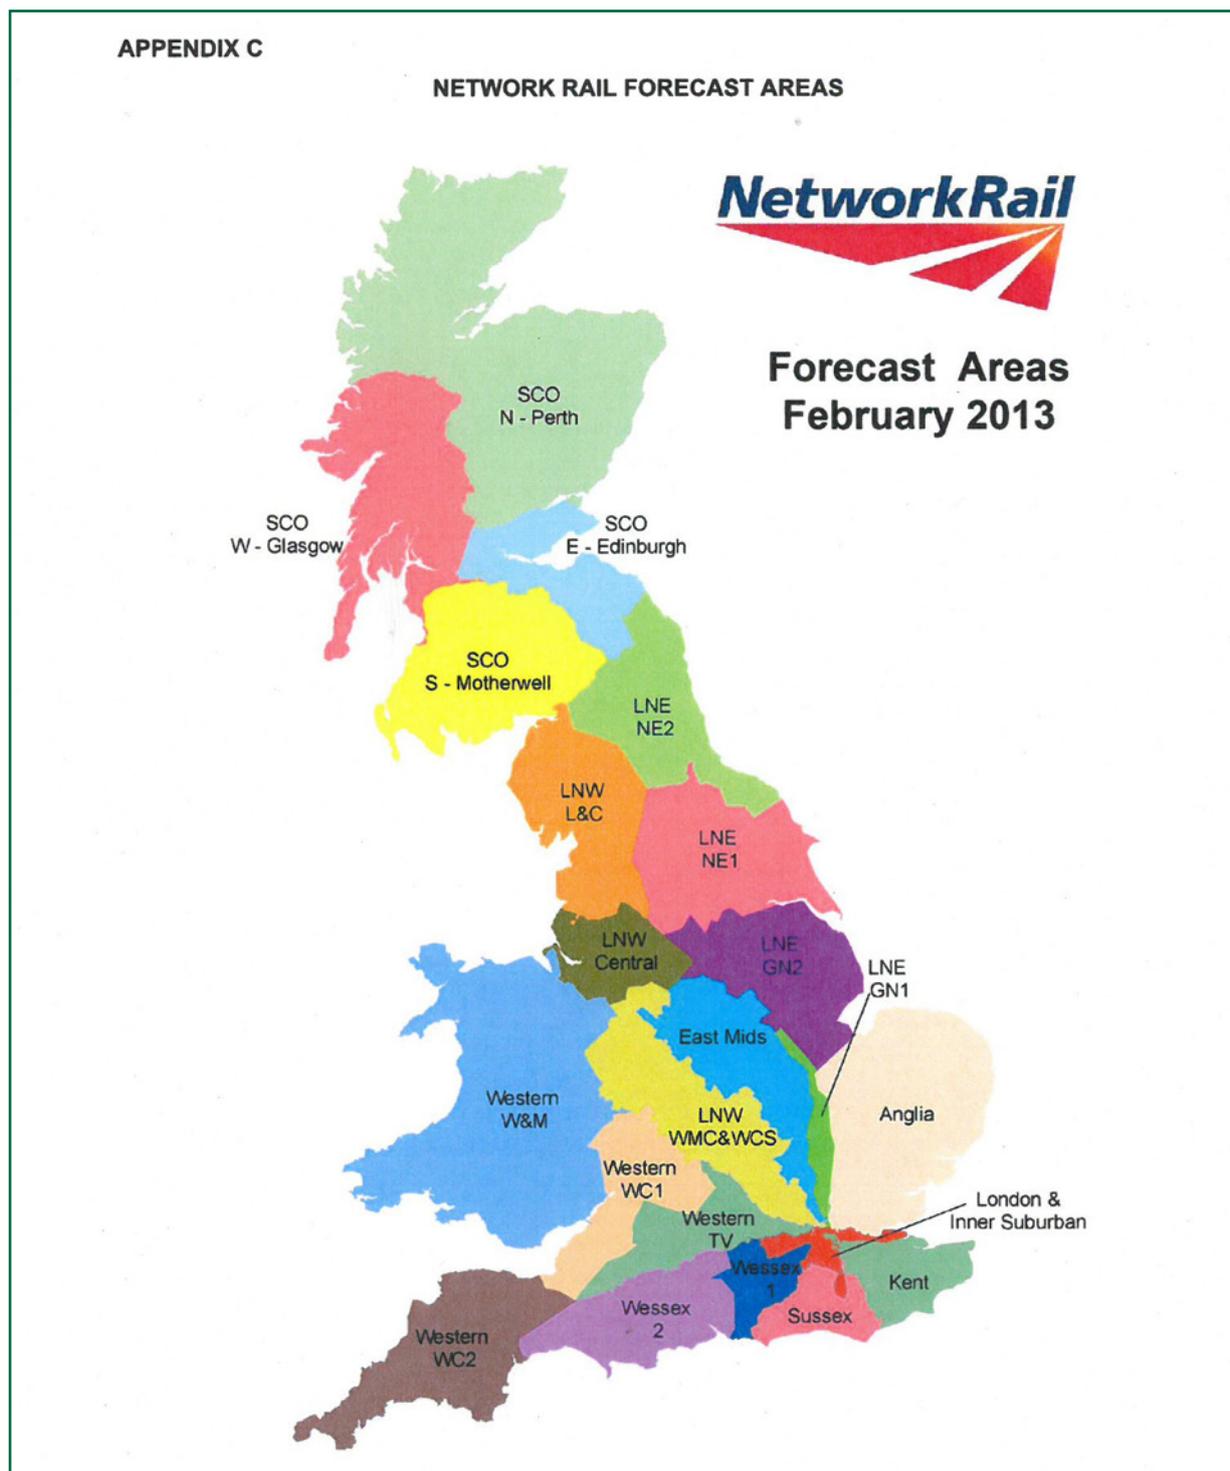
Figure 6: Network Rail's weather zones<sup>7</sup> (image from Network Rail standard NR/L3/OCS/043/7.1 Issue 6 National Control Instructions, courtesy of Network Rail)

- 43 The strong wind warning, however, did not apply to the route of train 4S83 in Scotland. The route to Coatbridge was within the Motherwell weather zone (figure 6) which was not subject to operating restrictions.

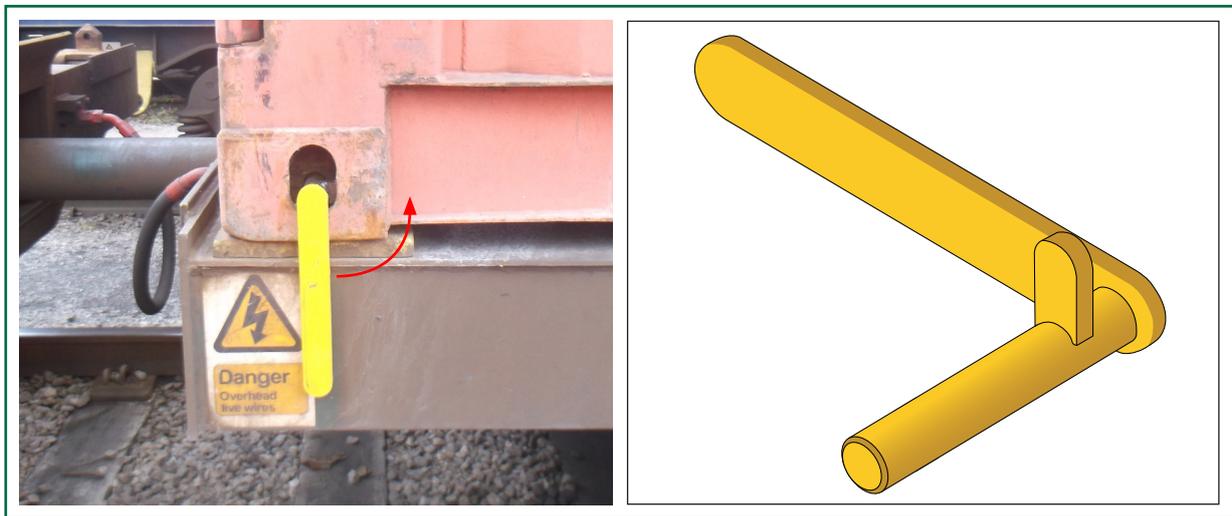
- 25 Freightliner reported that it began using spigot locking pins (figure 7) in June 2008 to secure empty containers to the spigots of FEA-B wagons (and also on its FEA-E wagons, which have the same design of inward hinging spigots) when wind speeds of over 55 mph (89 km/h) were forecast, removing the need to restrict the train speed to 60 mph (97 km/h) in high wind conditions.

Figure 7: Pin used to secure the container corner casting to the spigot head (images courtesy of Freightliner)
