Rail Accident Investigation Branch

# Rail Accident Report

## **Derailment at Washwood Heath West Junction, Birmingham 23 March 2015**

Report 01/2016  
January 2016

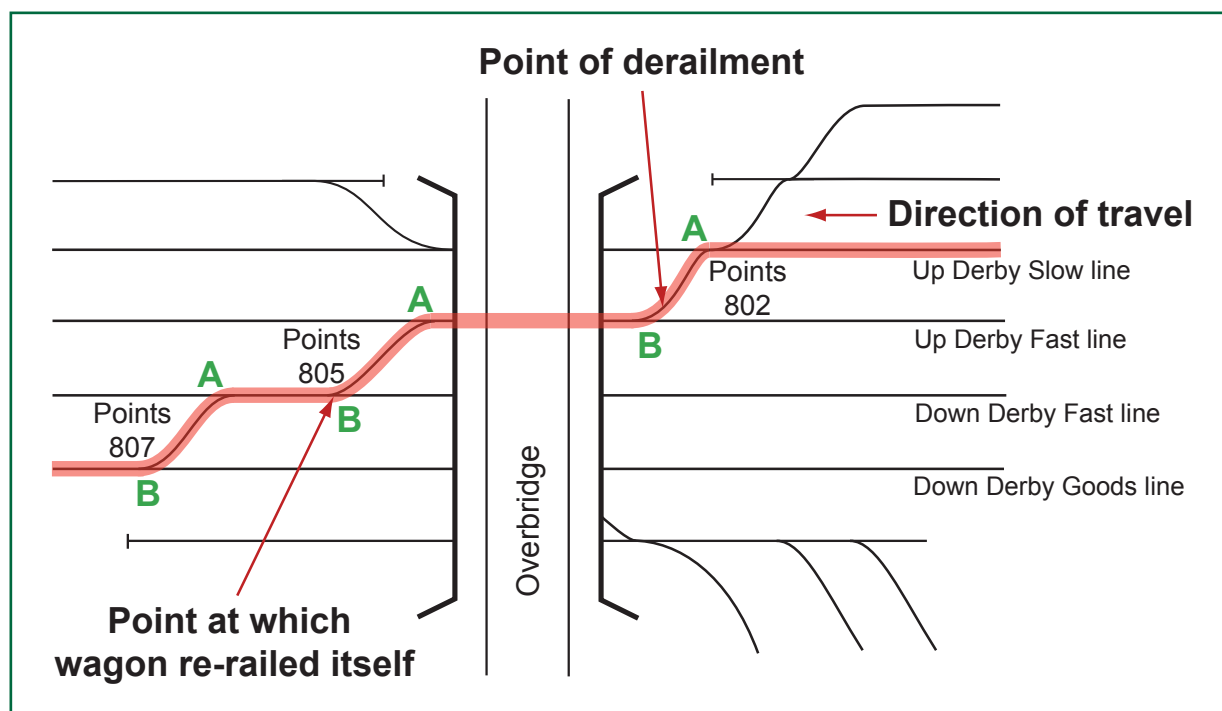
Figure 3: Track layout at Washwood Heath West

- 9 The train was crossing to the Down Derby Goods line via a series of crossovers, made up of points 802, 805 and 807, when the derailment occurred. Each of these crossovers consists of two points which operate together and have a suffix A or B to distinguish each end (figure 3). The derailment occurred as the wagon was running through 802B points.

- 11 As is normal for a crossover between two parallel tracks, crossover 802 included a *reverse curve*. The manufacturer's drawing showed that the minimum radius was 227 metres on the left-hand curve through 802A points and 286 metres on the right-hand curve through 802B points.

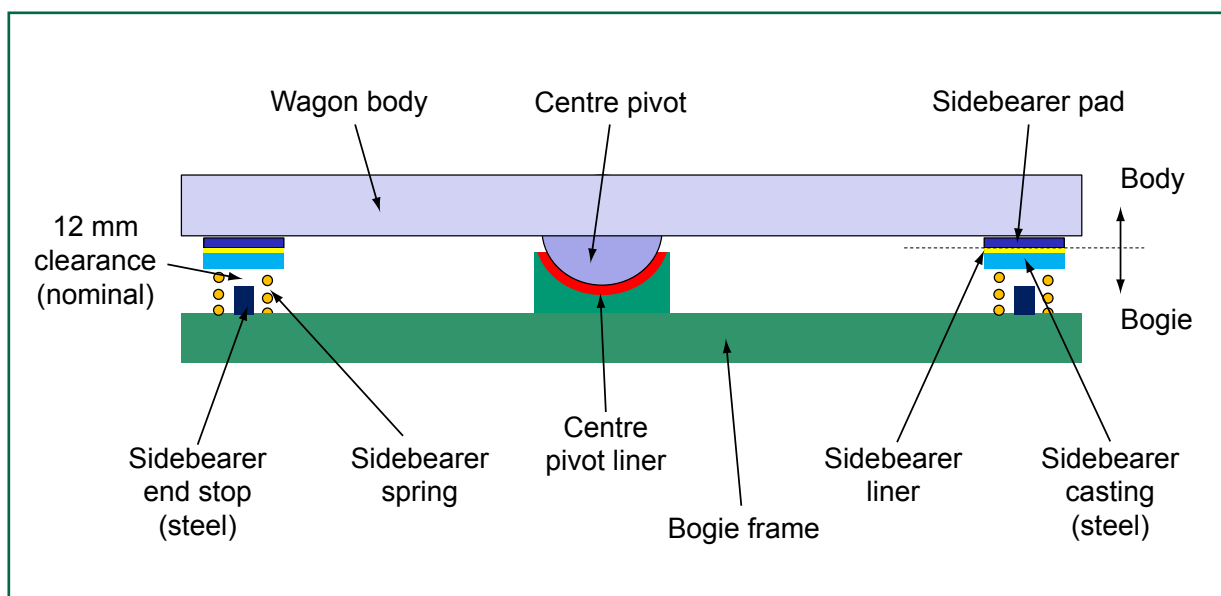
Figure 9: Diagram showing arrangement of sidebearers and centre pivot

- 73 The worn centre pivot liner reduced the clearance between the steel sidebearer castings and their steel end stops (figure 9). The AAE TSO specified that this clearance should be 12 mm, with a tolerance of  $-1/+2$  mm (ie an acceptable gap between 11 and 14 mm). Other maintainers' maintenance instructions for the Y33 bogie specified the same clearance but with a tolerance of  $-0/+2$  mm. When measured during the wagon examination, this gap was found to be zero on one side of the bogie which derailed and 4 mm on the other side (figure 13).

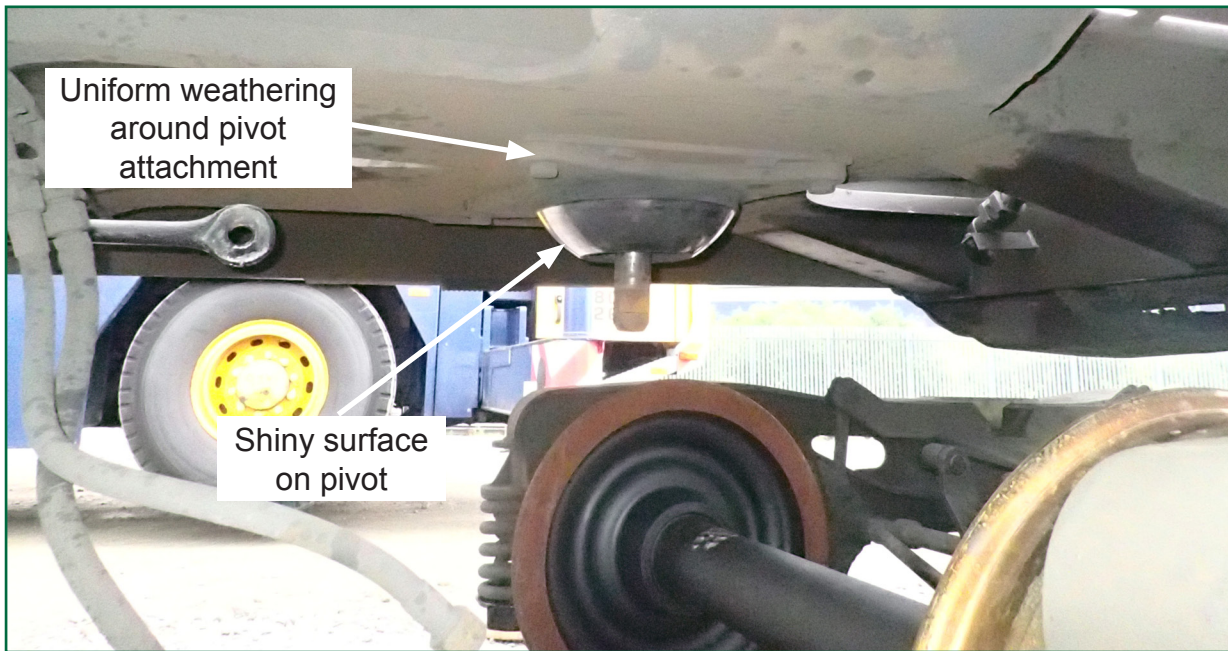
Figure 10: Centre pivot of another Megafret wagon

- 69 The AAE TSO specified that the wear of the liner be assessed by measuring its thickness using a special gauge placed across the centre pivot bowl. AAE stated, however, that other methods of checking the wear were acceptable provided that the liner projected above the steel bowl by a minimum of 2 mm at the bottom of the bowl and 1 mm at the top.

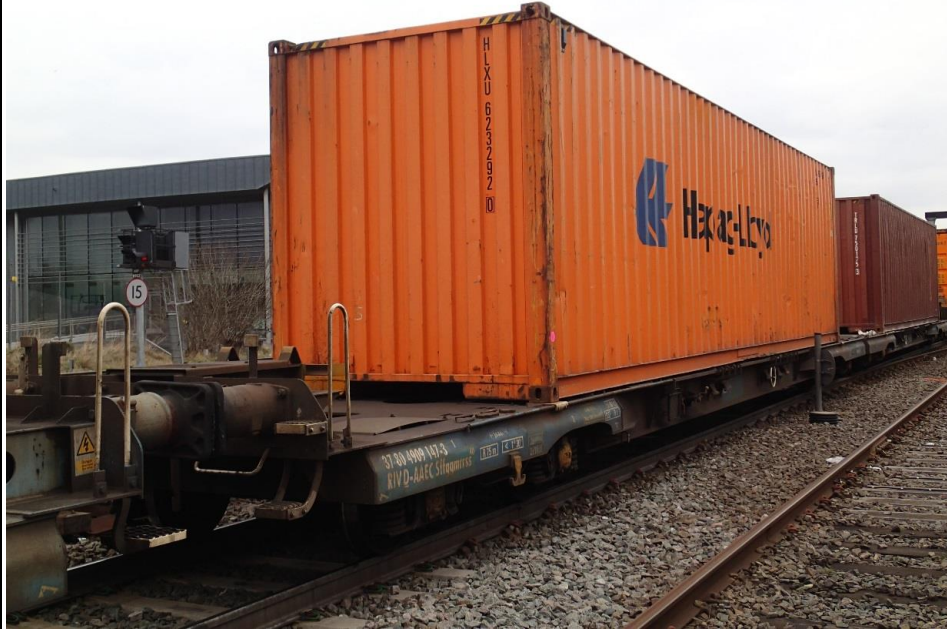
<p>Figure 1: The wagon involved.</p>

1. INCIDENT DESCRIPTION			
<b>LEAD / INSPECTOR</b>		<b>CONTACT TEL. NO.</b>	
<b>INCIDENT REPORT NO</b>	<b>0776</b>	<b>DATE OF INCIDENT</b>	23 March 2015
<b>INCIDENT NAME</b>	Derailment at Washwood Heath West		
<b>TYPE OF INCIDENT</b>	Freight train derailment		
<b>INCIDENT DESCRIPTION</b>	<p>At 08:03 hrs on 23 March 2015, the failure of signalling equipment in the vicinity of Washwood Heath West Junction, Birmingham, following the passage of train 4O14, alerted the Network Rail signaller to a possible problem with that train. It was subsequently discovered that the train had derailed and then re-railed when crossing from the Up Derby Slow line to the Down Derby Fast line. The train was brought to a stand at Landor Street Junction at 08:10 hrs and the driver was asked to examine the train. He found evidence that the 10th wagon on the train had run derailed.</p> <p>Train 4O14 was the 05:58 hrs Basford Hall (Crewe) to Southampton container service. It consisted of a Class 66 locomotive pulling a mix of 24 container wagons and had been travelling at 15 mph while negotiating a series of crossovers. The wagon that derailed was an IKA 'Megafret' wagon (8049091473), consisting of two flat wagons permanently coupled together. Examination of the track confirmed that the train had run derailed for a distance of 121 metres, before re-railing at a set of trailing points. The derailment caused significant damage to track and signalling equipment. No-one was injured.</p>
