# Rail Accident Report

**Collision between a train and a fallen bridge  
parapet at Froxfield, Wiltshire  
22 February 2015**

Report 02/2016  
January 2016

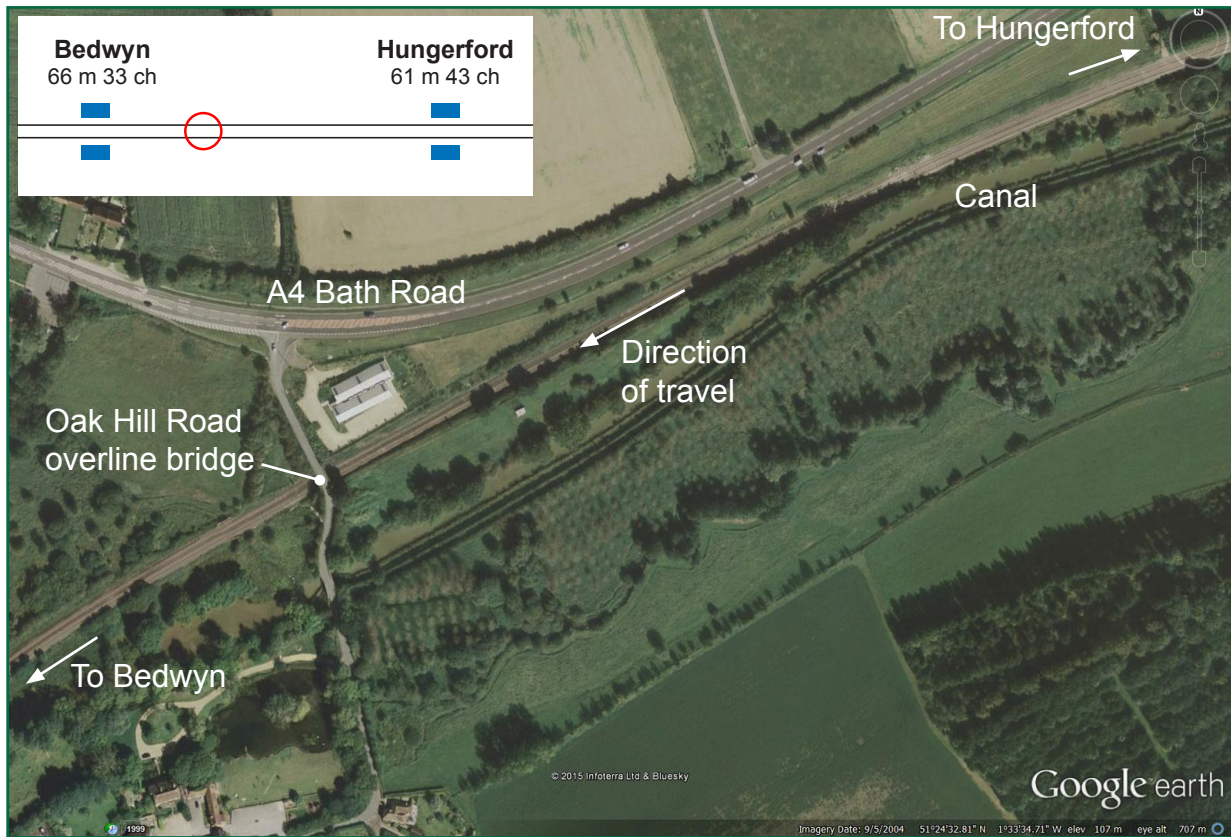
Figure 2: Schematic diagram and Google Earth images of the location of the accident

- 5 Eleven minutes before the train arrived at the bridge, a reversing articulated heavy goods vehicle (HGV) struck the eastern parapet of the bridge. The lorry driver had turned off the nearby A4 at the junction just north of the railway bridge, and crossed over the railway before encountering a canal bridge which he considered too narrow to pass. The lorry driver was attempting to reverse back over the railway bridge when the rear of his trailer struck the eastern parapet and pushed it off the bridge. The entire brick parapet, weighing around 13 tonnes, fell onto the railway, obstructing both tracks.

- 57 The entrance to Oak Hill Road from the A4 Bath Road is relatively wide compared to the width of the rail bridge (figure 2). There was no signage such as 'Unsuitable for HGVs' on the approach to Oak Hill Road from the A4 Bath Road and none just before the rail bridge. Furthermore, there was no signage on the approach to the rail bridge to warn drivers that the road narrowed further on. Had signage been in place, it is unlikely the driver of the HGV would have turned into Oak Hill Road and proceeded on to the rail bridge. The only signs that were in place on the approach to the rail bridge were a 'double bend' bend sign and a hump-back bridge warning (figure 10).

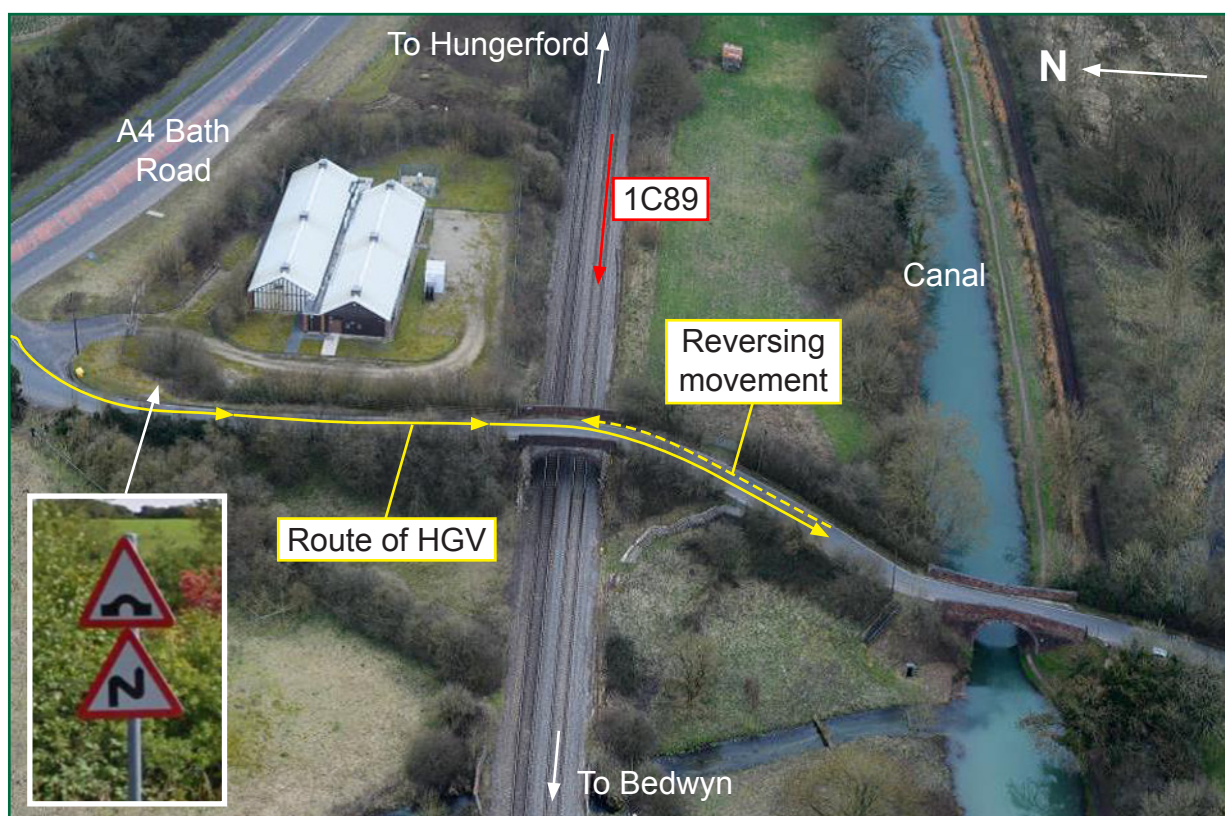
Figure 4: Oak Hill Road and the route taken by the HGV (image courtesy of Network Rail)

- 7 Oak Hill Road is an unclassified road, which runs from the A4 Bath Road, just east of Froxfield, across the railway and canal by means of masonry arch bridges (figure 4). It then runs parallel to the railway in a south westerly direction to the village of Little Bedwyn. The county boundary between West Berkshire and Wiltshire lies to the west and south of Oak Hill Road. The section of the road between the southern end of the canal bridge and the A4 Bath Road lies in the jurisdiction of West Berkshire Council (WBC) and the remainder of the road, south of the canal bridge, lies in the jurisdiction of Wiltshire Council.

- the driver was not familiar with Oak Hill Road;
  - the road between the rail and canal bridges was curved and uphill for the reverse move;
  - contact with the parapet would have been in a blind spot, due to the relative angle between the tractor unit and trailer (figure 4);

- 80 The reduction in the risk scores between 2010 and 2015 assessments were due to:
- the introduction of a steel palisade fence at the north eastern corner of the bridge, by the owners of the buildings adjacent to the railway (figure 4), and an increasing amount of vegetation on the approach to the bridge, both of which mitigate the risk of road vehicle incursion; and
