Collision between the fishing vessels *Silver Dee (B310)* and *Good Intent (SY79)* resulting in the foundering of *Silver Dee* Irish Sea 29 July 2015

SUMMARY

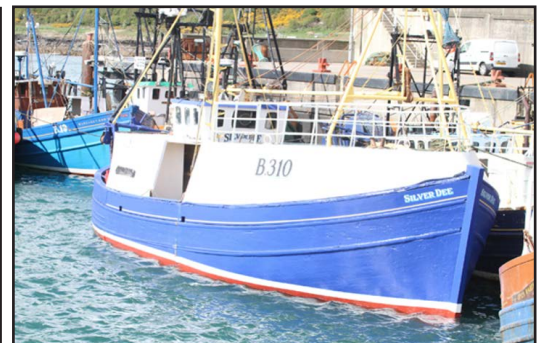
FV *Silver Dee*

If *Silver Dee* had been built today, the current construction standards applicable to wooden fishing vessels would have significantly increased the vessel's survivability.
