CONTENTS**SPECIAL BULLETINS / INTERIM REPORTS**

AAIB FIELD INVESTIGATIONS**COMMERCIAL AIR TRANSPORT****FIXED WING**

BAe 146-200	G-RAJJ	23-Feb-15	3
-------------	--------	-----------	---

Aircraft Type and Registration:	BAe 146-200, G-RAJJ
No & Type of Engines:	4 ALF502R-5 turbojet engines
Year of Manufacture:	1988 (serial number E2108)
Date & Time (UTC):	23 February 2015 at 1854 hrs
Location:	Guernsey Airport, Channel Islands
Type of Flight:	Commercial Air Transport (Passenger)
Persons on Board:	Crew - 4 Passengers - 47
Injuries:	Crew - None Passengers - None
Nature of Damage:	Shock absorber damaged beyond economic repair, damage to left main landing gear and No 1 tyre burst
Commander's Licence:	Airline Transport Pilot's Licence
Commander's Age:	58
Commander's Flying Experience:	8,428 Hours (of which 5,300 were on type) Last 90 days - 32 hours Last 28 days - 23 hours
Information Source:	AAIB Field Investigation

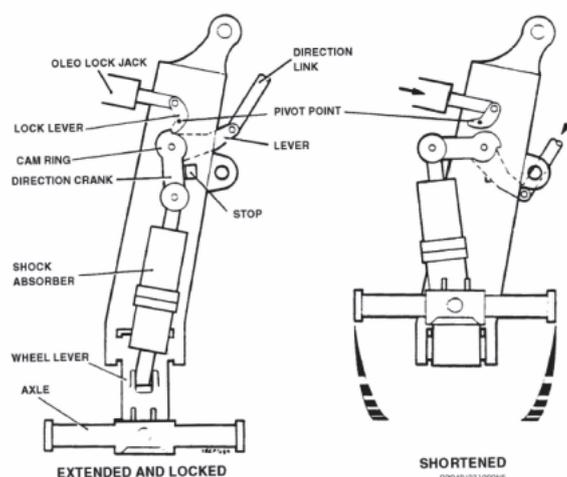
Figure 2

The main landing gear is a twin-wheel, inward retracting, lever suspension incorporating a nitrogen-charged two-stage shock absorber. Hydraulic pipes for the braking system are mounted on the outside of the landing gear. A side stay is installed between the main landing gear and the airframe to provide a mechanically-locked support when the gear is in the extended position. During the retraction sequence, movement of the direction link causes the shock absorber and the wheel lever to fold, which shortens the landing gear to allow it to fit into the wheel bay. The shock absorber remains fully extended during the retraction sequence, Figure 2.

Schematic of main landing gear

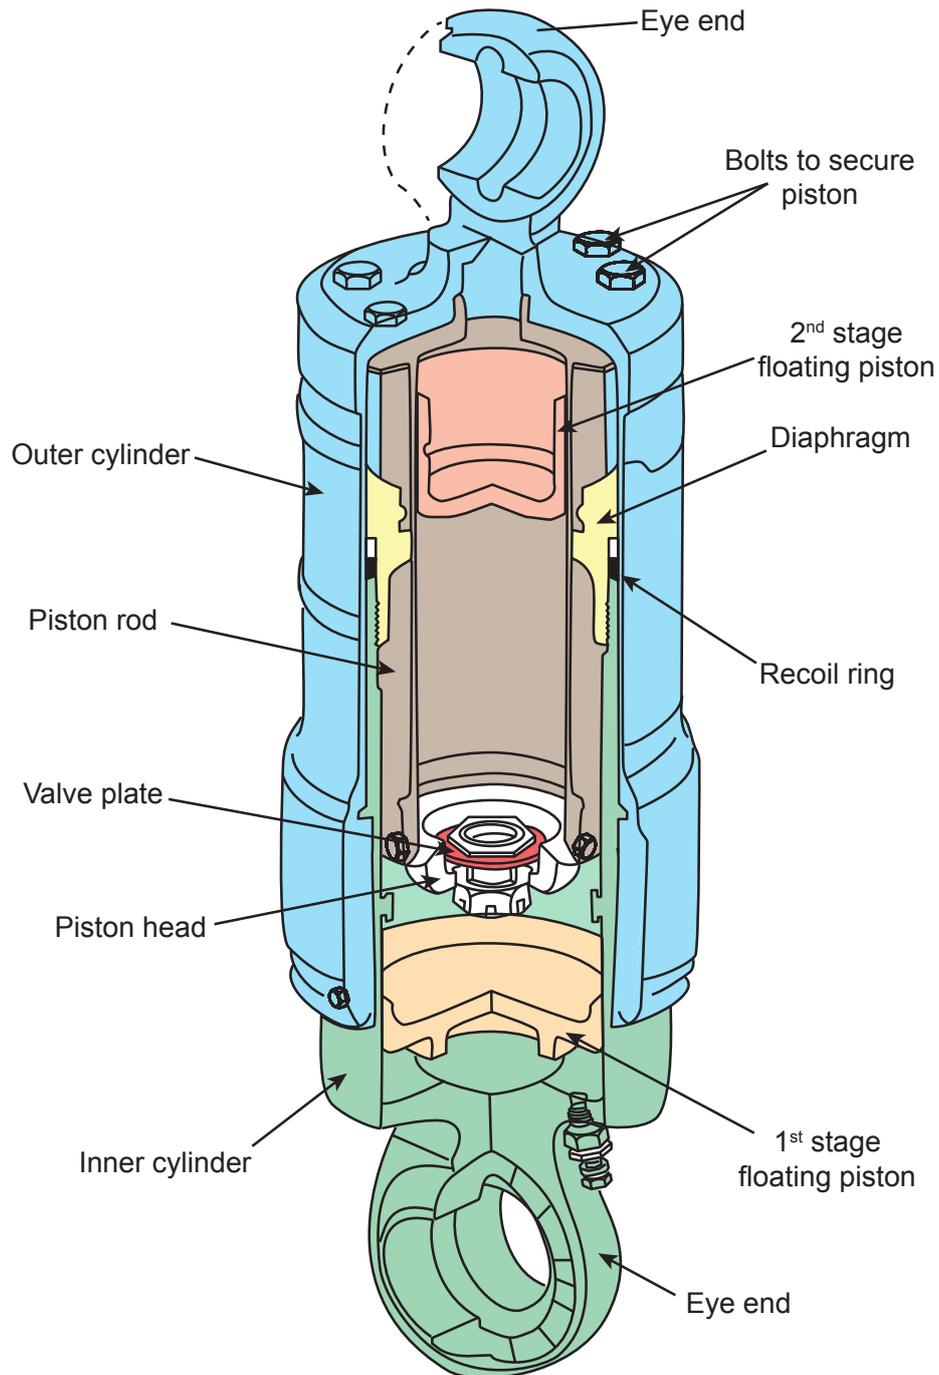
Figure 3

The shock absorber assembly consists of three main parts: an outer cylinder, inner cylinder and a piston rod, Figure 3. The stationary outer cylinder is connected at an 'eye end' to the main landing gear assembly by a crank lever and the inner cylinder is connected at an eye end to the wheel lever. The piston rod is bolted to the outer cylinder and the inner cylinder is free to slide within the outer cylinder.

Cutaway of shock absorber assembly

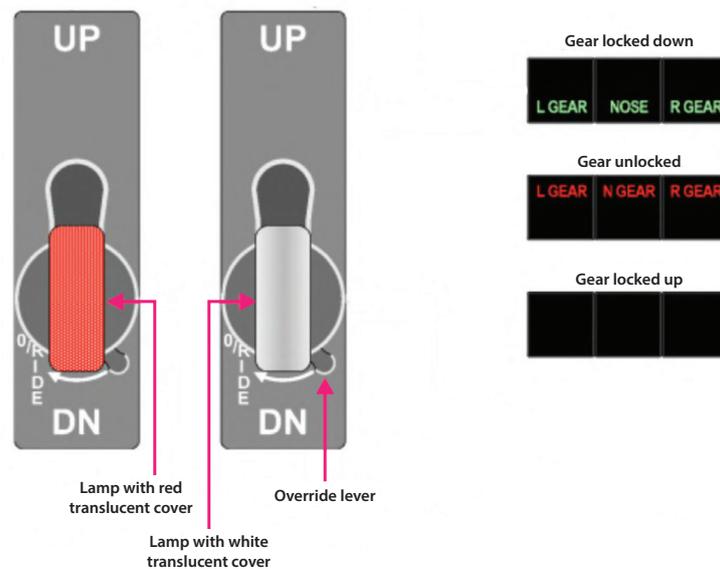
Figure 4
Landing gear annunciators

A visual indication that the landing gear is not in the selected position is provided by a red warning light on the landing gear selector lever (Figure 4). In addition, standby indicators are located beneath the landing gear emergency selection handle. These indicators only provide an indication when the gear is down-and-locked.

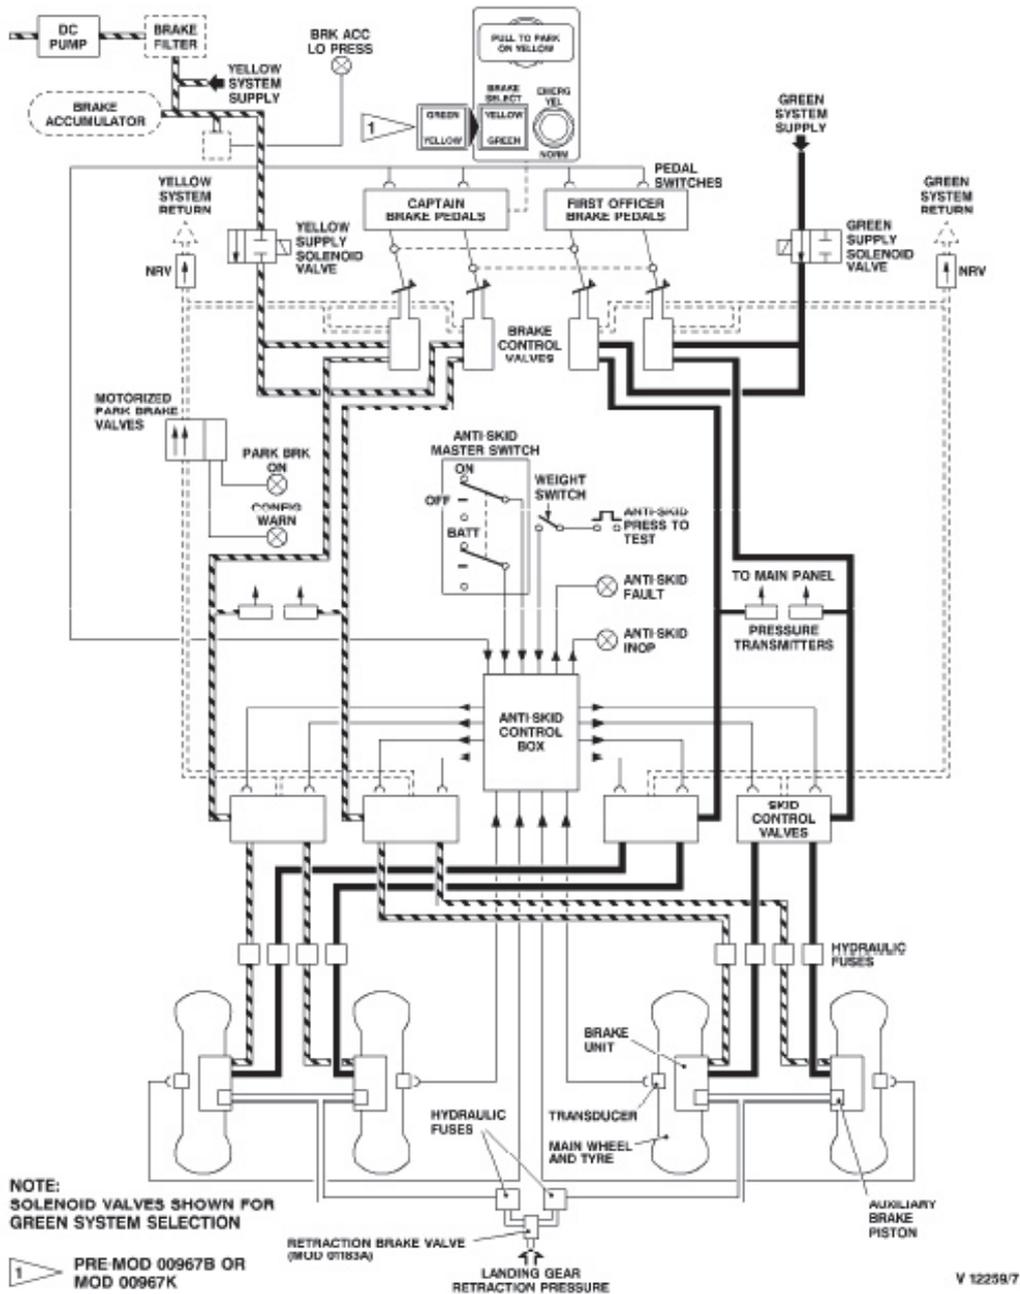
Figure 5
Aircraft hydraulic system

The aircraft is fitted with four mainwheels numbered 1 to 4 from left to right. The mainwheel braking system uses the Green and Yellow hydraulic systems with the Green system used for normal braking⁴ and the Yellow system as standby, Figure 5. A selector switch, located on the centre console, allows the crew to select the hydraulic system used for braking. The braking system incorporates hydraulic fuses, anti-skid control valves, a control box and a brake pack fitted to each mainwheel. Two hydraulic pressure gauges, one each for the Green and Yellow system, are mounted on the instrument panel and provide an indication of the hydraulic pressure applied by each of the four Brake Control Valves, which are mechanically linked to the pilot's corresponding pedal. The pressure transducers for these pressure indicators are mounted upstream of the anti-skid valves, which control the pressure from the hydraulic supply to the brake packs.

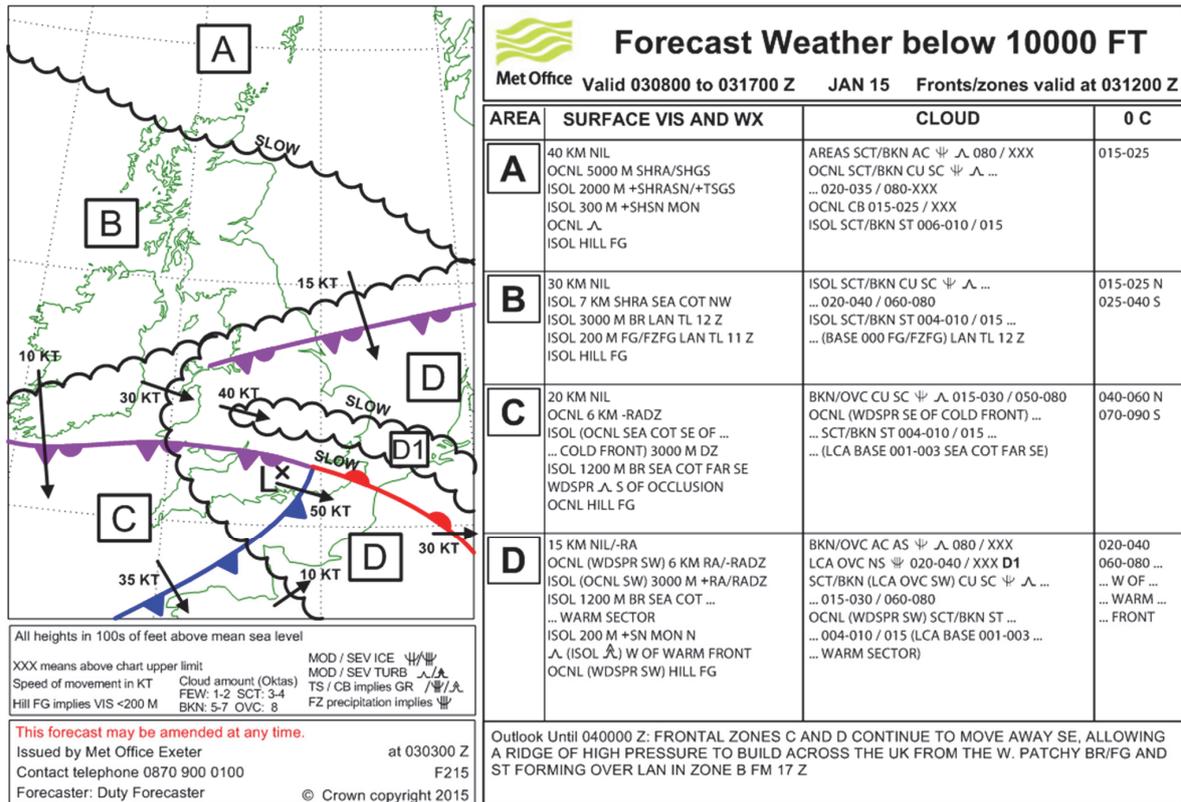
Figure 2

Study of this chart shows that the origin of the flight was within area D and that the aircraft would have had to fly through the occluded front (depicted in magenta). The forecast for the area was for scattered or broken stratus cloud with a base at 400-1,000 ft amsl and tops at 1,500 ft amsl. Above this a broken or overcast layer of cumulus and strato-cumulus extended up from 1,500-3,000 ft amsl with tops at 6,000-8,000 ft amsl. Visibility was forecast to reduce to 6,000 m in rain and drizzle but in isolated places it was forecast to reduce to 3,000 m or to 1,200 m near the coast. The freezing level was forecast to be no lower than 2,000 ft amsl to the north of the occluded front; measurements taken at Gatwick Airport, after the front had passed there, indicated the freezing level was above 4,000 ft amsl.

Forecast weather below 10,000ft (F215)

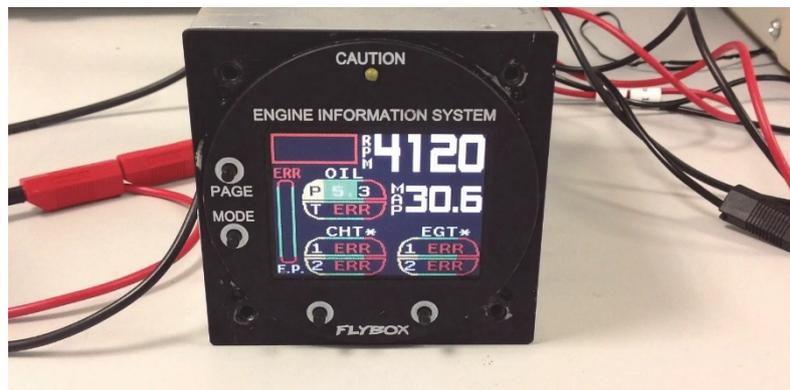
Figure 3

The aircraft instrument panel was equipped with a small Engine Information System (EIS) display (Figure 3). This was a user-configurable display that provided information such as flight time, fuel flow, exhaust gas temperature and other relevant parameters relating to the engine. It provided the only display of engine manifold pressure, which was sensed directly by the EIS from an air pressure tapping on the manifold⁴. The EIS also displayed engine rpm, which was an electronic tachometer signal generated by a magnet on the engine flywheel passing a coil. The signal was fed to the EIS via the TCU. The rpm display could be configured so that it changed to yellow, then red as it passed trigger thresholds set by the user. In the case of G-CGVO these were set at 5,770 and 5,800 rpm respectively. The manifold pressure display did not have any form of limit exceedence warning. The rpm signal was also supplied from the EIS to a traditional rpm dial gauge on the aircraft instrument panel.

EIS on test bench showing rpm and manifold pressure display

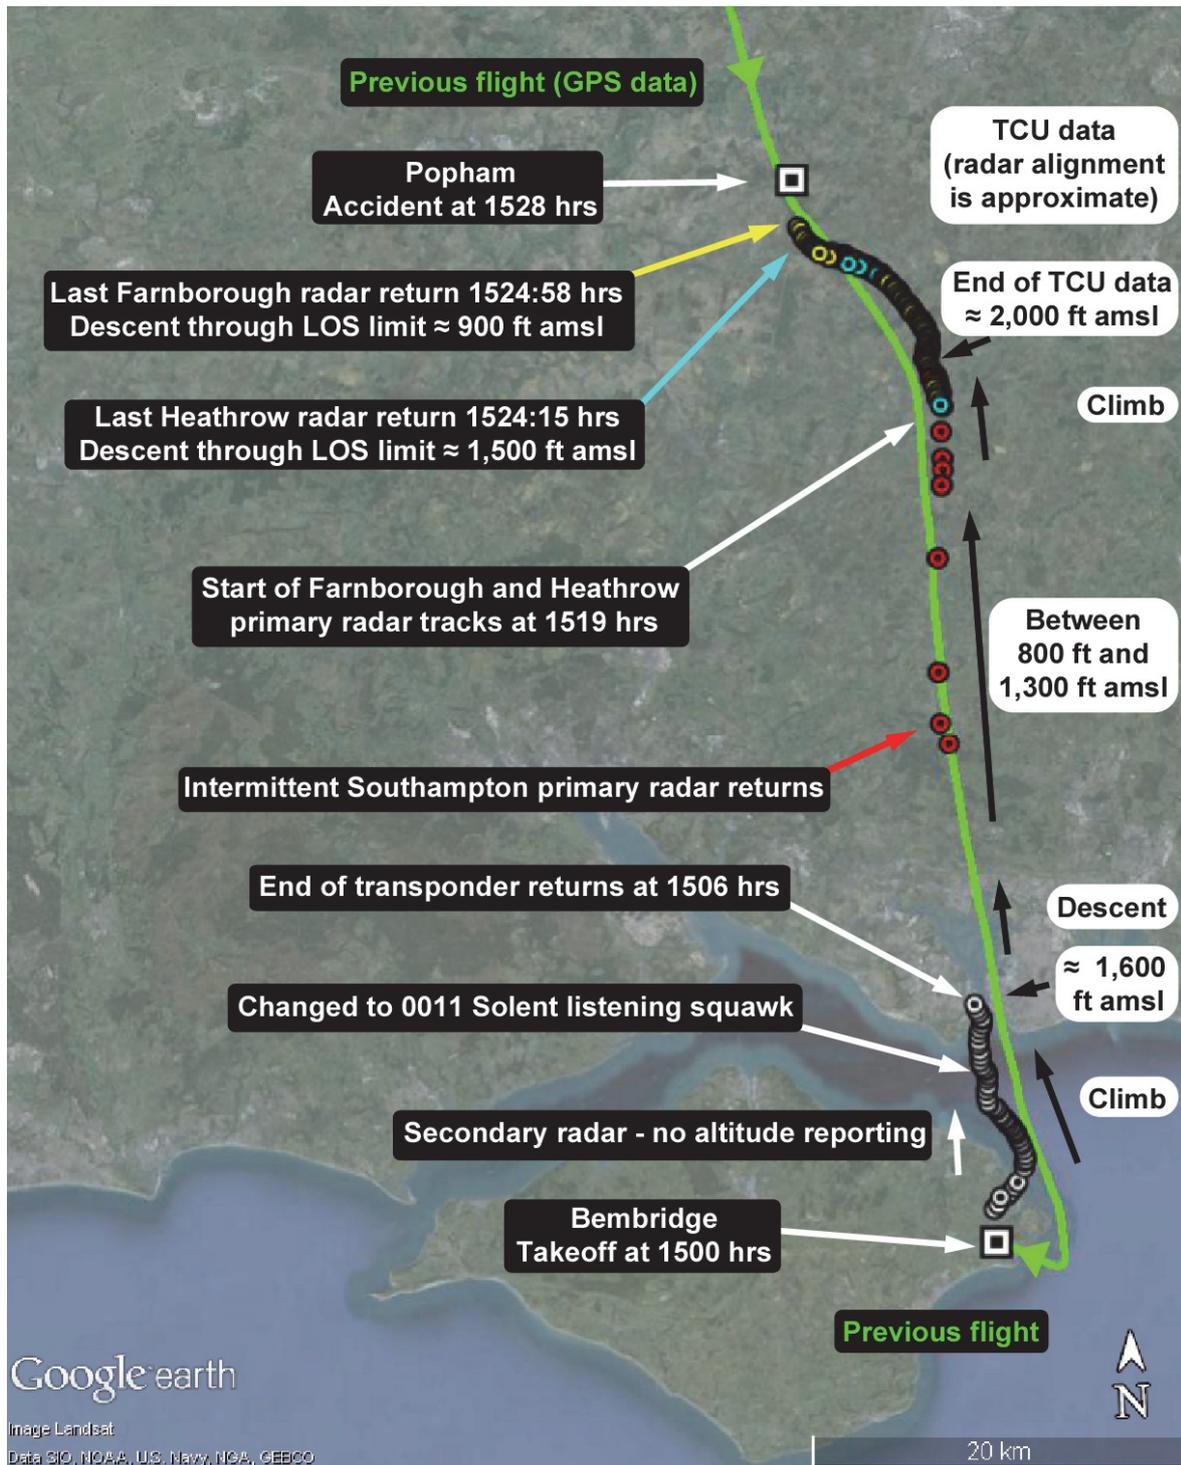
The pertinent recorded information is shown in Figure 5. The aircraft took off from Bembridge at 1500 hrs. The aircraft transponder was not reporting altitude but was initially squawking 7000 and then switched to the Solent listening squawk of 0011 whilst over the Solent, approximately 2 nm south of Gosport. The aircraft altitude reached approximately 1,600 ft amsl in the vicinity of Gosport after which the aircraft started to descend and the secondary radar track stopped.

Figure 5
Amalgamated recorded data

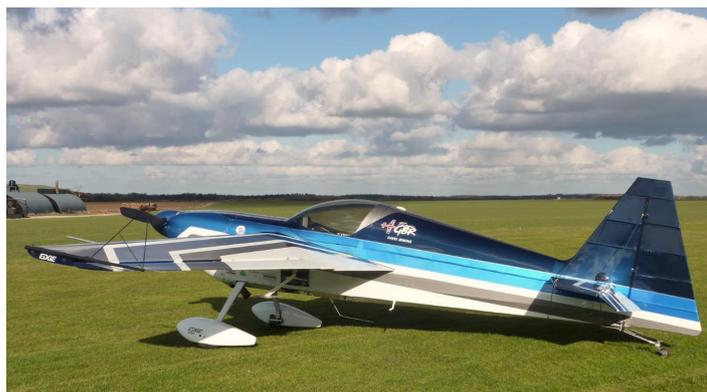
Figure 1

The accident aircraft: McKenzie Edge 360, G-EDGJ
