Report on the investigation into the girding and capsizing
of the mooring launch

Asterix

at Fawley Marine Terminal, Southampton, UK

30 March 2015

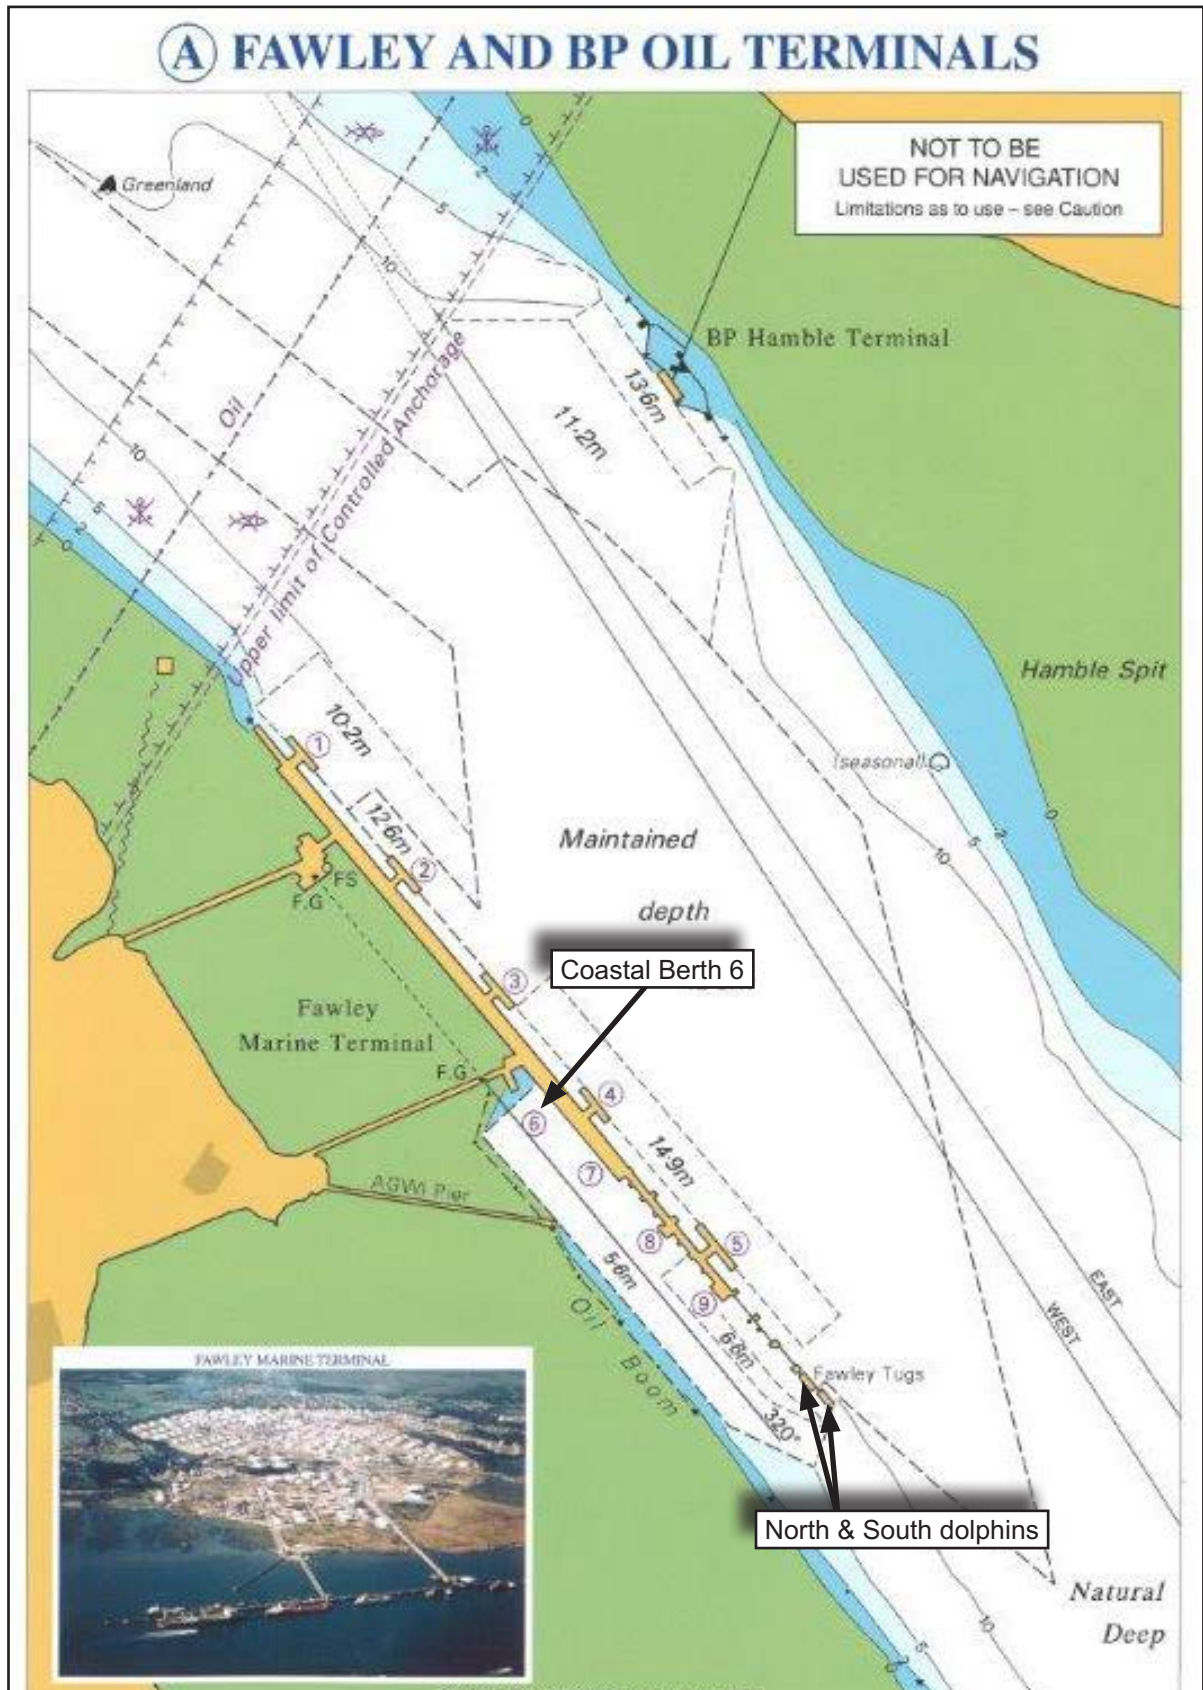
Figure 1 : Fawley Marine Terminal

On 30 March 2015, the small chemical tanker *Donizetti* was berthed port side alongside at coastal berth 6 at Fawley Marine Terminal (FMT) (Figure 1).

Donizetti continued to make headway along the line of coastal berths and ahead propulsion was applied, as required, to counteract the effect of the wind and prevent collision with the vessels moored alongside. At approximately 2014, *Donizetti* was adjacent to the south dolphin (**Figure 1**), at which point the tug *Apex* was manoeuvred alongside the vessel to hold it in position. *Asterix* remained inverted and connected to *Donizetti* by its towline. The mooring launch *Ibex* then came alongside *Donizetti*, took the towline and, by 2030, *Asterix* had been secured, still upturned, to the dolphin. Meanwhile, Solent Towage Ltd shore management attempted to source diving support to search the vessel.

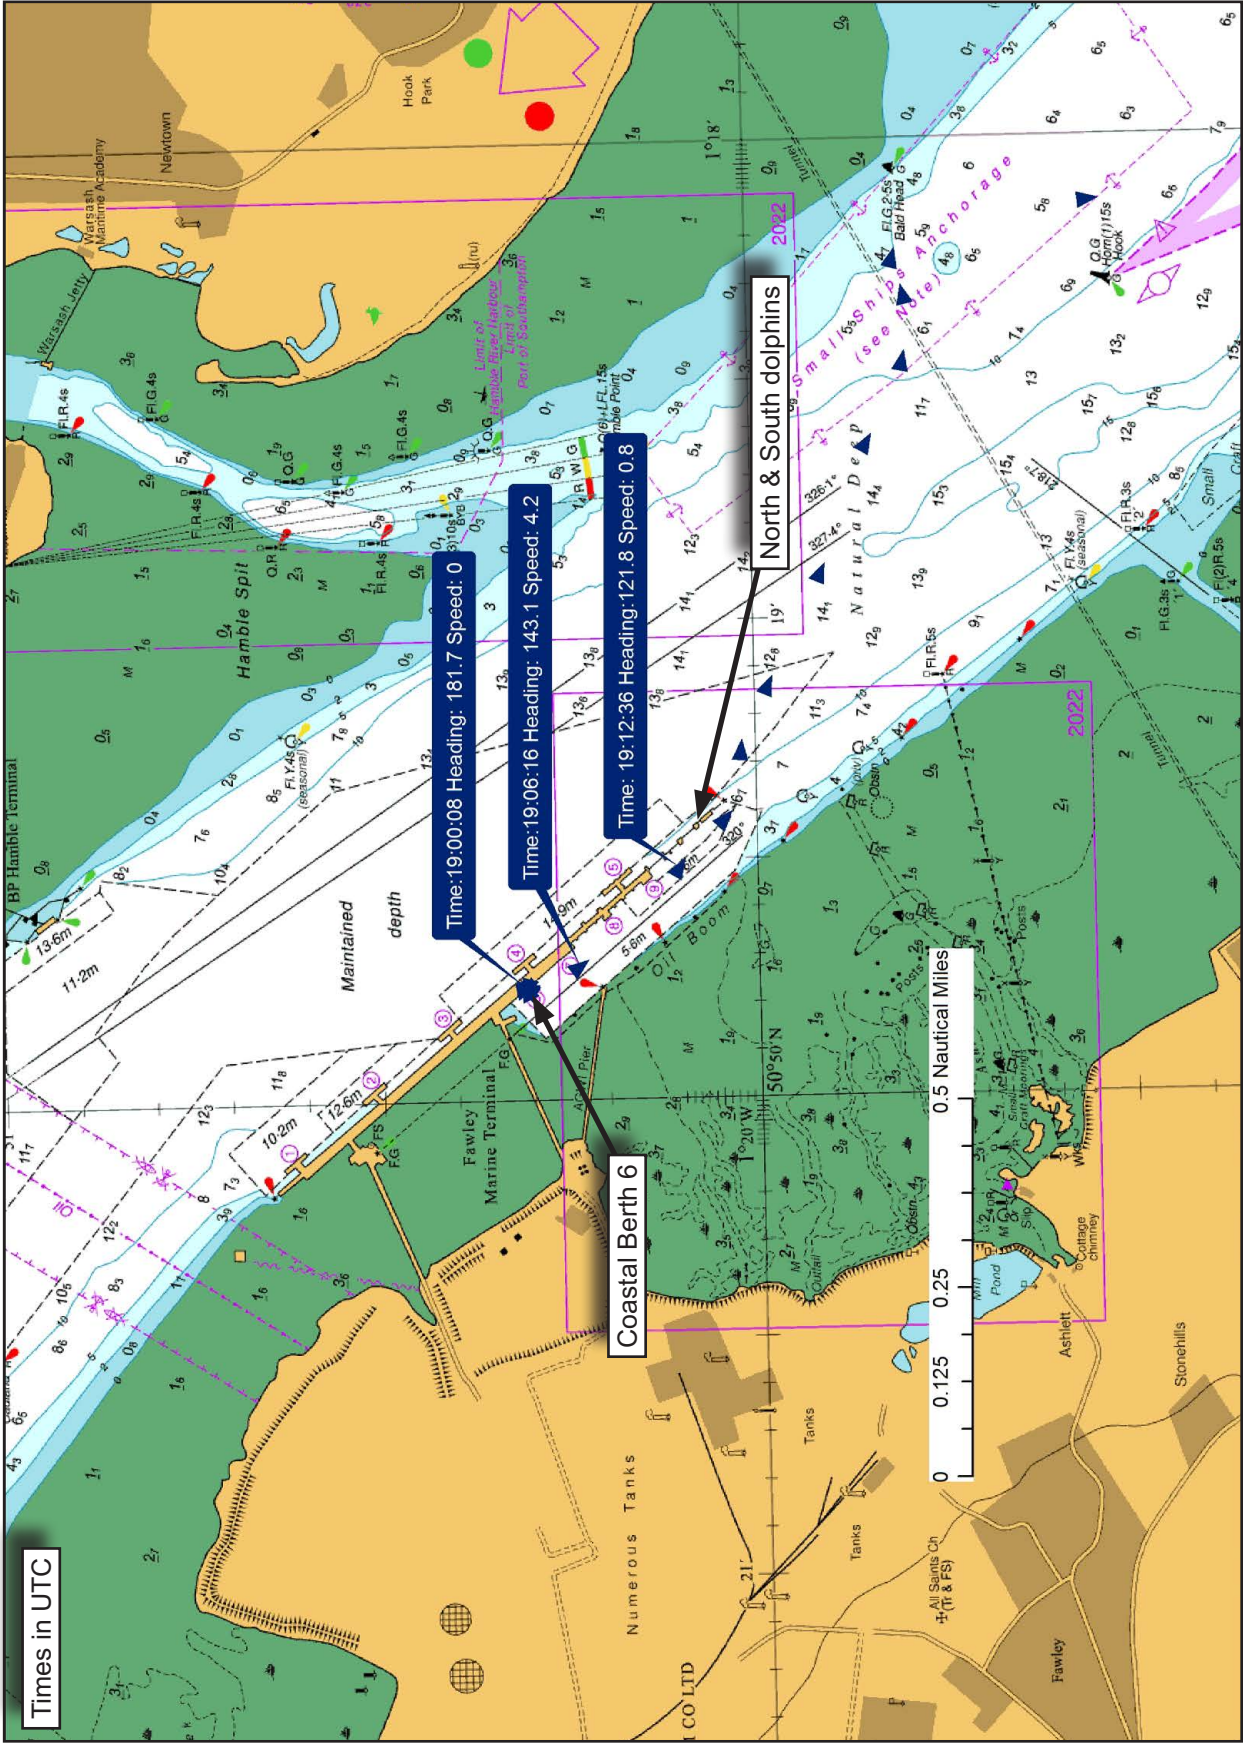
Figure 3: Donizetti automatic identification system track (times shown are in UTC)

At 2001, the pilot ordered the launch coxswain to make a 'tight line'³. *Donizetti*'s master ordered port full rudder, dead slow ahead on the controllable pitch propeller (CPP) and bow thrust to starboard. At the same time the headlines, stern lines and after spring were released. The forward spring was left attached to allow the vessel to move bodily off the berth. At approximately 2005, *Donizetti* began to move off the berth and the master brought the CPP control to zero. The vessel then began to drift astern as weight came on the forward spring, and the pilot called for clearance distances from the obstruction astern to be reported. The forward spring was then let go, and it is reported that the order '*Asterix* all easy' was passed by the pilot and acknowledged by the launch coxswain. The master moved the CPP control ahead and *Donizetti*'s speed increased to between 2 and 4kts ahead (**Figure 3**). *Asterix*'s coxswain attempted to turn the launch to port, applying port rudder with the
