Rail Accident Report

Freight train derailment at Angerstein Junction, 3 June 2015

Report 10/2016
June 2016

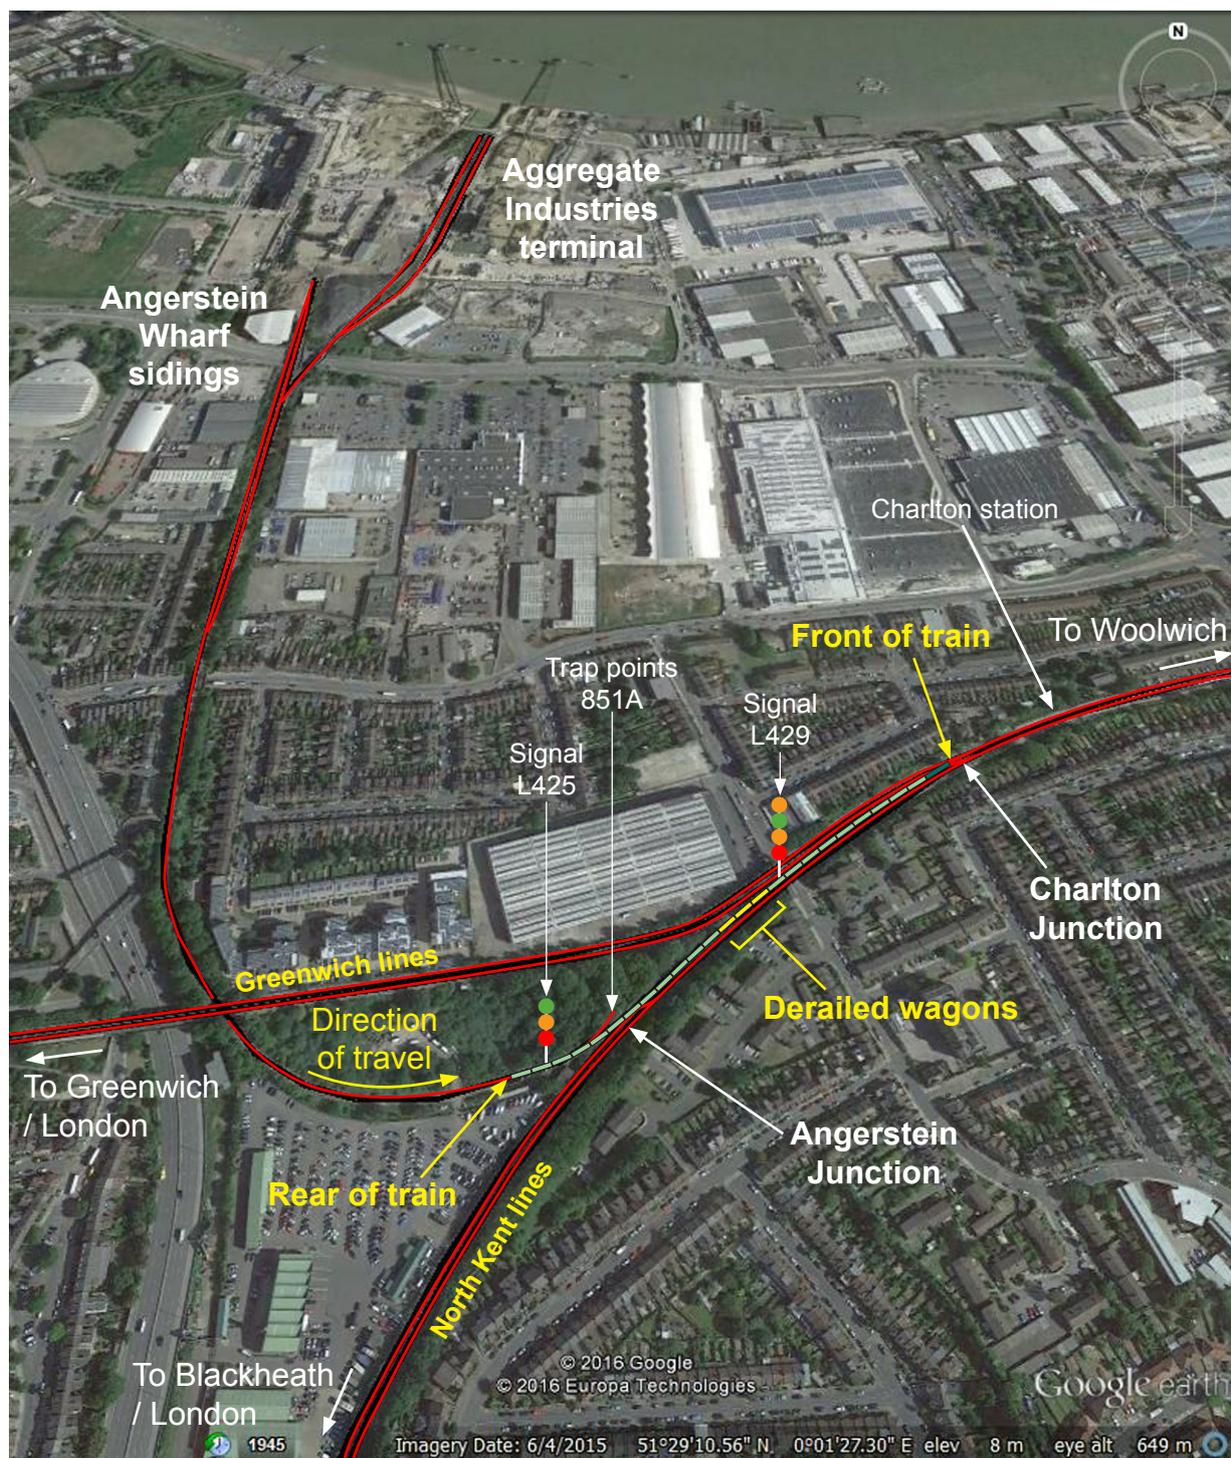
Figure 3: Google Earth image showing track layout and selected signals (showing train location after stopping)

- 6 The derailment occurred within the length of a set of curved *trap points*, approximately 50 metres before the line from Angerstein Wharf sidings joins the North Kent lines at Angerstein Junction¹. The train stopped approximately 160 metres after the initial derailment occurred, with three derailed wagons on the North Kent lines.
- 7 Angerstein Junction is located at 8 miles 46 *chains* on the North Kent lines, which connect Blackheath and Charlton (figure 3). At Charlton Junction, at 8 miles 63 chains, the North Kent lines join with the Greenwich lines.

- 23 On approaching Angerstein Junction, the train was stopped by a *red aspect* at signal L425 (figure 3) at 11:16 hrs, to await its timetabled *path*. This signal is positioned before trap points 851A, and controls entry from the sidings on to the North Kent lines.

- 116 After the derailment, Network Rail introduced an operational restriction to prevent unladen trains departing from Angerstein Wharf sidings onto the North Kent lines unless the second signal (L429) was showing a *proceed aspect* (indicated by a *green aspect* at signal L425 - figure 3). The intention of this restriction is to reduce the probability of departing trains having to brake while the rear wagons are still on the unchecked curve through the trap points 851A (paragraph 83).
- 117 Network Rail carried out its own investigation into the derailment, and this recommended that the efficacy of the layout of track and signalling through the derailment location should be reviewed in the light of this derailment and those of January/February 2015 (paragraph 103) and 2 April 2014 (paragraph 102).

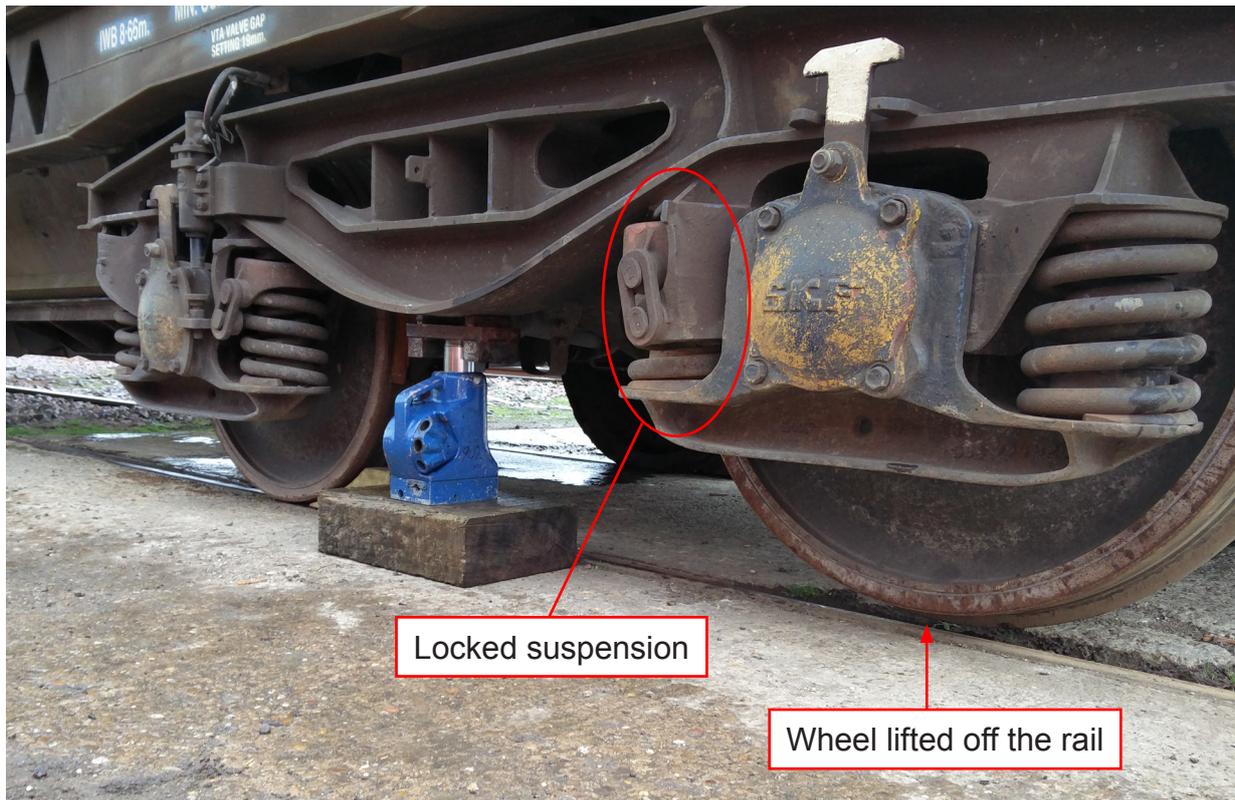
Figure 9: Effect of locked suspension when bogie side is jacked up

- 51 RAIB analysis of the Gotcha wheel weight data (paragraph 61) suggested that the suspension on the front bogie of wagon BHQ 17121 was not operating correctly. The RAIB observed, during testing of the wagon (paragraph 48), that the suspension on the front right wheel of wagon BHQ 17121 was locked, and not moving vertically. The effect of the locked suspension was demonstrated by jacking up the right side of the bogie (figure 9), and observing the front right wheel lifting off the rail while the other three wheels were still carrying load. Further wheel unloading testing of wagon BHQ 17121 provided evidence that the rest of the wagon's suspension was operating correctly.

- 52 The effect of the locked suspension on the front right wheel was to prevent it from retaining its share of the load as the wagon load was reduced and the other suspension springs lengthened (figure 10). A consequence of this was that the diagonally opposite rear left wheel also became lighter than should have been the case, as its suspension springs extended further to keep the front right wheel, whose springs were not extending, on the rail. The front left and rear right wheels then carried a greater load than would have been the case if the suspension had been fully working, as they took up the remaining load (table 1).

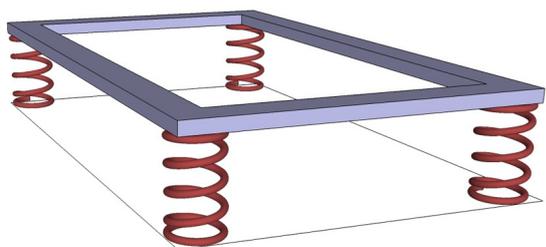
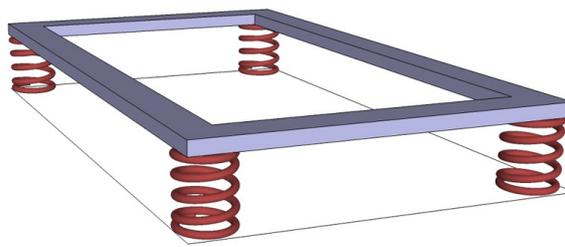
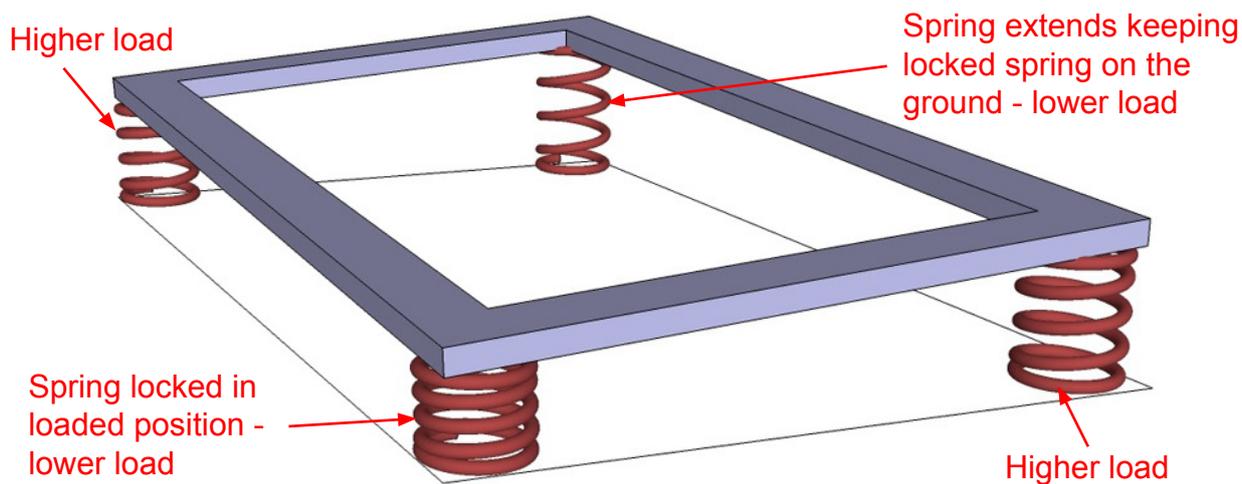
Figure 10: Representation of the effect of locked suspension on wheel loads

- 53 The RAIB observed the stripping down of the leading bogie of wagon BHQ 17121 to identify the cause of the locked suspension. The longitudinal wear plate (paragraph 36) on the front right-hand wheel's axle box had become worn such that there was a step change in profile of approximately 1 mm just above the position where the damper contacted it when the suspension was in the laden condition. The wear pattern and recess are shown in figure 11. The relatively unworn wear face of the damper is shown in figure 12.

- 54 This change in profile meant that the damper entered a recess that was approximately 1 mm deep when the wagon was laden, and was then unable to slide out of the recess onto the less worn surface that it would normally contact when the wagon was unloaded.

Tare condition prior to derailment, with front right spring locked in compressed condition

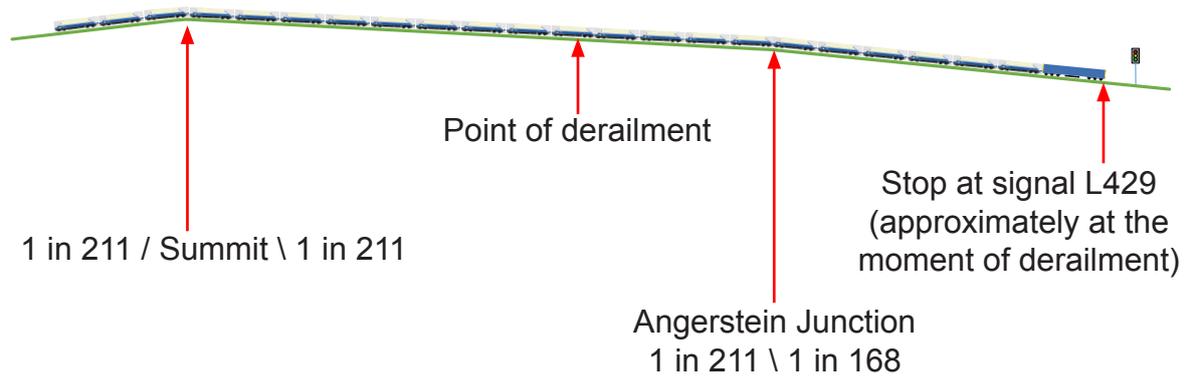
Figure 17: Gradient profile relative to the train position at derailment

- 83 The train was braking gently on a left-hand curve with the front 19 wagons on a downhill gradient (figure 17), at the time of derailment, and this could have affected the lateral forces between the wheels and the outer rail. This was a normal operational condition for any train that was required to stop at signal L429.

- 84 This scenario, where the signal positions and aspects meant that the train was required to brake with part of it on tightly curved downhill track, a portion of which had no check rail, was also present in the previous derailment that occurred at the same location on 2 April 2014 (paragraph 102).
