SAFETY FLYER TO THE FISHING INDUSTRY

Fishing vessel *St Apollo*, grounding and flooding, 24 August 2015

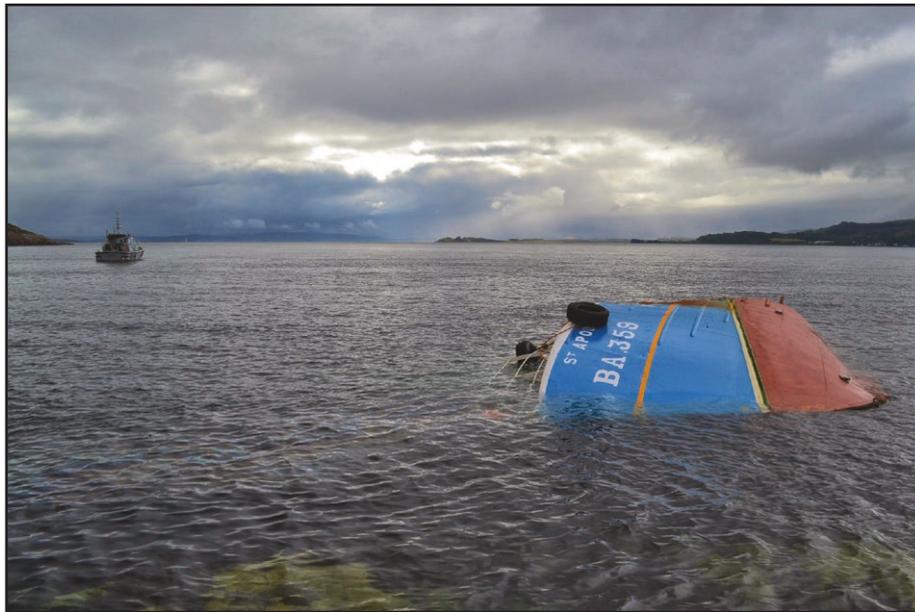
At approximately 0327 on 24 August 2015, while on passage to fishing grounds, the 17m scallop dredger *St Apollo* grounded on Eilean Rubha an Ridire, a small island at the south-east entrance to the Sound of Mull. The vessel was on passage with the automatic steering engaged, and it is reported that the vessel suddenly turned unexpectedly. The wheelhouse watchkeeper reduced the engine speed and alerted the skipper who was asleep in his bunk. However, the vessel grounded before the skipper had a chance to reach the wheelhouse.

The skipper and crew quickly mustered, donned lifejackets and determined that there was no water ingress. The coastguard was also informed. Attempts to re-float *St Apollo* were unsuccessful and, as the tide fell, the vessel started to list to starboard. The crew abandoned into a liferaft and were picked up by the Oban lifeboat that was standing by. At 0505, *St Apollo* toppled onto its starboard side and remained partially submerged in shallow water. The vessel was subsequently salvaged but was beyond economic repair.
