Rail Accident Investigation Branch

Rail Accident Report

**Signal passed at danger on approach to
Wootton Bassett Junction, Wiltshire
7 March 2015**

Report 08/2016
May 2016

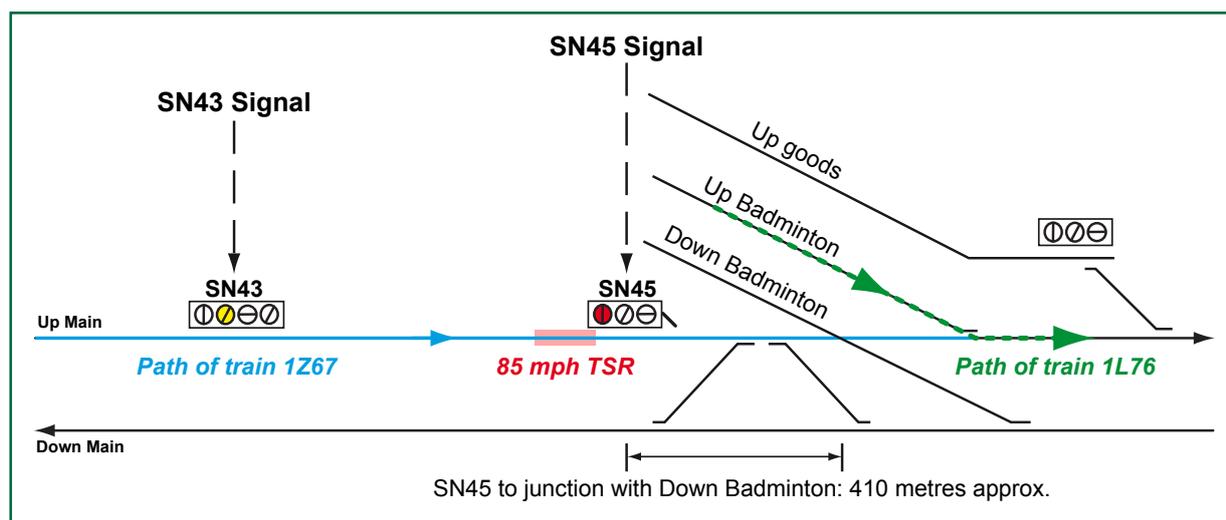
- 5 Wootton Bassett Junction is located between the stations at Chippenham and Swindon. It is a double track high speed junction which joins the up and down Great Western main lines which run between Bristol Temple Meads and London Paddington (via Bath) with the Up and Down Badminton lines which run to and from Cardiff. The junction also has two low speed crossovers between the up and down main lines (figure 2).

Figure 2: A diagram of the layout of Wootton Bassett Junction – note that some features have been omitted for clarity (not to scale)

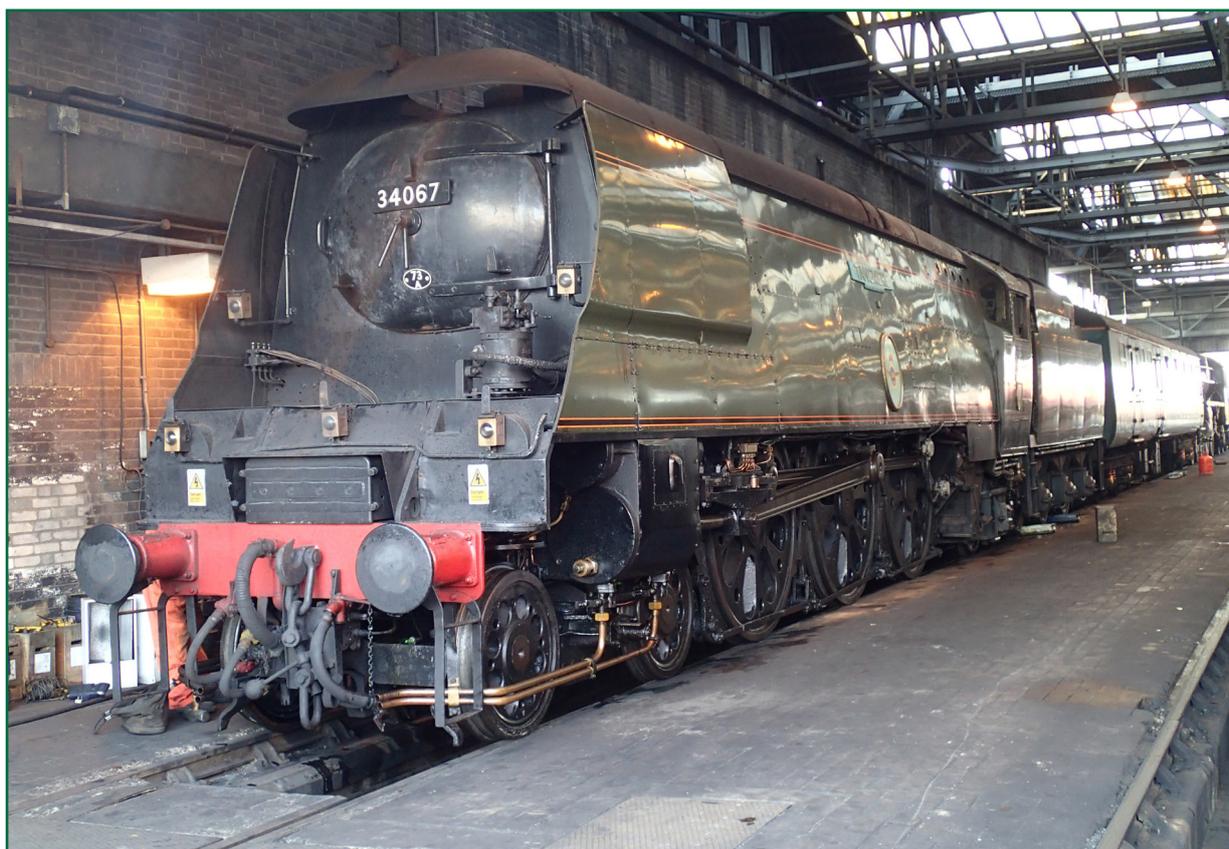
- 12 Train 1Z67 was formed of 13 *Mark 1* and *Mark 2* coaches, hauled by steam locomotive number 34067 'Tangmere'³ (figure 7). This locomotive was built in 1947 and was withdrawn from mainline railway service by British Railways in November 1963. The driver's slip for the train stated that it was 277 metres in length, weighed approximately 605 tonnes (including the locomotive and tender) and that it had a maximum permitted train speed of 75 mph (121 km/h). Twelve of the thirteen coaches were vacuum braked. The remaining coach, which was the support coach for the locomotive, was air braked.

Figure 7: Locomotive 34067 'Tangmere'
