# ***AAIB Bulletin***

***8/2016***

Published: 11 August 2016

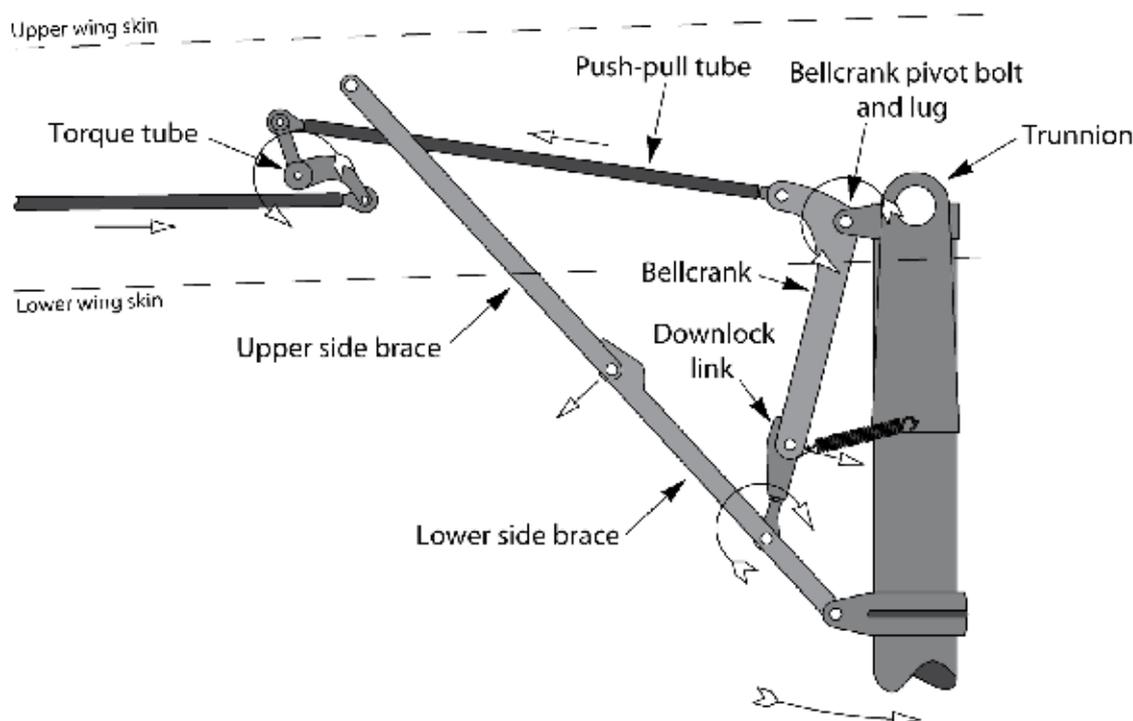
**Figure 1**

The landing gear retraction system is powered by an electric motor that drives, via a reduction gearbox, a series of rods, torque-tubes and bellcranks that move the landing gear legs. The main landing gear is held in the 'down and locked' position by a folding side brace. A downlock link, driven by a bellcrank, applies a force to the side brace to keep it in an over-centre position when the landing gear is down, Figure 1.

Schematic of the landing gear downlock mechanism

When the main landing gear leg is down and locked, the downlock link and bellcrank should be in an over-centre position, to hold the side brace over-centre and prevent it from folding. A microswitch, mounted on the downlock link, closes when it is over-centre and illuminates the green DOWN instrument panel light for that landing gear leg. The bellcrank is connected to the downlock link by a pin, which is secured in place by a set screw. To ensure that the screw engages in the detent in the pin, an arrow, which is stamped in the end of the downlock pin, must be aligned with the set screw, Figure 2.

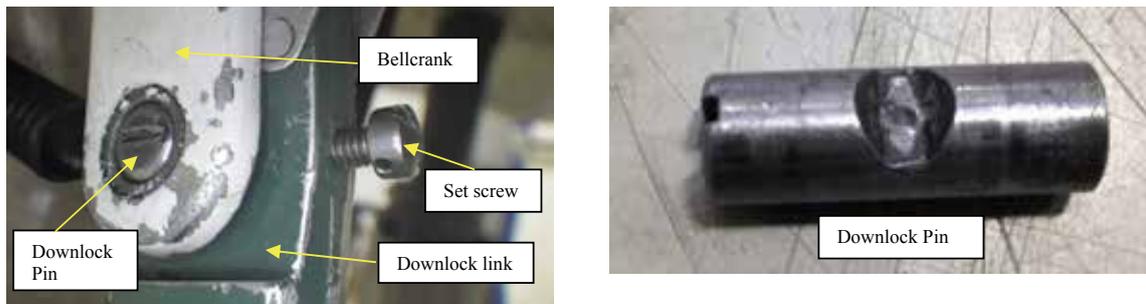
**Figure 2**

Downlock pin and set screw

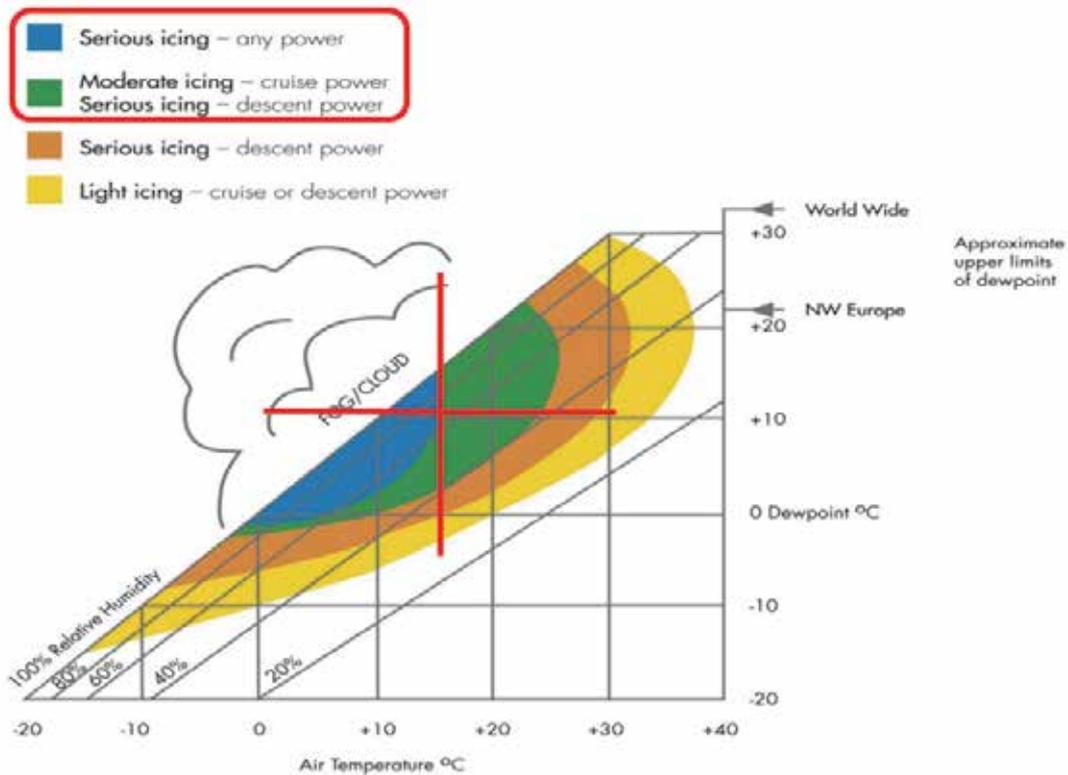
**Figure 1**

The CAA has published advice on carburettor icing<sup>1</sup>, including a graph showing a range of values of temperature and dewpoint and the degree of icing which might be expected. The values reported at Cranfield are shown as red lines on Figure 1, illustrating that the conditions were on the boundary between '*serious icing – any power*' and '*moderate icing – cruise power/serious icing – descent power*'.

CAA Carburettor Icing chart  
 (The temperature and dewpoint reported at Cranfield Airport  
 are shown by the two red lines)

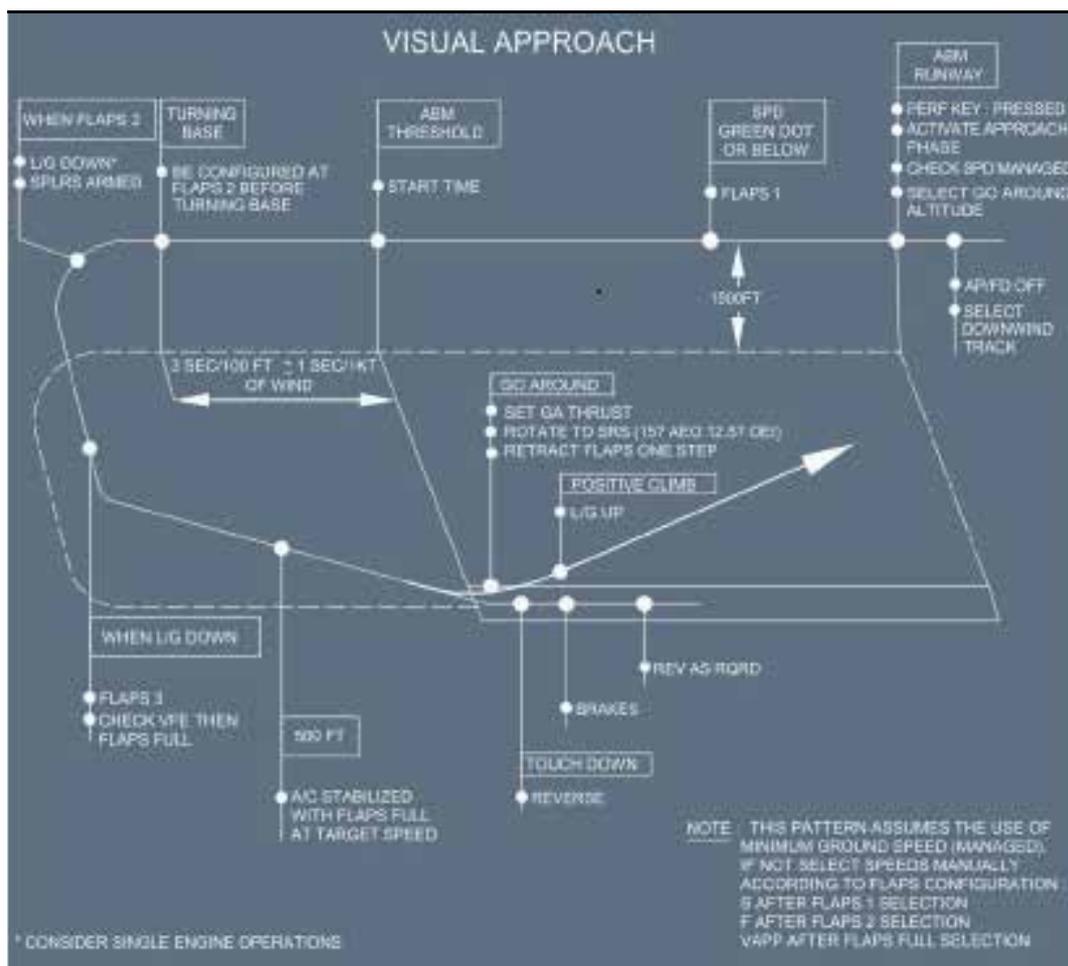
**Figure 1**

The Flight Crew Operating Manual (FCOM) also provides guidance on flying a visual circuit (see Figure 1).

Visual approach pattern
