Rail Accident Investigation Branch

Rail Accident Report

Overspeed at Queen's Park, London 5 January 2016

Report 19/2016
October 2016

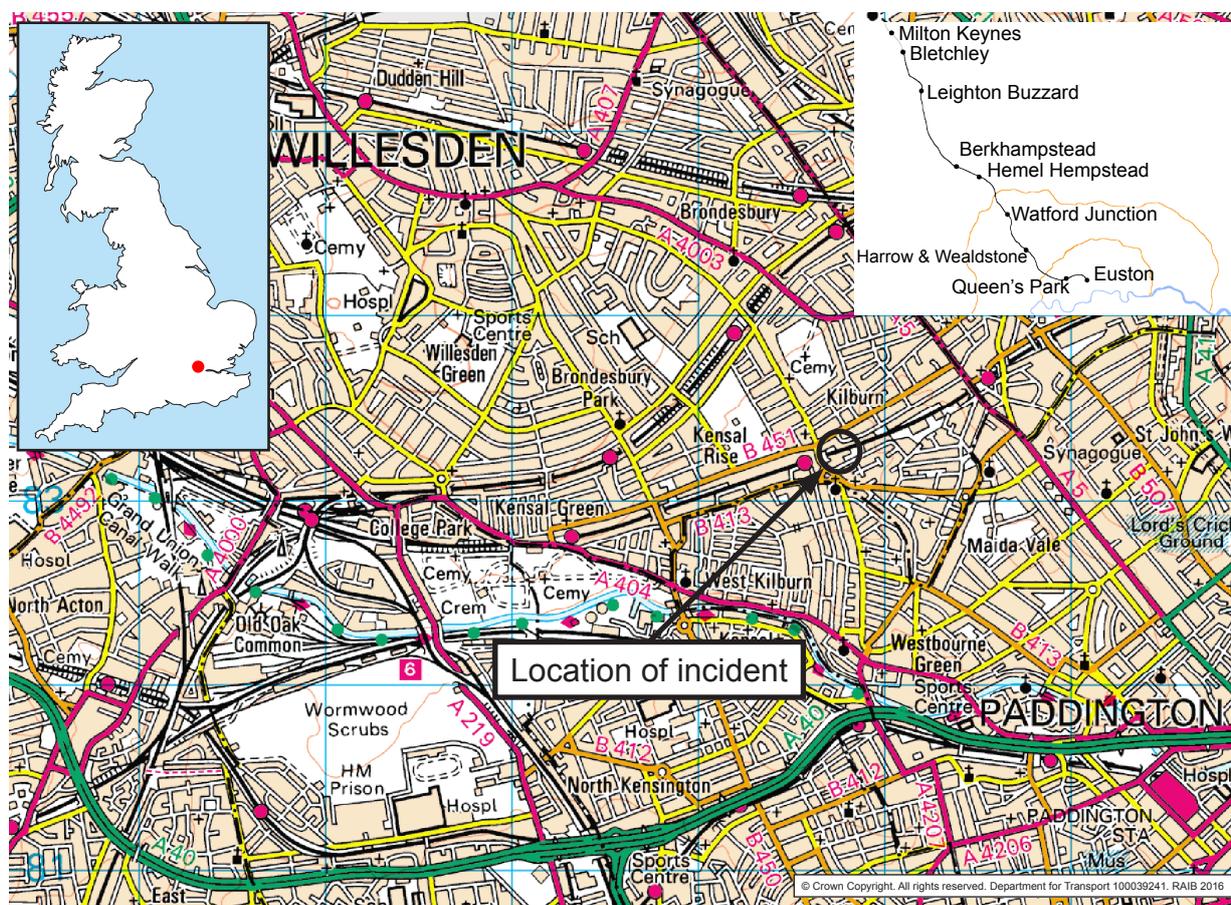
Figure 1: Incident location (inset: route map from Bletchley to London, outline of River Thames, North circular Road and M25)

- 3 At 08:28 hrs on 5 January 2016, a London Midland passenger train travelled at 75 mph (121 km/h) over a 5 mph (8 km/h) *emergency speed restriction* (ESR) immediately east of Queens Park station in north-west London (figure 1).
- 4 The train was the 07:39 hrs service London Midland service from Bletchley to London Euston. It was being driven by a *driver manager* who had recently joined London Midland and who was being assessed by another driver manager. Neither driver manager was aware of the overspeeding event until they arrived at Euston.

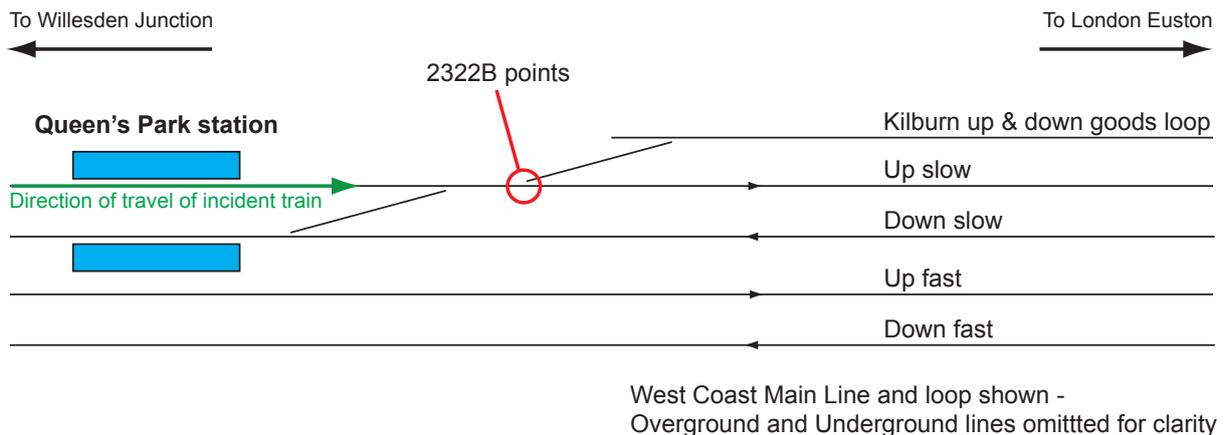
Figure 2: Track layout

- 5 The incident occurred on the up slow line at a set of *points* giving access to the Kilburn up and down goods loop (figure 2). The maximum speed normally permitted on the up slow line at this location was 75 mph (121 km/h). However, on the previous night, an emergency speed restriction had been imposed due to the discovery of a crack in part of the set of points.
- 6 There were no injuries, no damage to the train and no further damage to the infrastructure.

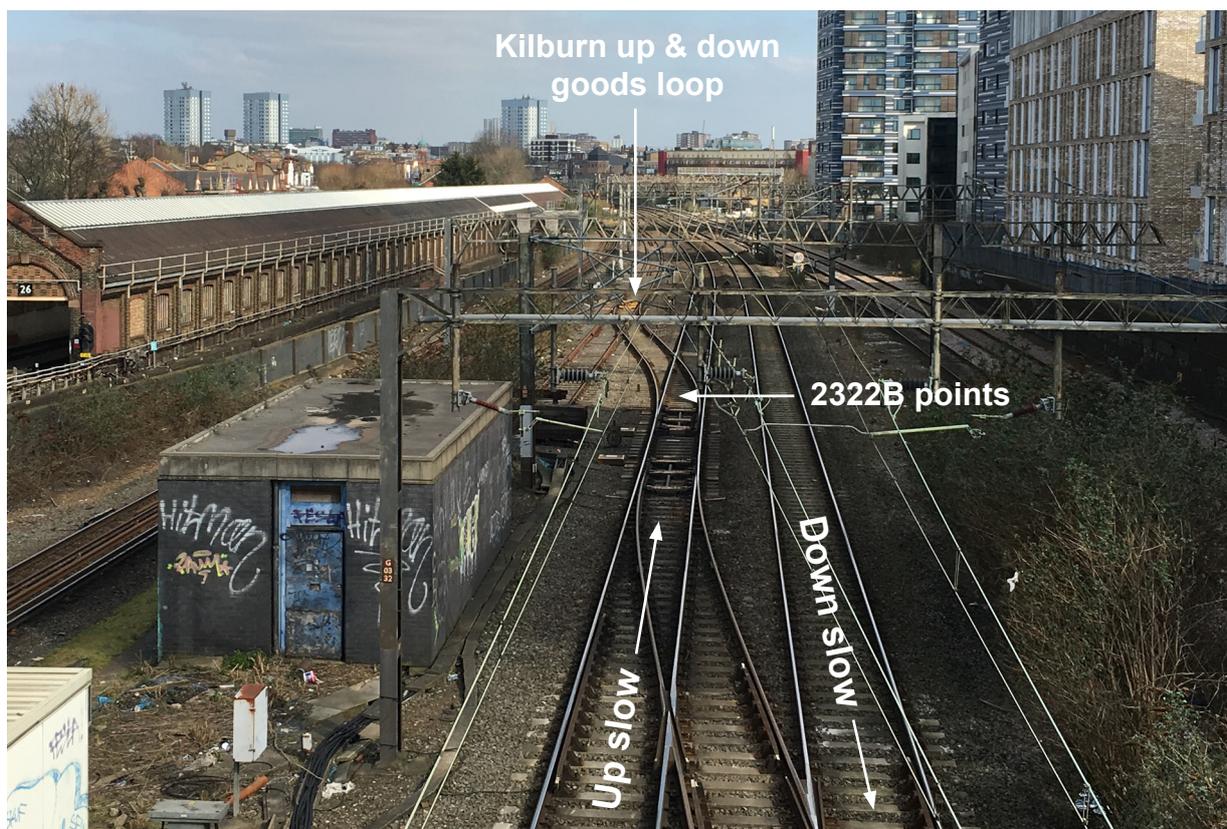
Figure 3: Incident location

- 16 The incident occurred at points number 2322B which have *inclined, flat bottom CEN60* rails with ‘C’ *switch* length. These are on the up slow line and give access to the western end of Kilburn up and down goods loop (figure 3). The points included a *crossing*, a component needed to allow the passage of wheel flanges across other rails where tracks intersect (figure 4).
- 17 London Midland’s Bletchley train crew and driver managers are based in facilities at Bletchley station. These facilities include an office shared by the driver managers and the train crew booking-on point, housing the *late notice case*.
