## Fatal accident while manoeuvring *Svitzer Moira* alongside an unmanned tug Royal Portbury Dock, Bristol 29 December 2015

### SUMMARY

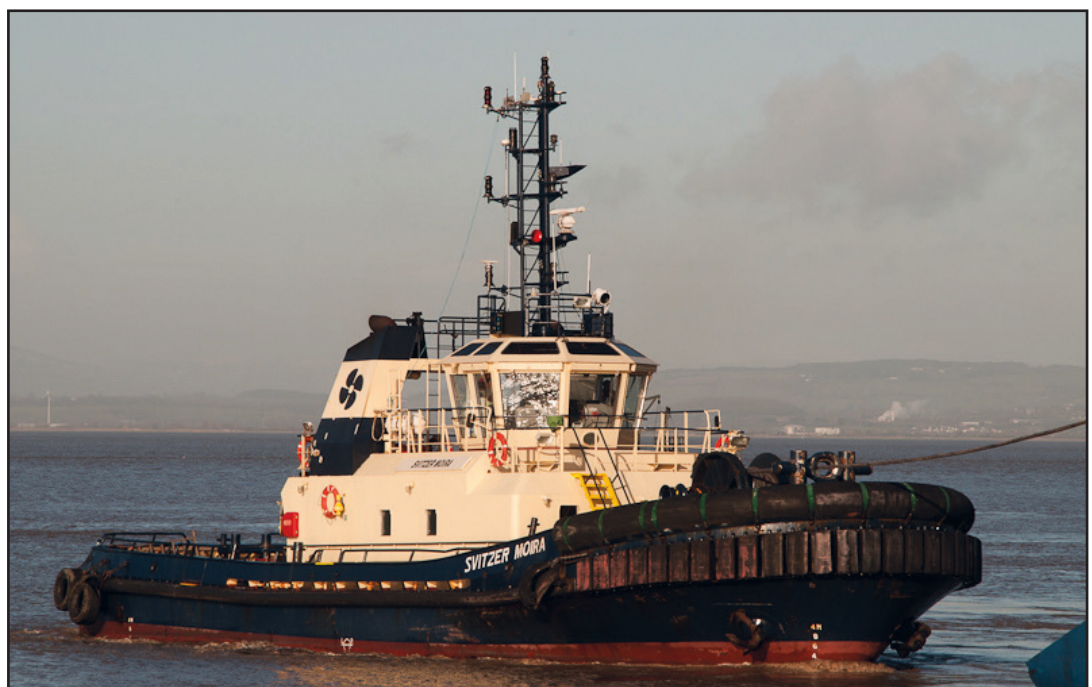
Figure 1: *Svitzer Moira*

On 29 December 2015, Mr Kevin Jackman, the engineer of the 29m harbour tug *Svitzer Moira* (**Figure 1**), was crushed and fatally injured after he fell from his vessel as it was being manoeuvred alongside an unmanned tug in Royal Portbury Dock, Bristol.
