Published 13 October 2016

## ACCIDENT

<b>Aircraft Type and Registration:</b>	Beech B200 Super King Air, G-BYCP	
<b>No &amp; Type of Engines:</b>	2 Pratt & Whitney Canada PT6A-42 turboprop engines	
<b>Year of Manufacture:</b>	1981 (Serial no: BB-966)	
<b>Date &amp; Time (UTC):</b>	3 October 2015 at 0920 hrs	
<b>Location:</b>	Near Chigwell, Essex	
<b>Type of Flight:</b>	Non-commercial	
<b>Persons on Board:</b>	Crew - 1	Passengers - 1
<b>Injuries:</b>	Crew - 1 (Fatal)	Passengers - 1 (Fatal)
<b>Nature of Damage:</b>	Aircraft destroyed	
<b>Commander's Licence:</b>	Commercial Pilot's Licence	
<b>Commander's Age:</b>	40 years	
<b>Commander's Flying Experience:</b>	1,941 hours (of which 162 hours were on type) Last 90 days - 61 hours Last 28 days - 50 hours	
<b>Information Source:</b>	AAIB Field Investigation

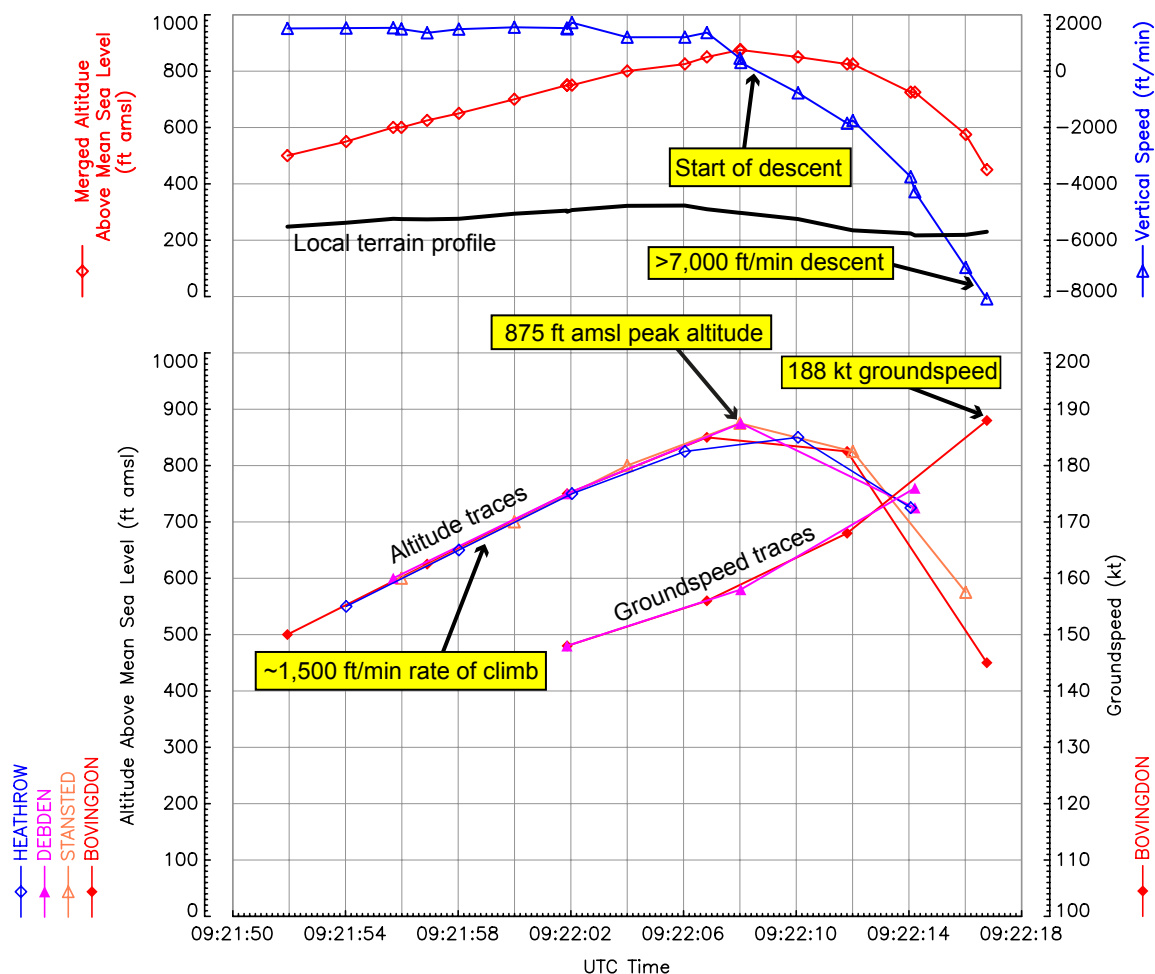
**Figure 5**  
Flight parameters

Ground tracks from the four radar installations are shown in Figure 4. Figure 5 shows the altitude and groundspeed values transmitted by the aircraft plotted against time. In the case of altitude, the values have been corrected for the regional pressure setting. In the upper half of Figure 5, the altitude trace, which shows merged altitude data from each radar installation, was used to derive the vertical speed trace.
