Runaway and derailment of a rail vehicle near Bury, Greater Manchester, 22 March 2016

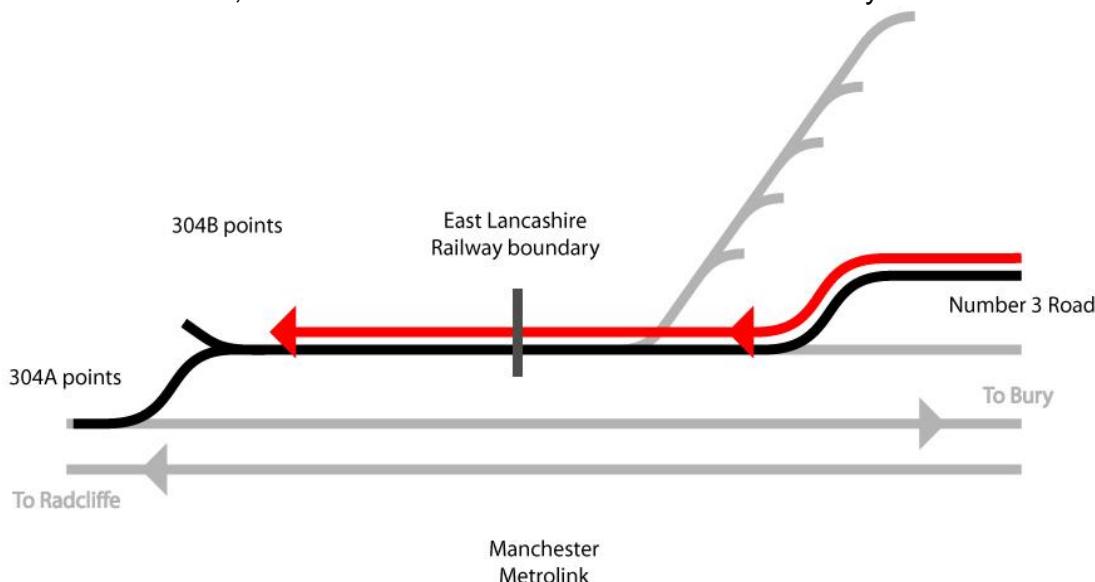
The East Lancashire Railway's Baron Street yard consists of a number of sidings and is on a 1 in 119 gradient, descending to the south. Number 3 Road of the sidings runs the entire length of the yard and is connected at its south end, via points, to a line which joins onto the Metrolink light rail system. The boundary between the two systems is marked by a fence and a locked gate.

Once on Metrolink infrastructure, this connecting line passes over a set of hydraulically operated points (304 points, which consist of an 'A' and a 'B' end). When set normally 304A points direct northbound trams to Bury, while 304B points act as trap points which are intended to derail movements from the yard towards the cess and away from the tramway. The cess is bordered at this location by trees and an embankment.

Simplified diagram showing the track layout (not to scale)
