AAIB Bulletin

12/2016

Aircraft Type and Registration:	Embraer EMB-505 Phenom 300, HZ-IBN	
No & Type of Engines:	2 Pratt & Whitney Canada PW535E turbofan engines	
Year of Manufacture:	2010 (Serial no: 50500040)	
Date & Time (UTC):	31 July 2015 at 1408 hrs	
Location:	Blackbushe Airport, Surrey	
Type of Flight:	Private	
Persons on Board:	Crew - 1	Passengers - 3
Injuries:	Crew - 1 (Fatal)	Passengers - 3 (Fatal)
Nature of Damage:	Aircraft destroyed	
Commander's Licence:	Airline Transport Pilot's Licence	
Commander's Age:	57 years	
Commander's Flying Experience:	11,000 hours (of which 1,181 were on type) Last 90 days - 23 hours Last 28 days - 5 hours	
Information Source:	AAIB Field Investigation

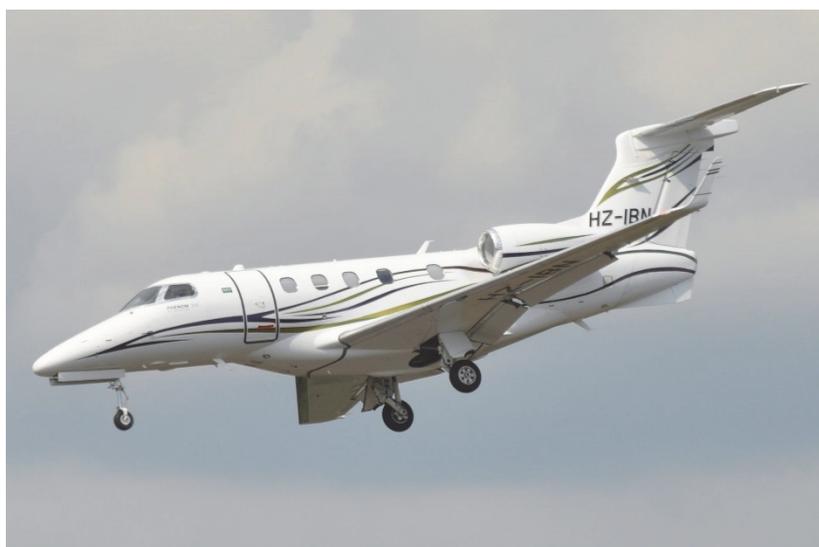
Figure 1

The aircraft (Figure 1) had positioned to Milan earlier in the day, flown by the same pilot, and was returning to Blackbushe with the pilot and three passengers on board. After descending through the London Terminal Manoeuvring Area (TMA) it was handed over from London

HZ-IBN on approach to Runway 25 shortly before the accident
(photograph taken by Geoff Pierce)

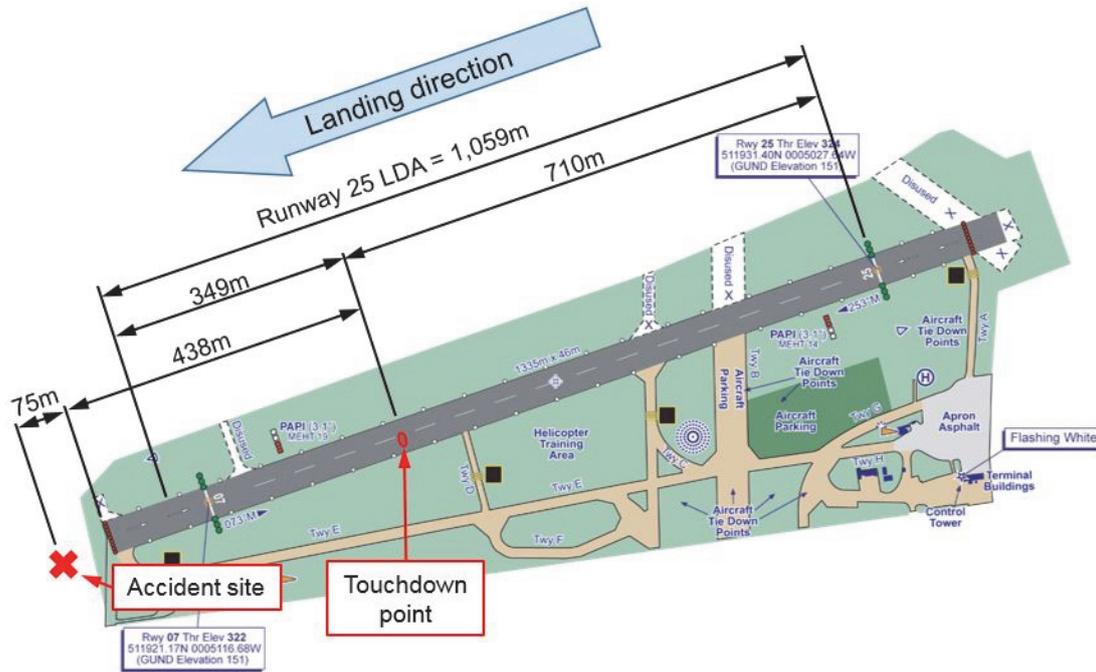
Figure 3

The aerodrome has one asphalt runway (Figure 3), orientated 07/25, measuring 1,335 by 46 m. The landing distance available on Runway 25 is 1,059 m, beginning at the threshold and ending at an unmarked point 89 m before the end of the asphalt surface. The Runway 25 threshold elevation is 324 ft and the runway has no appreciable slope. At the western end of the runway there is an earth bank one metre high, partially covered in low vegetation, beyond which a wire mesh fence separates the aerodrome from the car park.

Blackbushe aerodrome chart, showing LDA and approximate touchdown point

Data from the aircraft's CVFDR indicated that the aircraft crossed the threshold of Runway 25 at approximately 50 ft agl at 151 KIAS, 43 kt above the target threshold speed. The aircraft touched down 710 m beyond the Runway 25 threshold with a groundspeed at touchdown of 135 kt, and an airspeed of 134 KIAS. The performance model predicted that at this speed, the landing ground roll required to stop the aircraft would be at least 616 m⁹. Runway 25 has a declared Landing Distance Available (LDA) of 1,059 m; therefore the aircraft touched down approximately 349 m before the end of the declared LDA, 438 m before the end of the paved runway surface (Figure 3).

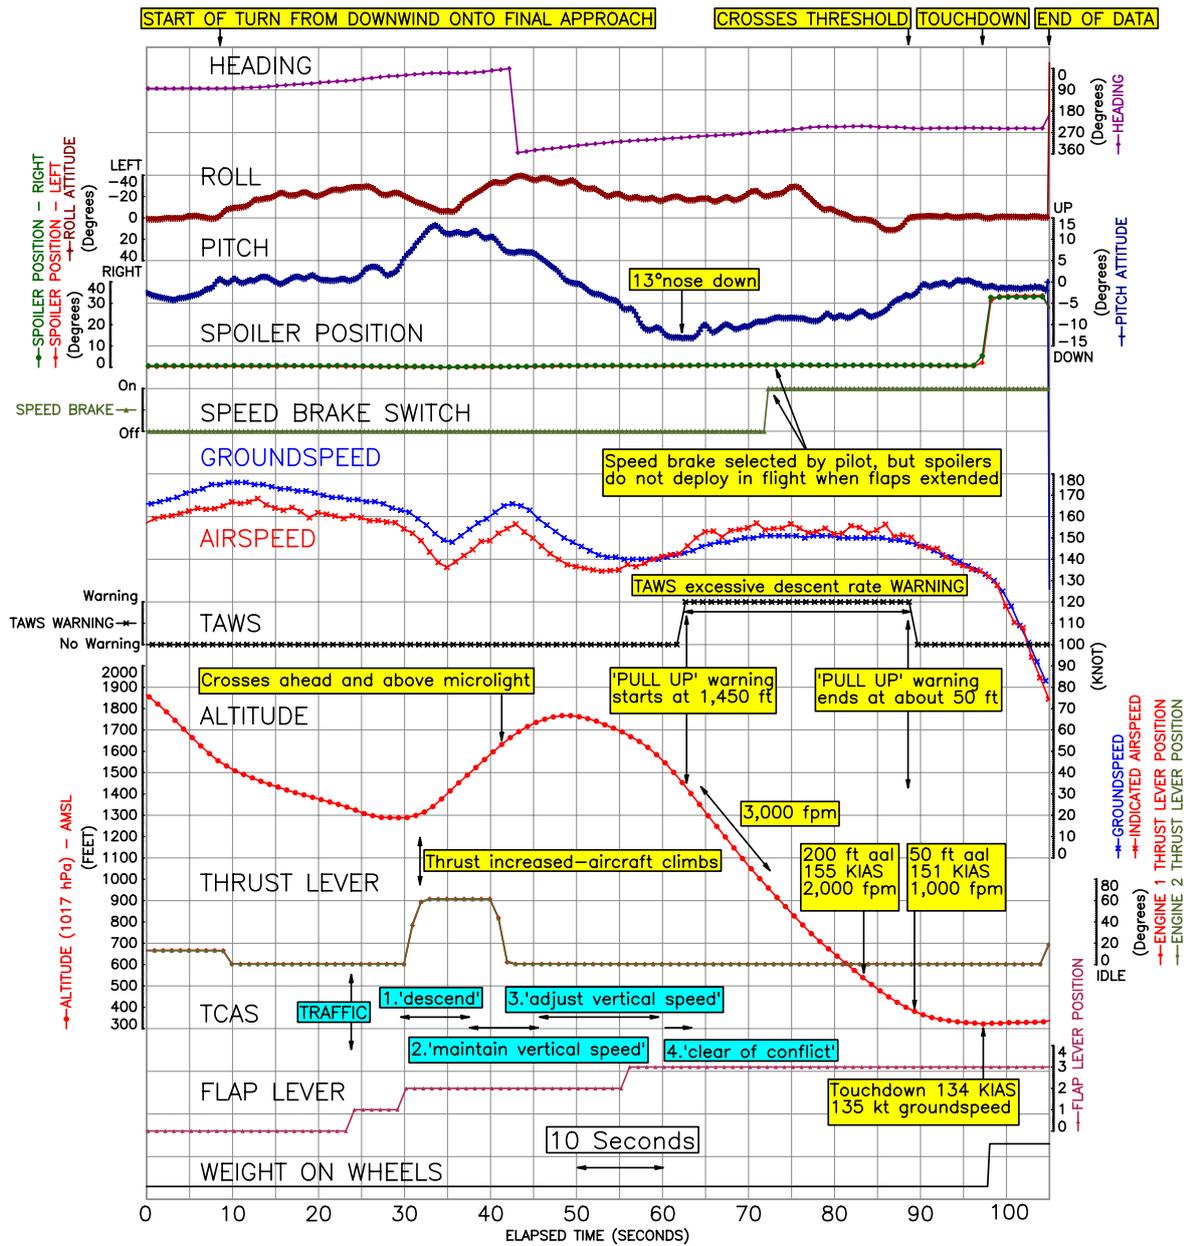
Figure 4 presents salient parameters from the CVFDR, starting just before the aircraft turned from downwind onto the final approach. Figure 5 presents the approach track of HZ-IBN to Blackbushe Airport. Figures 6 and 7 present the relative positions of HZ-IBN, the microlight and overflying aircraft when TCAS RA's occurred.

CVFDR data of approach

The approach continued and the aircraft crossed the threshold at about 50 ft aal at an airspeed of 151 KIAS with a rate of descent of about 1,000 fpm but reducing. This coincided with the sixth (and final) TAWS warning. The aircraft touched down about nine seconds later at an airspeed of 134 KIAS and a groundspeed of 135 kt. The ground spoilers deployed and the brakes were applied almost immediately. The aircraft decelerated at an average longitudinal deceleration of $-0.45g$ (Figure 11). When the aircraft reached the end of the paved surface of the runway its groundspeed was 83 kt and its airspeed was 84 KIAS. In the second before the end of the CVFDR data, both thrust levers were recorded as having been advanced from the idle position and the spoilers had started to close.

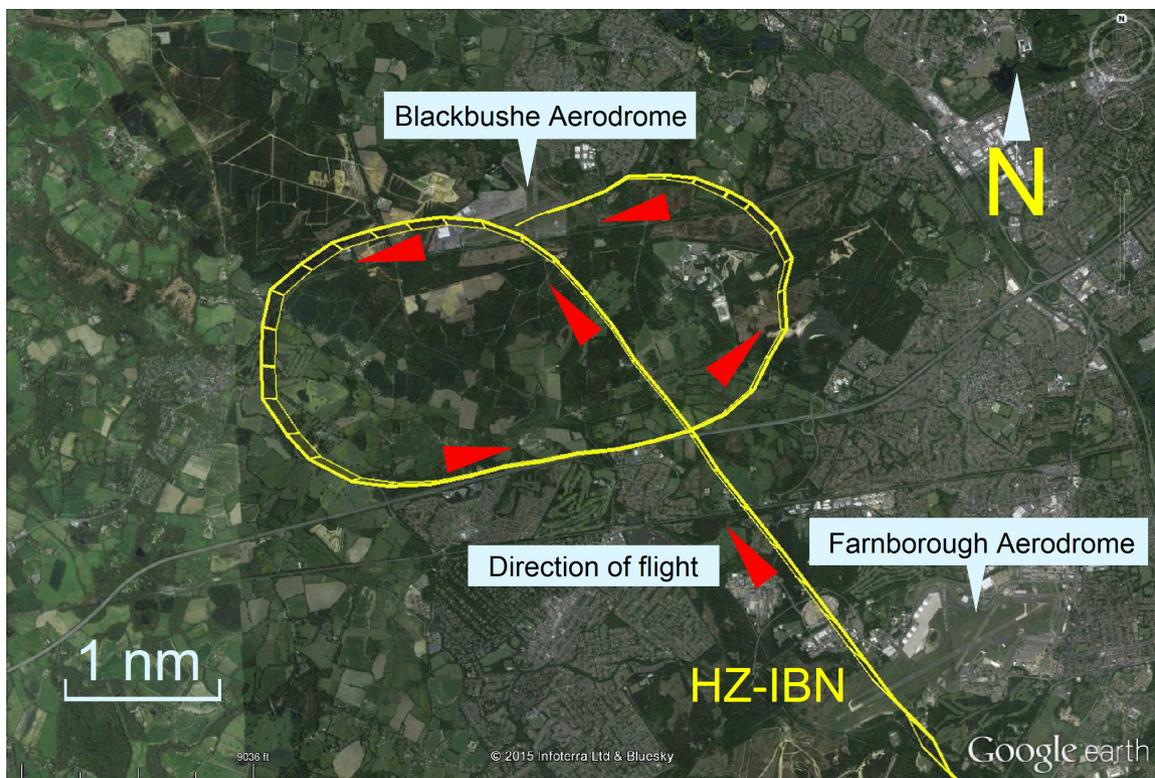
Figure 5
Approach path of HZ-IBN (Bovingdon radar)

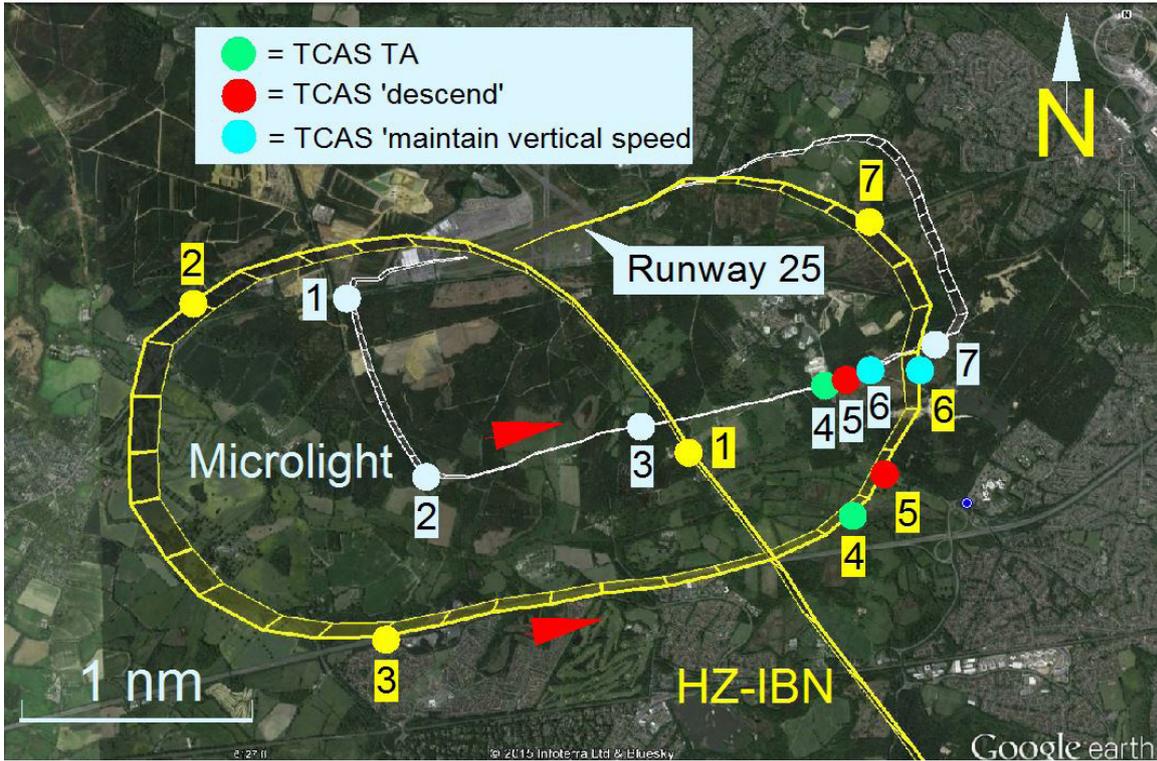
Figure 6

The microlight was now established on a downwind track laterally displaced 0.9 nm from the runway and HZ-IBN was displaced about 1.6 nm from the runway (Figure 6). Throughout this period several cockpit alerts and announcements were recorded on the CVR, with up to three sounds from different sources occurring simultaneously (ie RTF communications and aircraft systems such as TCAS and TAWS).

Relative positions of HZ-IBN and microlight
 (Paired numbers and colour codes indicate relative positions of the aircraft when the TCAS alerts were generated on HZ-IBN – the other aircraft were not TCAS equipped)

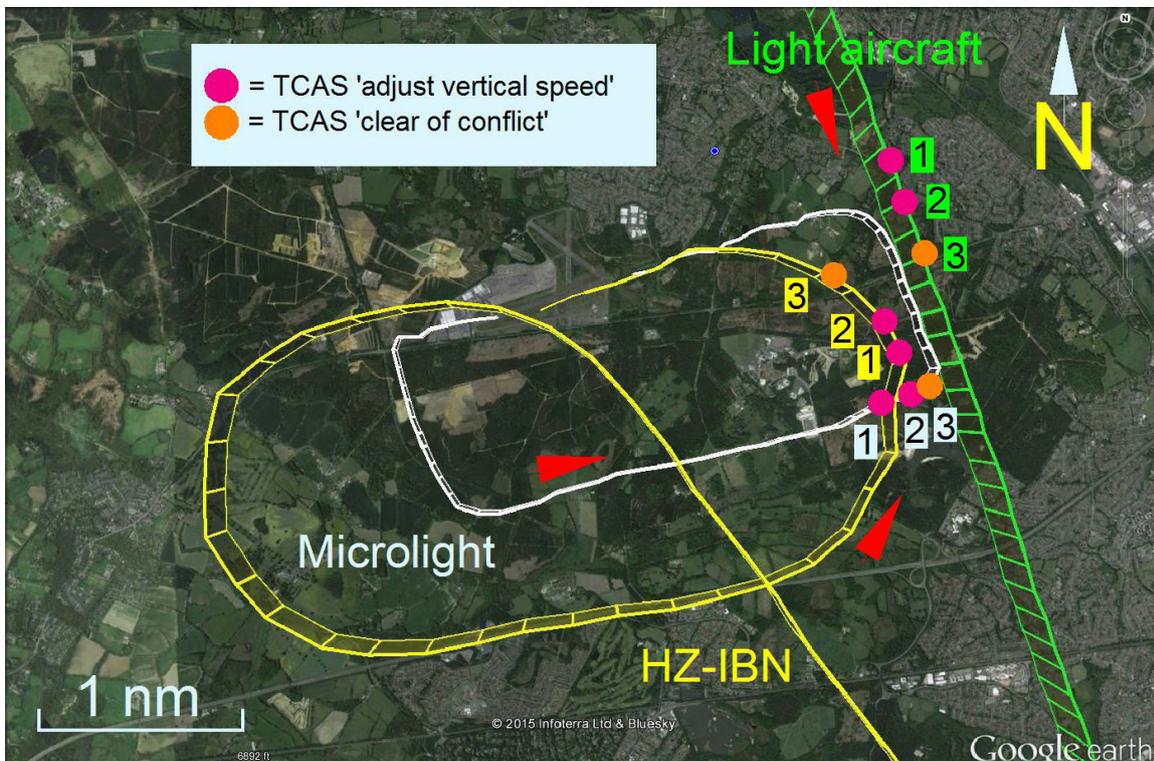
Figure 7

Relative positions of HZ-IBN, microlight and light aircraft
 (Paired numbers and colour codes indicate relative positions of the aircraft when the TCAS alerts were generated on HZ-IBN – the other aircraft were not TCAS equipped)

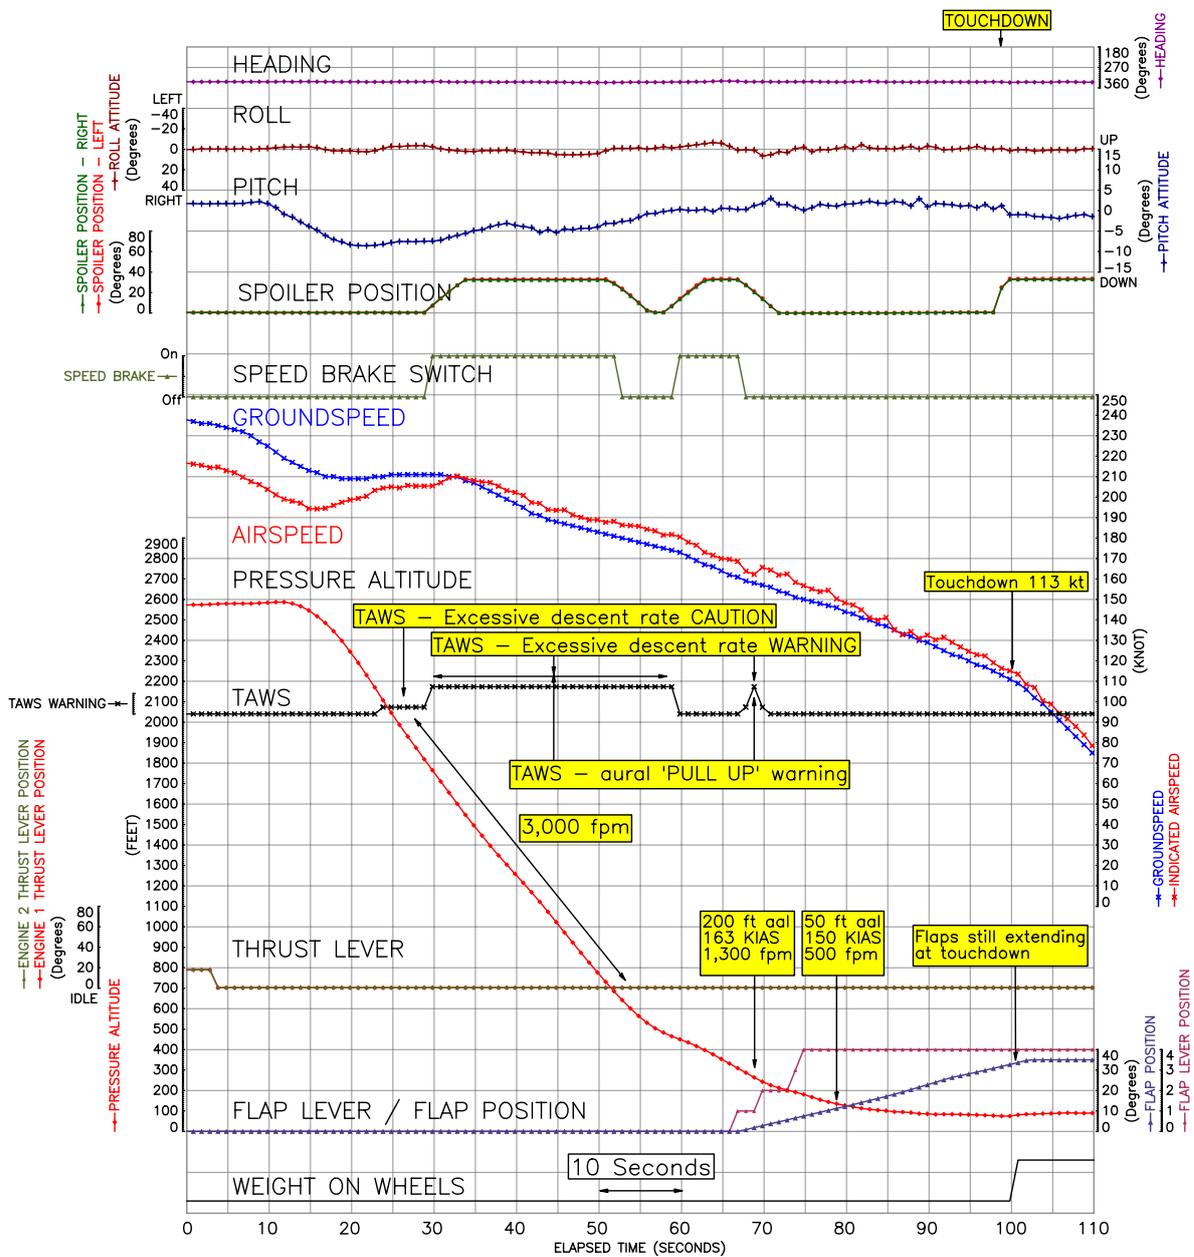
Twenty of the examined flights were flown by the pilot of the accident flight. On 18 April 2015 he had flown HZ-IBN from Riyadh to Jeddah King Abdulaziz International Airport, landing on Runway 34L which has a landing distance of 3,800 m available. Figure 8 presents the salient parameters for this landing. There were a number of similarities between this approach and that of the accident flight, with a high rate of descent, TAWS warnings and a speed of about 150 KIAS as the aircraft crossed the threshold at a height of about 30 ft. During this landing the flaps were still extending as the aircraft touched down. Another similar approach and landing was also identified; this had been flown by a different pilot landing at a different airport in Saudi Arabia. The operator stated that it was unaware of either of these events prior to the accident.

Pilot of HZ-IBN landing at Jeddah 18 April 2015

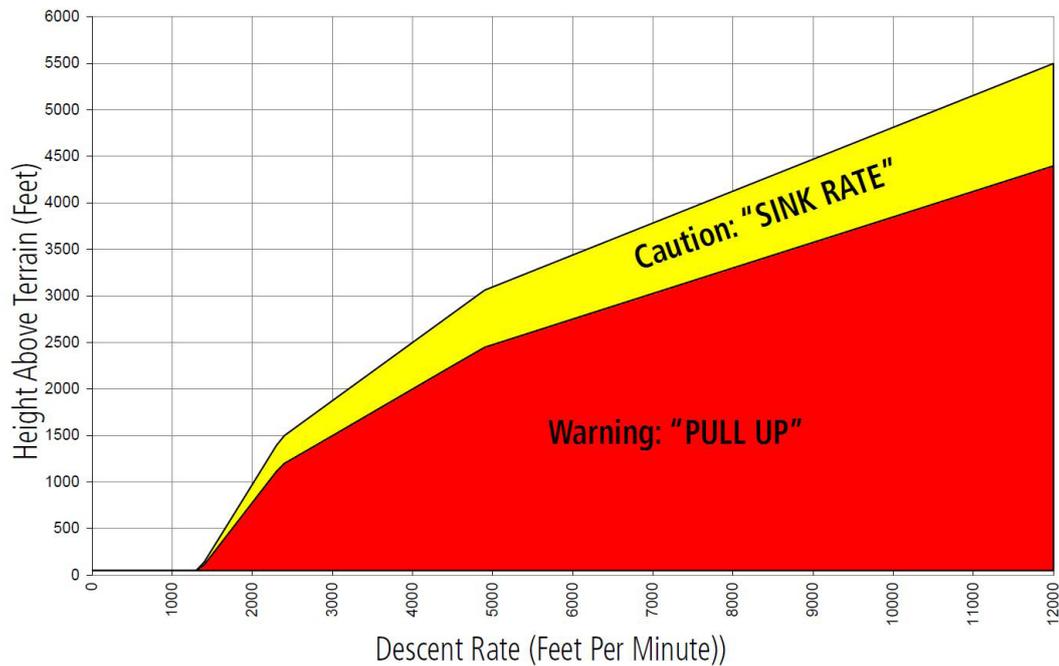
HZ-IBN was equipped with a TAWS. During the accident approach, the Excessive Descent Rate (EDR) warning was activated. This is intended to alert the pilot through both aural and visual means that the aircraft is descending towards terrain at an excessive rate⁷. Figure 10 provides the EDR caution and warning envelopes. If the caution envelope is entered, an aural alert of "SINK RATE" is provided in the cockpit and visual captions of TERRAIN and SINK RATE appear on the PFD's and MFD respectively. If the warning envelope is entered, an aural alert of "WHOOH WHOOP PULL UP" is provided in the cockpit with visual captions of PULL UP displayed on the PFD's and MFD. If the aircraft transitions quickly from no alert, through the caution and into the warning envelope, the warning alert is given priority and the caution alert is suppressed.

TAWS Excessive Descent Rate caution and warning envelopes

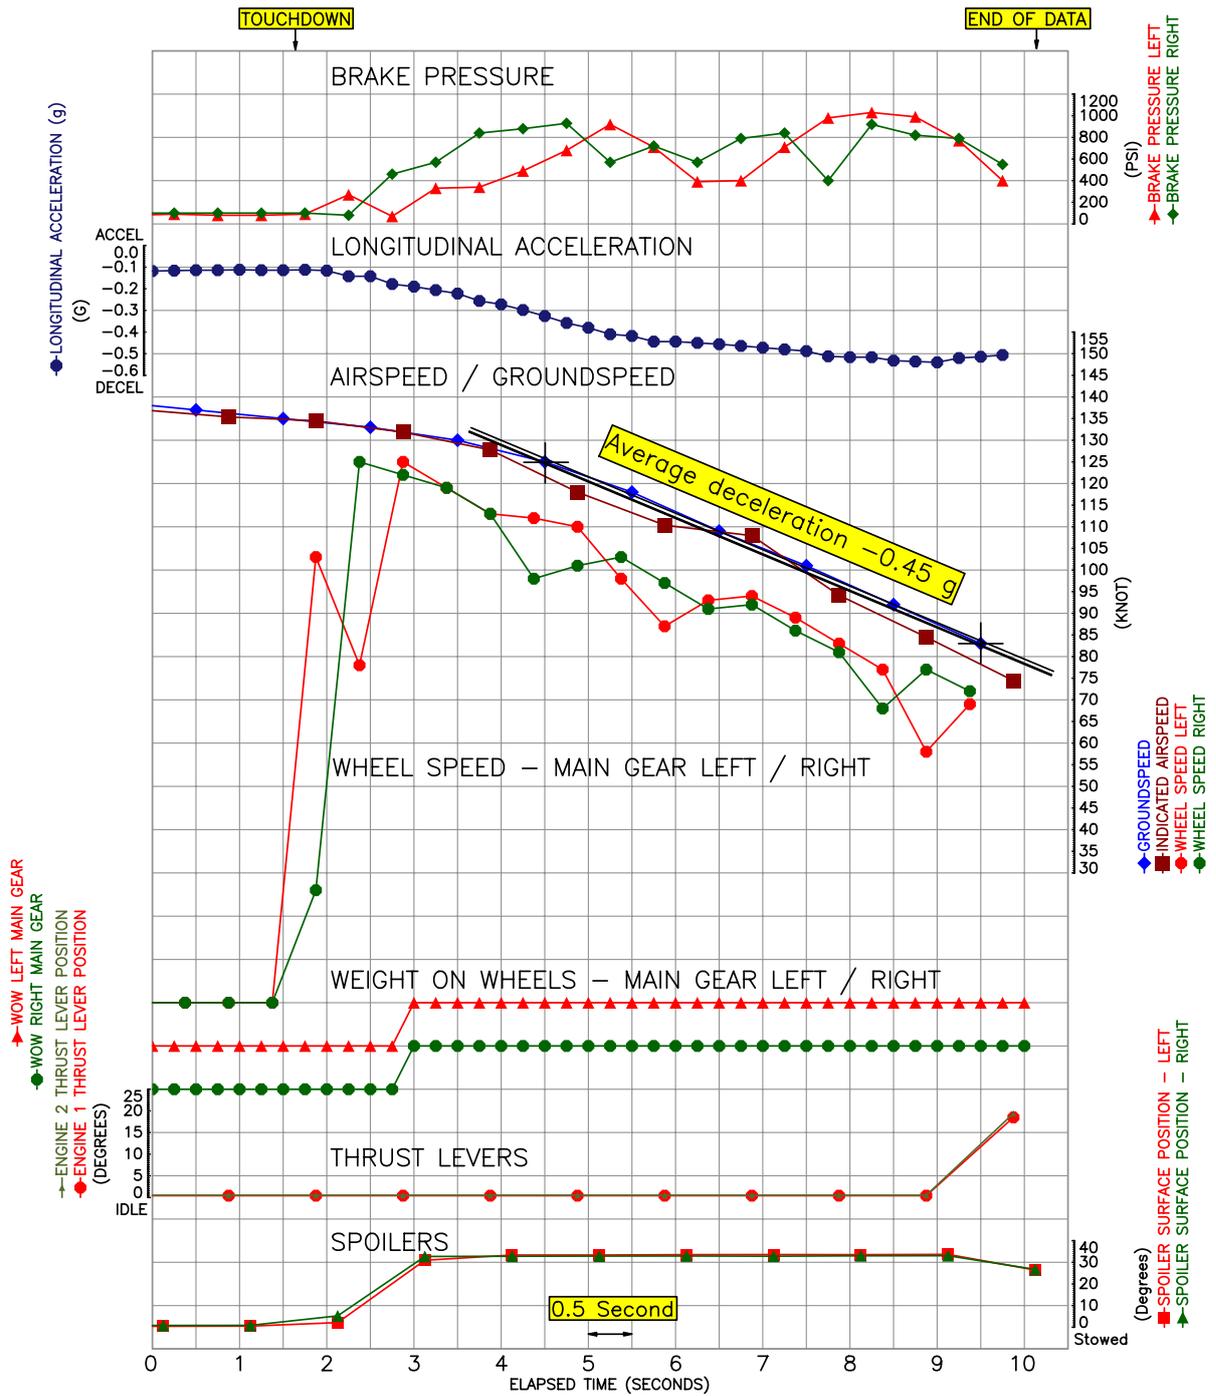
The aircraft's deceleration, as recorded on its CVFDR, is shown in Figure 11. This data shows that, 2.7 seconds after touchdown, the aircraft maintained an average longitudinal deceleration of -0.45g until it departed the end of the runway.

Figure 11
Braking system performance recorded by CVFDR

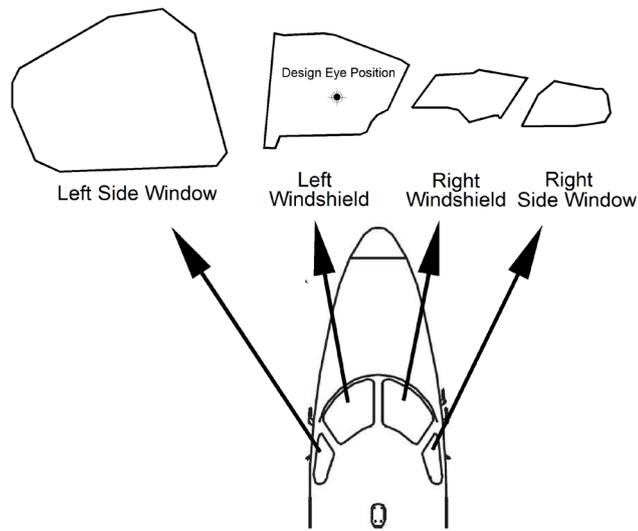
Figure 17 presents the perspective shape of the cockpit windows as observed from the left seat DERP. The following figures show the results of a perspective view analysis, taking account of the attitude of HZ-IBN and the positions of HZ-IBN, the microlight, and the light aircraft derived from radar. The angular size of the microlight and light aircraft is not represented in the figures; they are shown as points. Figure 18 provides the perspective view of the microlight as HZ-IBN approaches at 1406:54 hrs until just before it passes ahead at 1407:18 hrs; each position annotated is an average of 3 seconds apart with position 4 and 6 identifying when the TCAS TA and RA 'DESCEND' alert occurred. Figure 19 provides the perspective view of the light aircraft as HZ-IBN approached it between 1407:18 hrs and 1407:43 hrs; each position is 5 seconds apart with position 3 and 4 identifying when the RA 'ADJUST VERTICAL SPEED' occurred.

Perspective view of cockpit windows viewed from left seat design eye position

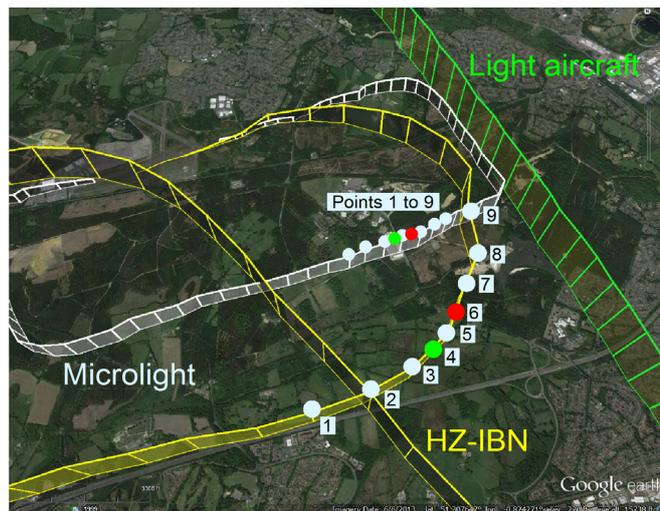
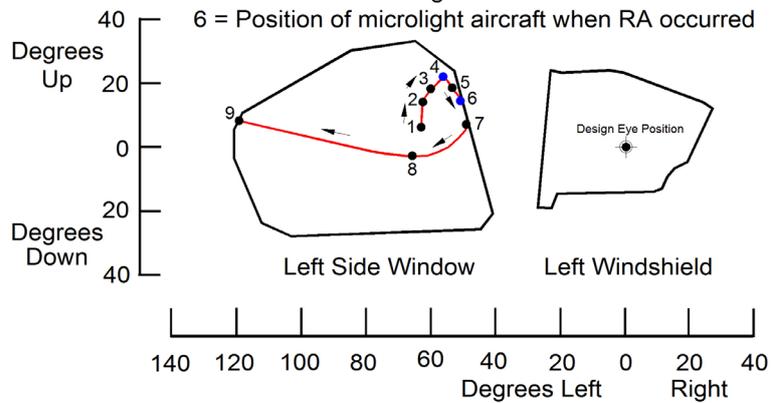
Figure 18

4 = Position of microlight aircraft when TA occurred
 6 = Position of microlight aircraft when RA occurred

Perspective view of microlight viewed from HZ-IBN cockpit left seat design eye position
 1406:54 hrs to 1407:23 hrs

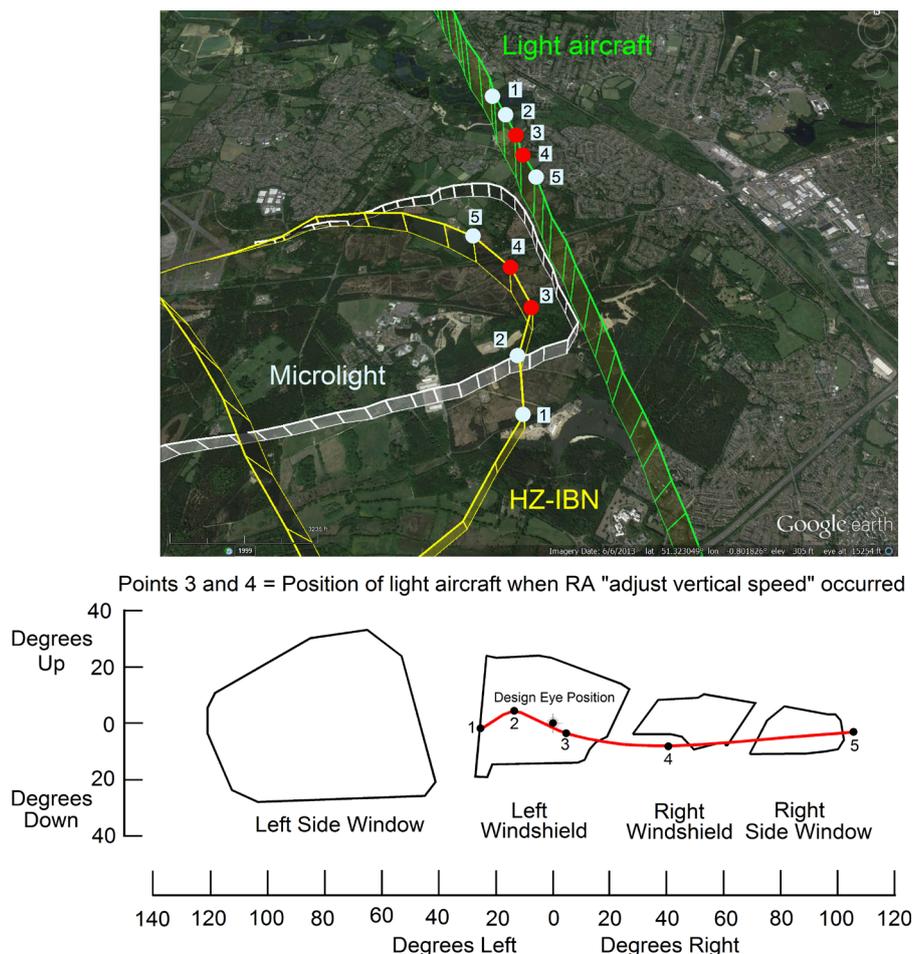
Figure 19

Perspective view of light aircraft viewed from HZ-IBN cockpit left seat design eye position
1407:18 hrs to 1407:43 hrs
