# Rail Accident Report

## Occupied wheelchair contacting a passing train at Twyford station 7 April 2016

Report 01/2017  
January 2017

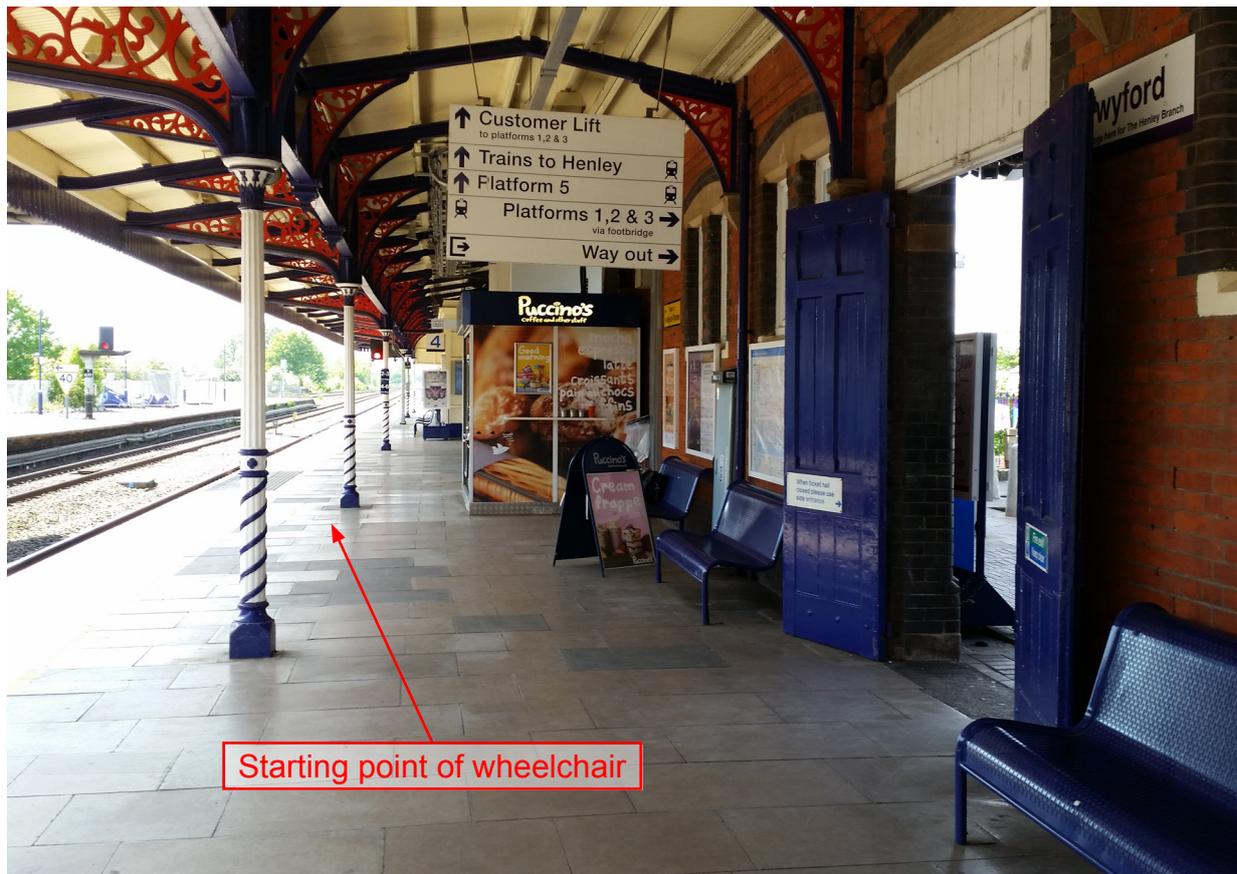
Figure 2: Platform 4 at Twyford station, looking towards Reading

- 7 The surface of platform 4 is laid with paving slabs (figure 2) and slopes towards the track at an angle of approximately one degree (1 in 57 or 1.7%)<sup>3</sup>. The platform is level in the direction parallel to the railway. A *tactile strip* is provided approximately 1 metre from the platform edge.

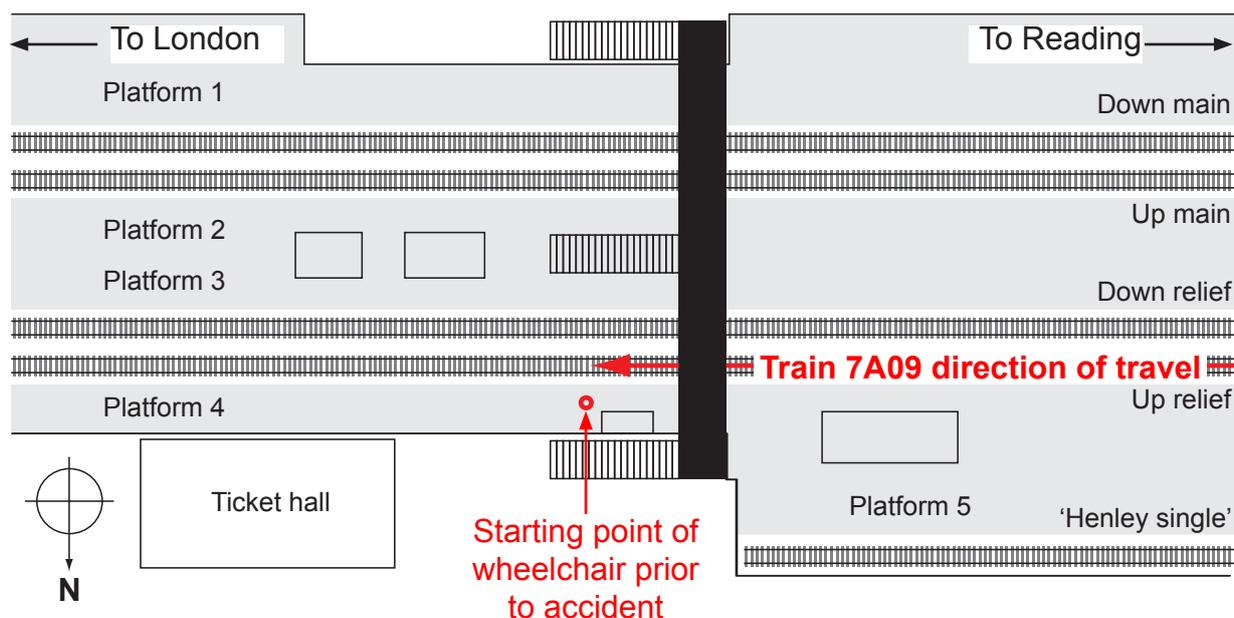
- 5 Twyford station is located between London Paddington and Reading, 31 miles and 22 yards from London Paddington. The station has five platforms. Platforms 1 and 2 are on the *down* and *up main lines* (figure 3). Platforms 3 and 4 are on the *down* and *up relief lines*. Platform 5 serves the branch line from Twyford to Henley.

Figure 3: Schematic plan of Twyford Station (not to scale)

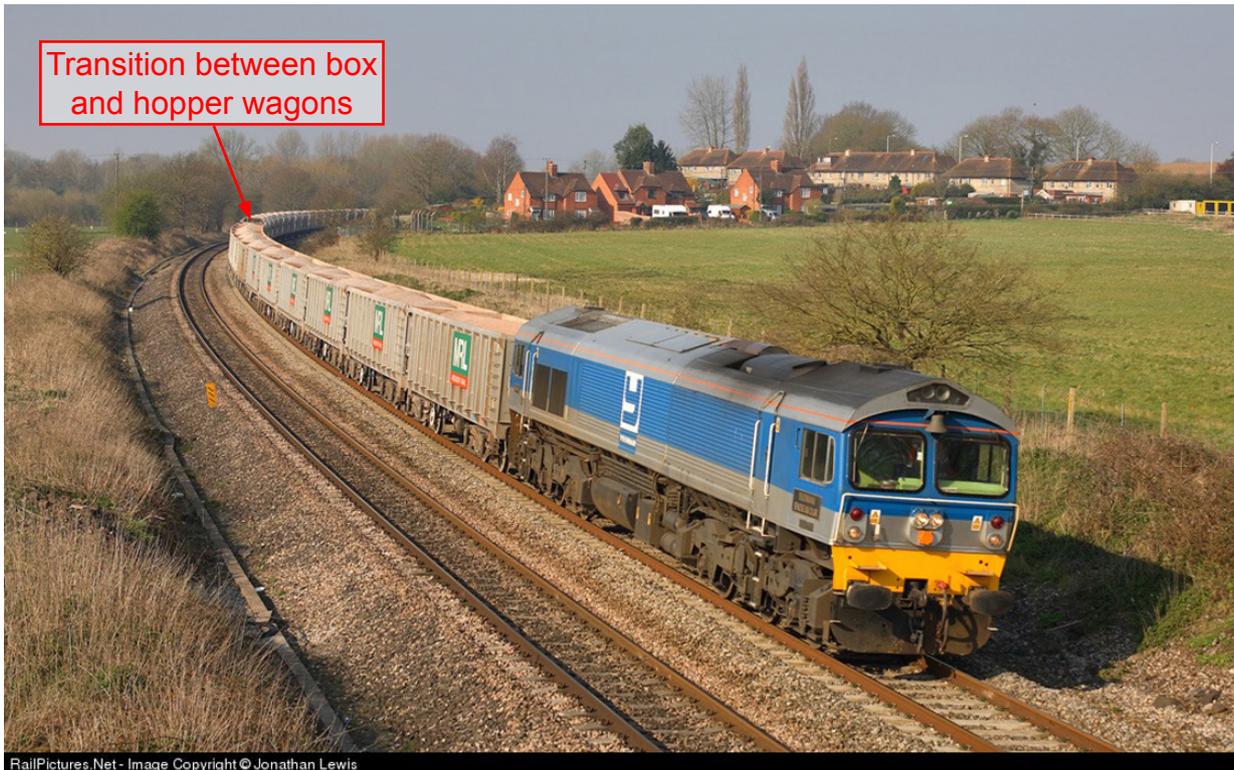
Figure 4: A train similar to 7A09. The train is formed of a mixture of box wagons (at the front of the train) and hopper wagons (image courtesy of Jonathan Lewis)

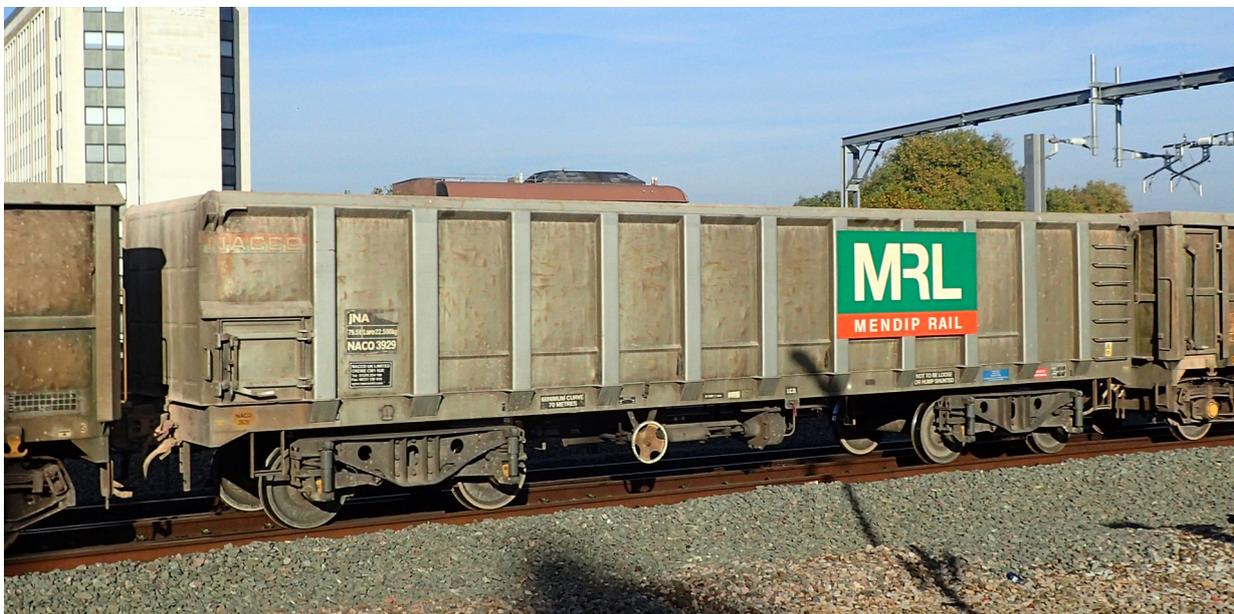
Figure 5: A JNA box wagon, similar to the wagons which formed part of train 7A09

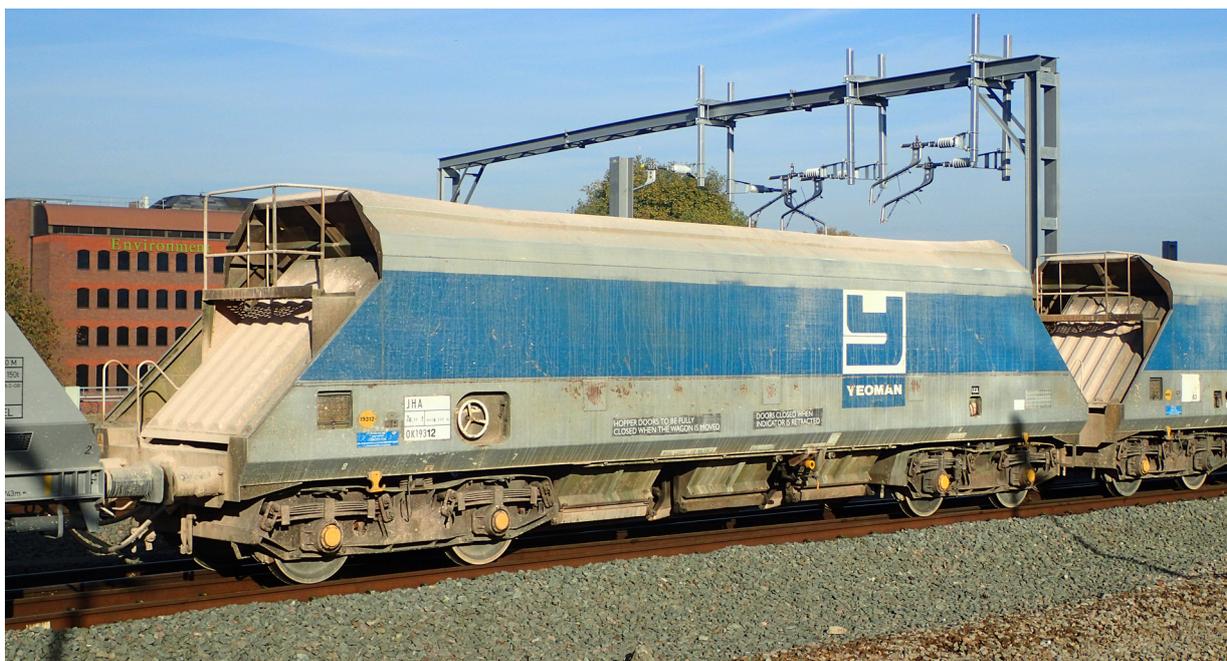
Figure 6: JHA hopper wagon, similar to the wagons which formed part of train 7A09

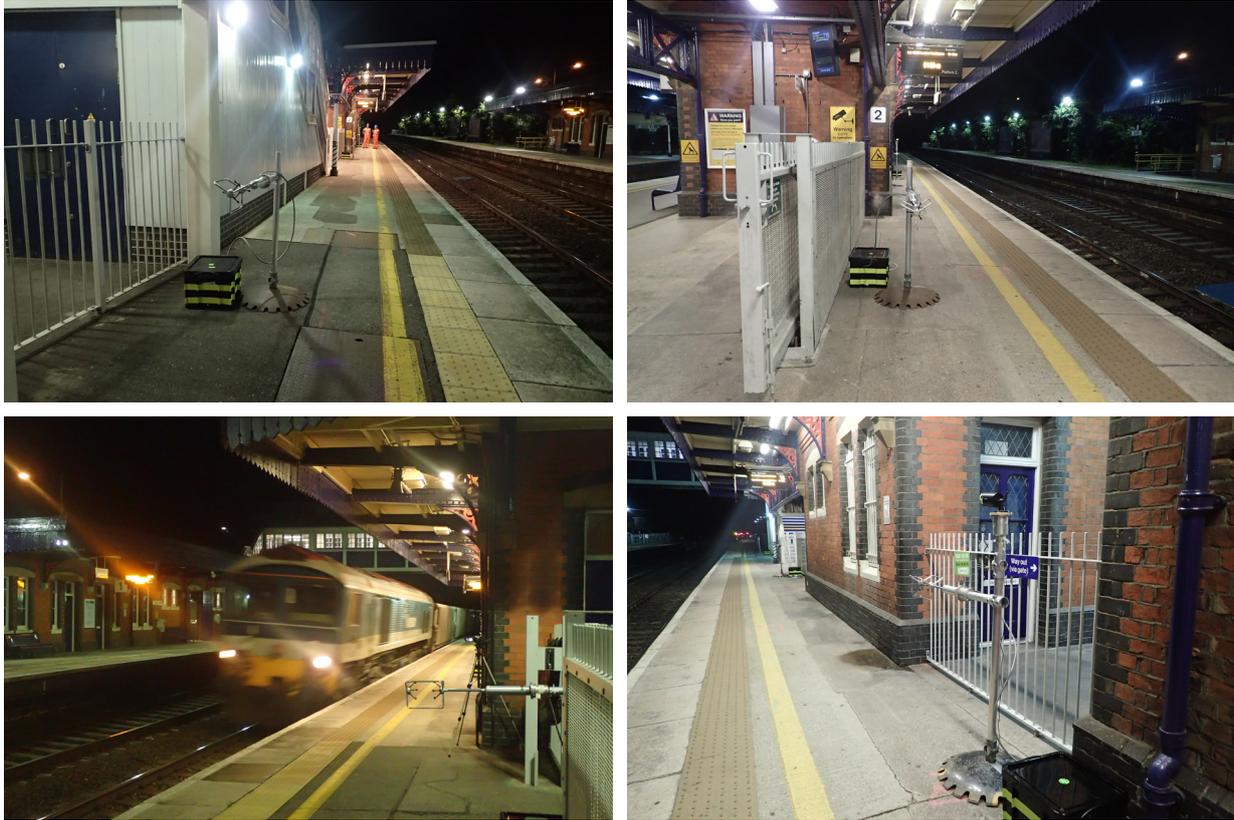
- 41 In order to understand the magnitude of the slipstreams generated by trains passing through Twyford station, the RAIB commissioned tests by the University of Birmingham during August 2016. The tests were undertaken at night. Due to overnight engineering work, trains passing through Twyford station during the testing period went through platform 2 so the testing had to be done on this platform instead of platform 4<sup>6</sup>. Slipstream measurements were made by means of four *sonic anemometers* positioned 2.4 metres from the platform edge (figure 13), which was the distance from the platform edge of the centre line of the wheelchair before it started moving (paragraph 20). The anemometers were spaced approximately 17 metres apart along the platform. The anemometers recorded air flows as trains passed, and also recorded the ambient conditions in the absence of a train. The ambient wind measured during the testing was negligible. The speed of passing trains was measured using a radar speed gun.

<sup>6</sup> There are physical differences between the layouts of platforms 2 and 4, such as the proximity of station buildings to the track and the presence of the kiosk on platform 4. However, a comparison between the anemometer readings obtained for platform 2 suggests that these physical differences would not have resulted in significantly different results had the tests been carried out on platform 4.

Figure 13: Anemometers set-up at Twyford station platform 2
