# ***AAIB Bulletin***

***1/2017***

Published 12 January 2017

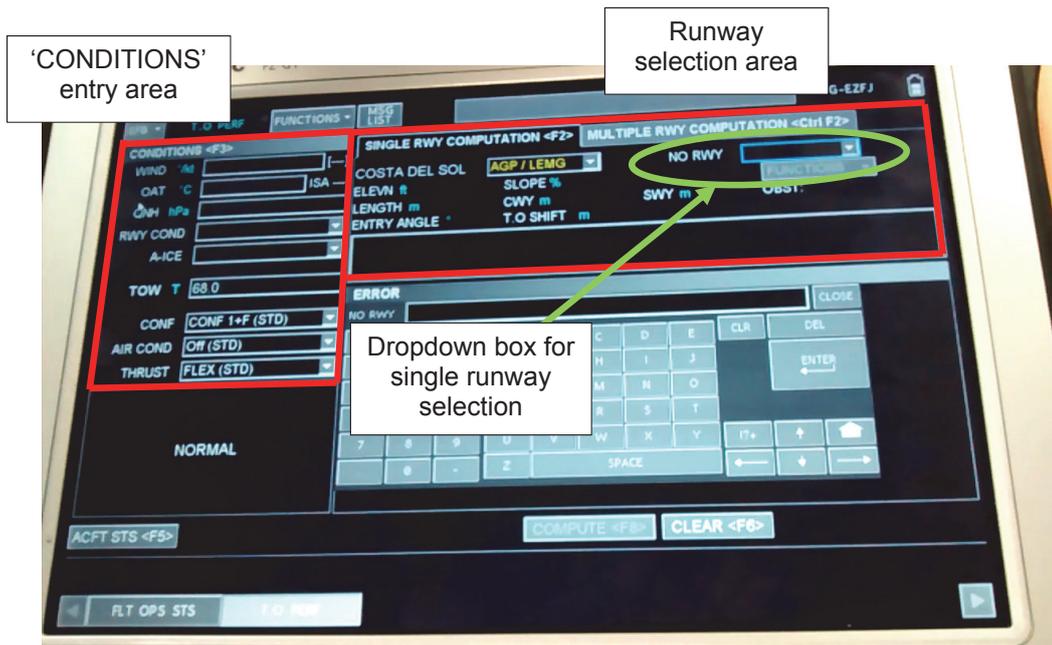
**Figure 1**

To calculate takeoff performance data, the crew enter aircraft and environmental information into the 'CONDITIONS' area and then select the runway they wish to use at the chosen airport (Figure 1). There are two options for runway selection; single and multiple. The operator indicated that most takeoff performance calculations were performed using the single runway option. The multiple runway option calculates takeoff performance data for all the selected runways to allow comparison and also a ranking of the runways in order of the highest thrust derate.

FlySmart takeoff performance screen

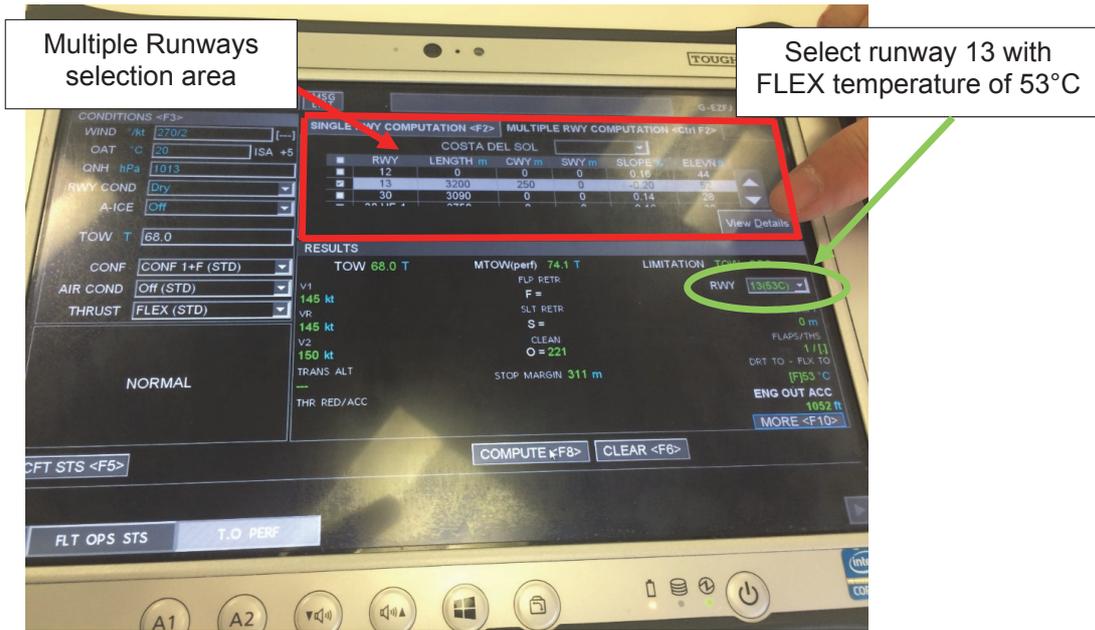
Figure 2

- Once the 'CONDITIONS' information has been entered, the 'MULTIPLE RWY COMPUTATION' tab is selected and a list of the available runways is presented in a table (Figure 2).
- Using a small checkbox located next to each runway, runways of interest can be selected, after which the user selects 'COMPUTE'.

Takeoff performance data is then displayed in the 'RESULTS' section. The selected runway in the 'RESULTS' section will be that with the highest FLEX temperature for the chosen runways (Figure 2). Other chosen runways can then be selected using this drop-down menu.

At this stage, specific runway information such as length, elevation and engine-out information is not displayed. To retrieve this information, the user has to select 'VIEW DETAILS'. The runway information will be selected but the 'RESULTS' screen will be obscured. The manufacturer commented that it should not be possible to display detailed runway information and the 'RESULTS' screen at the same time.

Results page for multiple runway computations

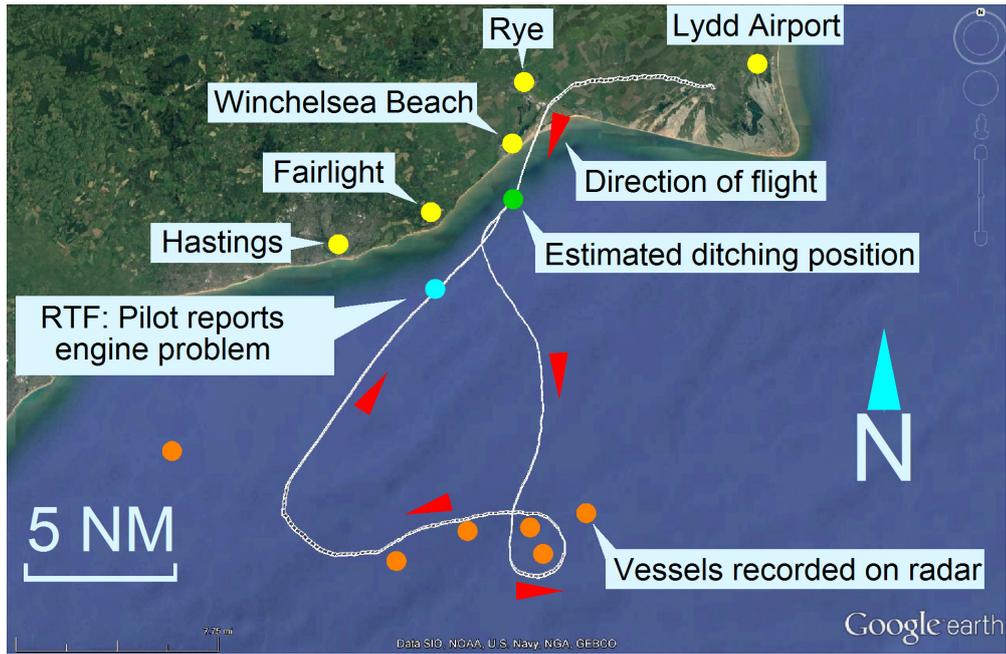
Figure 1

Flight from Lydd (Pease Pottage radar)

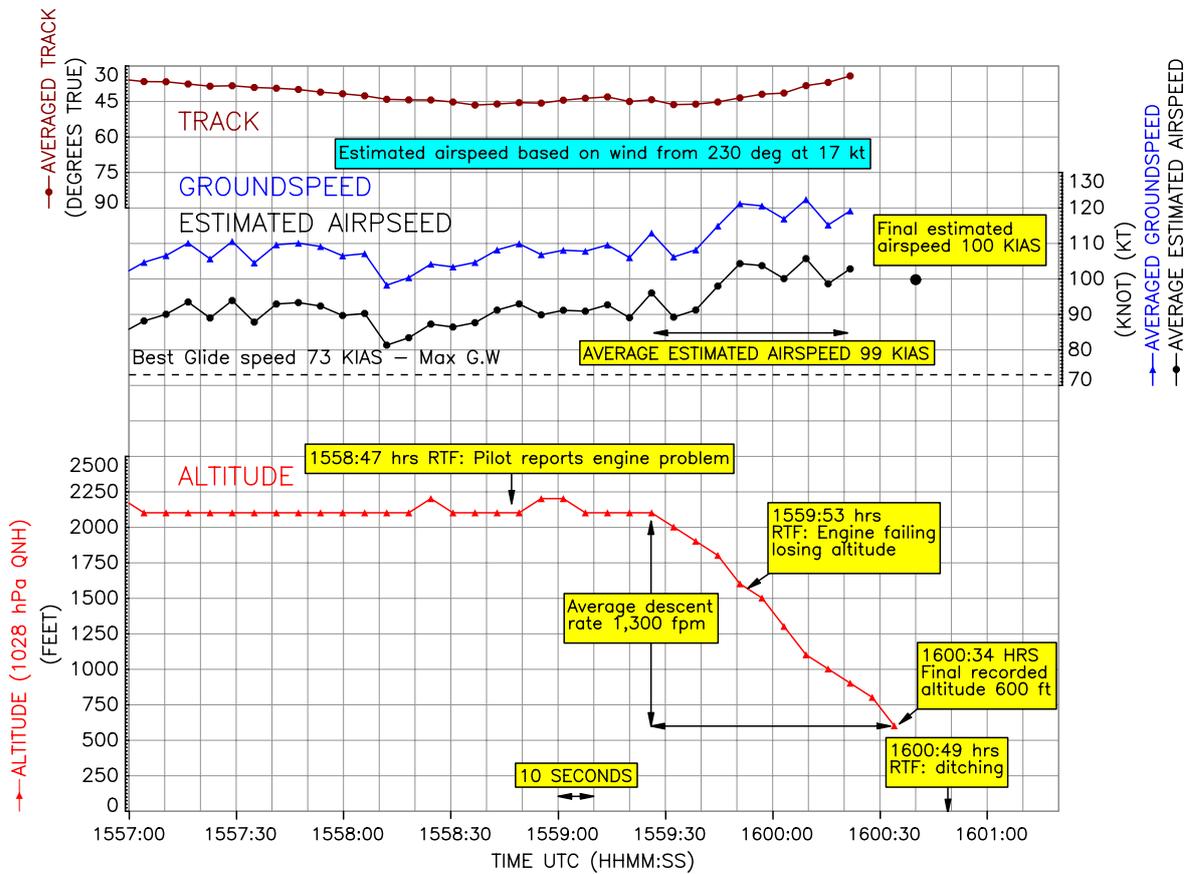
Figure 2

Accident flight data from Pease Pottage radar

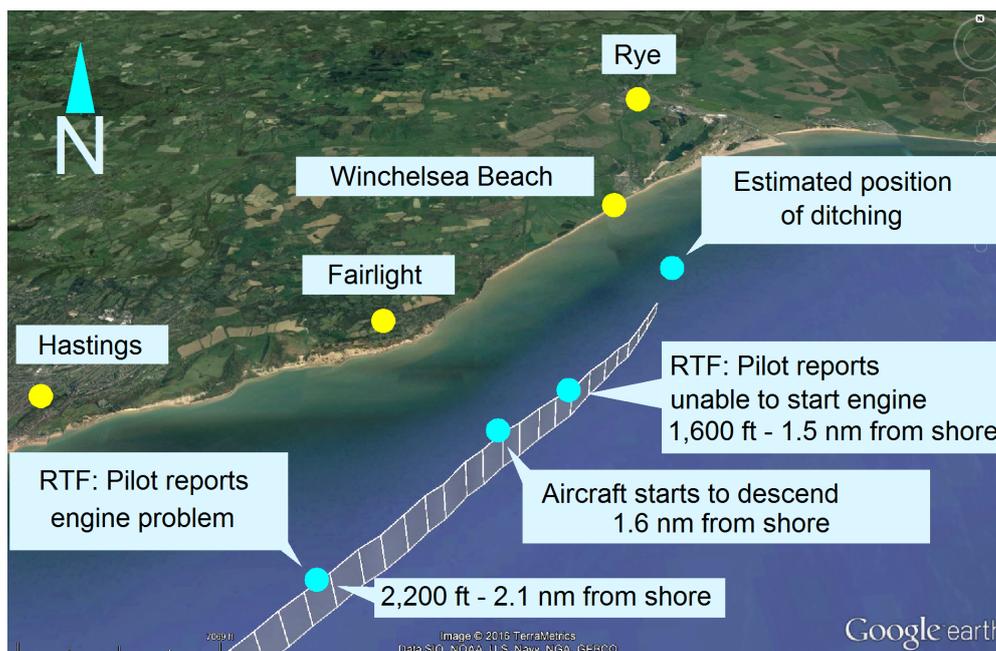
**Figure 3**

Final radar points (Pease Pottage radar)

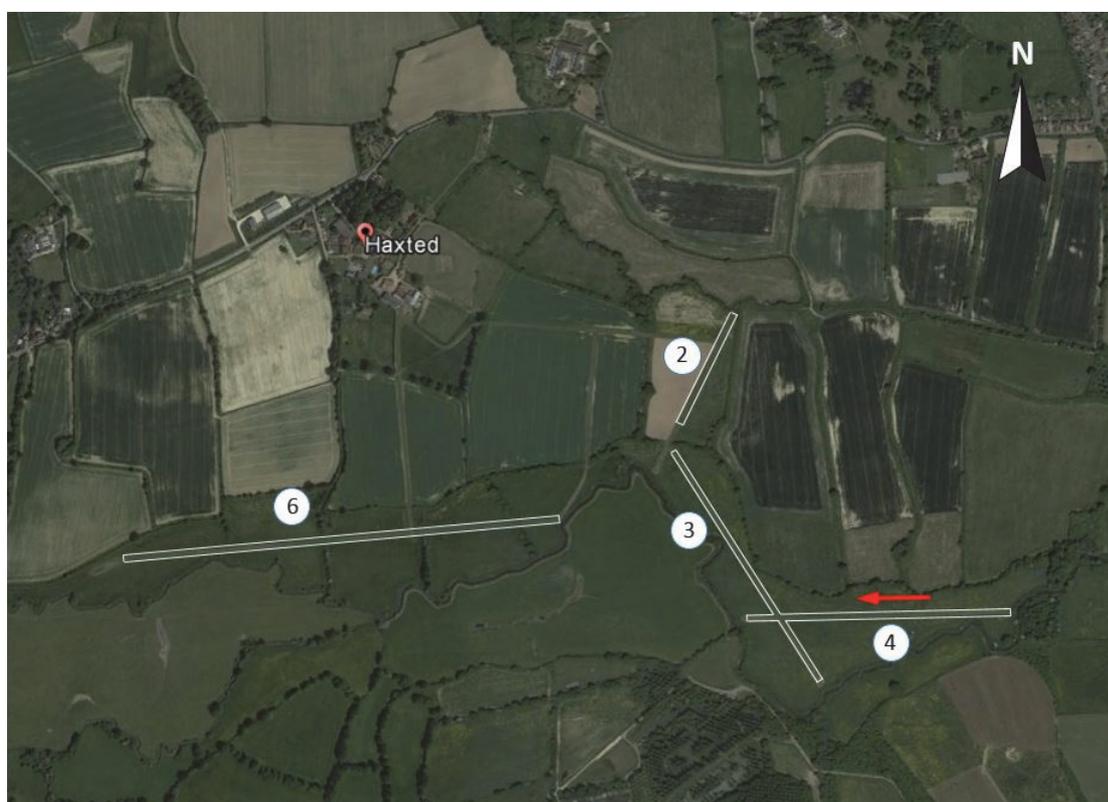
**Figure 1**

In the early afternoon the pilot spoke with several people who were around the club hangar area; they reported that the conversations were routine. He then carried out all the normal pre-flight checks on his aircraft, started the engine and taxied out towards the grass runway designated Strip 4 (Figure 1). He noticed the cloud cover had increased and suspected there might be thermic conditions. Strip 4 is 530 m in length and orientated 270°M (into wind on the day). It is located 1 km to the south-east of the club hangar (taxiing distance 1.6 km), from where it is out of sight.

A club hangar facility with an outdoor rigging area is available; aircraft were kept in the hangar de-rigged because of limited space. Four separate grass runways are located some distance away. Strip 4 is the furthest from the hangar and is out of sight on lower ground 1 km to the south-east (see Figure 1). The strip is level, orientated 270° / 090°M, 530 m in length and 10 m wide. Trees and hedgerows are in the vicinity of the strip and a public footpath crosses around the mid-point. At the time of the accident, hay was being made in the field in which Strip 4 is sited (see Figure 2). Walkers frequently use the mown grass area as a convenient pathway.

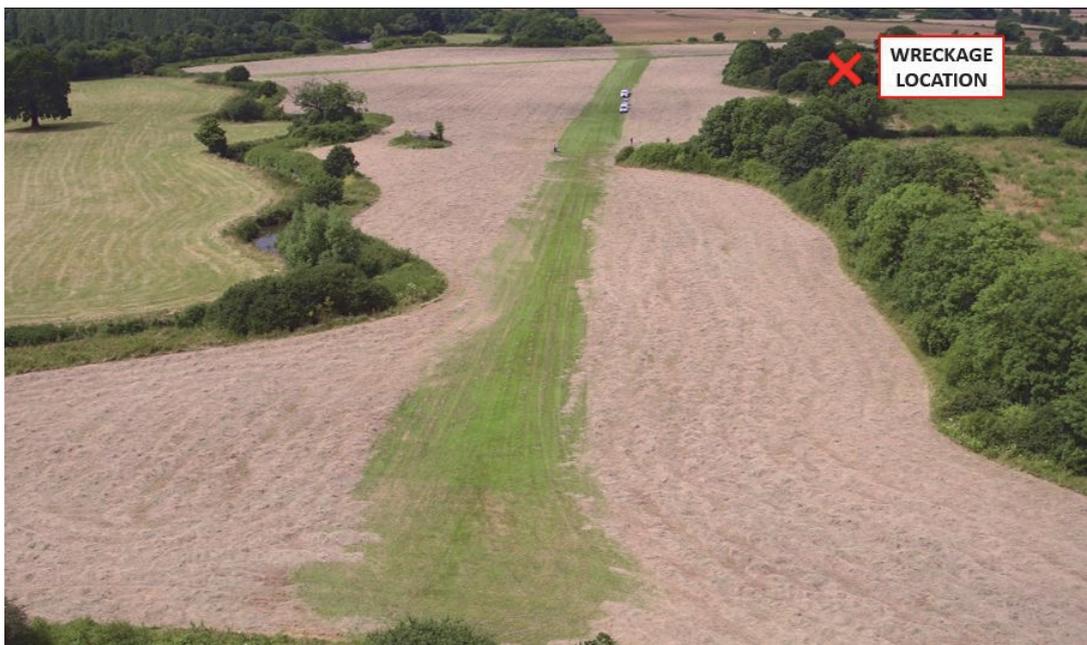
The aircraft crashed into a 20 m tall oak tree approximately halfway along Strip 4 at East Haxted Farm. The tree was part of a boundary hedge, displaced approximately 60 m to the north of the runway centreline (Figure 2).

**Figure 2**  
View of Strip 4 from east

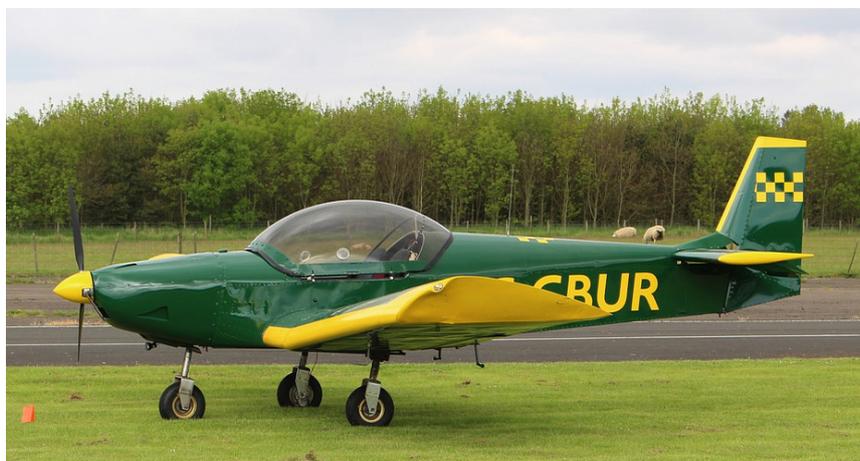
**Figure 1**

Runway 14 was used for takeoff as the pilot believed this offered sufficient downslope to compensate for a possible 3 kt tailwind. The temperature was 26°C and the aircraft was close to maximum weight but the pilot knew the airstrip well and did not calculate the required takeoff run. He anticipated being airborne before reaching a prominent dip in the grass surface, approximately two-thirds of the way along the 600 m strip.

Zenair CH 601UL Zodiac, G-CBUR  
(photograph courtesy of Mr Steve Barnes)

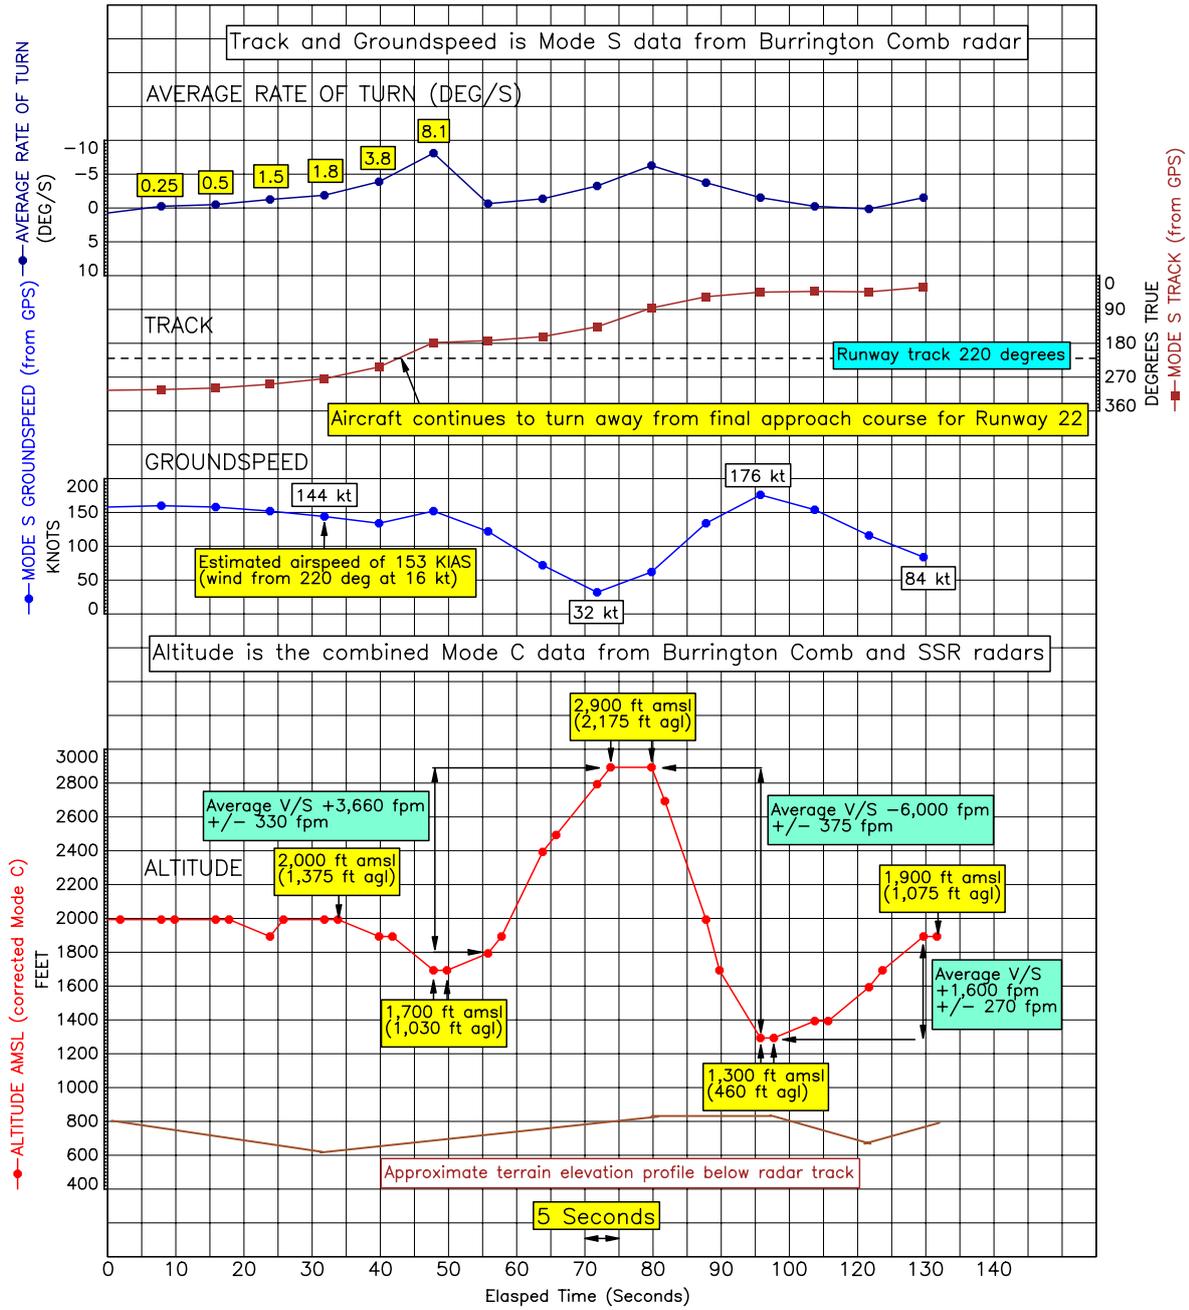
In the middle of Figure 3, under the altitude '2,900 ft amsl', the height should have been '**2,175 ft agl**', not '1,175 ft agl'. The supporting text, analysis and conclusions were unaffected by this error.

The corrected version of Figure 3 appears on the next page.
