Report on the investigation of the collision

City of Rotterdam

Primula Seaways

3 December 2015

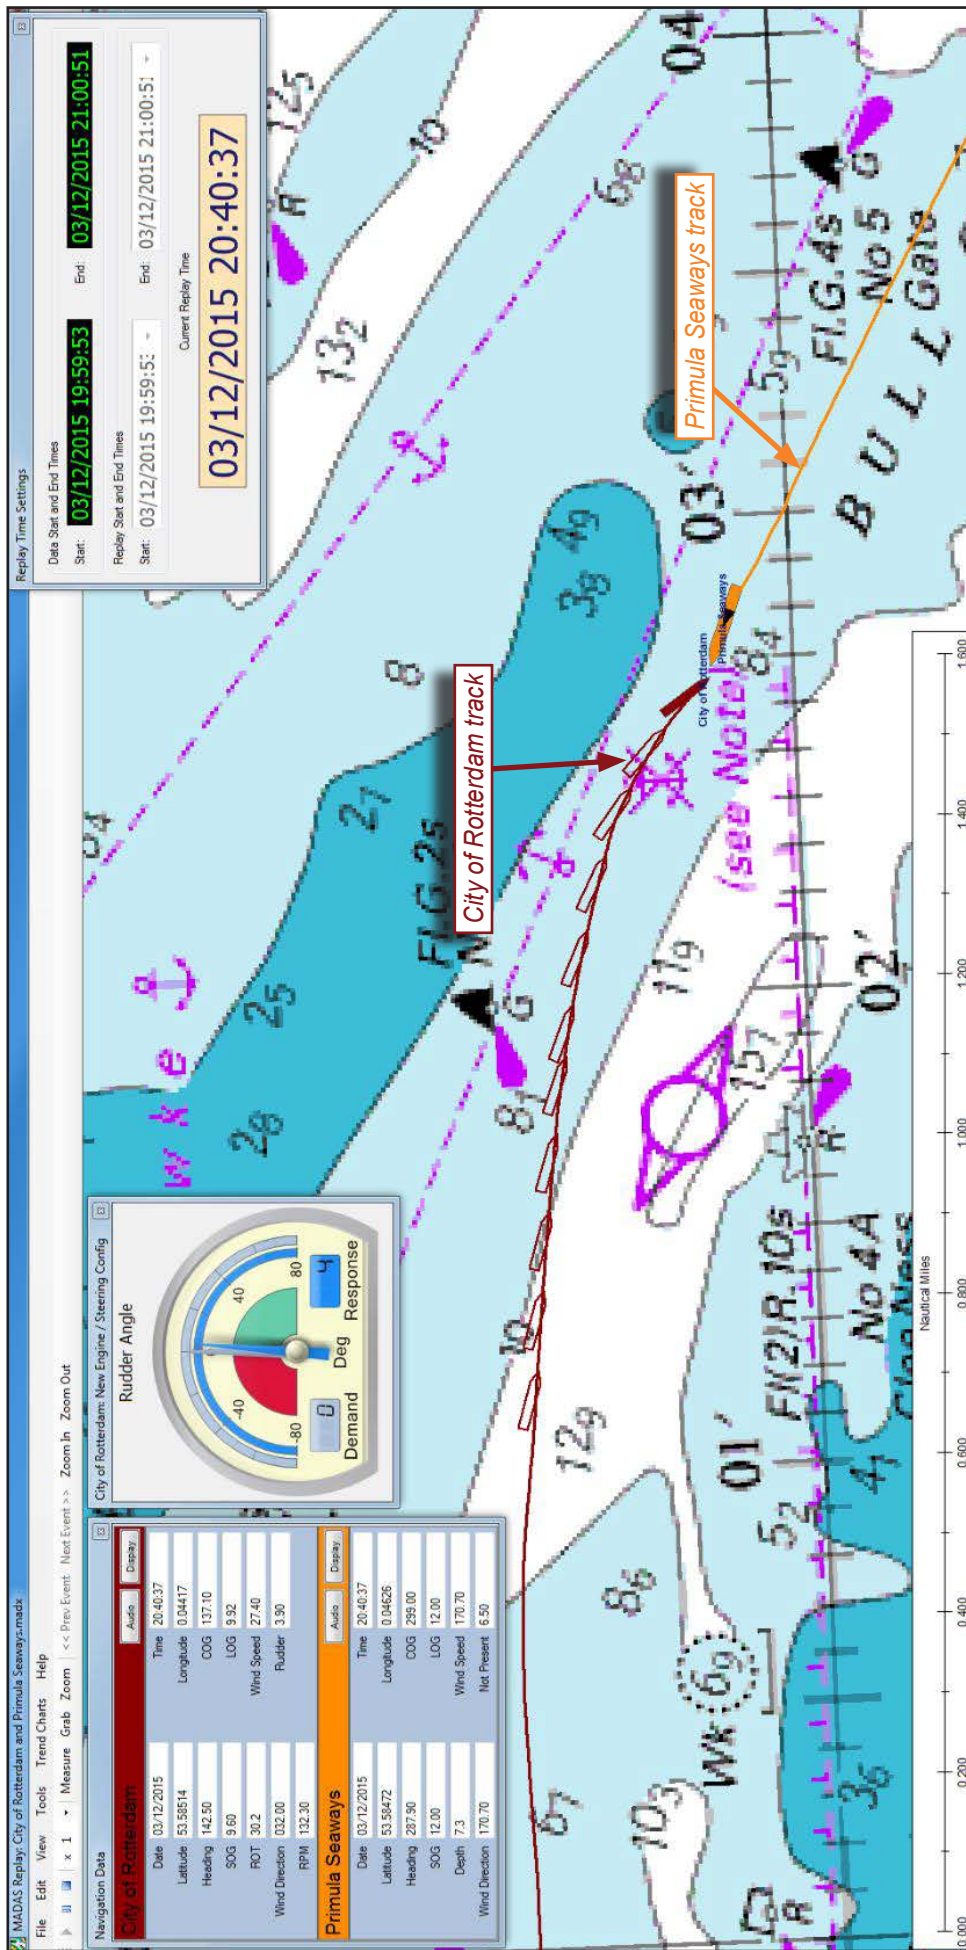
Figure 9: Vessels' positions at 2040

On impact, *City of Rotterdam* heeled to starboard. The master and pilot fell to the deck but they were not injured. The pilot reported the collision to the VTS and the car carrier was manoeuvred towards the Bull anchorage at slow speed. The general alarm was not sounded. The chief and second officers went to the bridge immediately. The chief officer then went forward to assess the damage while the on-watch engineers checked for damage in the machinery spaces.

City of Rotterdam's forward hydraulic system was badly damaged so the vessel was unable to anchor. As soon as it was confirmed that there had been no breach in the car carrier's watertight integrity, the VTS authorised the vessel to return to Immingham. The VDR data was saved, but no radar information was recorded due to the starboard radar display being on standby.

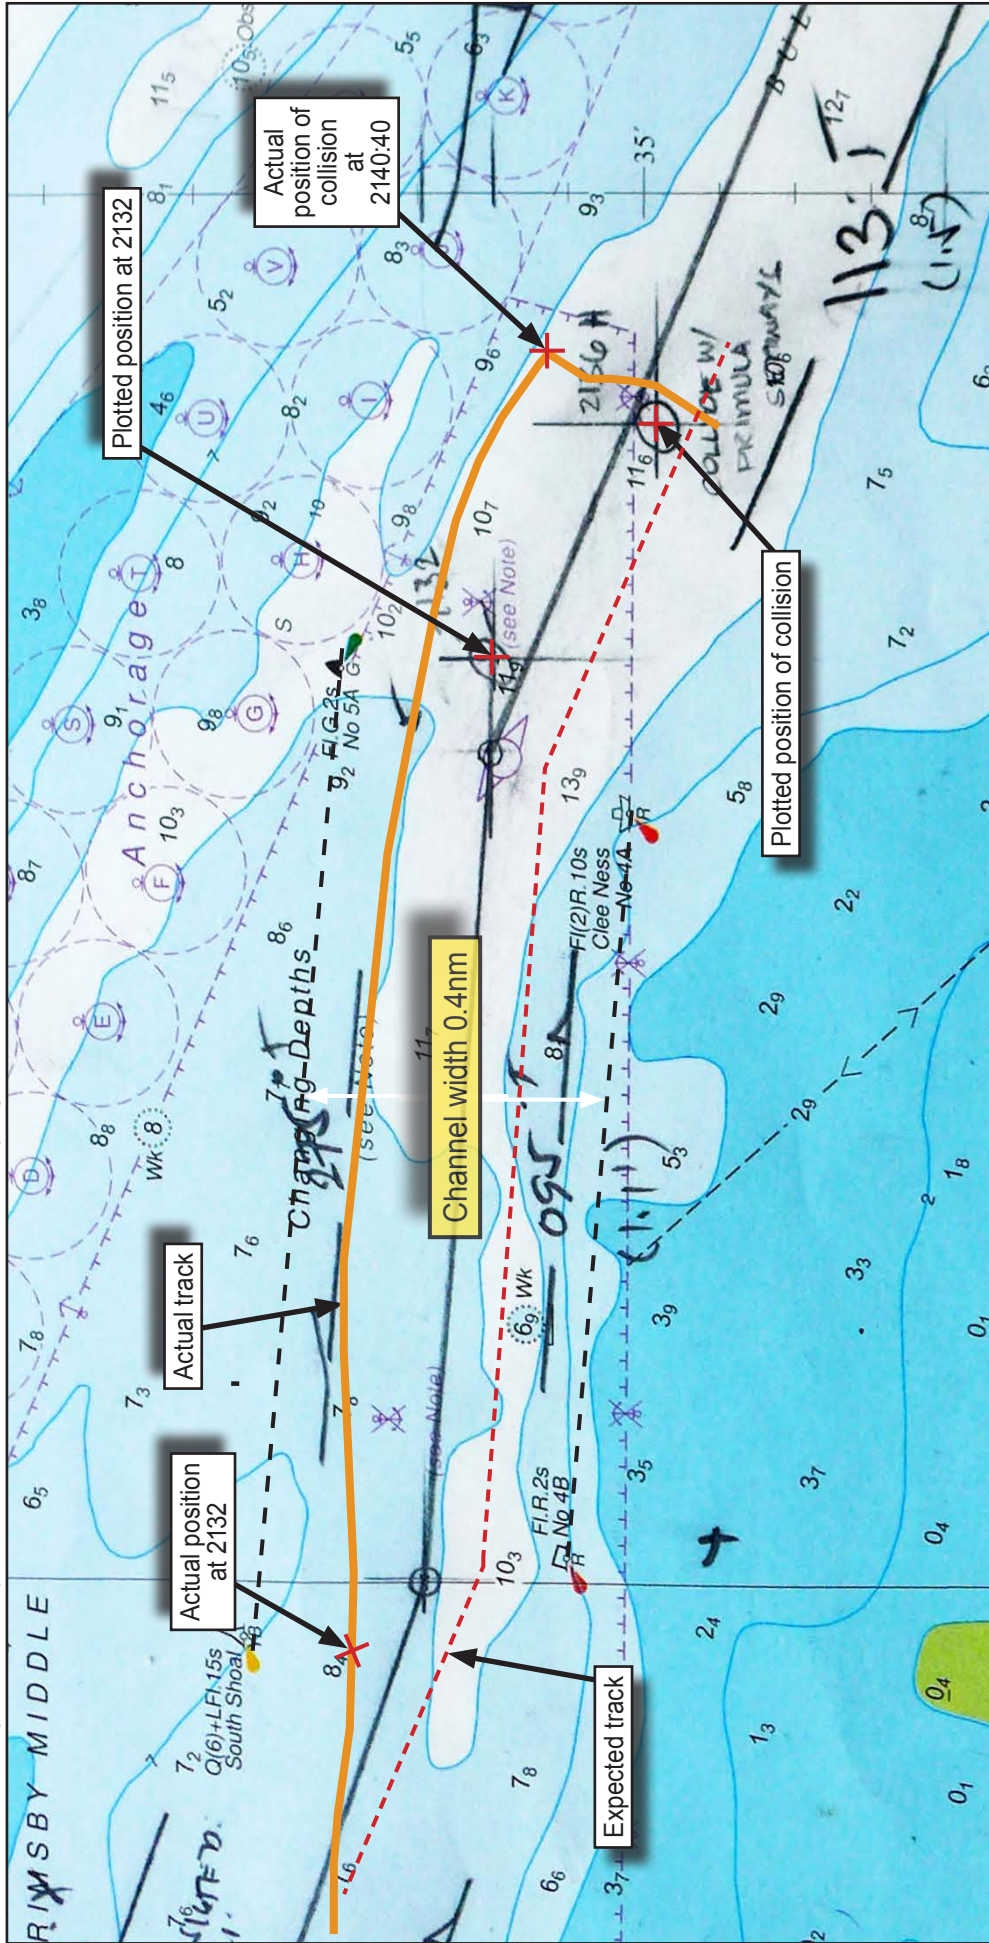
Figure 12: City of Rotterdam - extract of chart in use (with overlays)
Note: times on this chart are UTC (+1)

City of Rotterdam's primary means of navigation was paper charts, but the intended tracks for the vessel's departure from Immingham had also been input into the ECS. The tracks followed the axis of the buoyed channel and were generally equidistant from the port and starboard marks. During the passage in the Bull Channel, the third officer monitored the vessel's position on the ECS, but he had also periodically plotted positions on the chart (**Figure 12**).

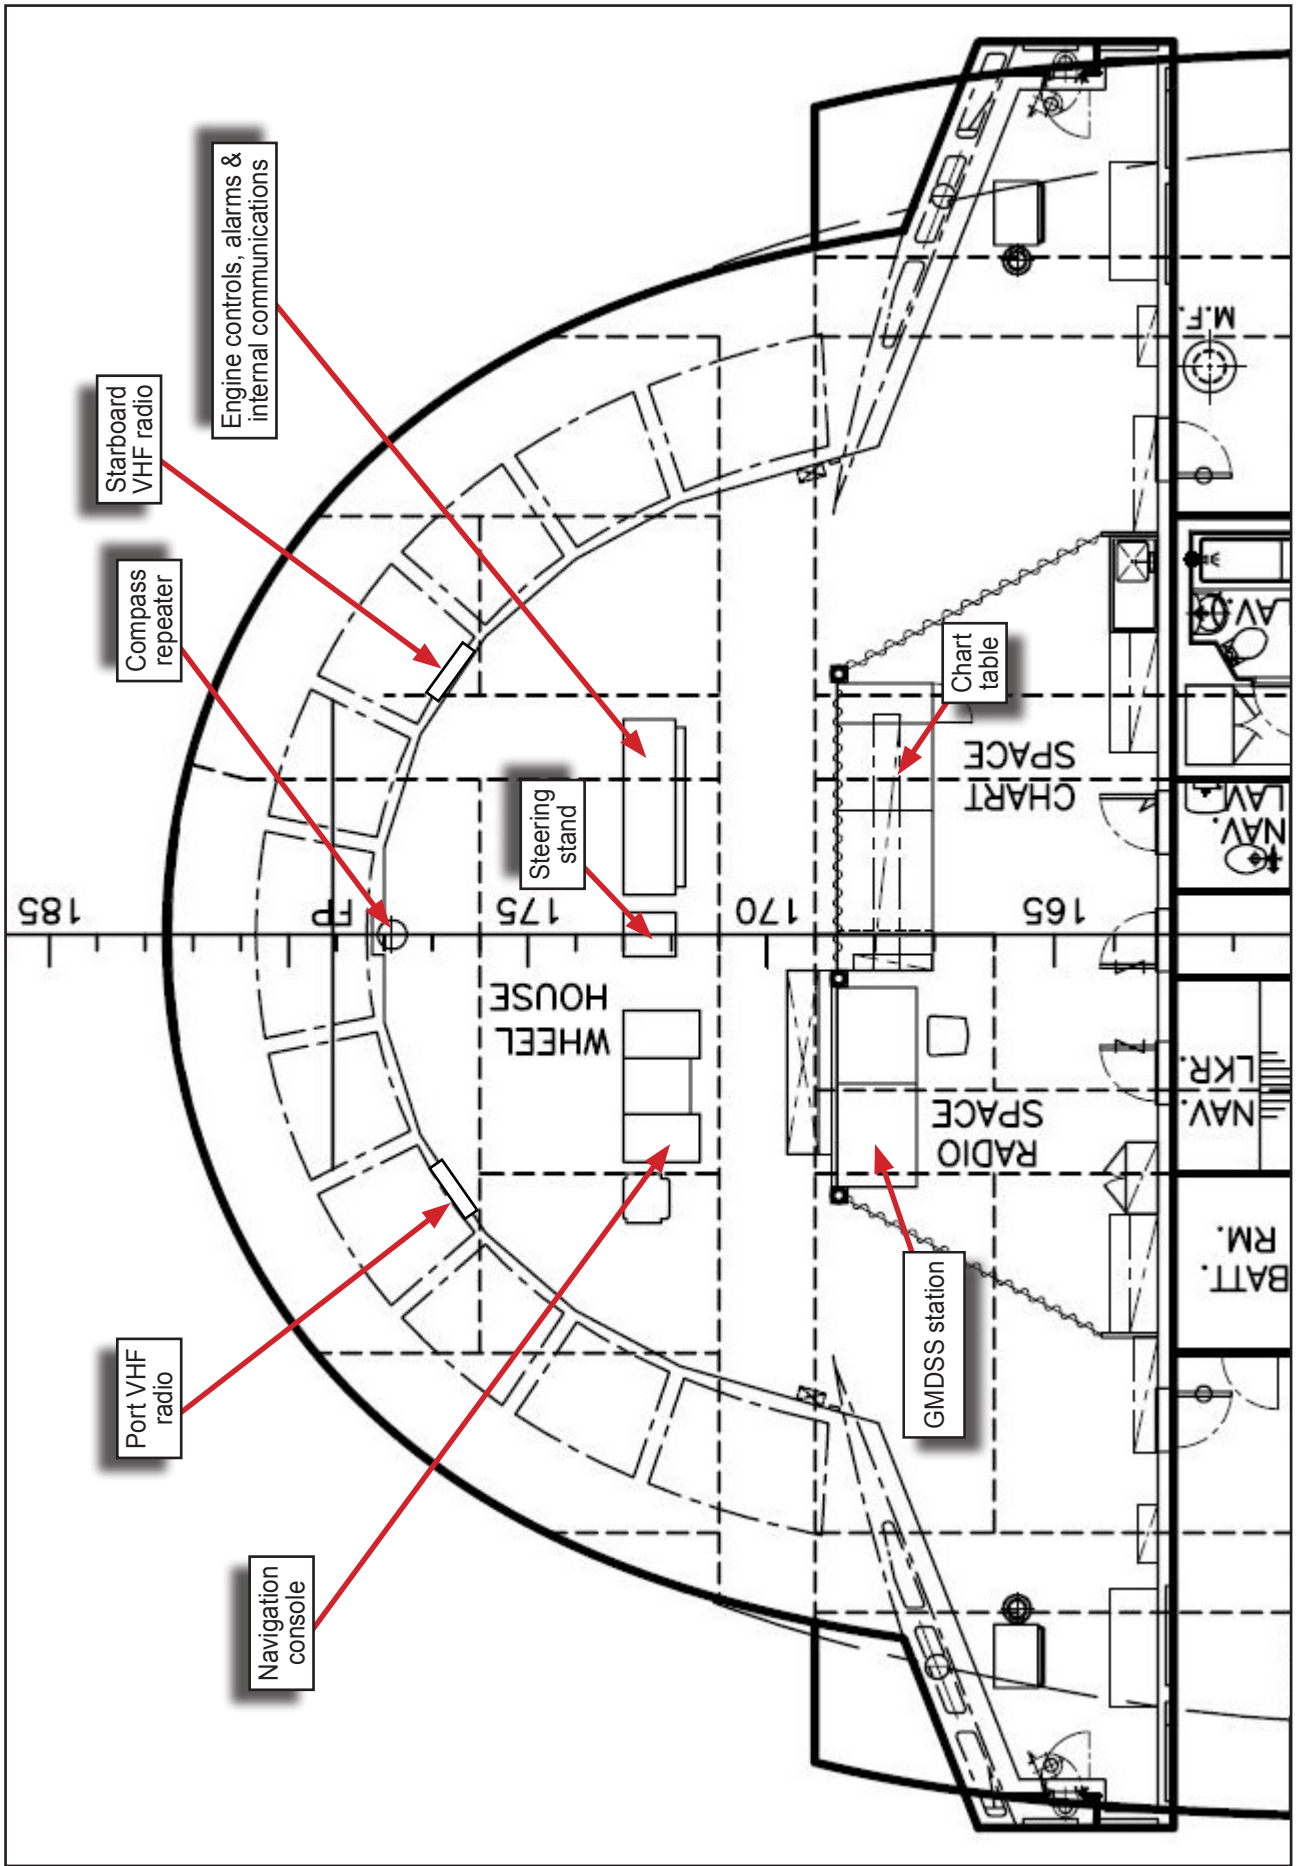
Figure 13: City of Rotterdam - Bridge arrangement

City of Rotterdam's hemispherical bow (**Figure 11**) was designed to reduce wind resistance and carbon emissions and to provide better fuel economy. A consequence of the bow's shape was that the vessel's bridge was of unconventional design (**Figure 13**). Only the front window on the centreline was perpendicular to the vessel's fore and aft axis. The angular difference between the centre window and the off-axis windows⁹ above the VHF radios mounted on the forward bulkhead was 33° (**Figures 14 and 15**). The windows also sloped inwards from the bottom at an angle of 55°.

None of the vessel's bow canopy was visible from the bridge, so to provide a visual reference of the vessel's centreline a length of black cord had been positioned down the middle of the centre window (**Figure 14**) with two green light emitting diodes (LEDs) at its base. A compass repeater, an automatic identification system (AIS) transceiver and a pilot plug were positioned by the centreline window (**Figures 2, 13 and 16**).

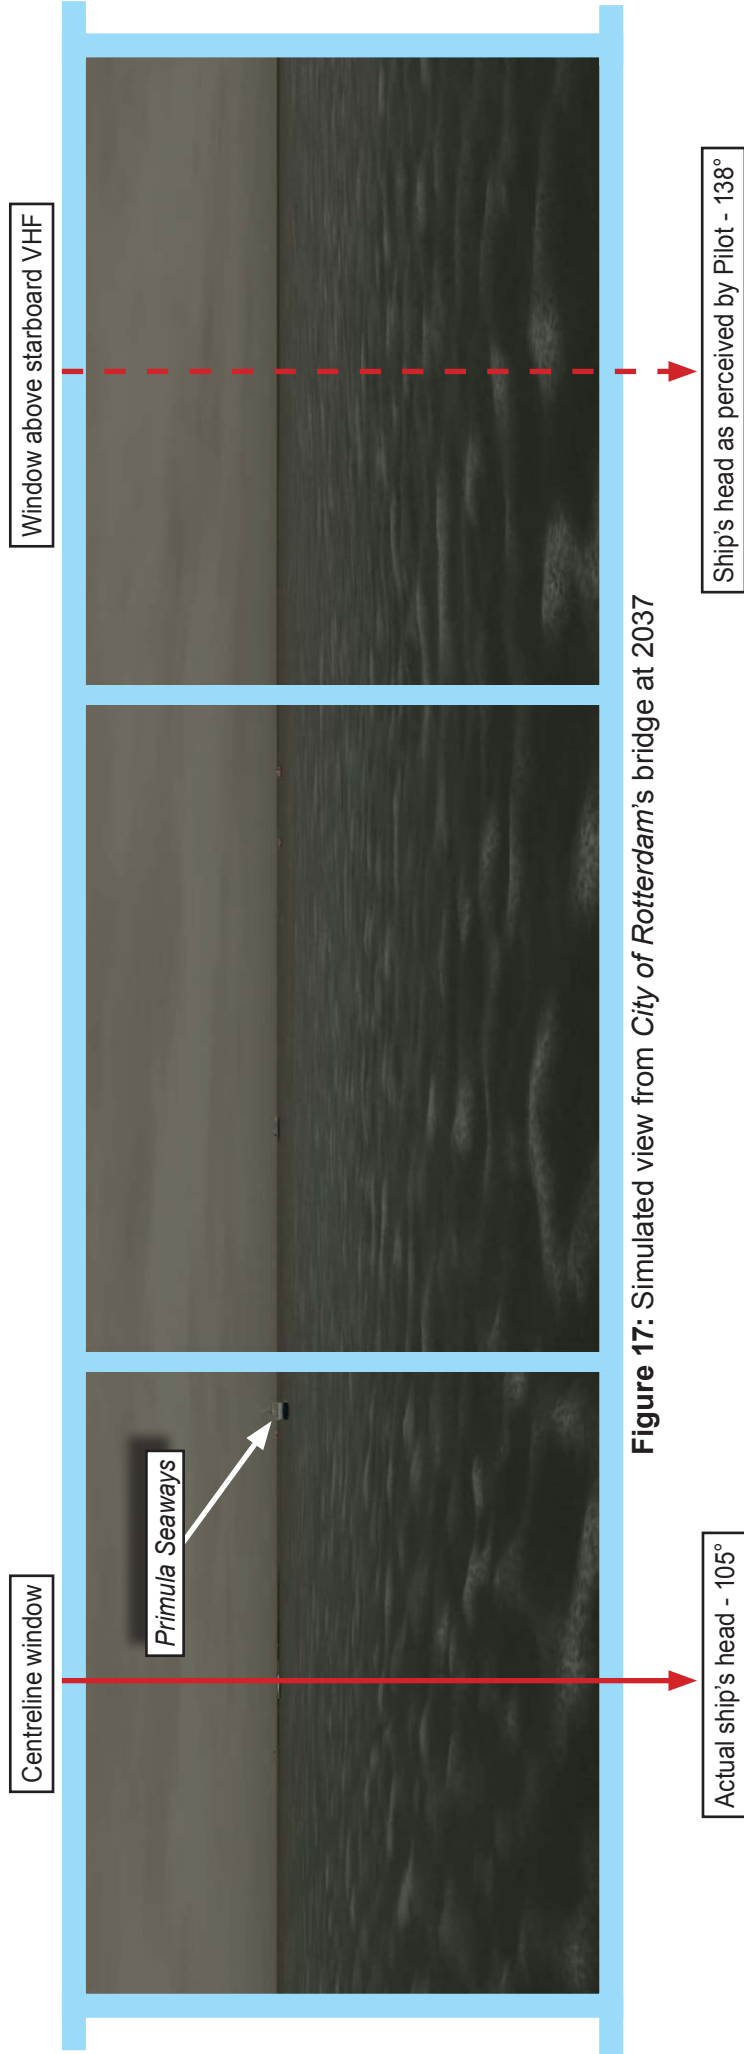
Figure 17: Simulated view from City of Rotterdam's bridge at 2037

- When *Primula Seaways* started to reduce speed to 'half ahead' at 2038:25, *City of Rotterdam* was within 1nm (**Figure 18**). The car carrier's pilot had informed the ferry's master several times that he was manoeuvring to the south, yet there was no sign of the vessel doing so. From the simulations, it was evident that a course alteration to starboard would have caused the ferry to cross *City of Rotterdam*'s bow while an alteration to port would have exacerbated the close quarters situation that was developing if the car carrier did turn more to the south as the pilot had indicated.
