AAIB Bulletin

4/2017

Published 13 April 2017

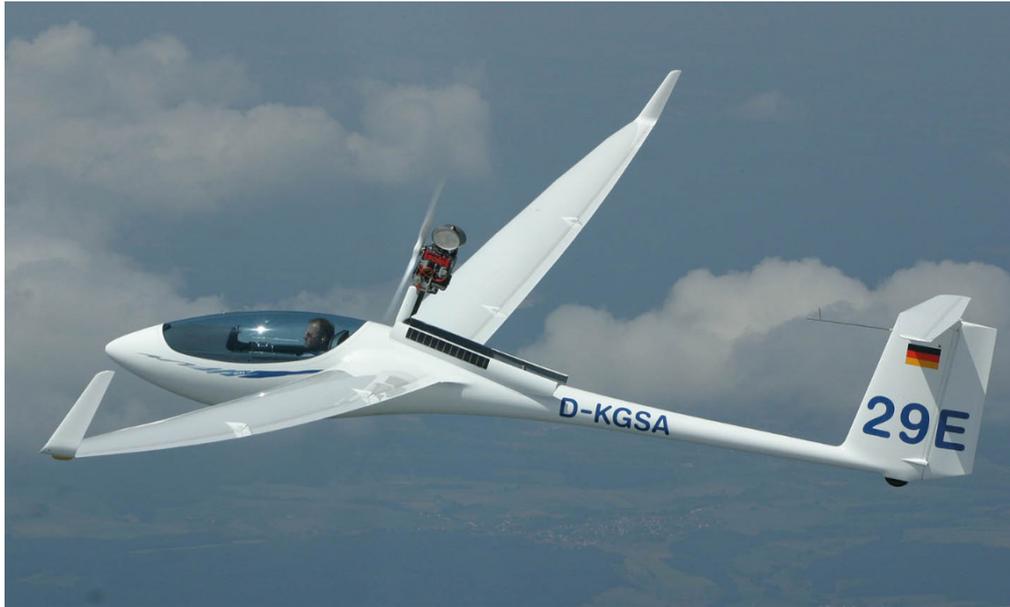
Figure 5

ASG 29E is the product name for the ASW 27-18E, which is a single-seat self-sustaining powered glider, designed and manufactured by Alexander Schleicher GmbH & Co. The glider is a derivative of the ASW 27 with a T-tail, retractable sprung landing gear and a water ballast system (Figure 5). Interchangeable outer wing sections allow participation in 15 m and 18 m competition classes.

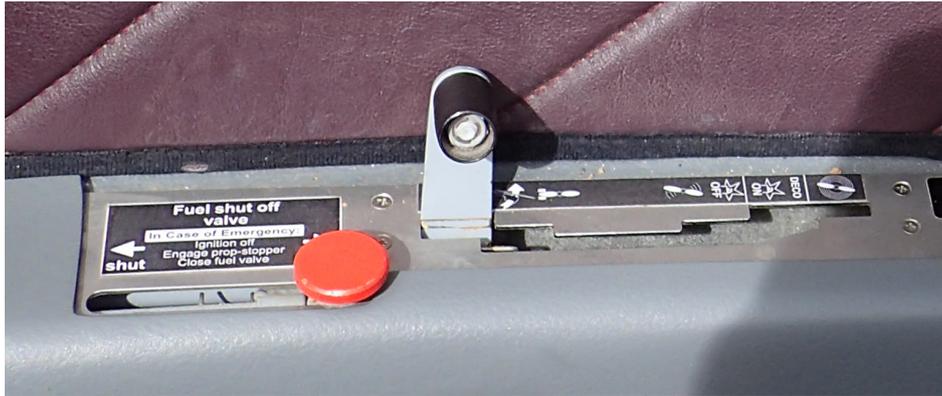
Figure 6

The engine is controlled using a lever that protrudes from a detented slot on the cockpit left side console (Figure 6). There are five positions and the lever is connected to an engine control unit by means of a mechanical linkage. The control unit is mounted behind a removable panel in the left side of the engine compartment and consists of a sliding assembly that operates electrical microswitches to 'sequence' the engine.

A fuel tank located just behind the pilot contains 10.5 litres of fuel, which is sufficient for approximately one hour of powered flight. The fuel shutoff valve is operated by a lever in the cockpit (Figure 6) and, if inadvertently left closed, is automatically opened by the action of moving the engine control lever to the ignition position.

Fuel shutoff and engine control levers

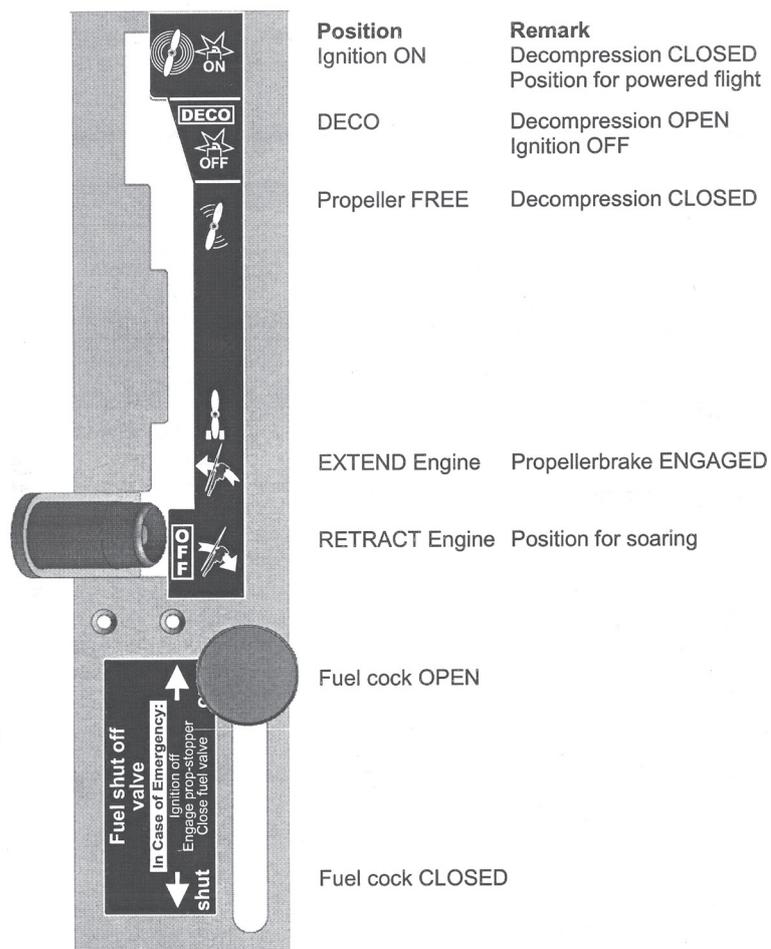
Figure 7

There are five detented lever positions for the engine control (Figure 7).

Engine control lever positions

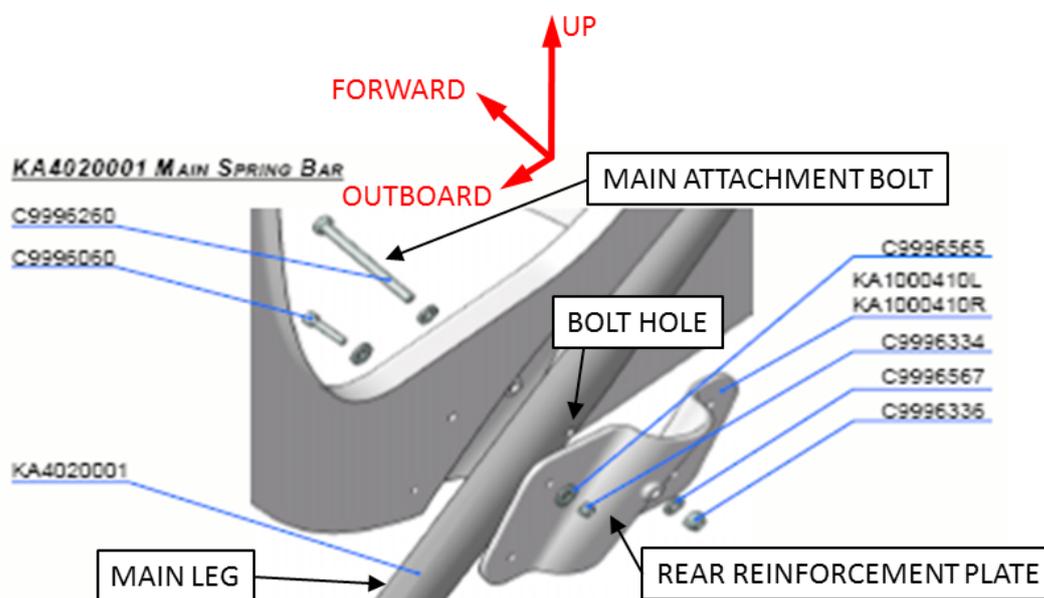
Figure 1

The CTSW is a two-seat microlight with a fixed tricycle landing gear. The main landing gear legs are tapered 7075-T6 aluminium alloy beams, supported at their upper ends by a bolted joint in a welded tubular steel socket, and restrained approximately a third along their length

by an M8 steel main attachment bolt. The main attachment bolt passes through a fuselage frame, a hole drilled through the leg and a glassfibre rear reinforcement plate, which covers the leg in this area (Figure 1).

CTSW left main landing gear leg and support structure
