Passenger ferry *Uriah Heep* contact with Hythe Pier near Southampton, United Kingdom 13 May 2016

SUMMARY

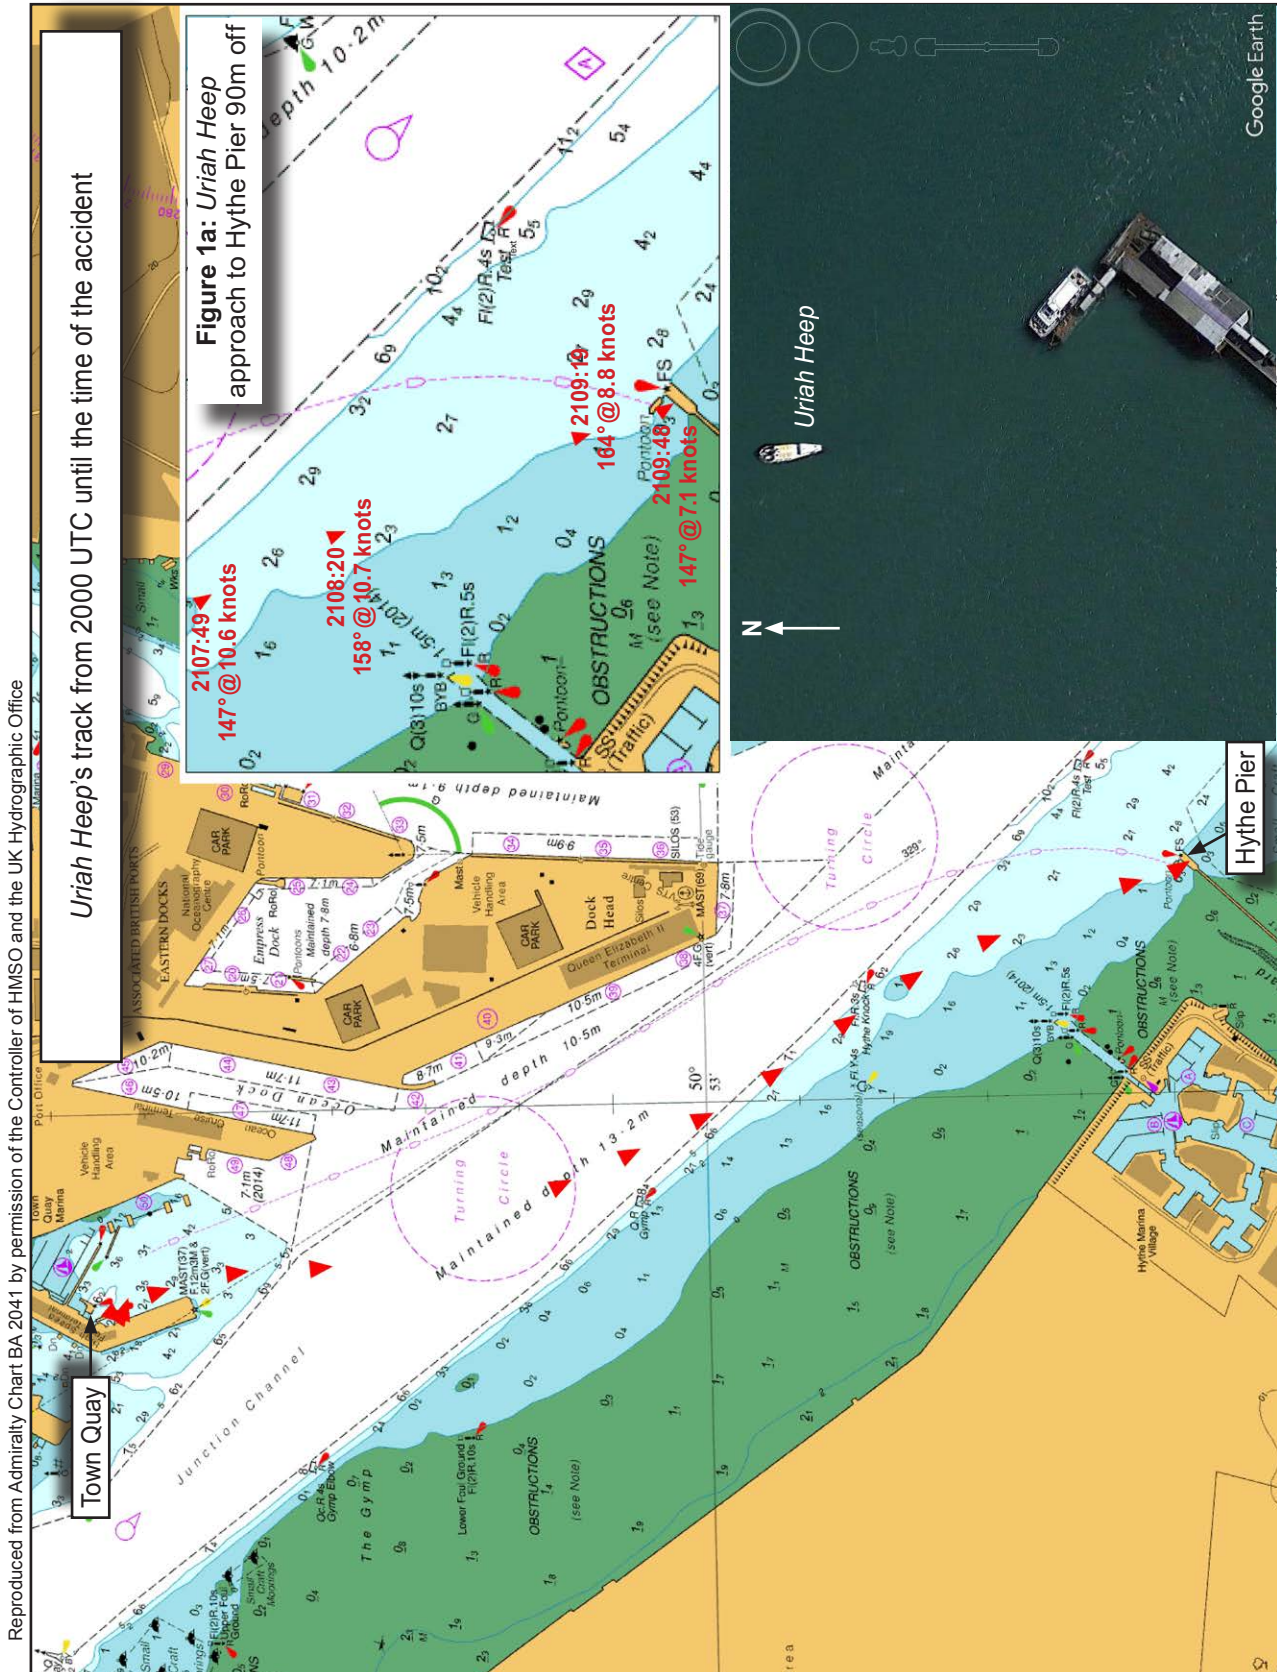
Figure 1: Uriah Heep track from Town Quay to Hythe Pier

At 2100¹ on 13 May 2016, the water jet propelled trimaran *Uriah Heep* departed Town Quay, Southampton, for passage along Southampton Water to Hythe, 1.4nm to the south-south-east (**Figure 1**). On board were the skipper, mate, deckhand and 15 passengers, who were briefed by the mate to remain

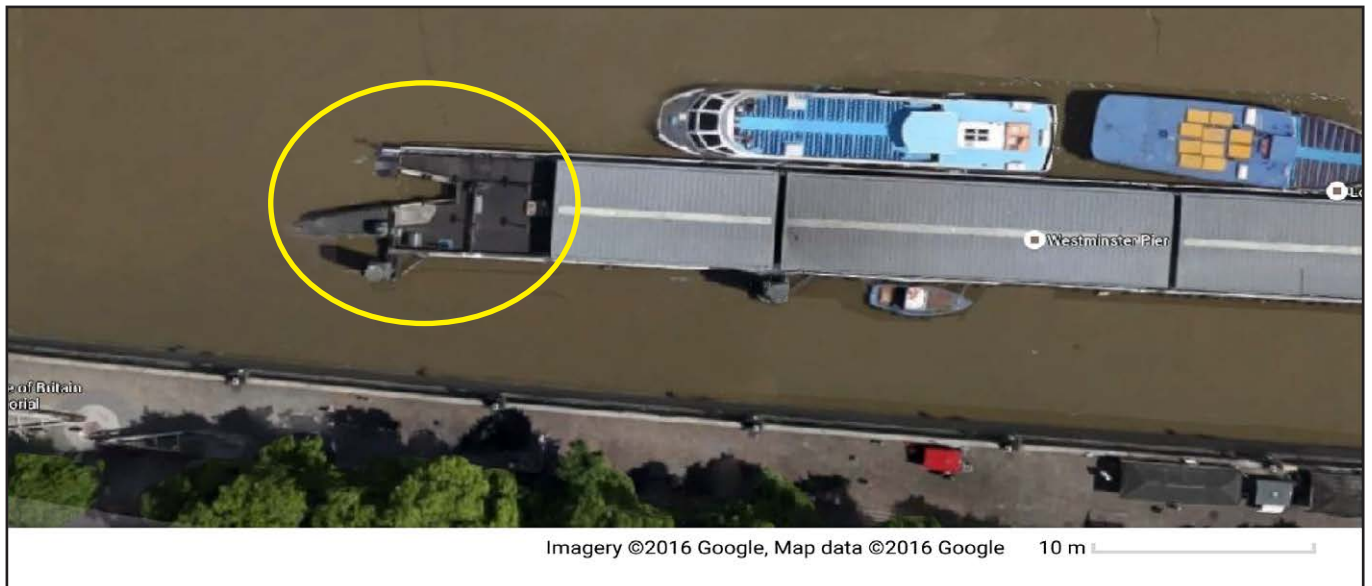
Figure 6: V-berth arrangement on River Thames

Uriah Heep was built in 1999 and was one of six vessels designed specifically for commuter services on the River Thames. The vessels operated to dedicated V-shaped berths that helped keep the craft steady as the passengers embarked and disembarked (**Figure 6**). In 2001, the vessels' operator, White Horse Ferries Ltd, ceased its services on the Thames and *Uriah Heep* was taken out of the water and laid up in Gravesend (**Figure 7**).

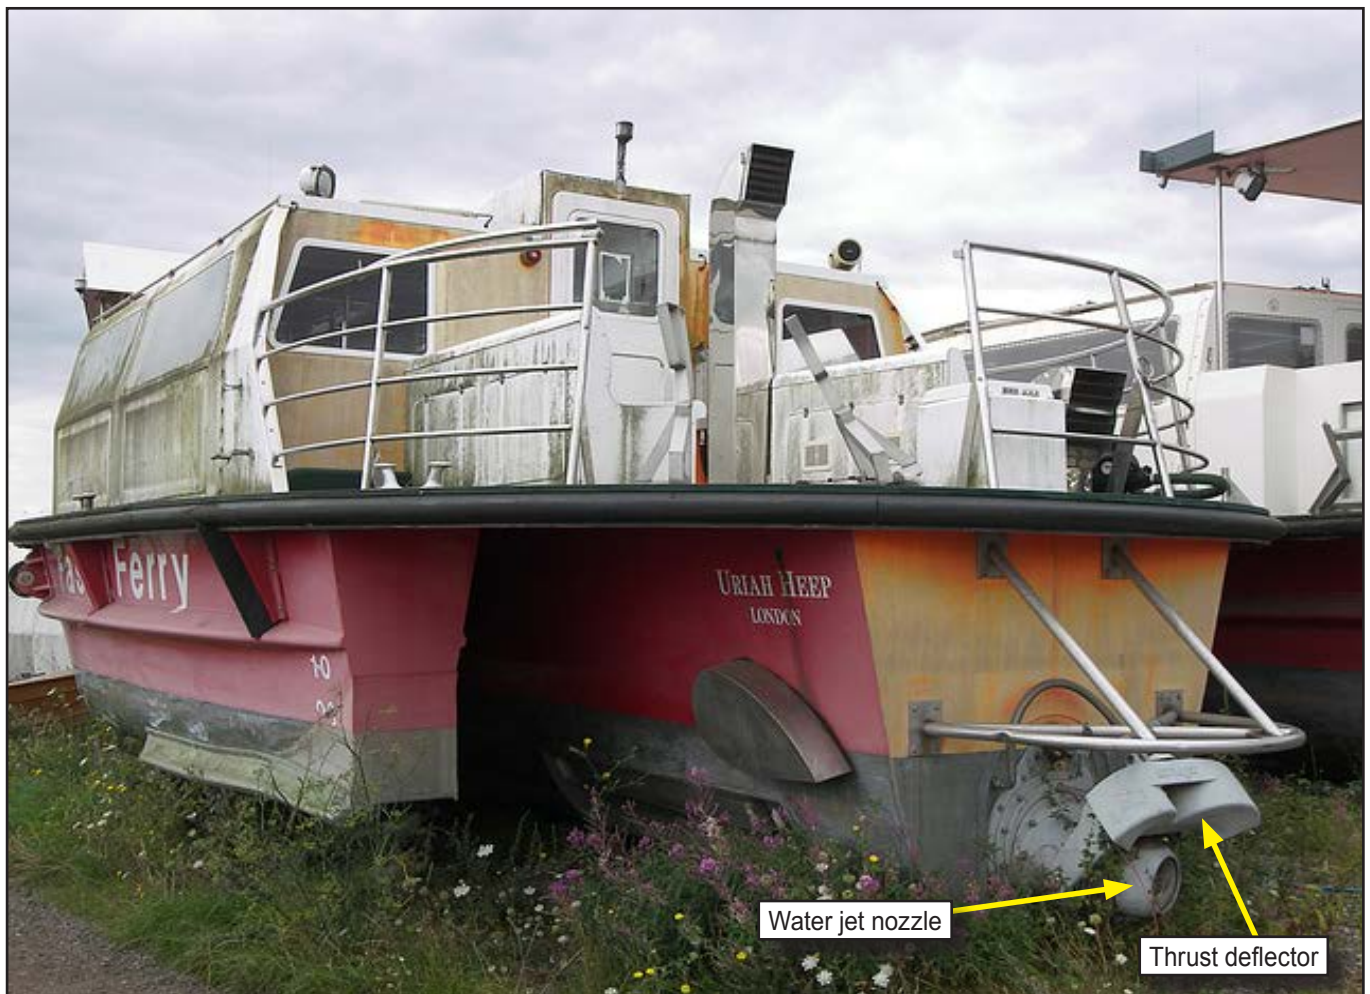
Figure 7: Uriah Heep laid up at Gravesend

Uriah Heep was fitted with a single water jet (**Figure 7**) powered by a 388kW diesel engine. The amount of thrust generated by the water jet was directly proportional to the speed of the impeller driven by the engine. Engine speed was regulated by a Morse control lever and indicated by a tachometer, both of which were sited on the wheelhouse's forward console (**Figure 3**). The minimum engine speed generally used when manoeuvring was approximately 1500rpm.
