Rail Accident Report

Near miss between a train and a level crossing user at Dock Lane, Melton, Suffolk 14 June 2016

Report 08/2017
May 2017

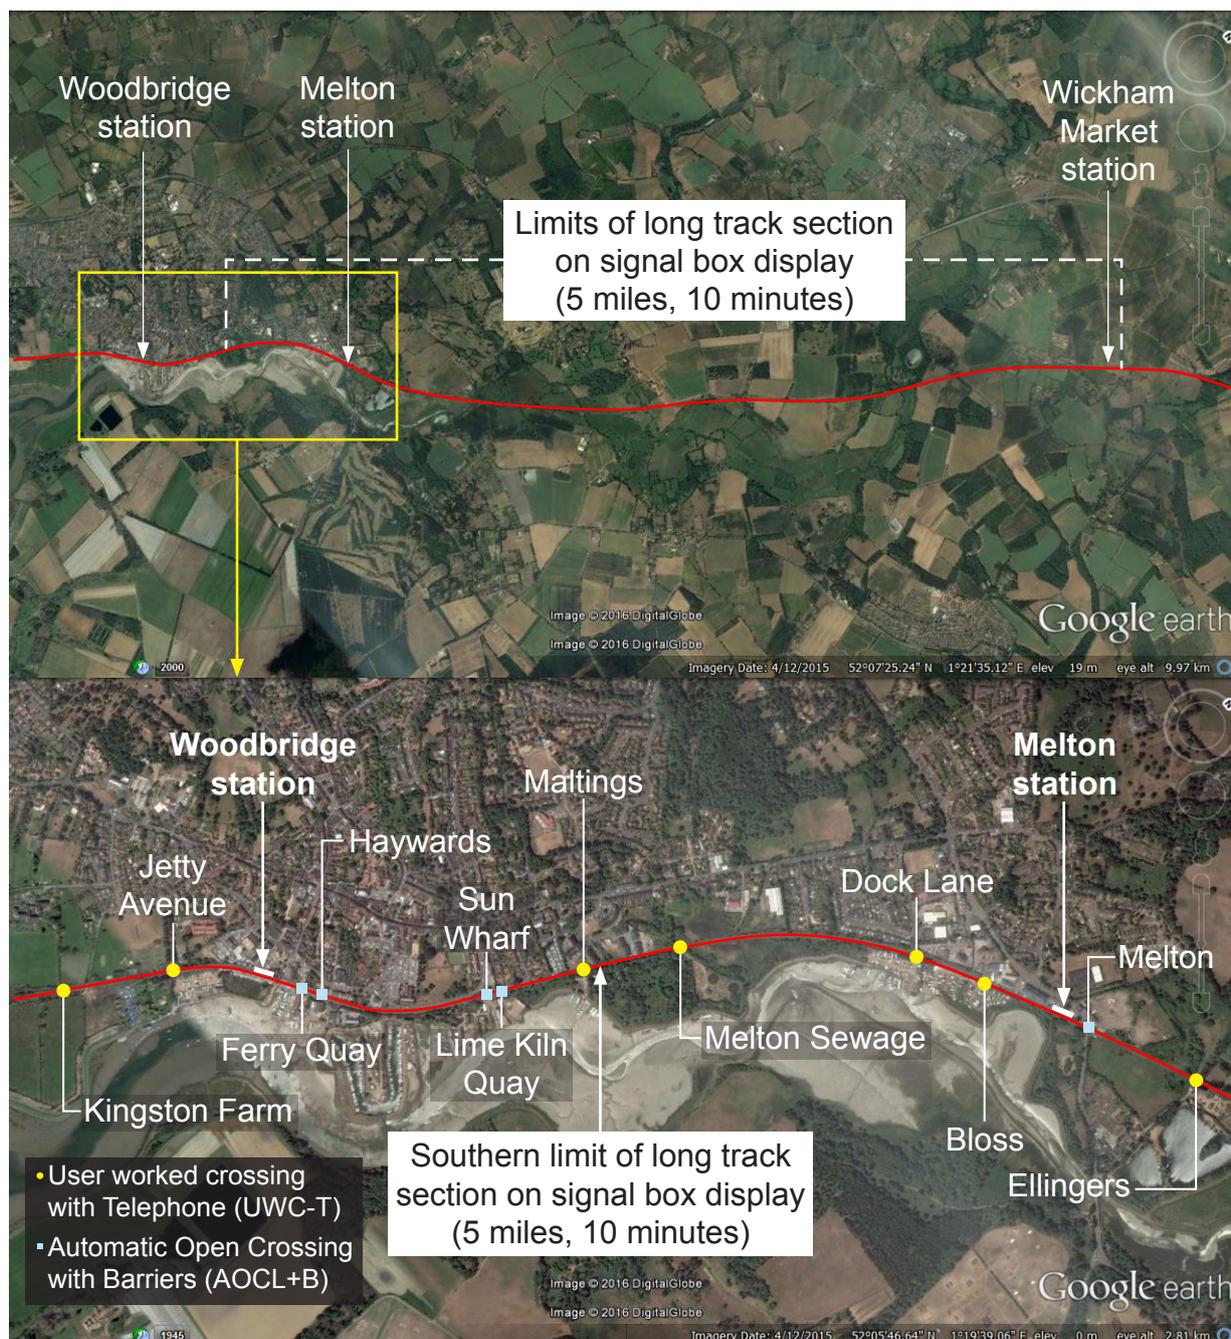
Figure 3: Level crossings in the Woodbridge/Melton vicinity

- 8 Dock Lane is one of a number of user worked level crossings in the Woodbridge/Melton area (figure 3). Another similar crossing, Bloss, is located between Melton station and Dock Lane. There are also a number of *automatic open crossings* that are fitted with both lights and half barriers.

- 83 Around the time that the signalling system was being upgraded, there were proposals to install telephones at the user worked crossing at Jetty Avenue, south of Woodbridge station (figure 3). At that time, the local Operations Risk Control Co-ordinator⁴ for that crossing recorded that he had concerns about fitting telephones at Jetty Avenue because he was aware that the signaller at Saxmundham was ‘already overstretched’ in dealing with the large numbers of level crossing calls. However, telephones were seen as a temporary solution, because the Wavetrain miniature stop lights were proposed for installation at Jetty Avenue and at several other crossings. As a result, telephones were not installed there in 2012.
