Air Accidents Investigation Branch  
Farnborough House  
Berkshire Copse Road  
Aldershot  
Hants GU11 2HH

Published 8 June 2017

Airbus A319-131	G-EUPM	19-Oct-16	3
-----------------	--------	-----------	---

Westland Wasp HAS1	G-KAXT	23-Sep-16	18
--------------------	--------	-----------	----

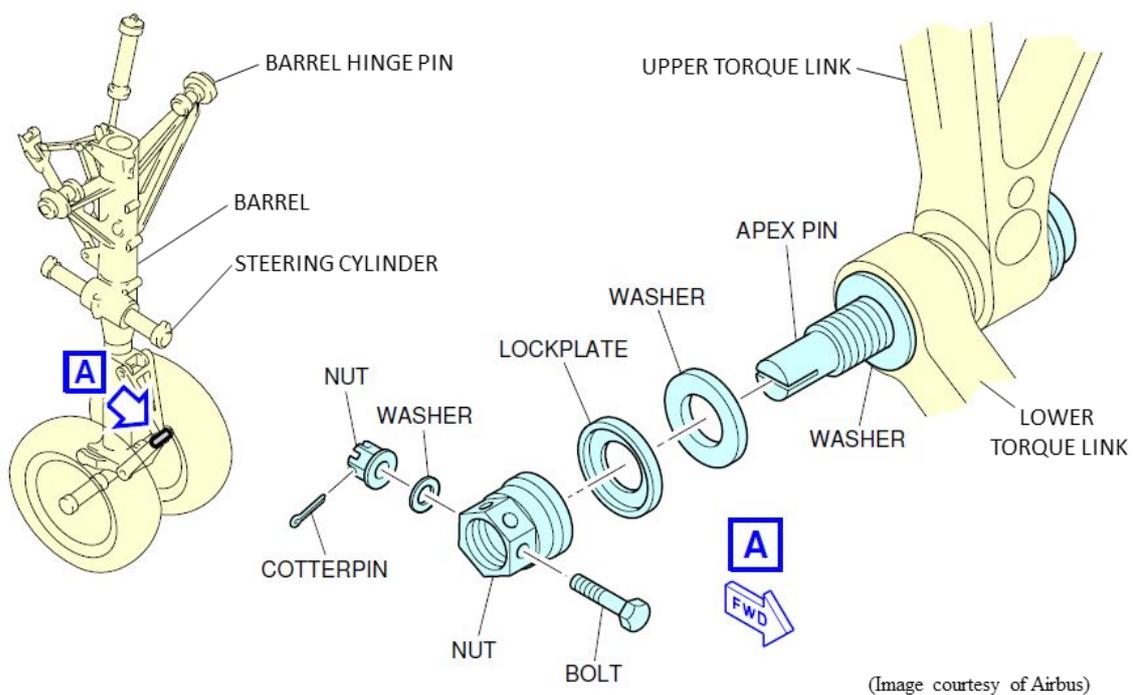
**Figure 4**

Nosewheel steering is performed by a hydraulic actuating cylinder attached to the landing gear barrel. The hydraulic actuator rotates the upper torque link, which transmits torque through the lower torque link to rotate the nose wheels. The upper and lower torque links are attached by an apex pin (Figure 4), providing articulation of the torque links to accommodate vertical displacement of the oleo strut.

Nose landing gear torque link apex pin assembly

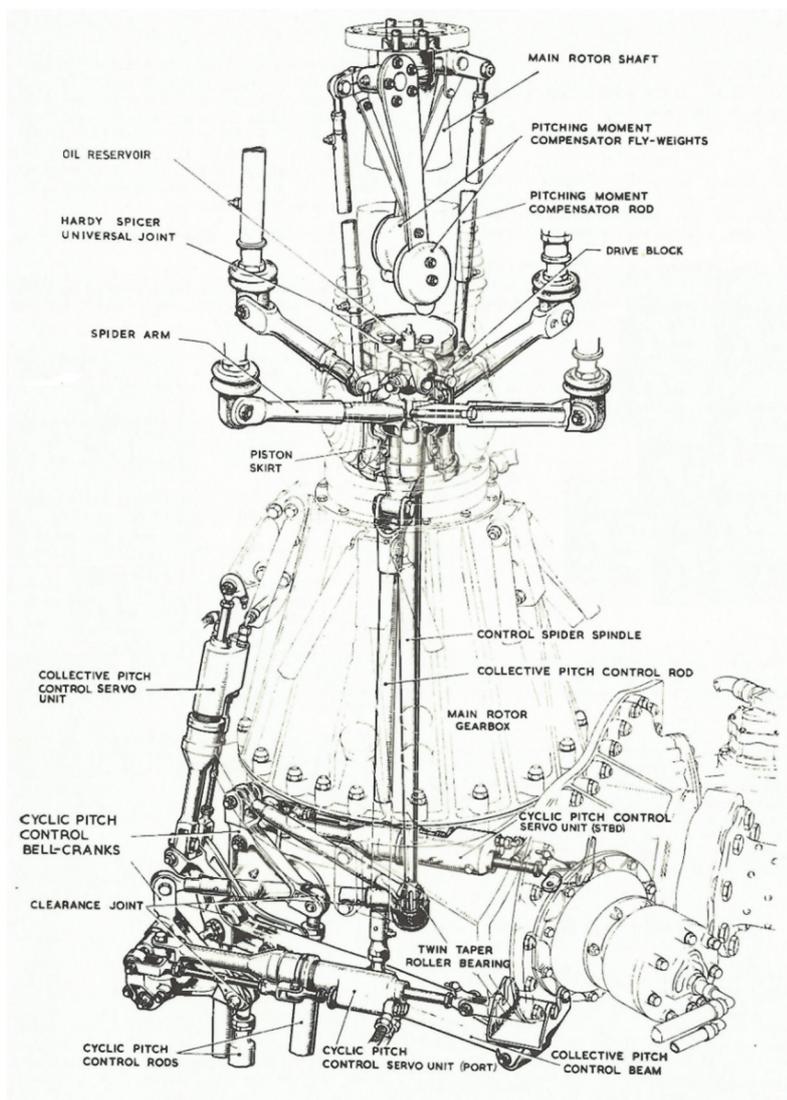
**Figure 1**

The control rods from the collective pitch and cyclic control column run aft under the cabin floor and, through a series of bell cranks and levers, extend upwards to the control spider at the base of the main rotor shaft (Figure 1).

### Main rotor gearbox controls

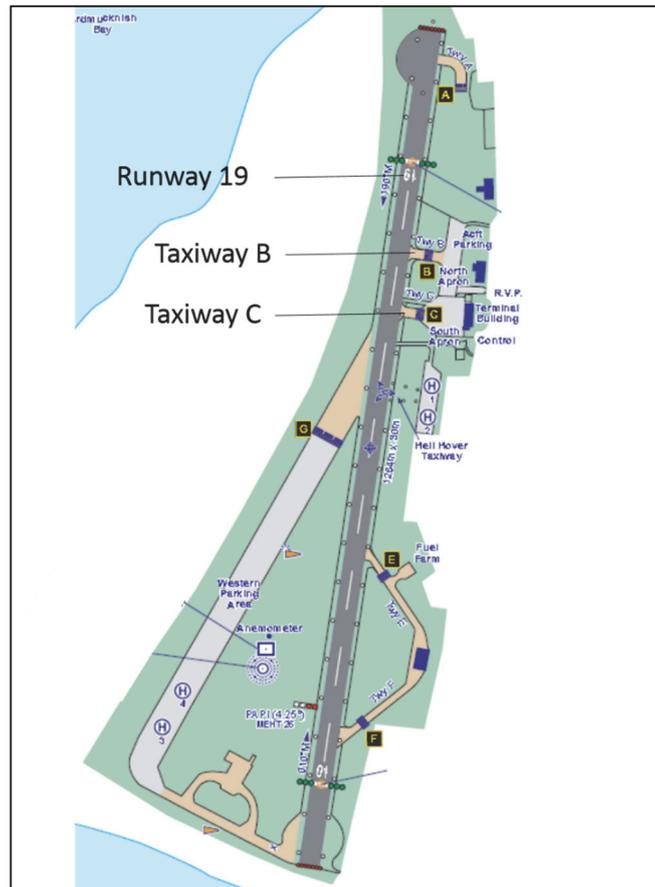
**Figure 1**

Extract of UK AIP entry for Oban Aerodrome

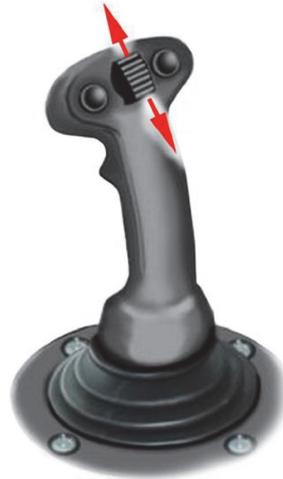
**Figure 2**

The UA control unit carried by the operator includes a joystick for cyclic control with a force sensitive thumb rocker sensor located on the top for climb-rate inputs (Figure 2). It includes a display of input commands.

Operator joystick showing climb-rate thumb rocker control
