Service Inquiry

Yak-52 G-YAKB

8 Jul 16

SERVICE INQUIRY INVESTIGATION INTO ACCIDENT INVOLVING Yak-52 G-YAKB on 8 Jul 16.

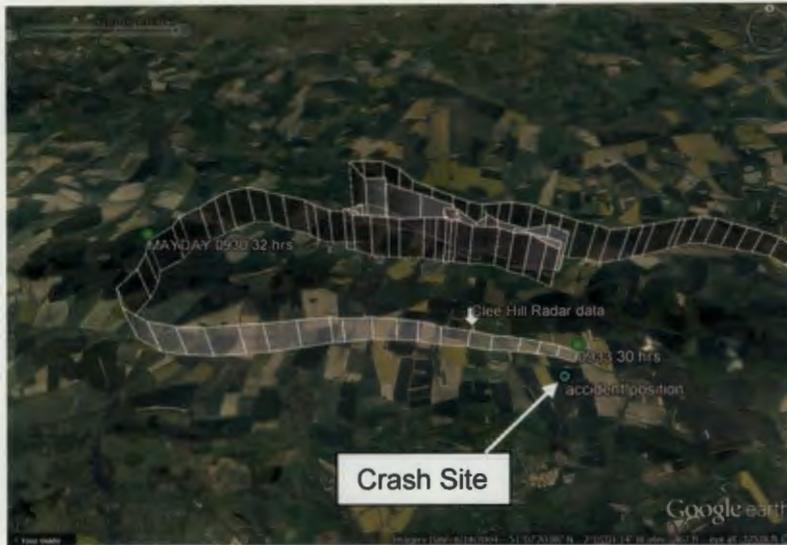
1.3.13. Figure 1.3.2 provides an overview of the latter stages of the flight. The crew had flown to the west of BDN where they had conducted aerobatic manoeuvres before the engine stopped, leaving the propeller wind-milling and with no residual thrust.

Figure 1.3.2. Radar Trace of Latter Stages of Flight Path taken by G-YAKB.
(Picture Source: AAIB)

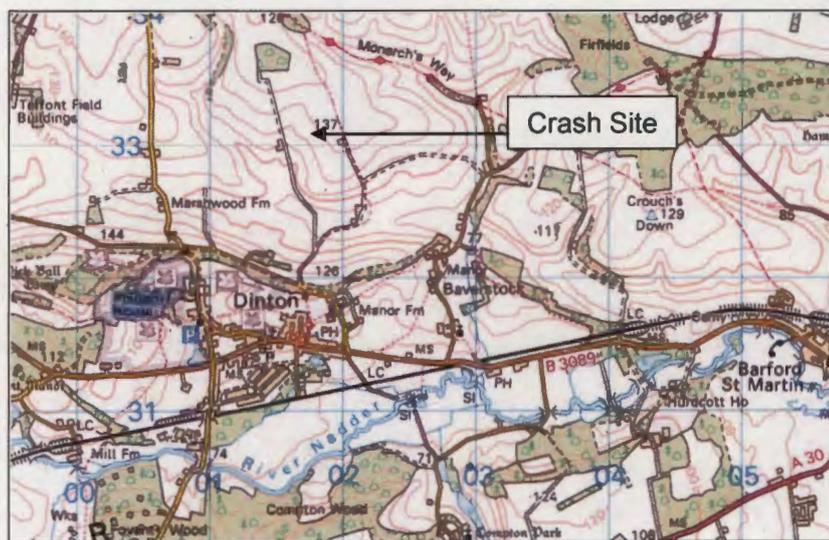
the south western edge of a landing strip orientated east/west, approximately 800m to the south west of the last radar contact. Four distinct witness marks indicated the initial impact point of the aircraft and subsequent movement. The aircraft had impacted the ground left wing first travelling downwind in an easterly direction, rotated onto its nose and subsequently came to rest facing in a northerly direction amidst, and partially concealed by, standing crops. The surrounding crops at the fourth impact point were mostly undamaged and indicated a near vertical arrival at the final resting point. During the accident sequence the FSP was thrown from the aircraft. The crash was contained within approximately 33 metres. The aircraft fuselage, wings and tail-plane were intact; the engine, although co-located with the remainder of the wreckage, was almost completely detached.

Figure 1.3.3. Map Orientated Grid North to the Top, Showing Crash Location¹⁰.

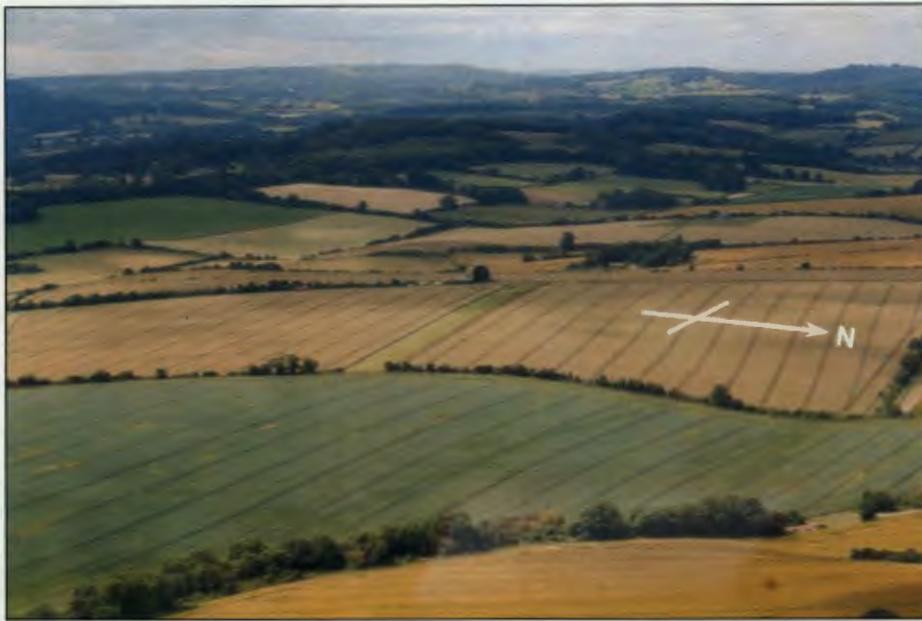
Figure 1.4.9 Aerial View of Landing Strip looking Southwest into Wind taken on 8 Jul 16

1.4.178. The accident crew probably realised during the glide that recovery was not possible given G-YAKB's glide performance and their range from BDN, unless they successfully re-started the engine. The PIC's recollection indicates that the crew became fixated with the low fuel pressure and operation of the fuel primer handle as a means to alleviate the loss of power. This may have led to them continuing the glide to the east and not establishing a Forced Landing pattern. The FSP's radio transmission indicates that the FSP considered it likely that they would have to Forced Land at the point of the 1032:04 transmission; 92 sec after the Mayday call. The continued glide to the east, after the FSP had transmitted the intention to Forced Land indicates that the PIC had not yet committed to a Forced Landing or was selecting a landing area. By spending the time between the two transmissions continuing to glide to the east the accident crew reduced the landing surface options available to them. As shown in Fig 1.4.9 the countryside over which the accident crew flew provides multiple opportunities for Forced Landing. The PIC recalled that he saw a suitable wheat field prior to committing to the Forced Landing. The FSP's use of the word 'field' to describe the intended landing point and the PIC's description of a wheat field are consistent and indicate that the initial aiming point for the Forced Landing was a field.

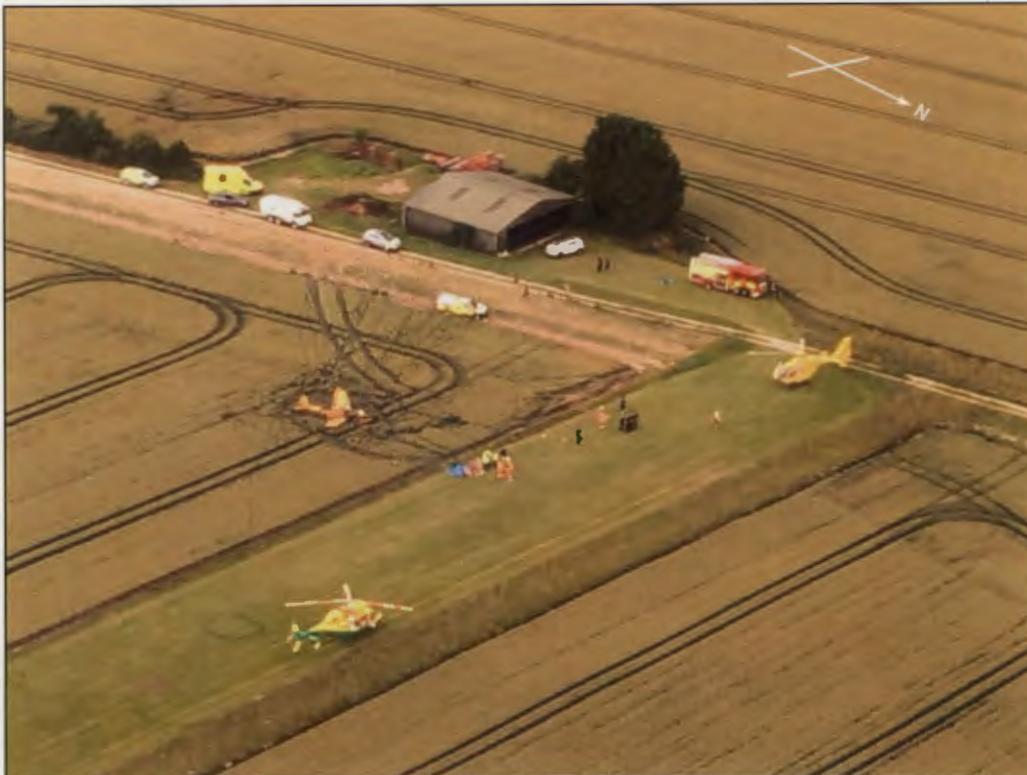
Figure 1.4.10. Aerial View Overhead the Landing Strip and looking southwest taken on 8 Jul 16

1.4.183. The impact point was directly upwind of the final radar position. At the final radar position G-YAKB was heading east. There was sufficient height available from this position to conduct a 150° right turn, losing approximately 300ft in the manoeuvre⁶⁹, leaving the

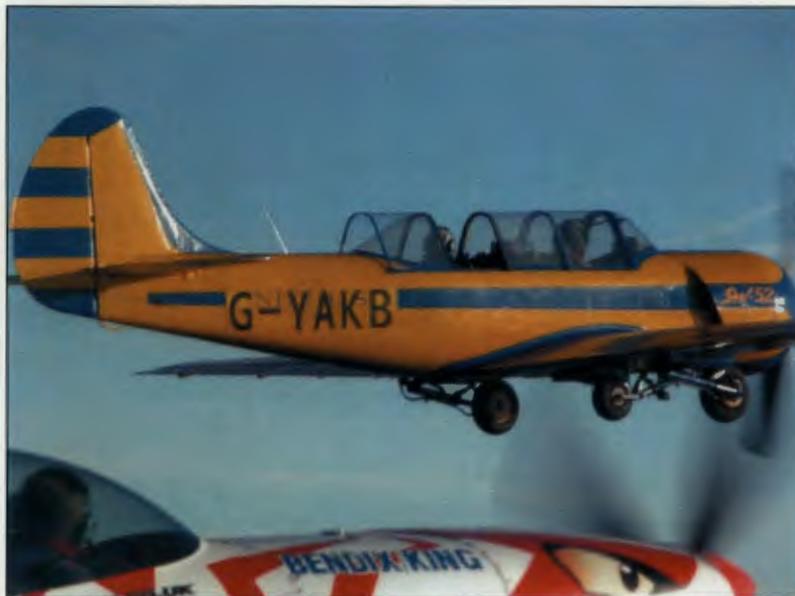
Figure 1.4.14 G-YAKB in formation, showing under-carriage fully retracted.
