Rail Accident Investigation Branch

Rail Accident Report

Freight train collision near Logan, East Ayrshire
1 August 2015

Report 13/2016
July 2016

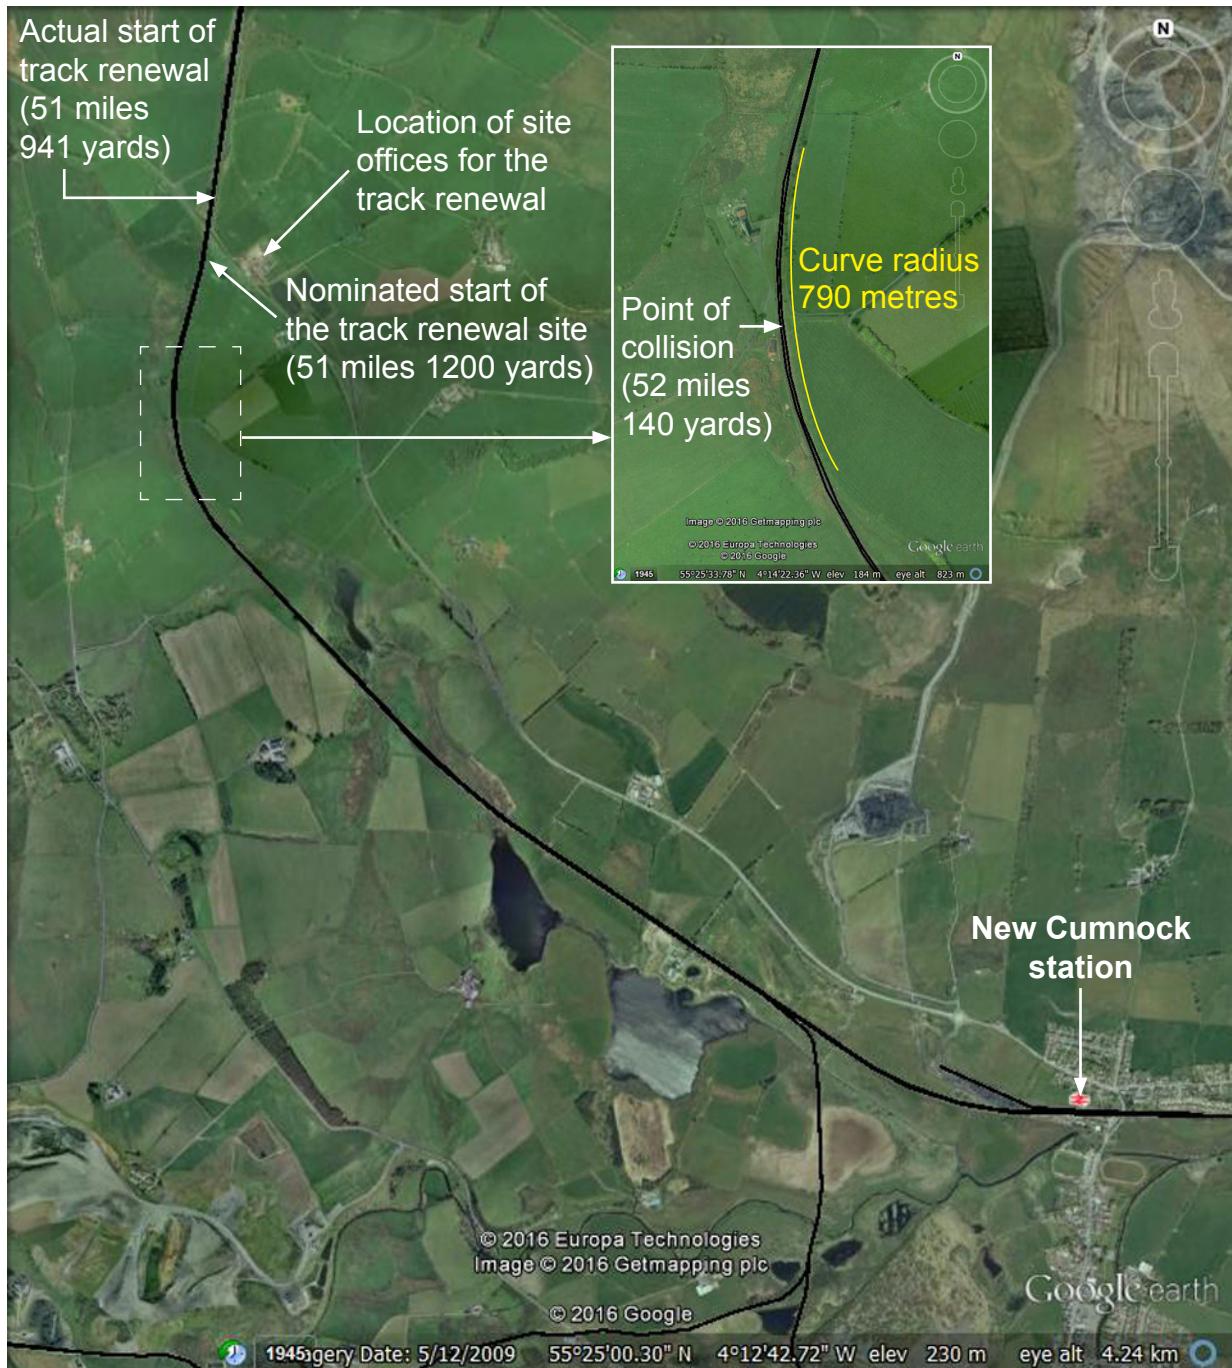
Figure 3: Google Earth view of accident site

- 6 The collision happened on a right-hand curve (in the train's direction of travel) of about 790 metres radius (figure 3) and on a falling gradient of about 1 in 175 (0.57%). Trains are normally signalled through this area using the *absolute block* system, with the controlling signal boxes located at New Cumnock (54 miles 1452 yards) and at Mauchline (43 miles 44 yards). However, at the time of the accident the signalling system was not in use as this section of railway was under possession and both lines were within a work site.

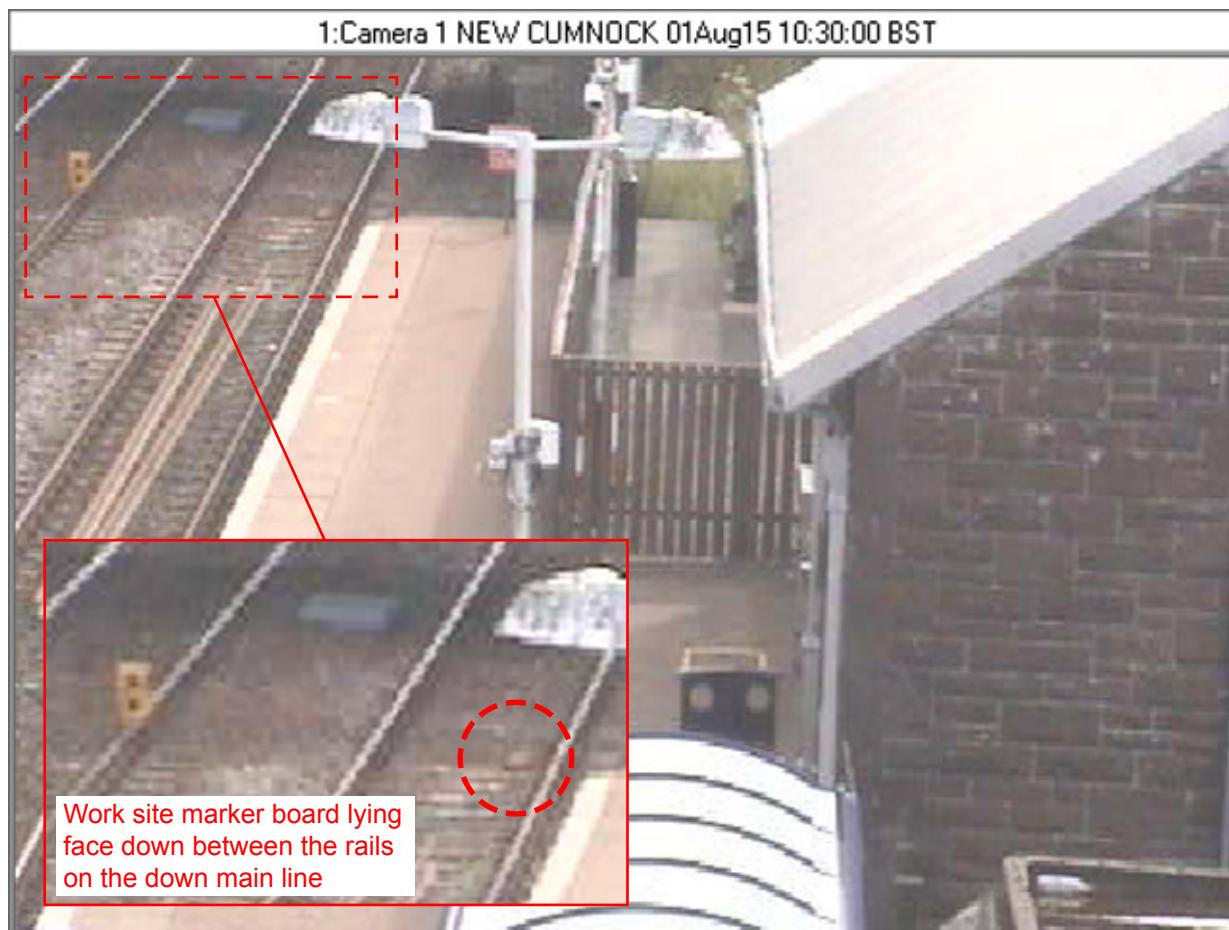
Figure 12: CCTV image from New Cumnock station (courtesy of ScotRail)

- 63 After the accident, the driver of train 6K07 stated that he might have thought he was driving in a possession rather than a work site while travelling from New Cumnock to site of the track renewal, and so could proceed at a speed of up to 40 mph (65 km/h). The protection arrangements in place at the entrance to the possession and work site may have led to the driver's uncertainty. At New Cumnock, the possession limit boards and the work site marker boards were located together at the possession detonator protection (figure 11). However, when train 6K07 approached, the work site marker board was not visible to the driver as it was lying face down between the rails (figure 12). It is not known when it was placed in this position but the RAIB obtained CCTV footage from New Cumnock station, which began at 10:30 hrs, that showed it was already lying face down by this time.

- 64 Section 3.4 of GE/RT8000/HB12 states that the work site marker board will normally be placed at least 100 metres from the possession detonator protection. It also states that if this distance cannot be achieved, the work site marker board should be placed at the detonator protection along with the possession limit board. At New Cumnock, the work site marker board was placed next to the last detonator, so was placed about 20 metres from the possession limit board which was located at the middle detonator. However, only the possession limit board was visible to the driver of train 6K07.

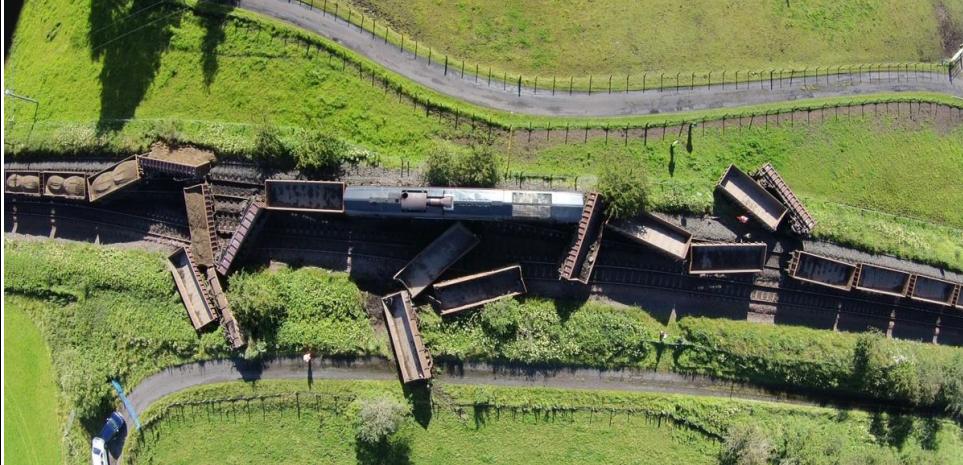
1. INCIDENT DESCRIPTION			
LEAD / INSPECTOR		CONTACT TEL. NO.	
INCIDENT REPORT No	0795	DATE OF INCIDENT	1 August 2015
INCIDENT NAME	Logan, near New Cumnock, East Ayrshire		
TYPE OF INCIDENT	Collision between engineering trains in a work site		
INCIDENT DESCRIPTION	<p>At about 11:13 hrs on 1 August 2015, two freight trains, which were being operated in connection with engineering work, were involved in a collision near Logan, East Ayrshire, on the railway line from Carlisle to Glasgow via Dumfries. The collision happened on the Down Main line at 52 miles 140 yards, which is about 3 miles (4.8 km) north of New Cumnock station. Both trains were within a work site contained inside an engineering possession. Train reporting number 6K06, the 0703 Carlisle Yard to New Cumnock, was stationary and waiting to enter into the site of work where the track on the Up Main line was being renewed. Train 6K07, the 0917 Carlisle Yard to New Cumnock, had entered the work site at New Cumnock station and been authorised by the Engineering Supervisor to move up to site of work behind train 6K06. It ran into the rear of train 6K06 at 28 mph (45 km/h).</p> <p>No one was injured but the locomotive and 7 wagons from train 6K07 and 11 wagons from train 6K06 were derailed; the locomotive of 6K07 and some wagons were severely damaged. One wagon came to rest across a minor roadway. There was also extensive damage to the track. Although the accident did not result in any injuries, the potential for more serious consequences is evident.</p>
