Maritime &
Coastguard
Agency

SS RICHARD MONTGOMERY SURVEY REPORT 2015

MARITIME & COASTGUARD AGENCY
DECEMBER 2016

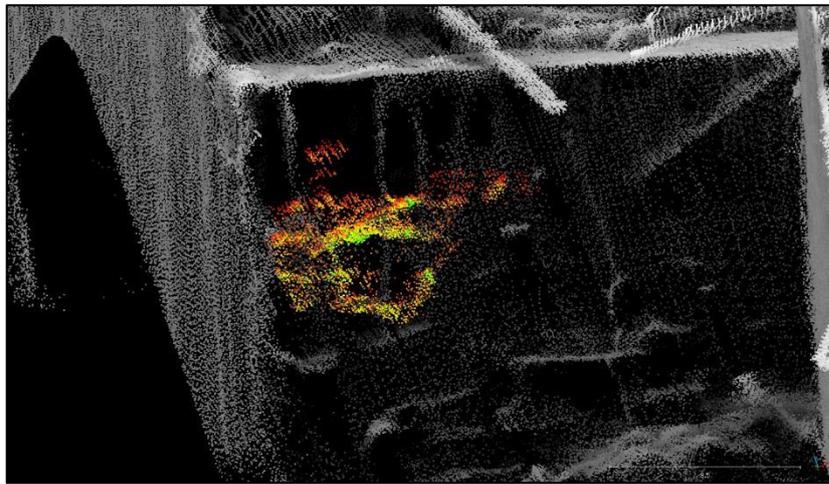
Fig. 22 2 Contents of Hold 3 (ID94) coloured orange and yellow to distinguish from data from the vessel exterior (SSRM2015)

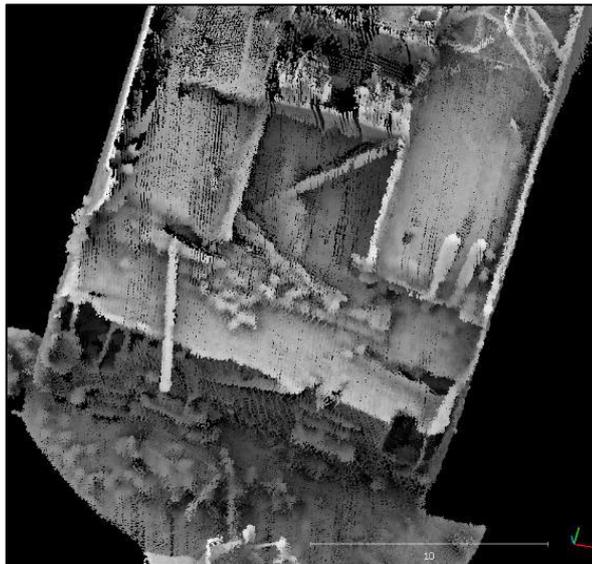
Fig. 23 Debris on the aft end of Hold 3

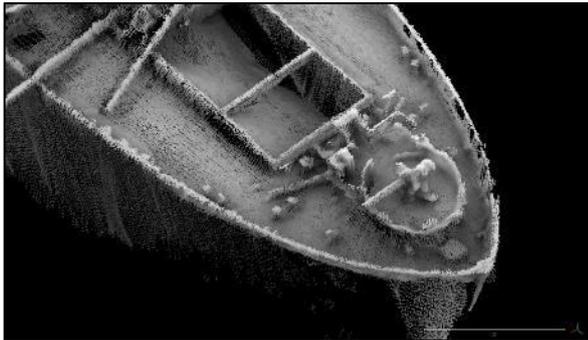
4.28.1 The Forward Gun and Gun Tub (ID50) are located on the Gun Platform that is placed directly over the bow. This feature was well defined in 2015 dataset with imagery improved over 2014 due to increased density from the use of the 512 beam setting. Comparison of the point cloud imagery shows that there has been no deterioration of the gun, which is still in the same position as in previous datasets. Similarly, the stern gun tub showed no change. Across the other gun tubs on the wreck, no changes were noted, although some sediment movement was evident in some areas.

Fig. 24 Bow gun, 2015

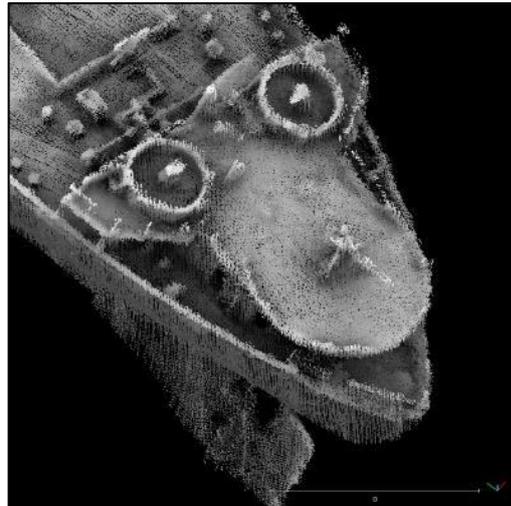
Fig. 25 Stern gun, 2015

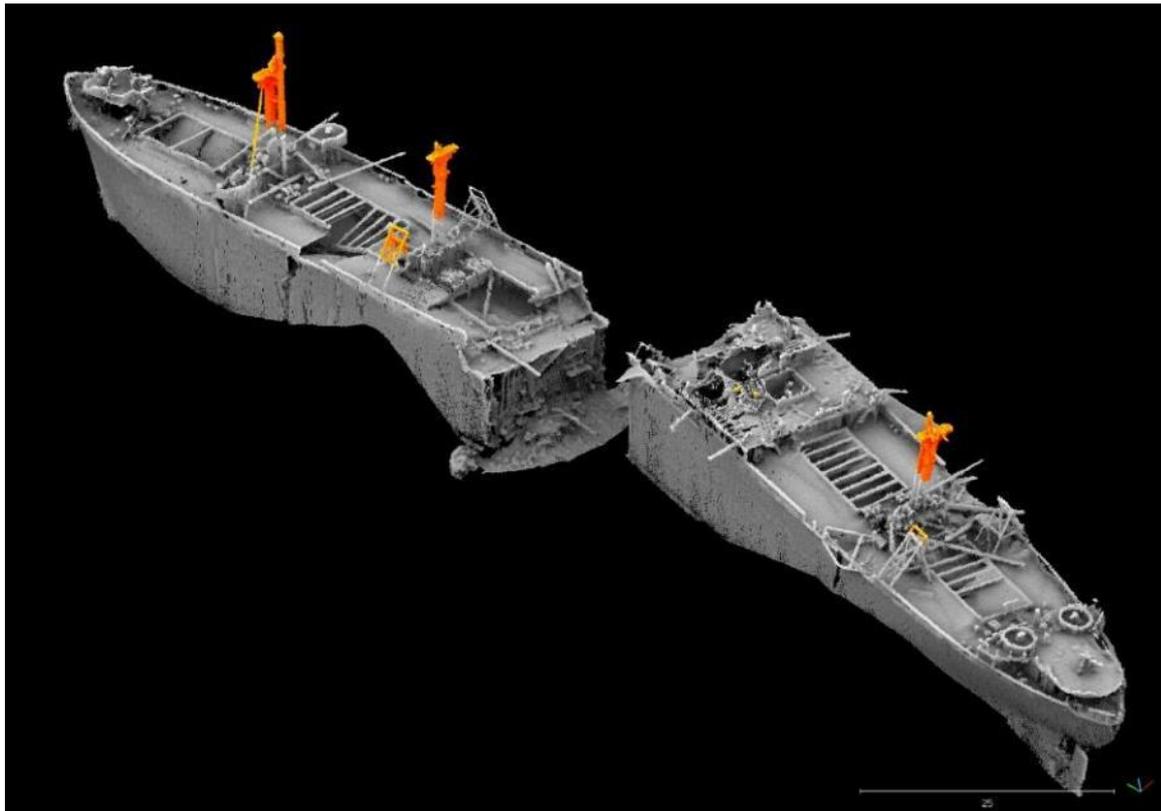
4.29.8 Examination of the point clouds from the 2015 and 2014 surveys suggested that the mast structure had remained static and no signs of advancing structural deterioration were observed. Surface difference analysis showed that there has been little deterioration here although small changes around the complex debris are present. These changes are likely to relate to subtle differences in cleaning but larger scale shifts indicative of deterioration of the wreck were not observed.

4.29.9 Three cargo handling booms remain in the Mizzen Mast area and are clearly visible in the point cloud imagery. All appeared to have remained stable, which no indication of deterioration.

Fig. 26 Multibeam & laser data (orange), 2015, showing all three masts

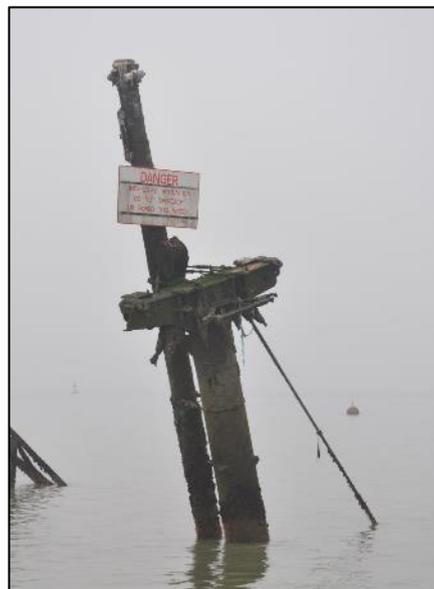
Fig. 28 The fore mast, showing warning sign

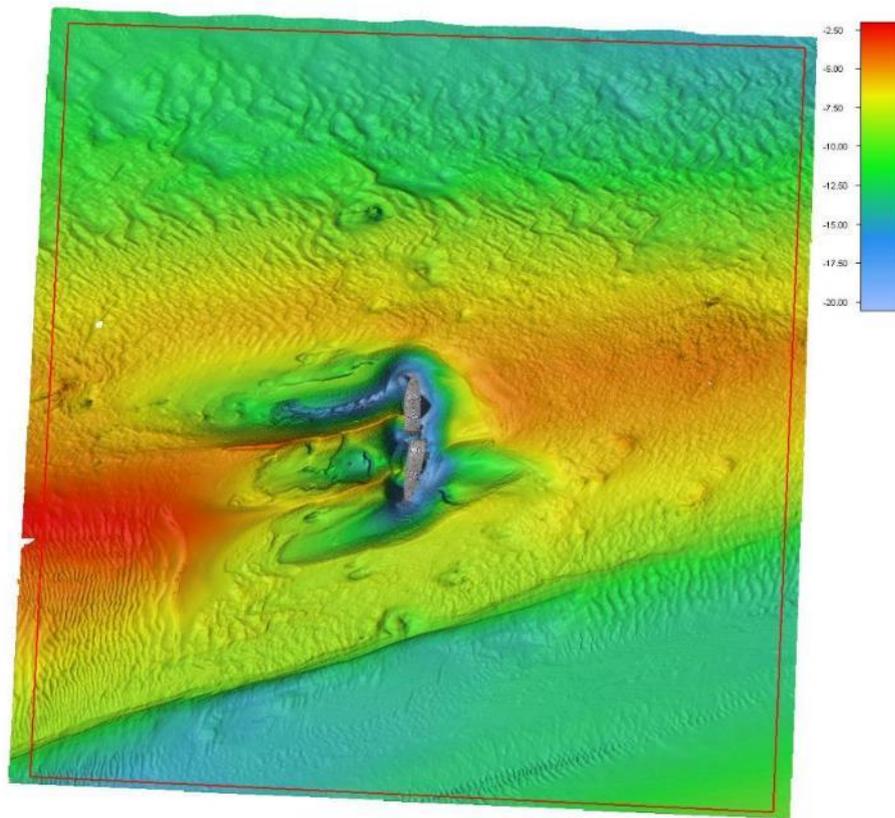
5.1 A key part of the SSRM project is to undertake a high-resolution survey that covers the seabed over an area extending 400 metres from the centre of the wreck. This was performed using the MV Yantlet whilst also acquiring the TVG data. Fig. 29 shows the results of this seabed survey. The data collected is used identify where changes to the seabed topography around the wreck have occurred. This is achieved by performing surface difference analysis against historical datasets and by comparing contours created from these surfaces.

Fig. 29 Results of the SSRM 2015 seabed survey

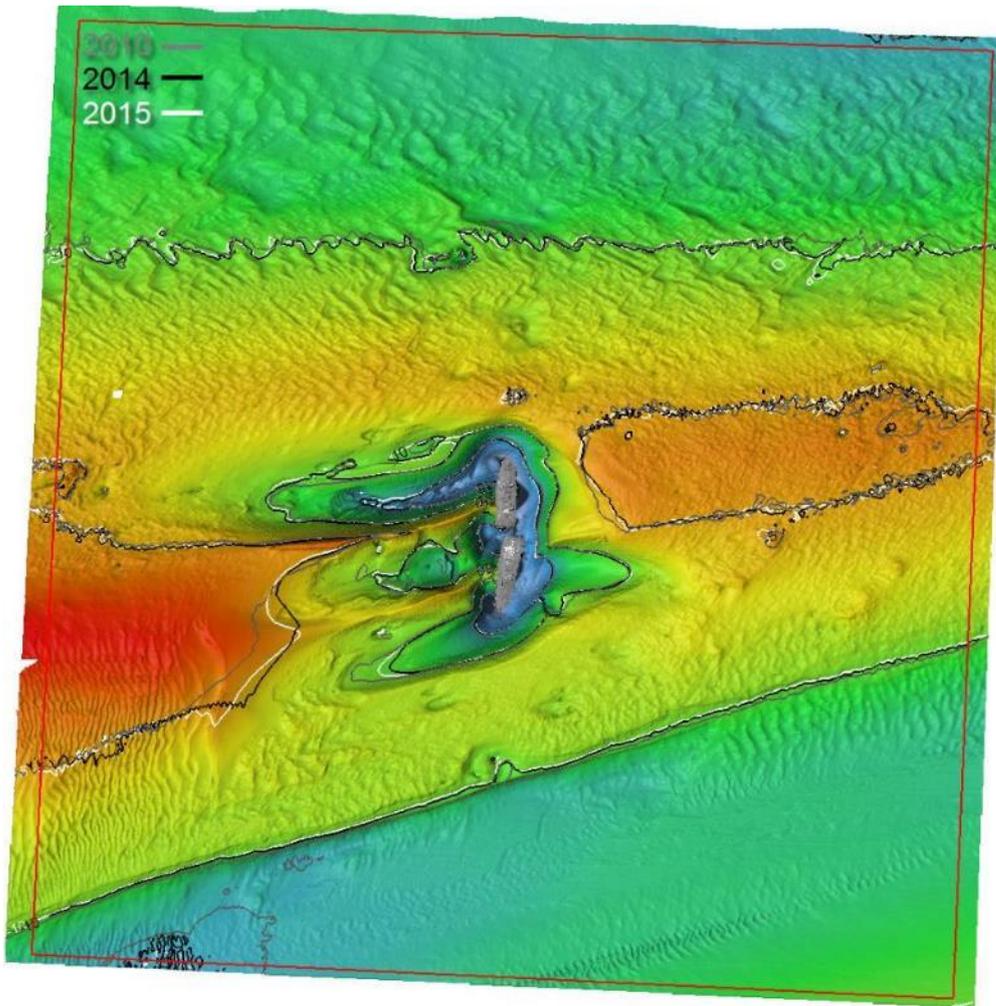
Generally, there is a close alignment between the contours from 2014 and 2015. This suggested that although the site is highly dynamic due to the strong tidal currents, the sediment transport processes are in relative equilibrium.

*Fig. 30 Charted depth contours across the whole survey site
Contours generated are 5m, 10m, 15m and 20m*

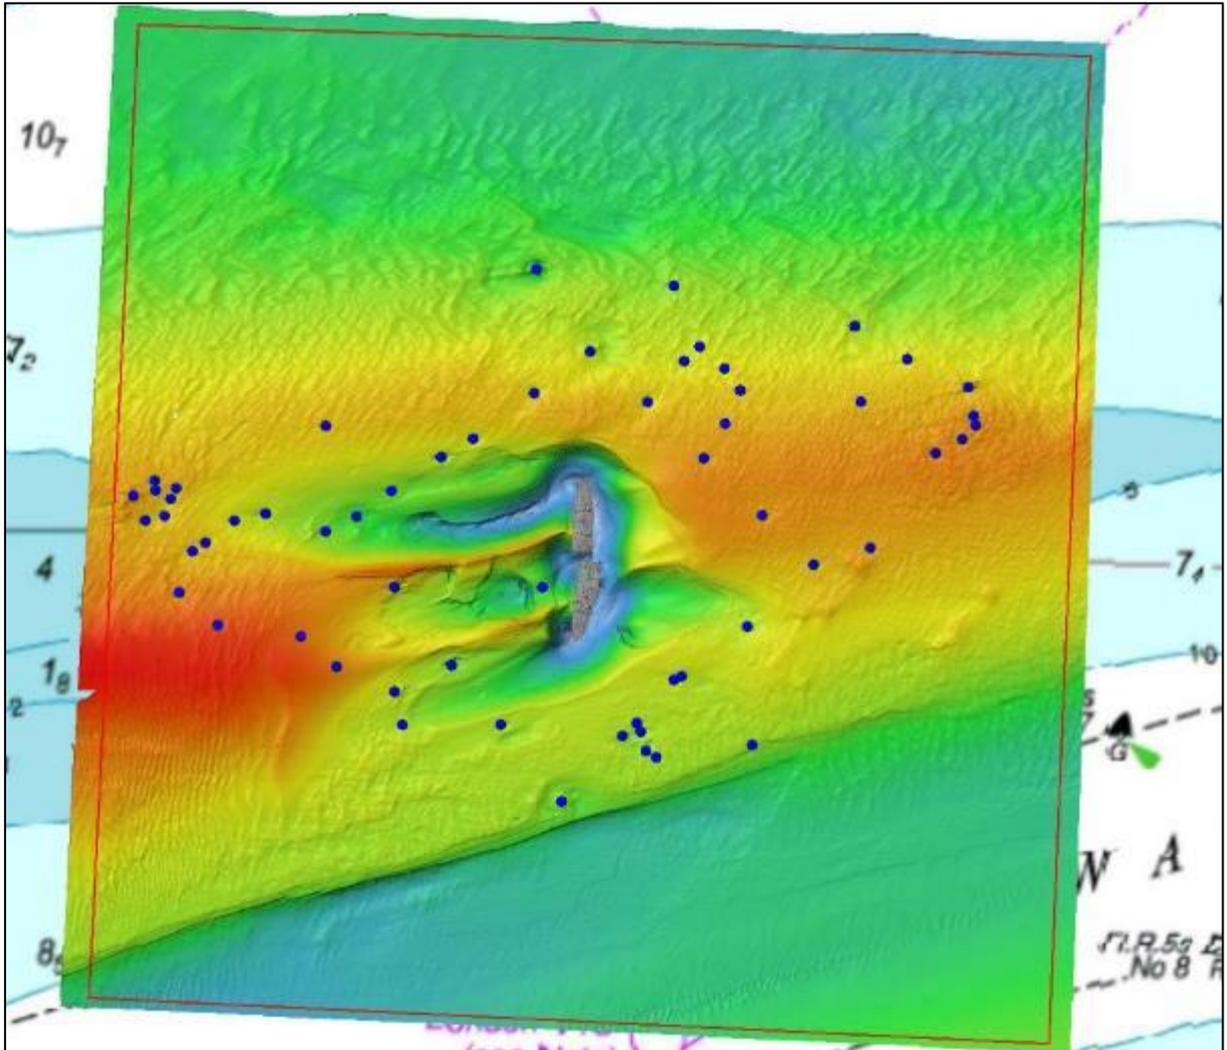
5.8.4 The majority of seabed targets identified in the 2015 survey data related to ones which have been previously recorded. Four new objects were located, only one of which lies within the prohibited area.

Fig. 31 Locations of the Seabed Contacts 2015

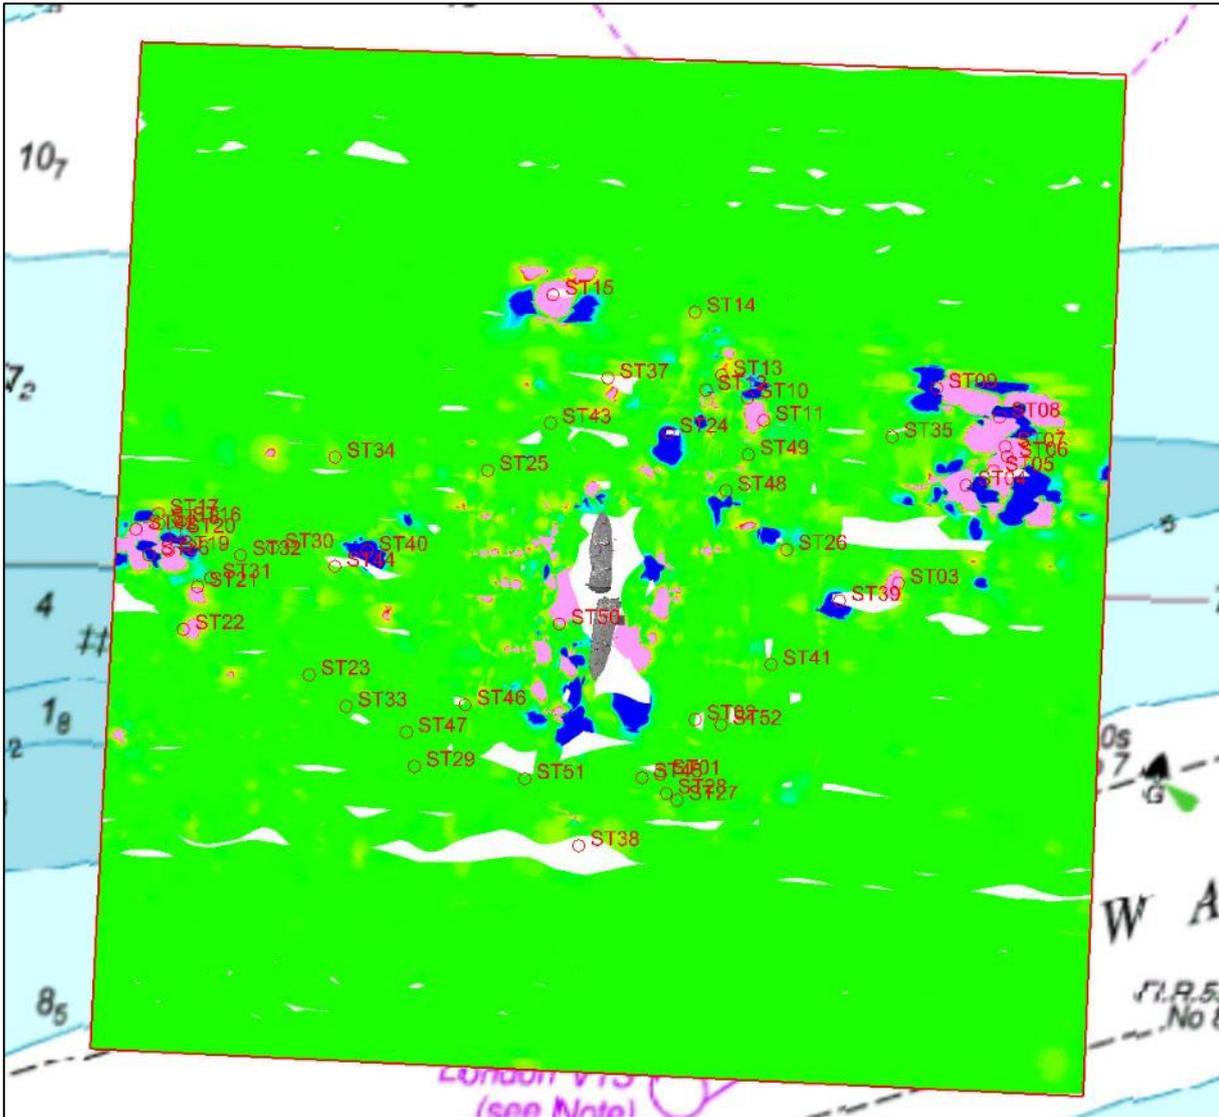
6.7 A number of anomalies were detected in the TVG results and these are mainly clustered in three areas within the survey area. These are on the West, North and East of the wreck. At these locations the targets are also present in the MBES data. A few smaller anomalies were detected that could not be seen in the bathymetry. These may correspond to smaller items of debris or items that have become buried.

Fig. 33 TVG results with Seabed Target locations shown
