AAIB Bulletin

10/2017

Published 12 October 2017

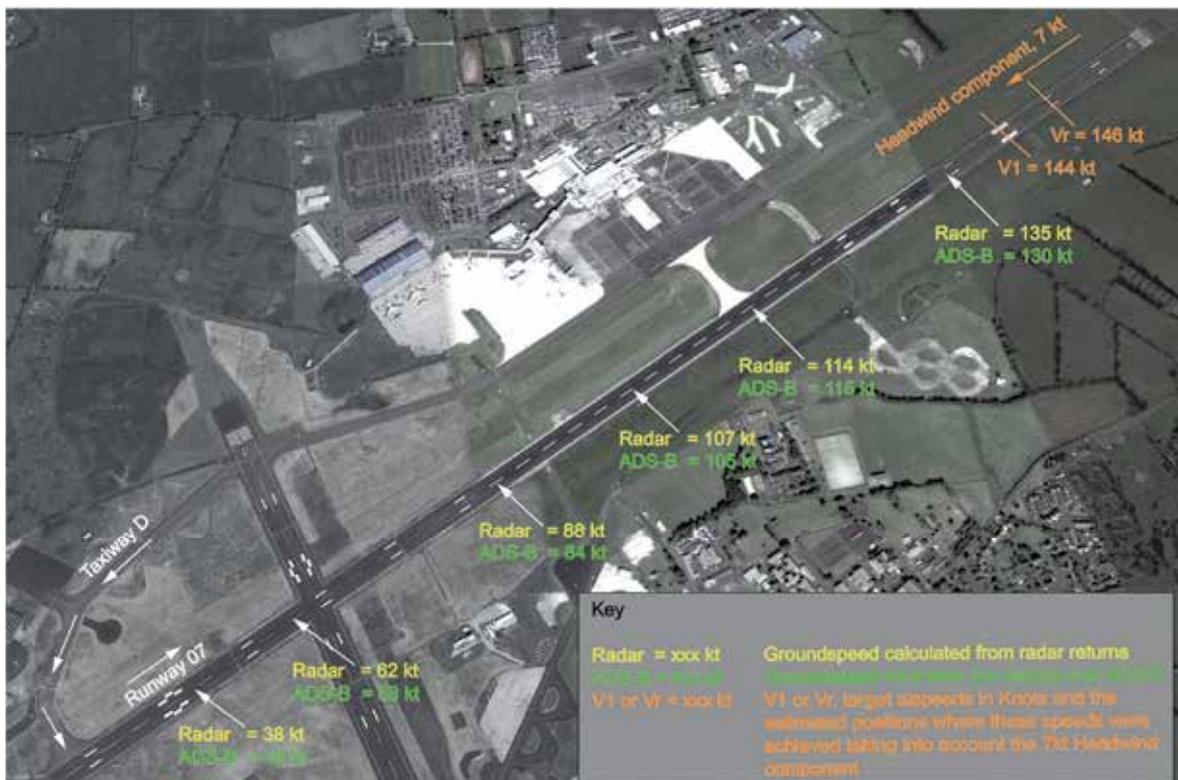
The radar installation at Belfast International Airport tracked the aircraft along Runway 07 and during initial climb-out, when altitude data also became available from the aircraft's transponder. The radar returns allowed groundspeed for the aircraft to be calculated which was supplemented by both groundspeed and altitude data transmitted from the aircraft over its ADS-B⁴ data link. This data is shown in Figure 1 for the ground roll, where the text in yellow represents calculated groundspeed data from the radar track and, in green, the received ADS-B groundspeeds. Orange lines show the approximate position where the aircraft achieved airspeeds equivalent to V_1 and V_R ⁵, taking into account a 7 kt headwind component.

Groundspeed data for the takeoff in relation to V_1 and V_R

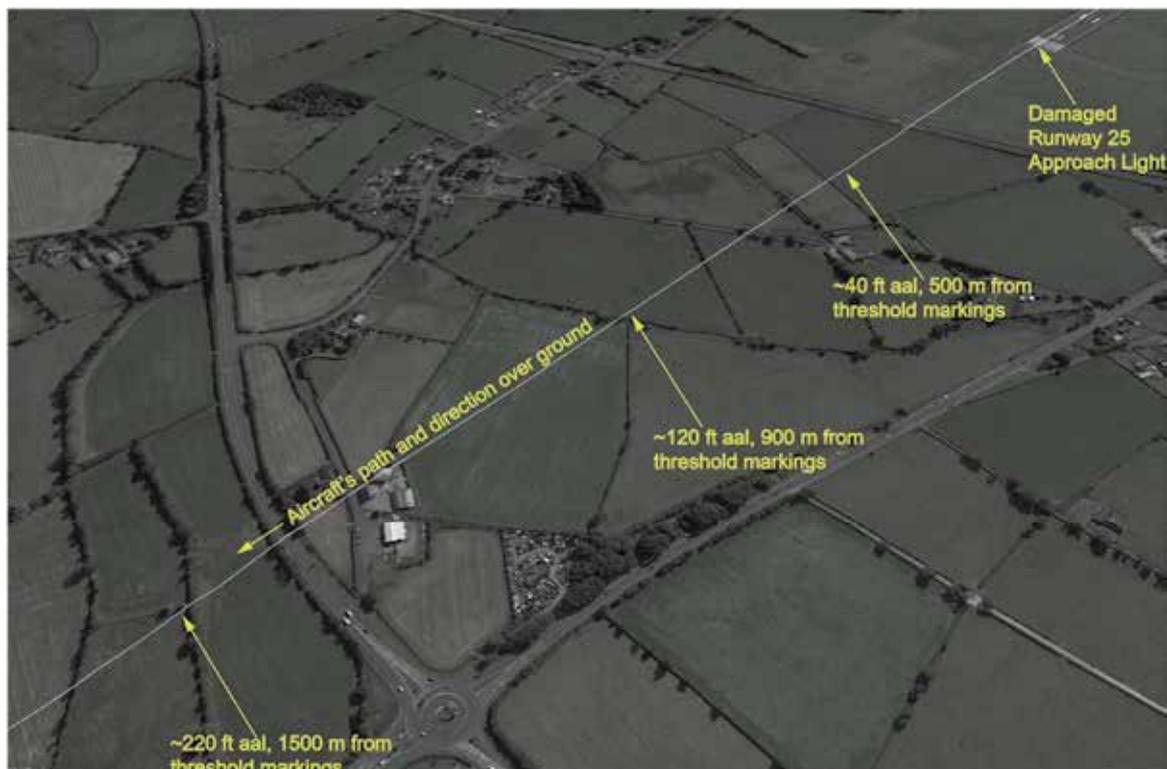
Figure 2 shows spot heights above the elevation of Belfast International Airport (268 ft amsl) for the aircraft's initial climb, derived from the aircraft's ADS-B reports (these heights are annotated 'above airfield level' (aal)). At no time during the climb-out was the aircraft's Enhanced Ground Proximity Warning System Mode 3 aural alert ("DON'T SINK") triggered⁶.

Vertical profile for the initial climb-out
© 2017 Google, Image © 2017 DigitalGlobe

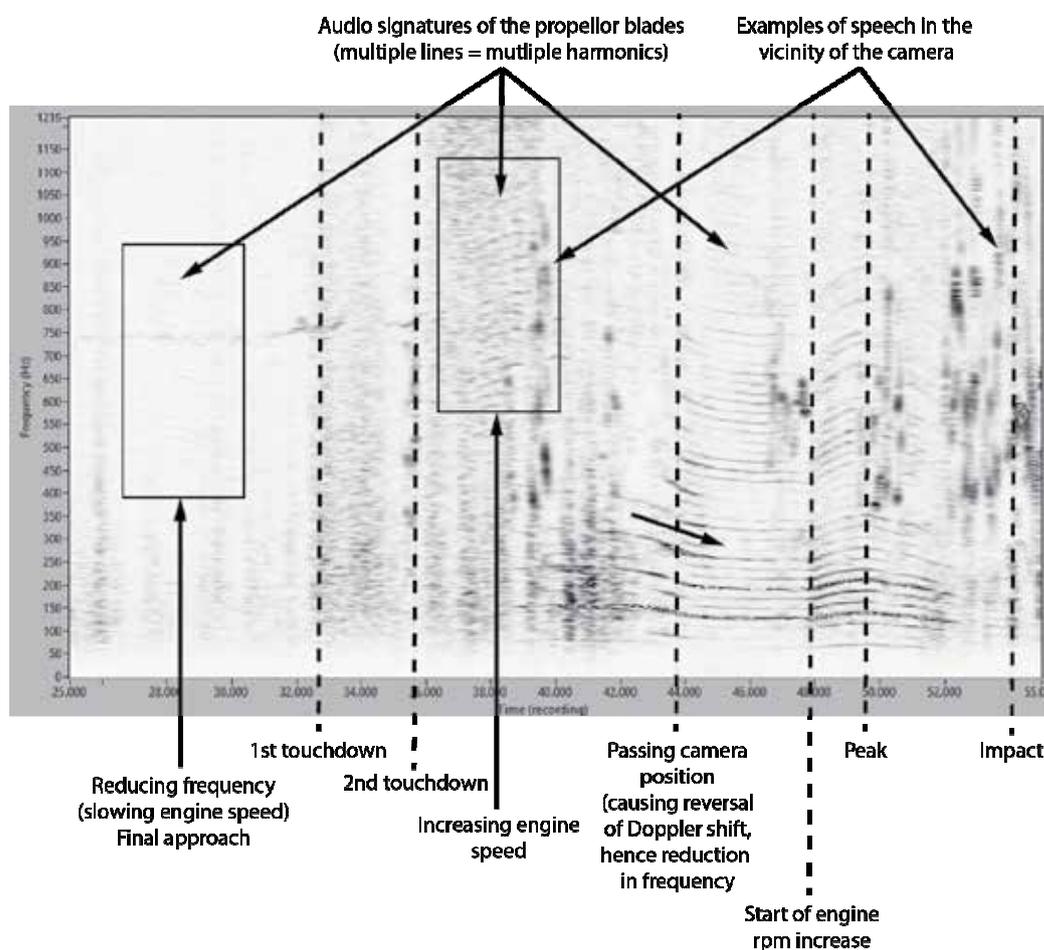
Figure 10

The Doppler shift itself, assuming steady ground speed and engine speed, indicated that the aircraft passed the camera position with a speed of between 74 and 83 mph.

The audio signatures from the propeller were analysed and calculations indicated an engine speed of approximately 2,300 rpm just prior to initial touchdown. The audio signatures at this point were not prominent, indicating the engine was at low power. Just after the second touchdown, the signatures became prominent again indicating increased engine power and increasing engine speed. The engine speed was calculated to be approximately 2,800 rpm as the aircraft passed the camera, assuming the engine speed and ground speed were approximately constant as it passed. Six seconds before impact with the tree, the propeller speed rose again reaching a maximum after 1.5 seconds and then steadily reducing until the point of impact.

Spectrum Analysis of video audio

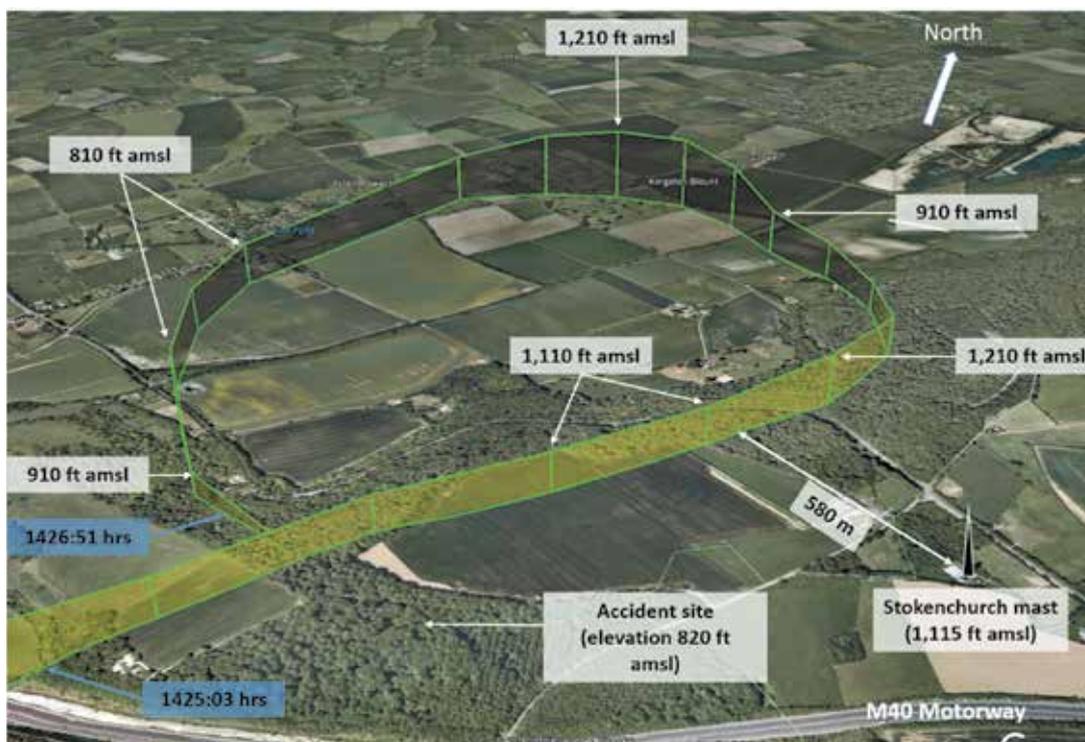
Figure 2

The aircraft continued south until it was 2.7 nm east of Chalgrove Airfield, when it turned left onto a track of approximately 060°M. The turn took the aircraft from an area where the terrain was generally below 400 ft amsl towards a ridge of higher ground, with terrain up to approximately 850 ft amsl (Figure 2). The aircraft flew along the ridge for approximately 1.5 nm, at an altitude of approximately 1,100 ft amsl (equivalent to 300 to 400 ft agl), and then turned left through approximately 270°. The turn took the aircraft back over the lower ground and then towards the ridge again at between 400 ft and 500 ft agl. It continued

to fly towards the rising ground until it struck the top of some trees at 920 ft amsl. The aircraft broke up as it descended through the trees and the pilot, who had been wearing a three point harness, was fatally injured during the accident sequence.

Final track of the aircraft (©Google Earth)

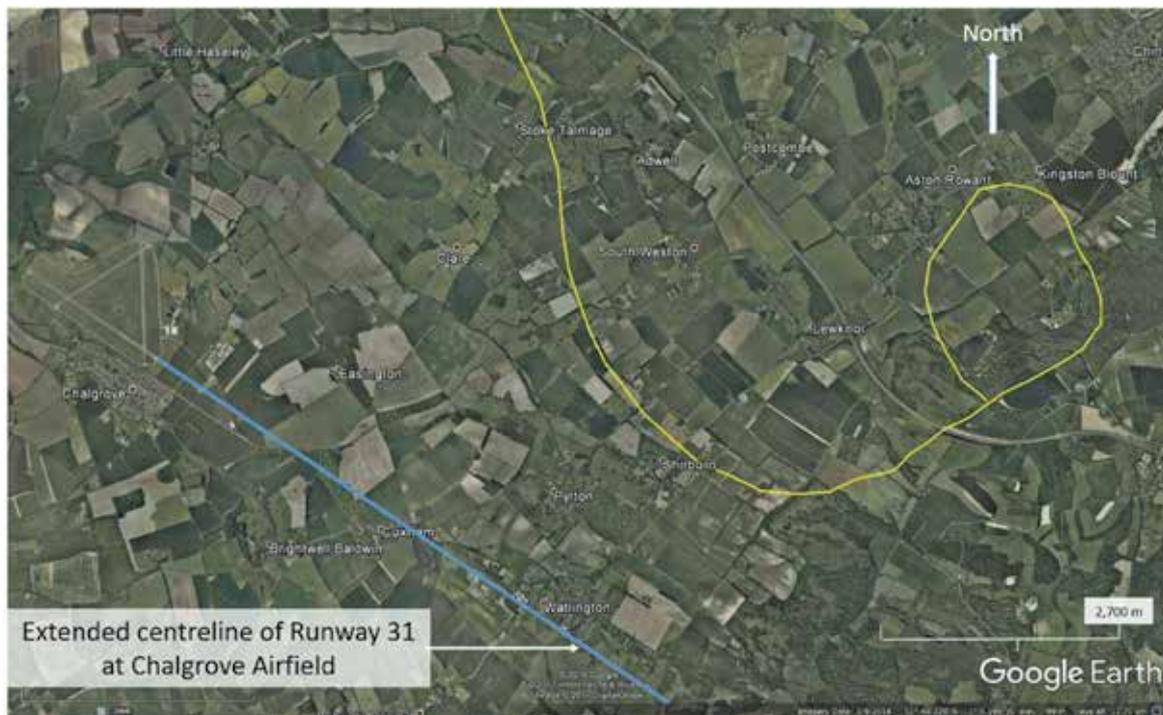
Figure 4

The aircraft's track took it to a point east of its intended destination of Chalgrove Airfield at an altitude of approximately 1,000 ft amsl. The radio was found tuned to the destination frequency, and the altimeter (which was found set to 1012 hPa) would have read approximately zero ft agl on the runway at the destination¹². Had the aircraft slowed down and turned right it would have been in a good position to join the extended centreline of Runway 31 at Chalgrove Airfield in preparation for landing. Instead, however, it turned left towards a ridge of high ground (the Chilterns) at approximately 1424 hrs (Figures 1 and 4).

G-ATMT's track relative to the extended runway centreline at Chalgrove Airfield
(©Google Earth)

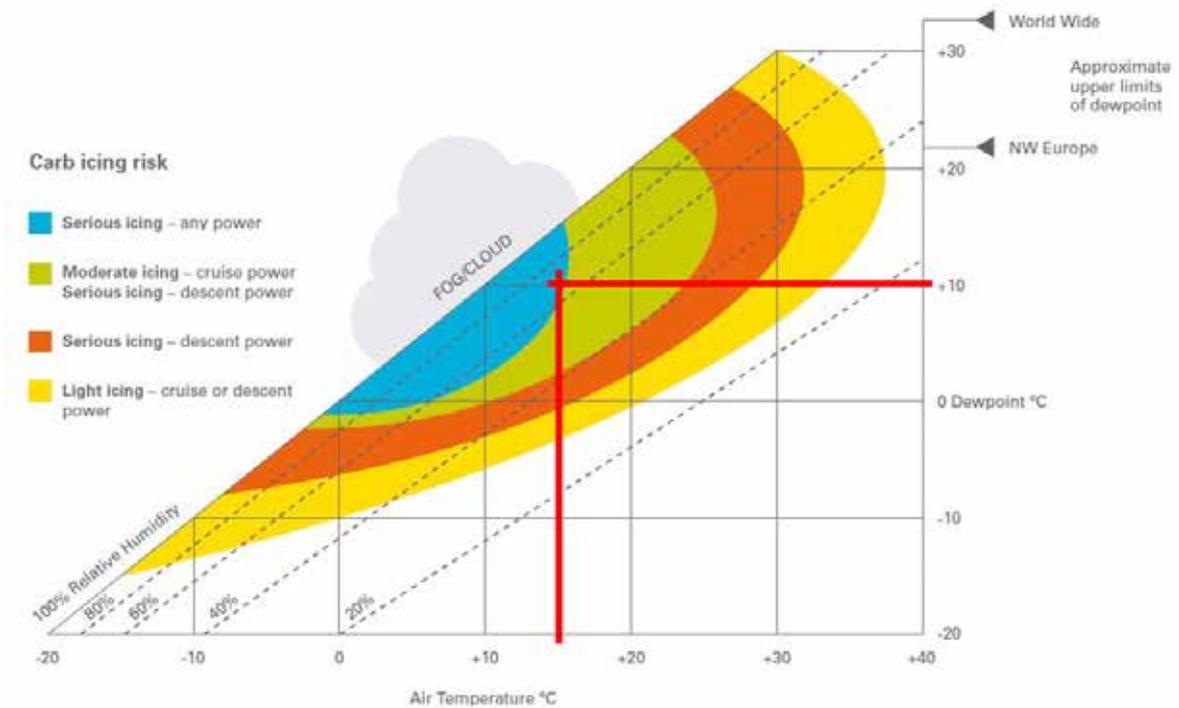
Figure 3

The weather conditions reported at the time the accident occurred were no cloud below 5,000 ft and a visibility of more than 10 km. The wind was from 120°M at 10 kt, the temperature was 15 °C and the dew point was 10 °C. The carburettor icing chart published by the CAA² indicates the possibility of a serious risk of carburettor icing at all power settings, Figure 3.

CAA carburettor icing chart
