Published 9 November 2017

CONTENTS**SPECIAL BULLETINS / INTERIM REPORTS**

S3/2017 HPH Glasflugel 304 eS	G-GSGS	10-Aug-17	3
-------------------------------	--------	-----------	---

Aircraft Type and Registration:	HPH Glasflugel 304 eS, G-GSGS	
No & Type of Engines:	1 LZ Design D.O.O FES-HPH-M100 brushless electric motor	
Year of Manufacture:	2016 (Serial no: 059-MS)	
Location:	Parham Airfield, West Sussex	
Date & Time (UTC):	10 August 2017 at 1121 hrs	
Type of Flight:	Private	
Persons on Board:	Crew - 1	Passengers - None
Injuries:	Crew - None	Passengers - N/A
Nature of Damage:	Fire damage to FES batteries and FES battery compartment	
Commander's Licence:	British Gliding Association Gliding Certificate	
Commander's Age:	55 years	
Commander's Flying Experience:	314 hours (of which 25 were on type) Last 90 days - 9 hours Last 28 days - 7 hours	
Information Source:	AAIB Field Investigation

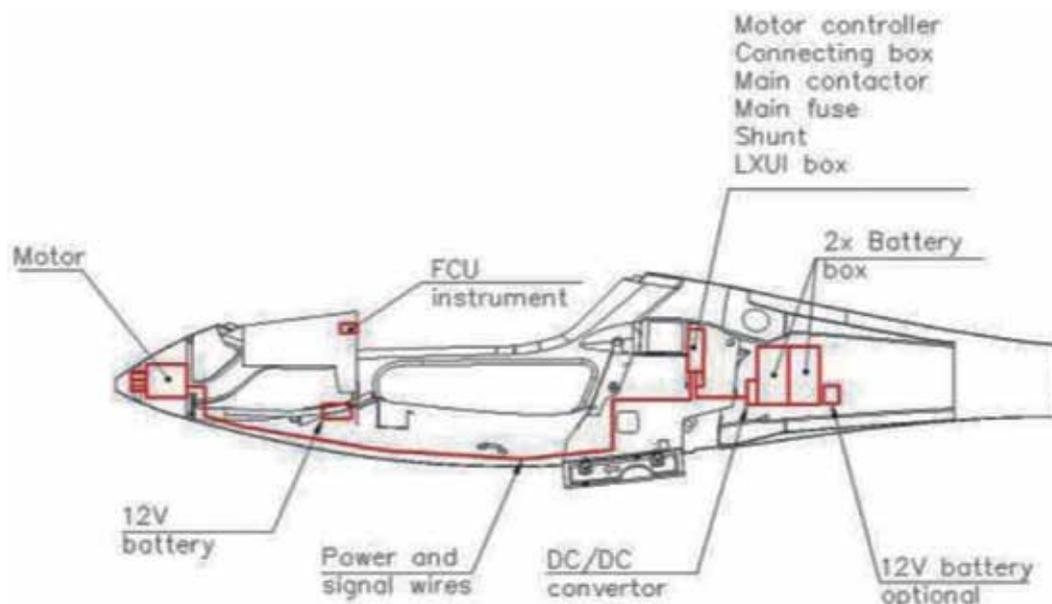
Figure 2

FES system installation in the HPH Glasflugel 304 eS powered sailplane
(courtesy HPH Spol. S.r.o.)

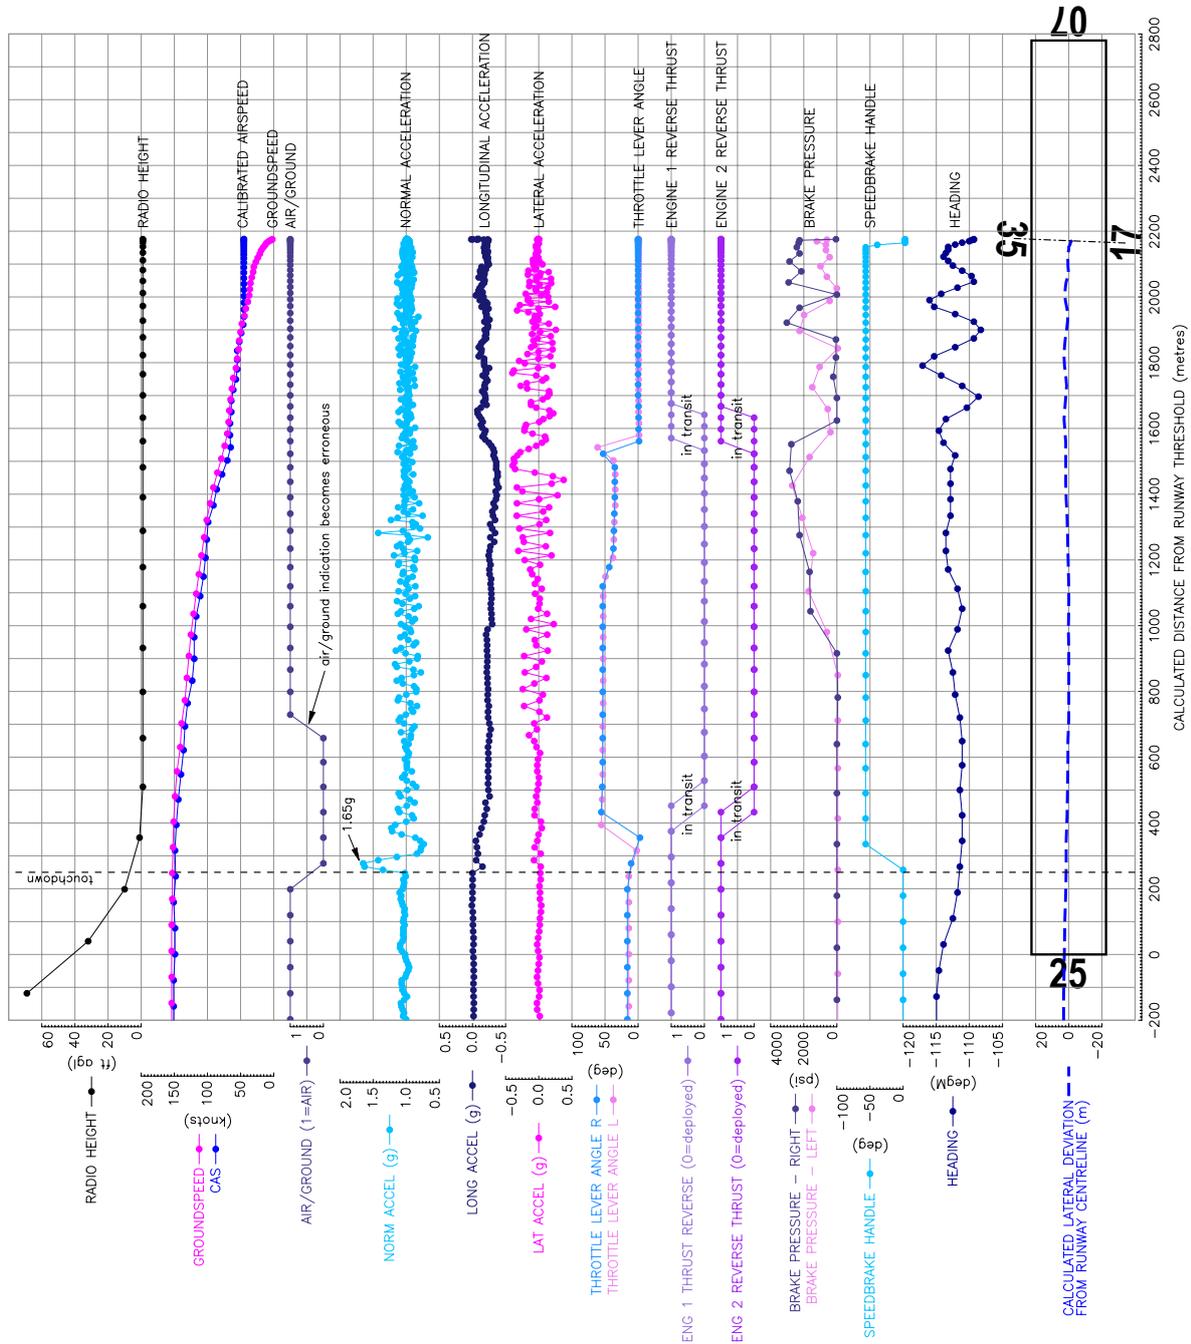
Figure 6 shows the pertinent data for OE-IAG during the landing rollout and the resulting ground track. The distance on the x-axis (CALCULATED DISTANCE FROM RUNWAY THRESHOLD) is based on an integration of the groundspeed, then working back along Runway 25 from the crossing with Runway 17/35 where the aircraft came to a stop and runway information published in the UK Integrated Aeronautical Information Package. The lateral distance of the aircraft from the runway centreline (CALCULATED LATERAL DEVIATION FROM RUNWAY CENTRELINE) is based on localiser deviation.

threshold, the air/ground discrete erroneously changed to AIR, followed by oscillations in lateral acceleration.

At 950 m beyond the threshold, the brakes were applied. They were released temporarily after about 600 m when the thrust reversers were re-stowed. The aircraft then oscillated from the runway centreline before stopping 2,170 m beyond the threshold.

Figure 6
Pertinent FDR data and ground track on landing

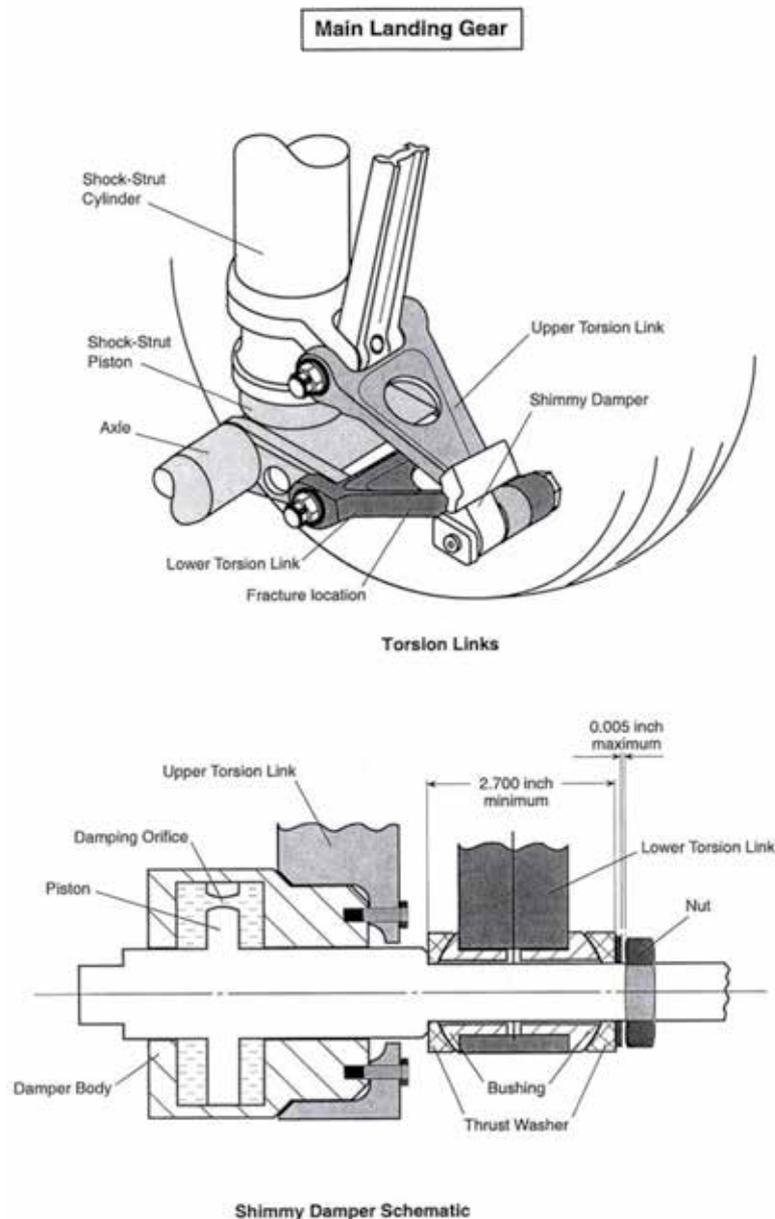
Figure 7
Schematic of MLG and shimmy damper

The Boeing 737 MLG leg consists of a cylinder/piston type shock-strut, with the outer cylinder attached to the wing structure, and the lower end of the inner piston carrying an axle with two main wheels. The axle centreline is located 9 cm behind the shock-strut centreline to provide a castoring effect.

A scissor linkage, made up of an upper and lower torsion link, is intended to prevent rotation of the inner piston relative to the outer cylinder, while allowing axial movement to provide shock absorption (Figure 7). The upper torsion link is attached to the outer cylinder via a horizontal pivot joint and the lower torsion link is similarly attached at the inner piston.

A shimmy damper is connected between the apexes of the upper and lower torsion links in order to control the rotary oscillation of the shock-strut inner piston relative to the outer cylinder and thereby prevent excessive MLG vibration (shimmy) during high-speed taxi and under heavy braking. The apex of the upper torsion link is bolted to the damper body and the apex of the lower torsion link is connected to the damper piston rod via a bearing assembly. This consists of spherical bushes sandwiched between two thrust washers and is clamped against a shoulder on the rod by an end nut. The torsion links can pivot relative to each other but horizontal displacement between their apexes is controlled by the damper action (Figure 7).

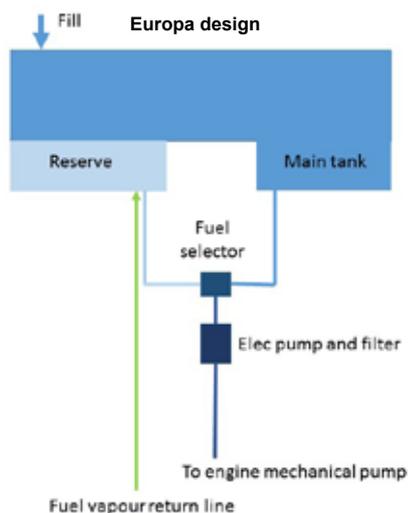
Figure 3

The fuel system on the aircraft was found to be in good condition and its installation was similar to the manufacturer's recommended design configuration but with some notable differences (Figures 3 and 4).

Fuel system schematic based on Europa build manual

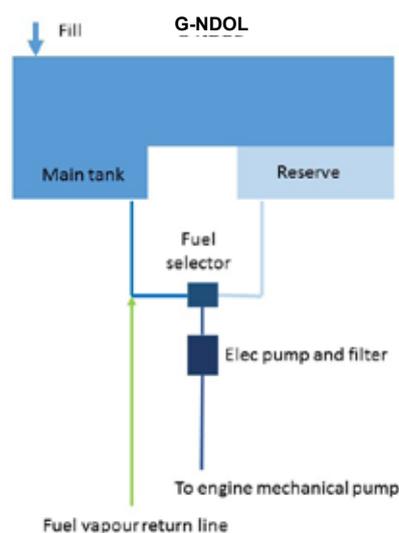
Figure 4

G-NDOL fuel system schematic

No coarse fuel filters were found on the tank outlet fittings.

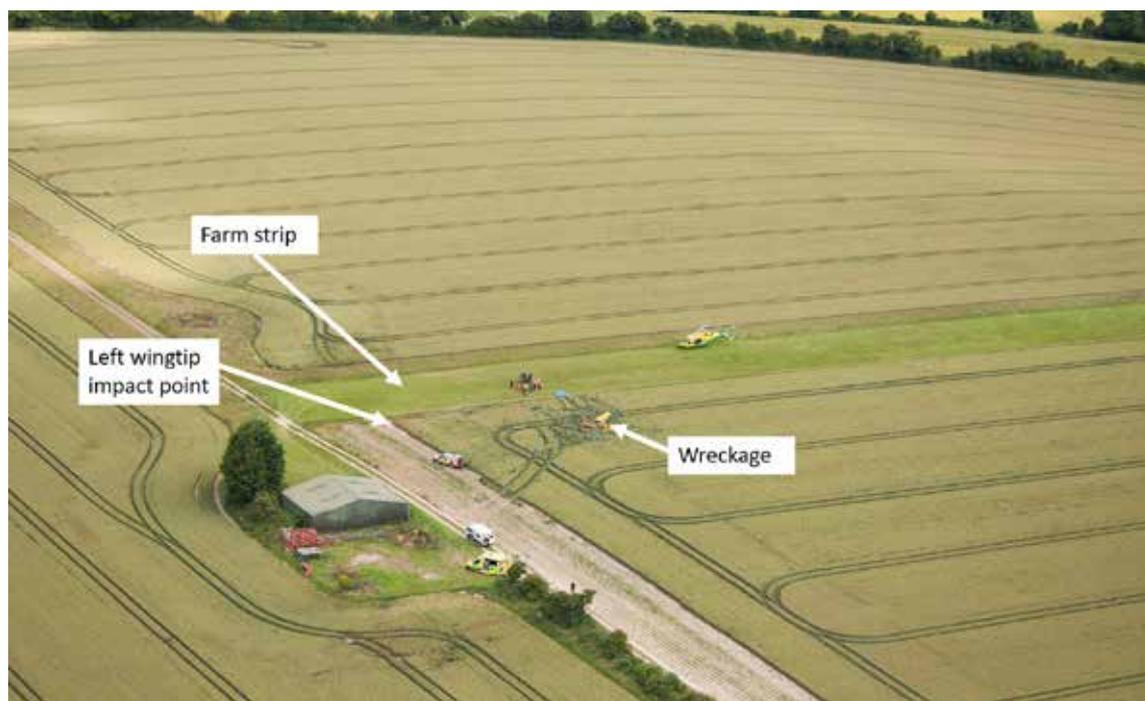
Figure 3

The aircraft wreckage was located in a wheat field on the southern edge of a private farm strip, 1 nm north of Dinton, at an elevation of 436 ft amsl (Figure 3). The private strip was not shown on any aeronautical chart or in any airfield guide and, according to its owner, was not easily visible from the air. The strip was 473 m long, 20 m wide and orientated in the direction 080°(M).

Aerial view of accident site (looking north) and private farm strip
(Photograph courtesy QinetiQ)

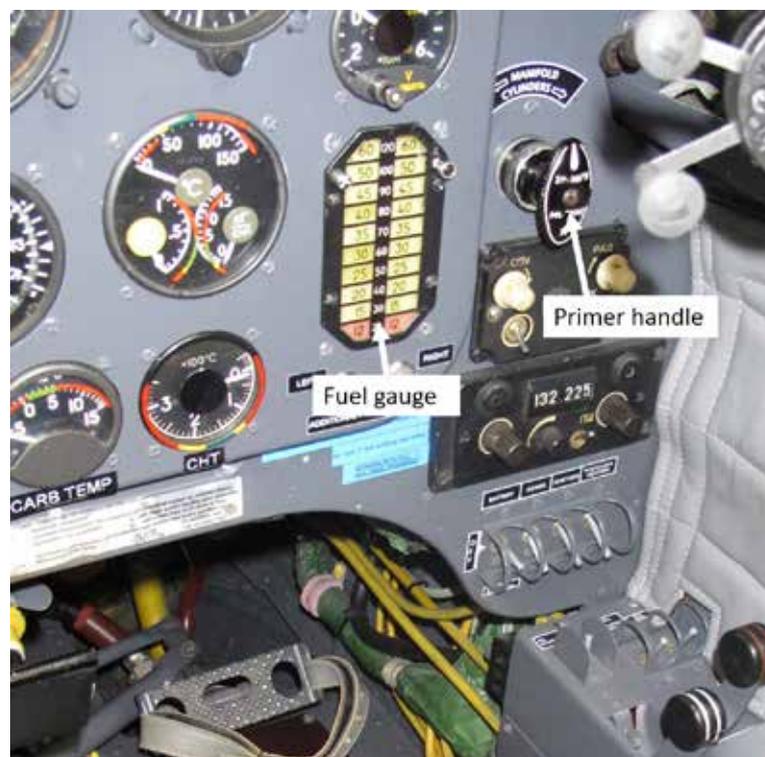
Figure 8

Front cockpit controls (right side) from a different Yak-52

The light bulbs inside the fuel gauge (Figure 8) were also examined and three of the bulbs were found to be stretched. These were for the left tank quantities 40 and 45, and for the right tank quantity 40. During transition from one indicated level to the next, the two quantities can be flickering on and off. This indicated that the left fuel tank quantity was probably between 40 and 45 litres and the right fuel tank quantity was probably about 40 litres.

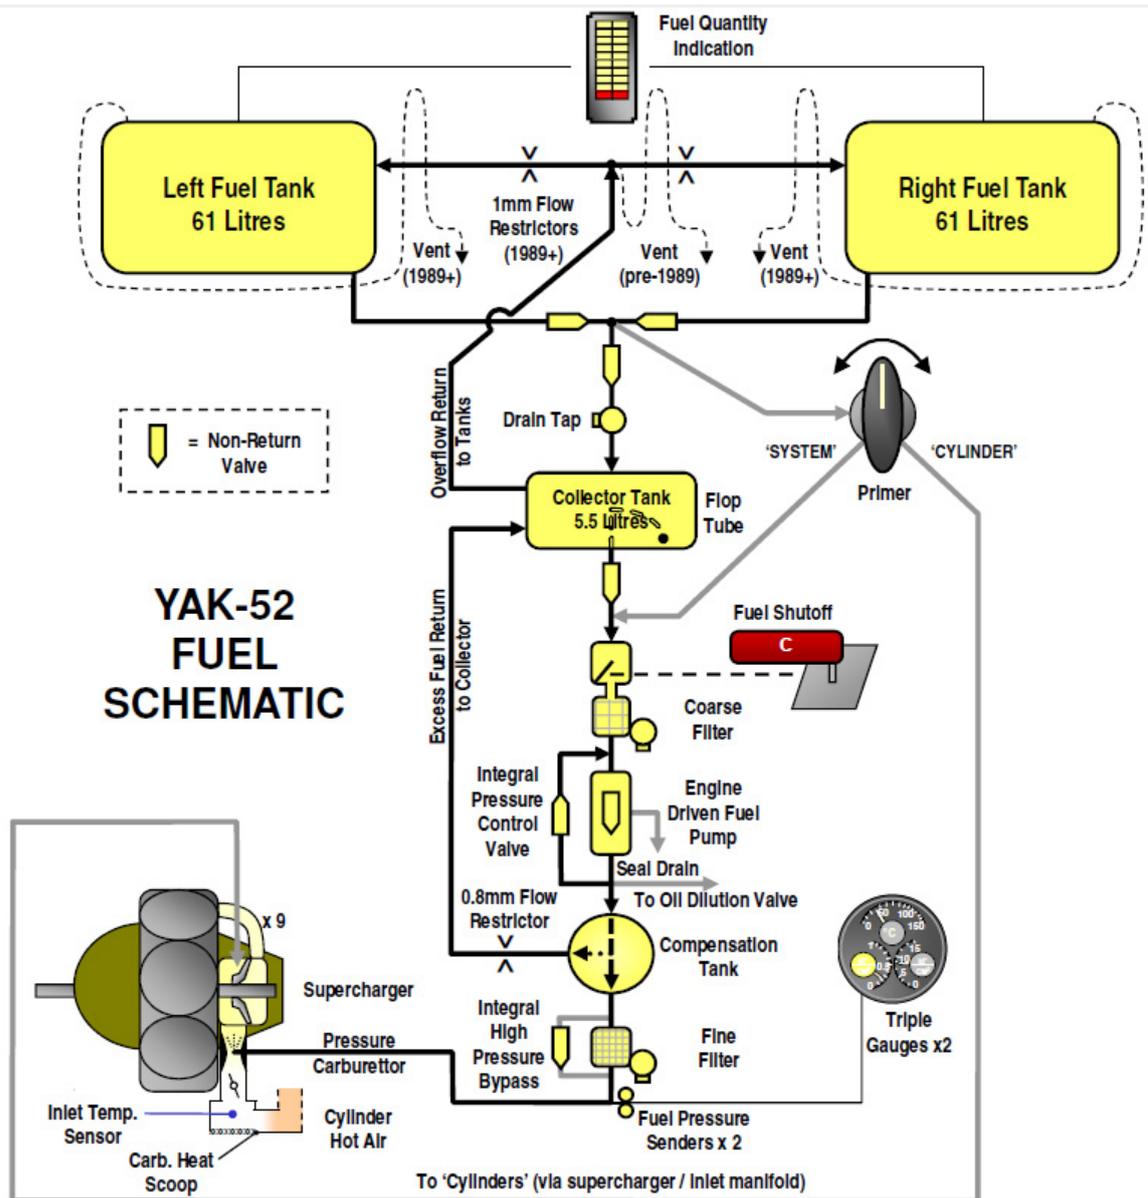
Figure 9

The fuel system includes two wing tanks, each of 61 litres capacity, which gravity-feed a 5.5 litre collector tank in the lower centre section of the aircraft (Figure 9). The engine-driven fuel pump draws its fuel supply from the collector tank which provides a short-term supply of fuel for inverted flight (up to 2 minutes is permitted). There is no left/right fuel tank selector, so both tanks feed the collector tank continuously via non-return ('flapper') valves. The first pair of non-return valves prevent fuel from passing from one tank to the other. The third non-return valve prevents fuel from flowing from the collector tank back to the main tanks. A rubber flop-tube inside the collector tank is connected to the fuel outlet. The flop-tube is weighted at its end so that it rests at the bottom of the tank during normal flight and rests at the top of the tank during inverted or negative-g flight; this ensures that the outlet can always draw the fuel in the tank.

pushed in, the plunger in the handle draws fuel from a position upstream of the collector tank, as shown in Figure 9, and pumps it into a position between the collector tank and fuel shutoff valve. This primes the fuel lines, fuel pump and carburettor for engine start. When the primer handle is turned to the right 'Cylinder' position and pumped, fuel is drawn from the same location but is pumped into the supercharger compressor. This provides some vapourised fuel ready to be drawn into the cylinders as soon as the engine is turned over.

Yak-52 fuel system diagram (© Robert A. Rowe)

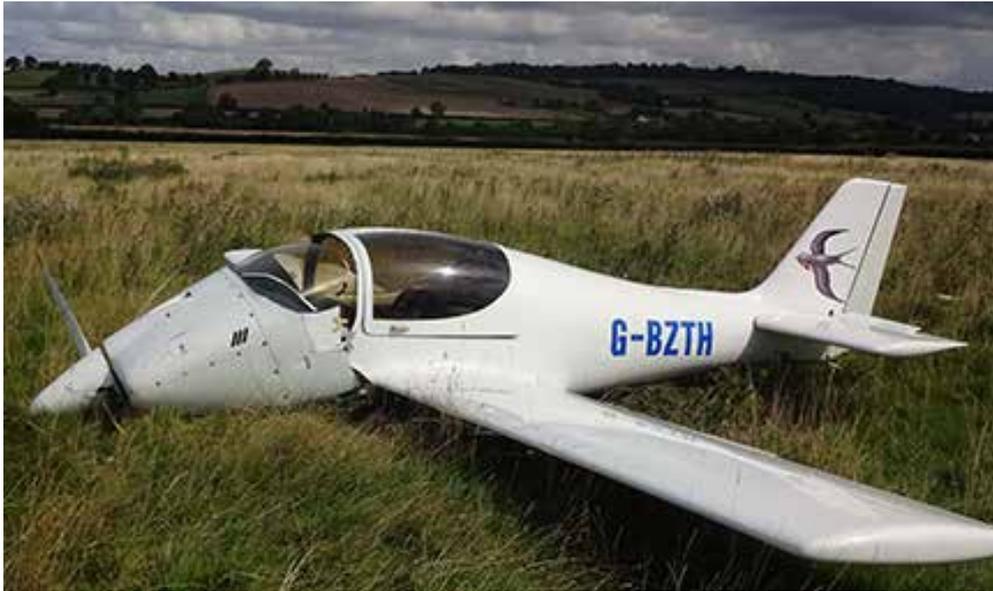
Figure 1

After running along the ground a short distance, the aircraft decelerated violently and came to a halt. The pilot exited through his door and then noticed there were ground ridges which were not visible from the air. He had landed across the ridges and it was one of these that caused the deceleration and the damage to the aircraft (Figure 1).

Following recovery of the aircraft, the pilot discovered that the oil drain plug for the engine was missing and the engine had seized due to lack of lubrication.

The engine and forward fuselage of G-BZTH seen resting on a ridge with the rear fuselage in a broad furrow

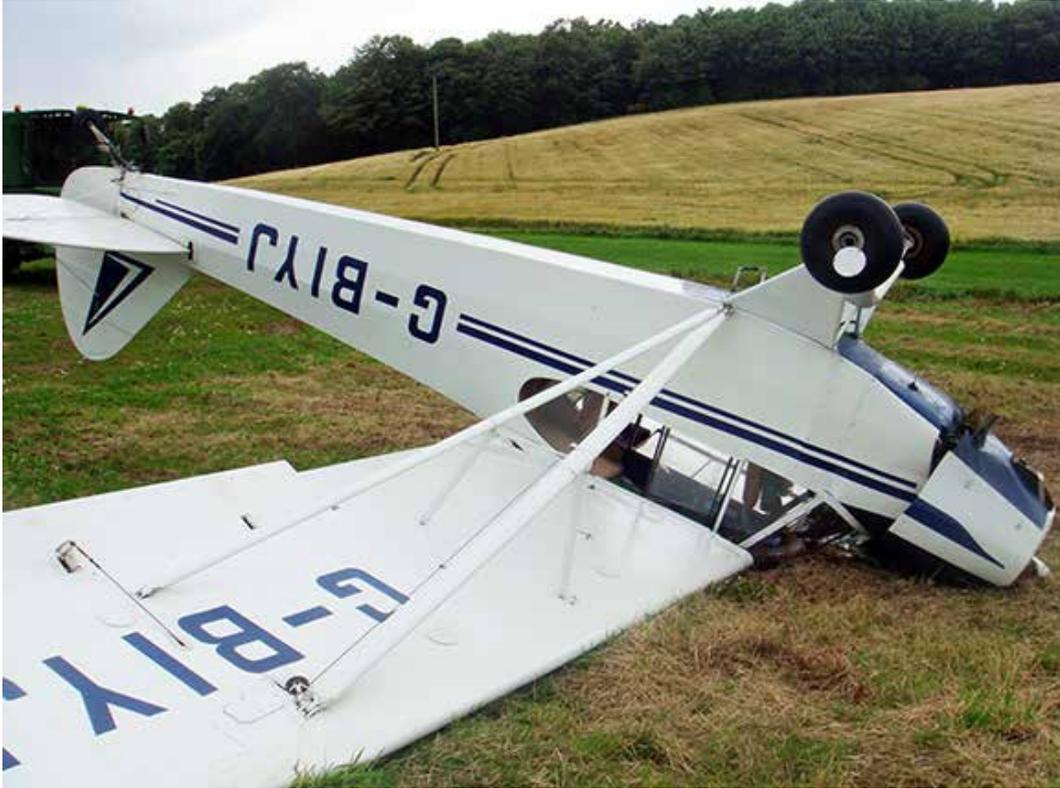
Figure 1

After being flipped upside down (Figure 1), the aircraft came to rest with the engine stopped and the pilot was able to turn off the electrics, undo his seat belt and escape through the door onto the upturned right wing. His assessment was that a sudden gust of wind caused the aircraft to swing right. He later discovered that, just before the accident occurred, a person spraying nearby crops experienced squally conditions which caused them to suspend their work.

The airstrip can be seen above the upturned fuselage and the farm vehicle is partly visible behind the tail of G-BIJJ

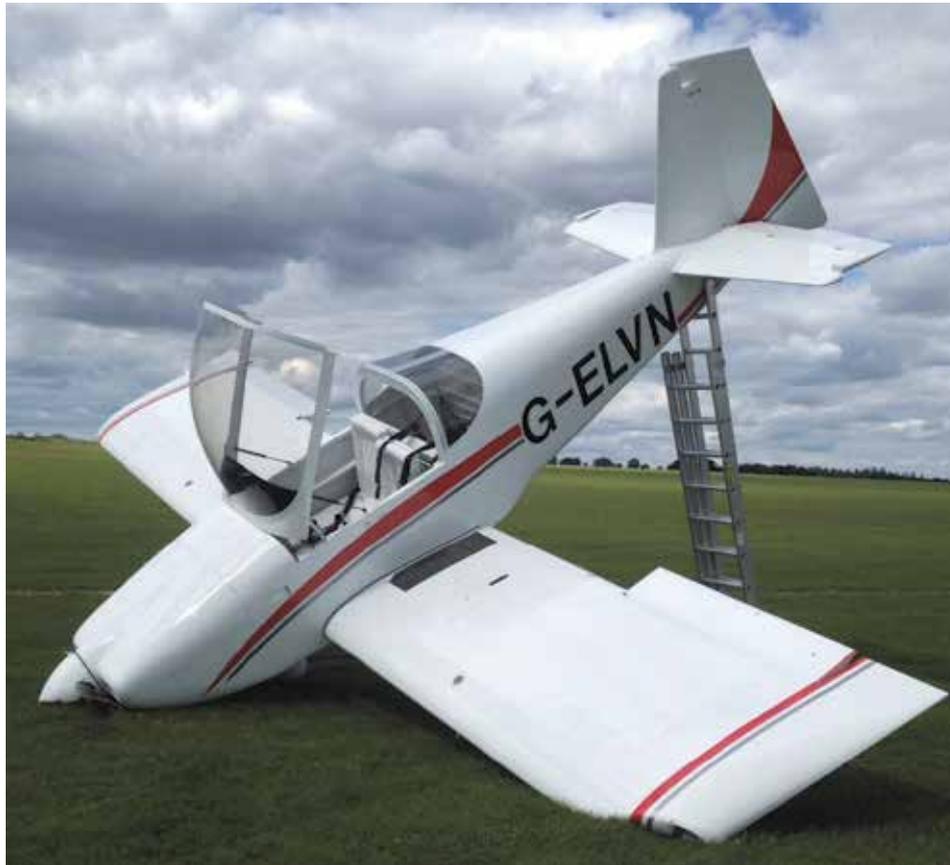
Figure 1

touchdown and that the grass of the landing surface was too featureless to assist his precise judgement of the aircraft's height.

The pilot stated that his successful landing earlier that day was made a few metres from the centreline and that he used the visual aspect of the centreline markings to ascertain his height.

G-ELVN after the accident,
with runway centreline markings visible to the aircraft's right

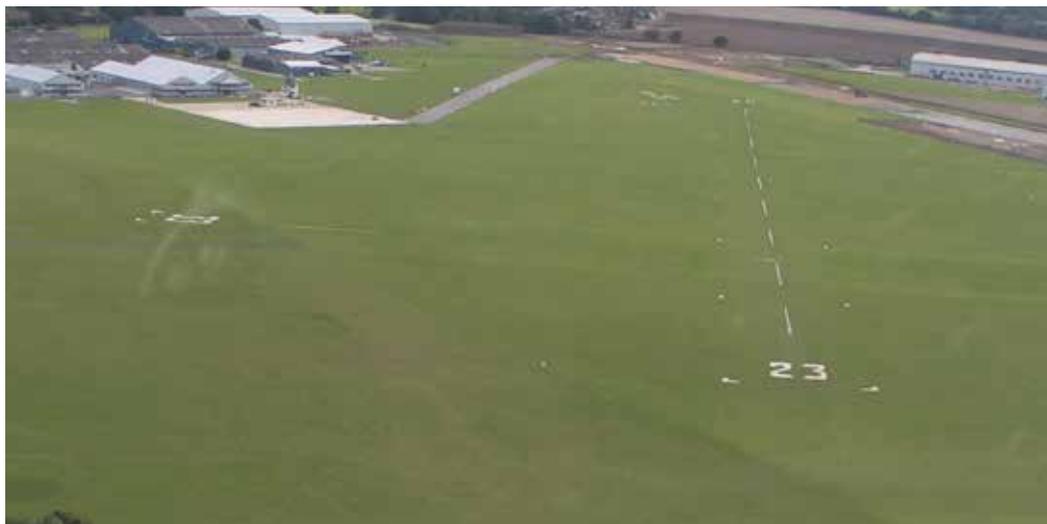
Figure 3

The aerodrome authority stated that the markings on Runway 23 accord with the CAA's '*Licensing of Aerodromes*' publication¹ and were re-chalked less than four months before the accident. A photograph taken after the aircraft was moved shows two ground marks made by the nose landing gear, with the gap between (Figure 2) which suggests that the aircraft landed heavily on the nose gear and then bounced. A historic photograph of the aerodrome (Figure 3), illustrates the markings on Runway 23 from the air.

Aerial photograph of Sywell Aerodrome, dated 2008, showing the Runway 23 markings
(Photograph courtesy of Mr Jeff Bell)
