Air Accidents Investigation Branch
Farnborough House
Berkshire Copse Road
Aldershot
Hants GU11 2HH

This bulletin contains facts which have been determined up to the time of compilation.

Published 14 December 2017

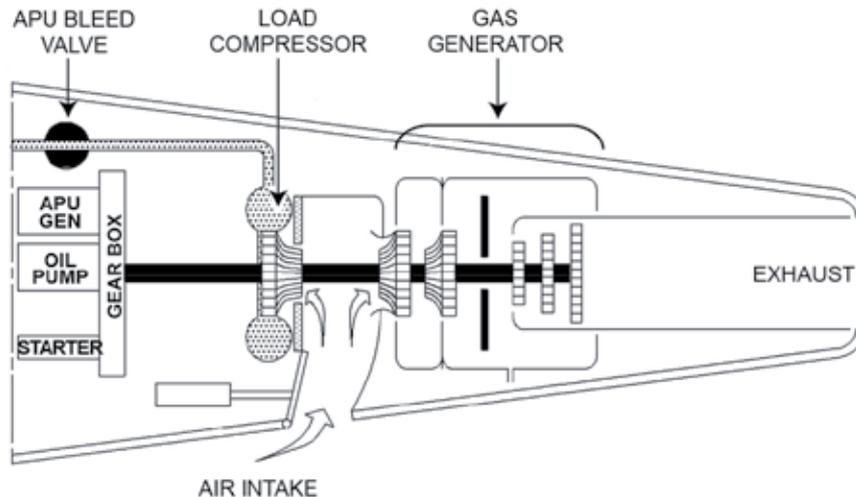
Figure 3

The source of the smoke was traced to a failure of the Auxiliary Power Unit (APU) load compressor carbon seal that allowed hot oil to enter and pyrolyse in the bleed air supply.

Metallic debris in the shared oil system compromised the load compressor bearing, leading to the failure of the load compressor carbon seal.

Schematic diagram of APU

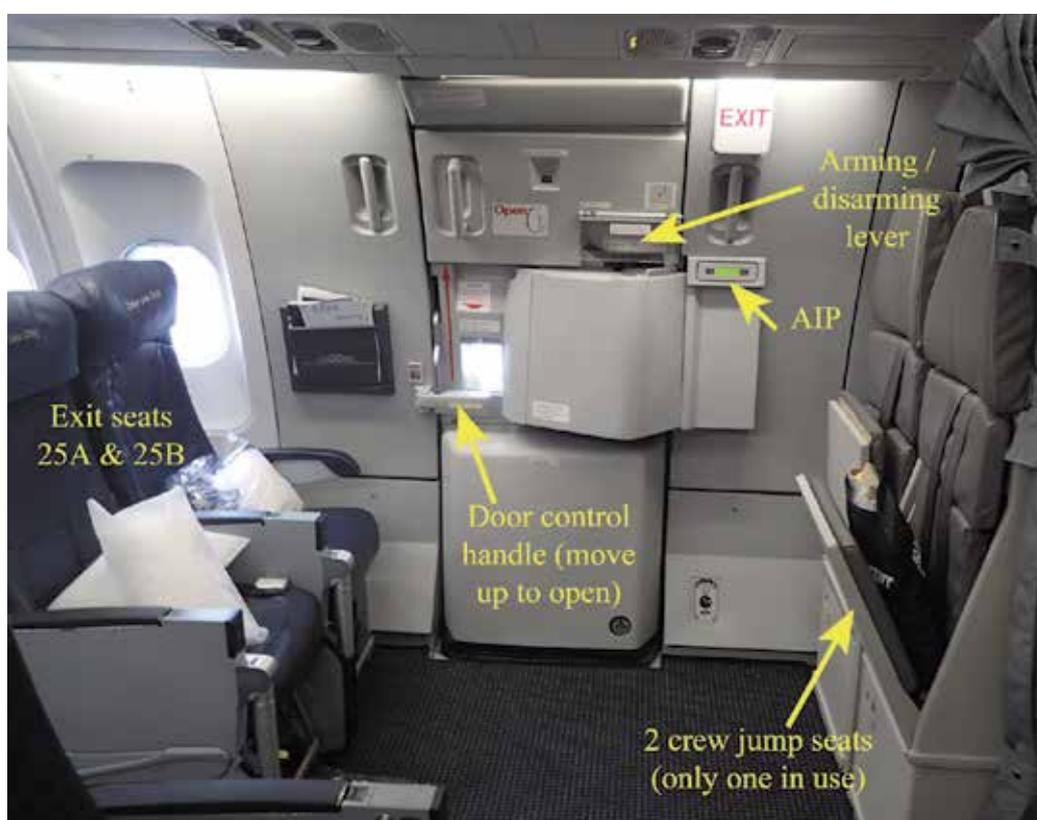
There were four seats on this A330-323 designated as exit seats, as defined in FAR 121.585; seats 25A and B adjacent to exit 3L, and seats 25G and H adjacent to exit 3R. Figure 5 shows exit 3L and adjacent seats. For a fully laden aircraft the door sill height is a minimum of 5.2 metre above ground level at exits 3L and 3R.

Photograph of Exit 3L and surrounds; the Attendant Indication Panel (AIP) is described in *Crew stations*

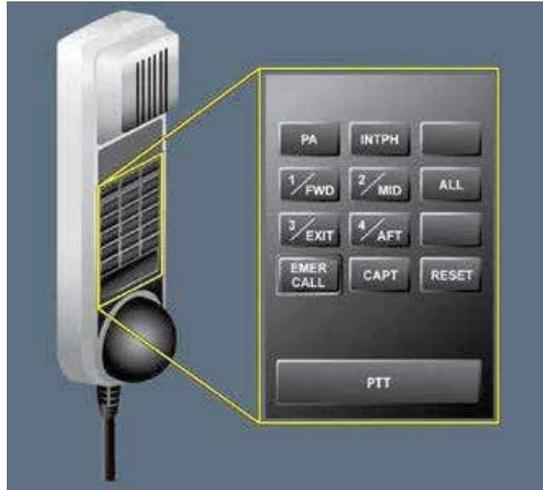
Figure 7

There is no common standard concerning the keypad layout on interphone handsets for passenger aircraft, therefore neither the equipment manufacturer nor the aircraft operator have any obligation to consider keypad standardisation between aircraft types. On the Airbus A330-300 each FA station has an interphone handset with a number of buttons (Figure 7). When a handset is lifted from its base station and the button marked CAPT is pressed, a single long buzzer¹¹ sounds through the flight deck loudspeakers and small push buttons, marked ATT, flash amber on the pilots' Audio Control Panels (ACPs). When a pilot responds by depressing his ATT push button, the interphone system connects to the calling station and the light in the push button changes to green. If no pilot responds to the call within 60 seconds, the lights in the ATT push buttons extinguish. Replacing the handset in its cradle or pressing the reset button returns the handset to its original status.

Interphone communication handset showing keypad

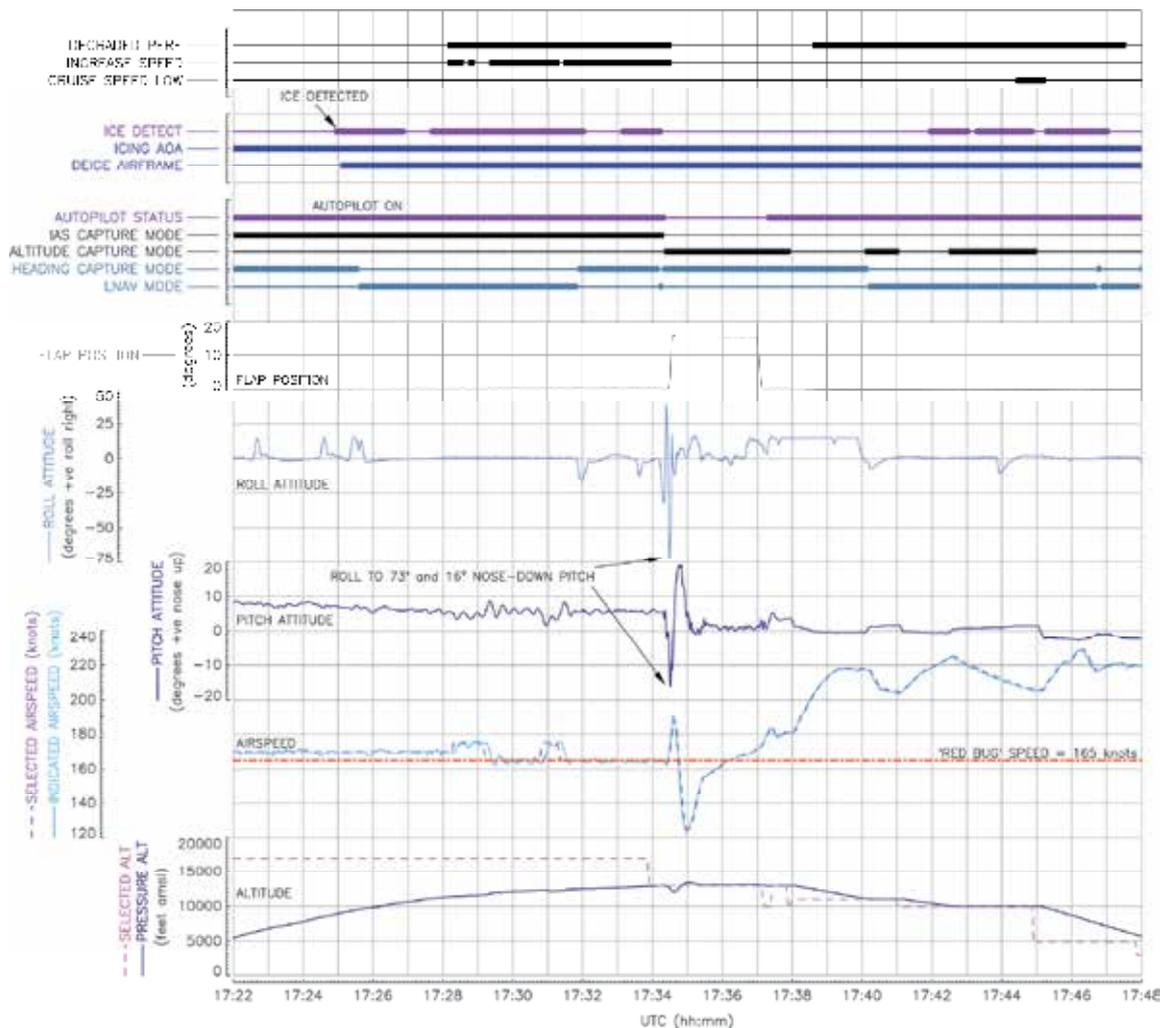
Figure 1

Recorded data⁶ showed that at the point of the upset the aircraft initially rolled left to 32° the autopilot disengaged, before rolling right to 38°. It then rolled left again, reaching attitudes of 73° in roll and 16° nose-down in pitch.

Salient data from the FDR and DAR

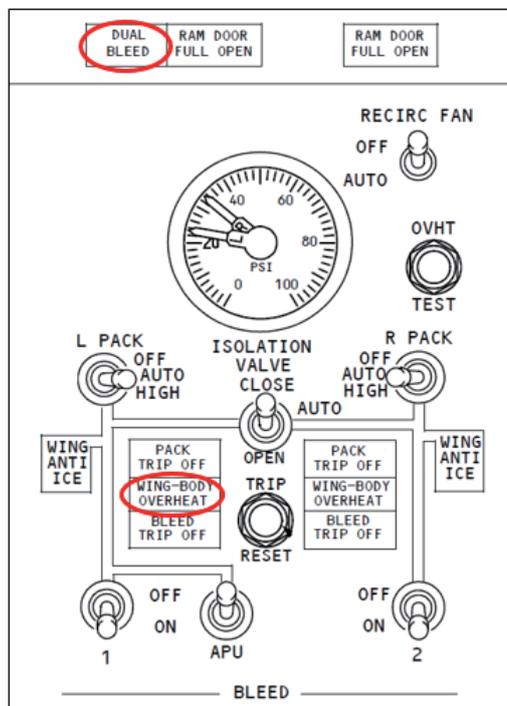
Figure 2

Boeing 737-300 air conditioning control panel, showing positions of the DUAL BLEED and left WING-BODY OVERHEAT captions

Once this has been completed, the APU bleed air switch should be set to ON; this causes the DUAL BLEED warning light to illuminate on the air conditioning overhead panel, accompanied by illumination of the cockpit glareshield MASTER CAUTION warning lights and AIR COND annunciator light, Figure 2. This is a normal part of the pre-flight procedure, as the APU bleed air valve is open at the same time as the left engine bleed air valve, allowing possible back-pressure of the APU if the left engine is operated above idle power whilst the bleed air valves are in this configuration, Figure 3.

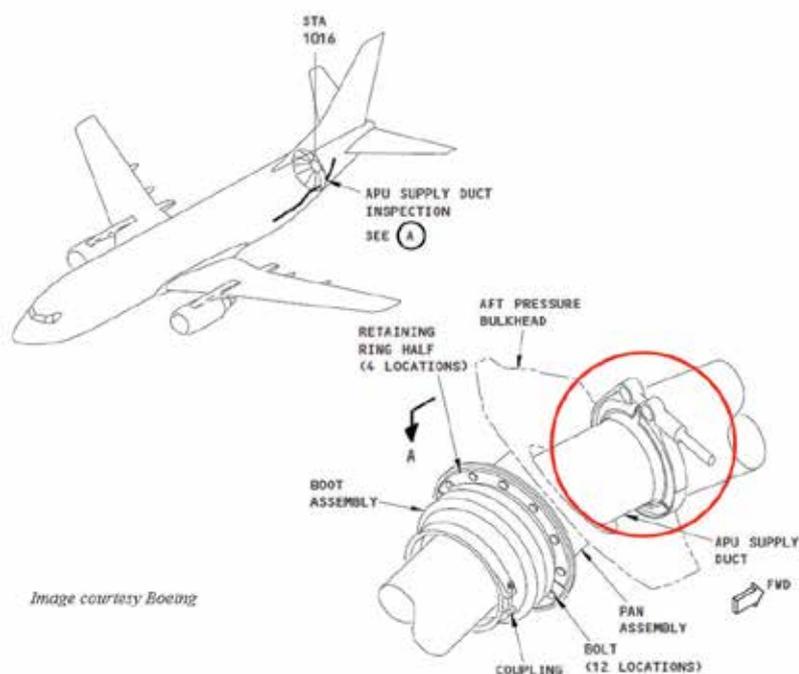
Figure 4

Investigation by the operator's engineering personnel revealed that a V-band clamp⁴ had separated from a joint on the APU bleed air duct in the rear equipment bay, immediately forward of the aft pressure bulkhead, beneath the main deck cargo floor in the vicinity of fuselage station (STA) 1016, Figure 4.

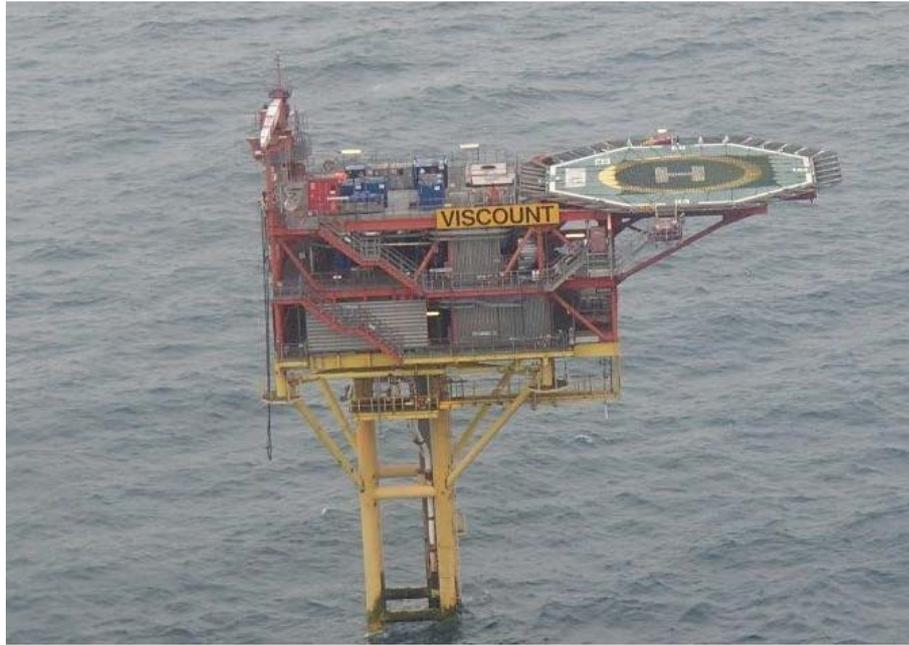
Figure 1

After completing their landing checks the crew confirmed the name painted on the platform was '*VISCOUNT*' and then landed normally (Figure 1). Once on the helideck they realised there were no passengers for them and consequently they discovered they should have flown to the Vampire platform. They subsequently lifted from Viscount flew to Vampire and then completed the remainder of their task without further incident.

The Normally Unmanned Installation (NUI) known as Viscount

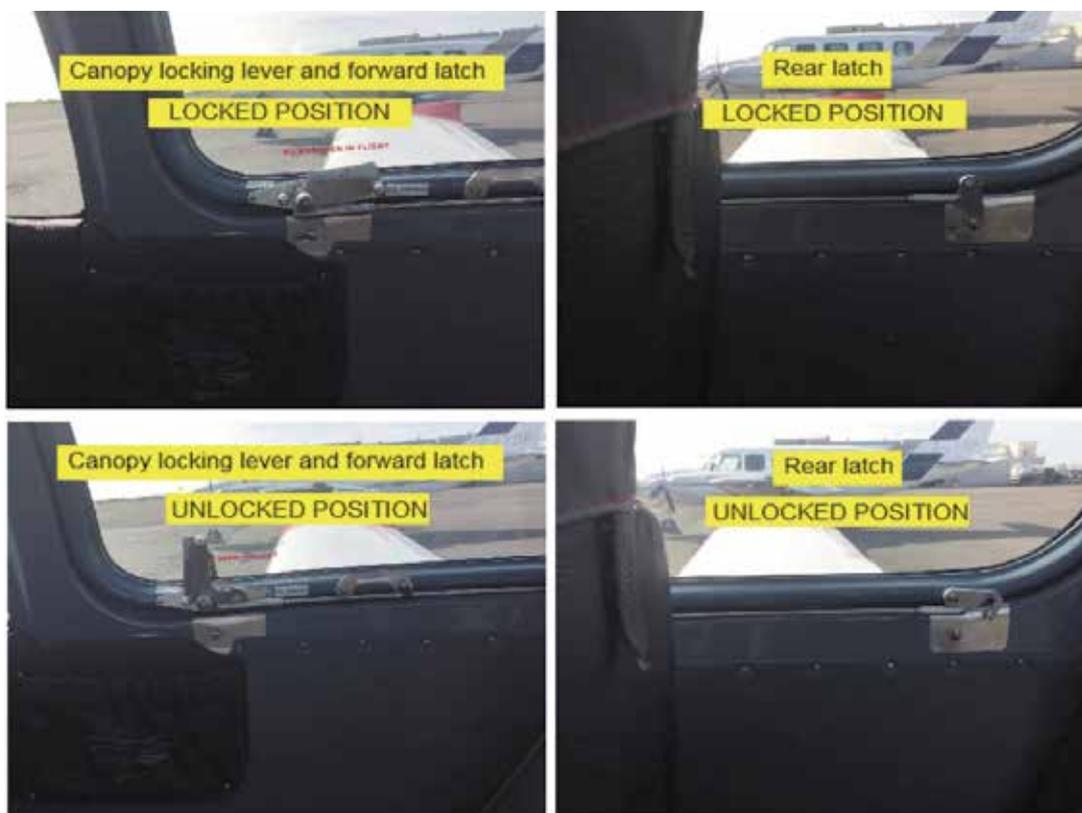
Figure 1

The Sling 4 is fitted with two canopy doors, one on the left and one on the right side of the cockpit that open in a 'gullwing' design. Each canopy door is attached to the top of the fuselage by two hinges and secured by a single over-centre lever that moves two latches, one adjacent to the lever assembly and one at the rear of the canopy via a pull-push rod (Figure 1). The levers are located forward of the pilot and passenger seats (Figure 2).

Passenger canopy locking lever and latches

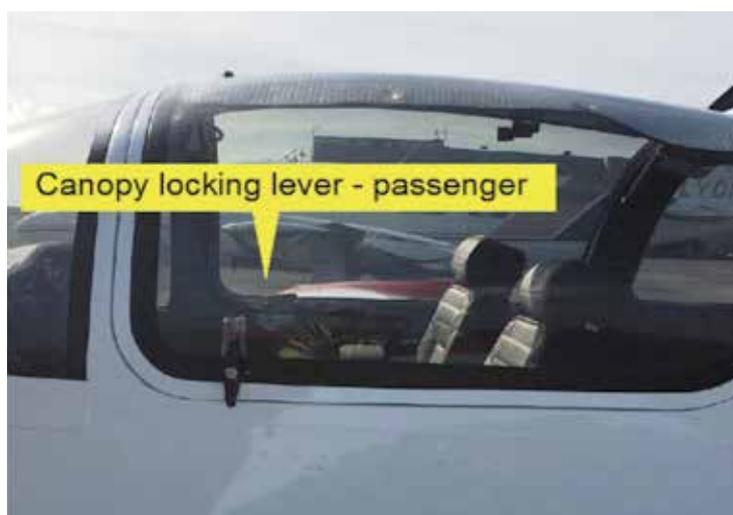
Figure 2

Passenger canopy locking lever position
