AAIB Bulletin

1/2018

Published 11 January 2018

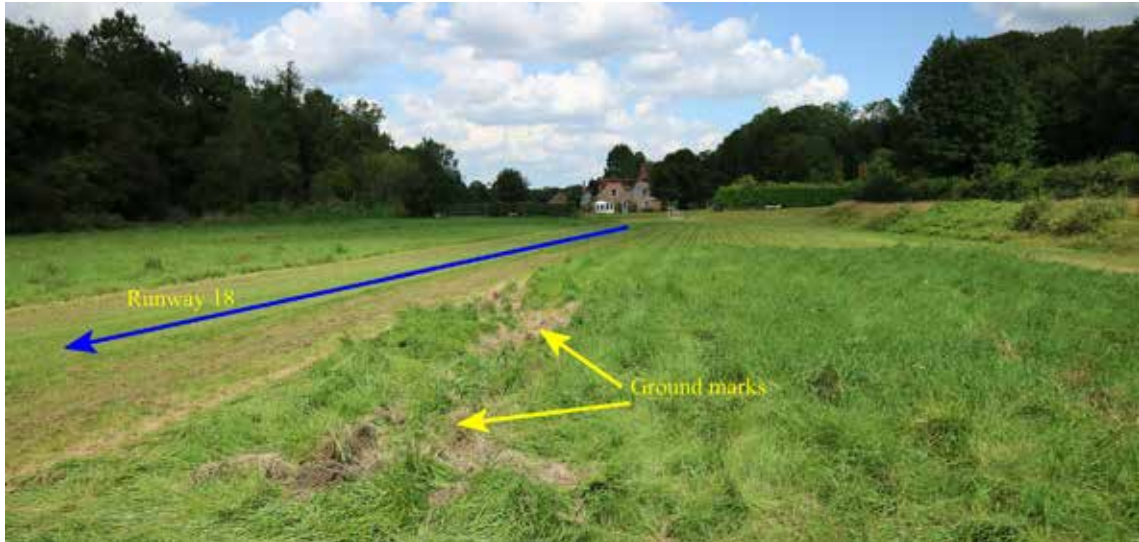
Figure 1

A northerly view of Runway 18.
Note the trees and buildings to the north of the airstrip, on the approach to Runway 18

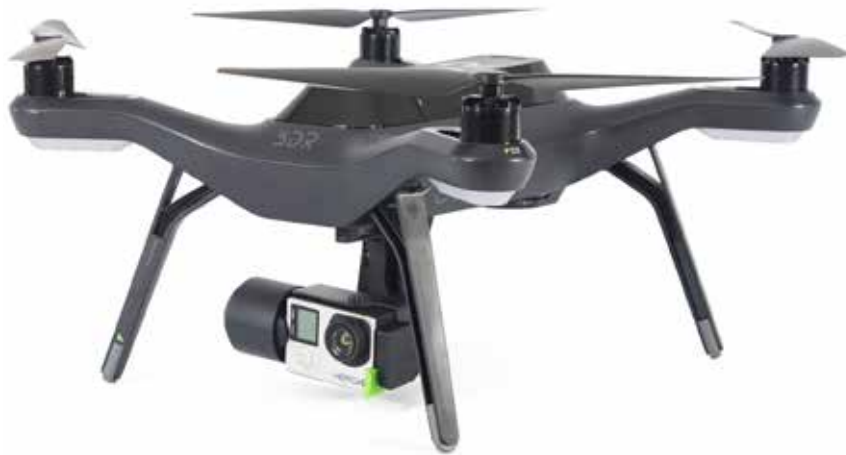
Figure 1

3DR Solo UAS with Go Pro Hero 4 camera

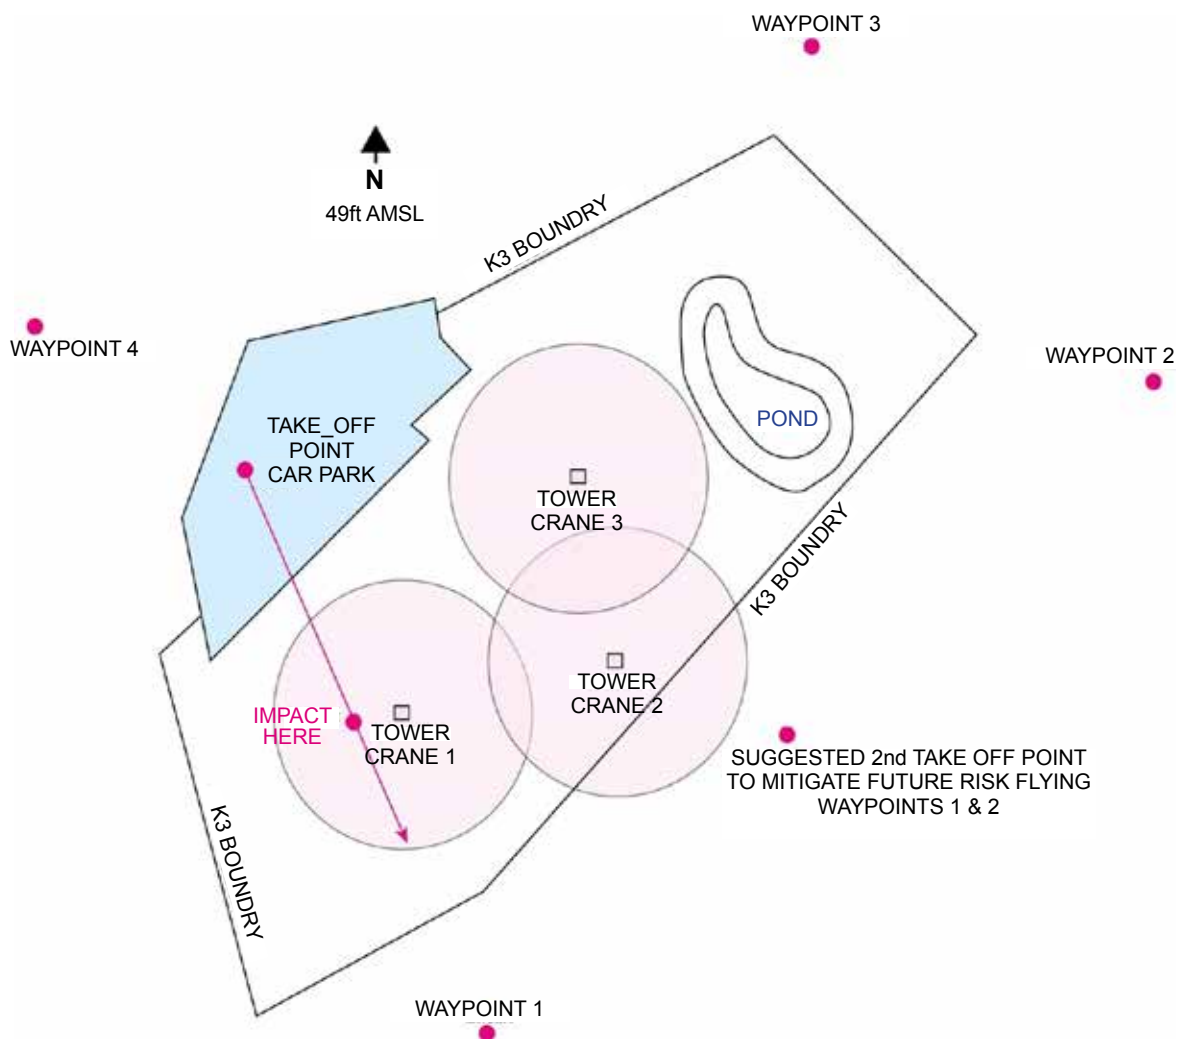
Figure 2

The pilot had flown the UA previously at the construction site using a pre-programmed mission profile with four waypoints. All waypoints were programmed to be flown at 400 ft agl, which was above the height of the three cranes at the site. The UA took off from a car park on the north side of the site and started climbing to its first waypoint at the south-western tip of the site (Figure 2). Before it reached 400 ft agl it collided with the jib of a crane. The crane had not been at the site during the previous flight, and from where the pilot was situated in the car park it was difficult for him or his observer to tell that it was about to strike the crane because of a lack of perspective. The UA fell to the ground and was damaged but there was no damage to the construction site.

The planned route and location of the collision

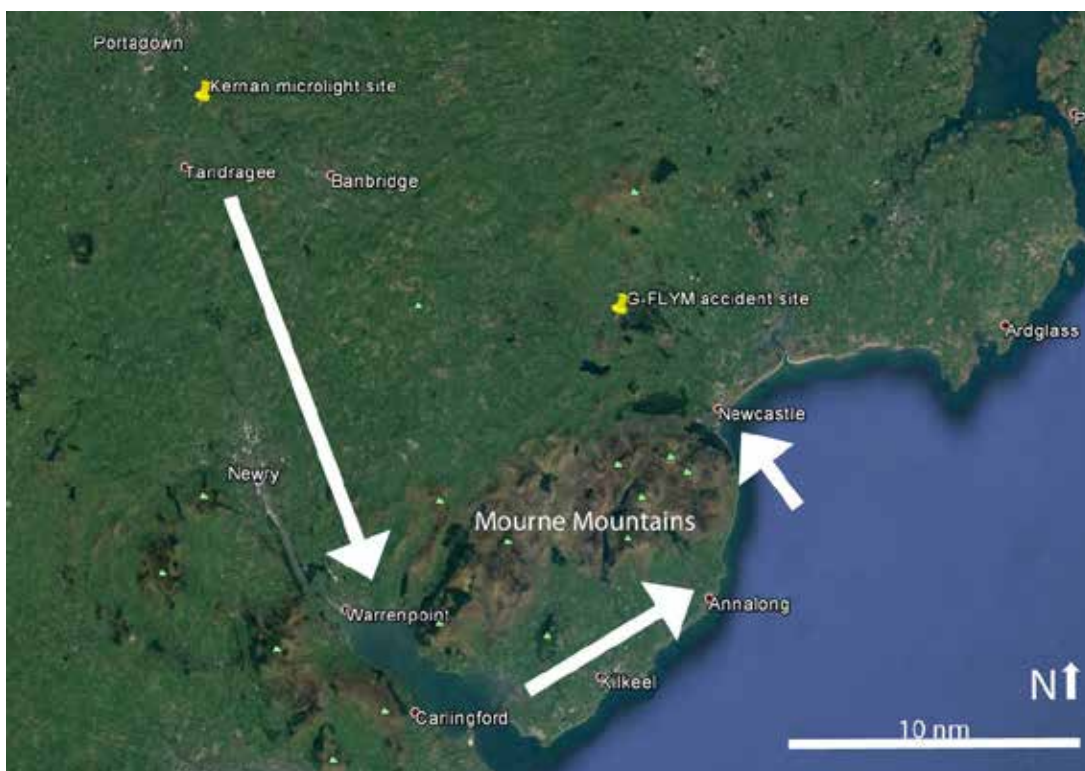
Figure 1

Approximate route flown from Kernan microlight site to the accident site
(underlying image © Google Earth)

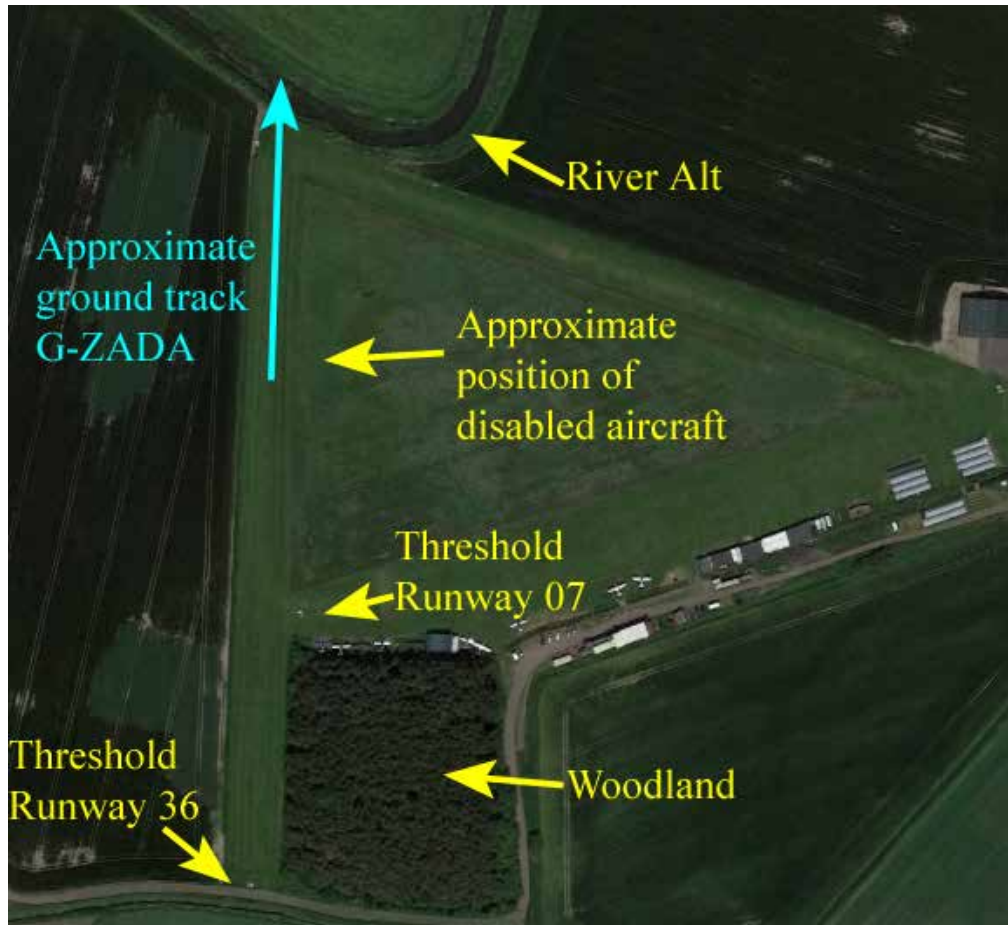
Figure 2

The pilot of the lead aircraft provided a GPS-derived plot of his aircraft's flight which indicated that it stopped approximately two-thirds of the way along Runway 36 (Figure 2) and this correlated with his recollection, as well as that of other witnesses. He did not see G-ZADA land but, after helping to push the disabled aircraft clear of the runway, his passenger glanced back and saw G-ZADA touchdown approximately in line with his own position and then lost sight of it.

Ince Airfield; Runway 36 and aircraft's approximate ground track after touchdown
 ©2017Google, Image © DigitalGlobe
