Rail Accident Report

Runaway of a maintenance train near Markinch, Fife 17 October 2017

Report 01/2018
January 2018

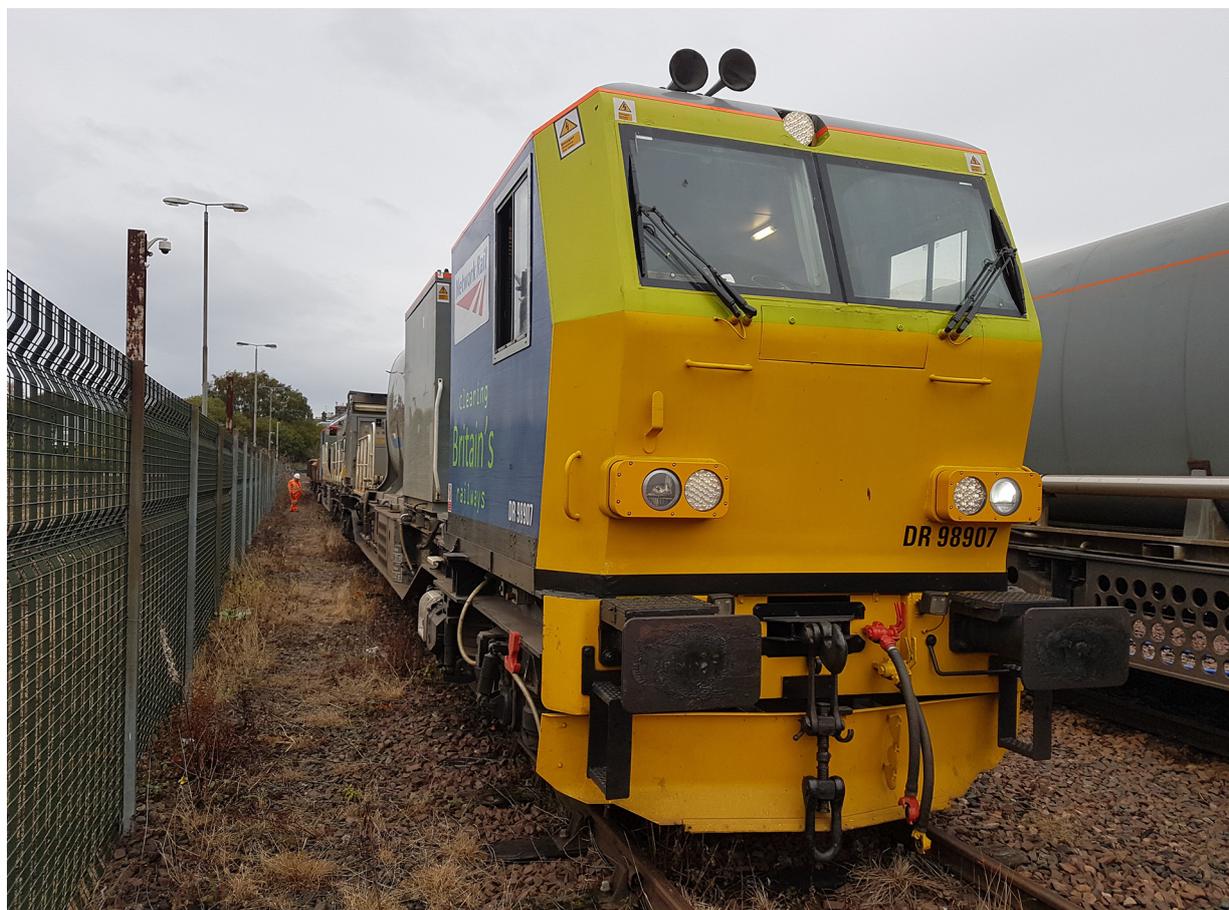
Figure 2: The Multi-Purpose Vehicle involved (photographed at Slateford depot)

- 6 The train was a *Multi-Purpose Vehicle* (MPV) that was carrying out *Rail Head Treatment Train* (RHTT) duties. It consisted of slave vehicle DR98957, which was leading at the time, and master vehicle DR98907. This type of MPV entered service between 1999 and 2001 and consists of two flat-decked vehicles coupled together, each of which has a driving cab at the outer end (figure 2). The master vehicle is powered in each MPV, while the slave is unpowered.
- 7 The MPVs can be fitted with a variety of modules to undertake different duties, such as weed spraying and de-icing. At the time of the accident, the MPV was fitted with water jetting and *adhesion modifier* spreading equipment. This is intended to clear leaf debris from the tracks and to improve the friction between train wheels and the rails.

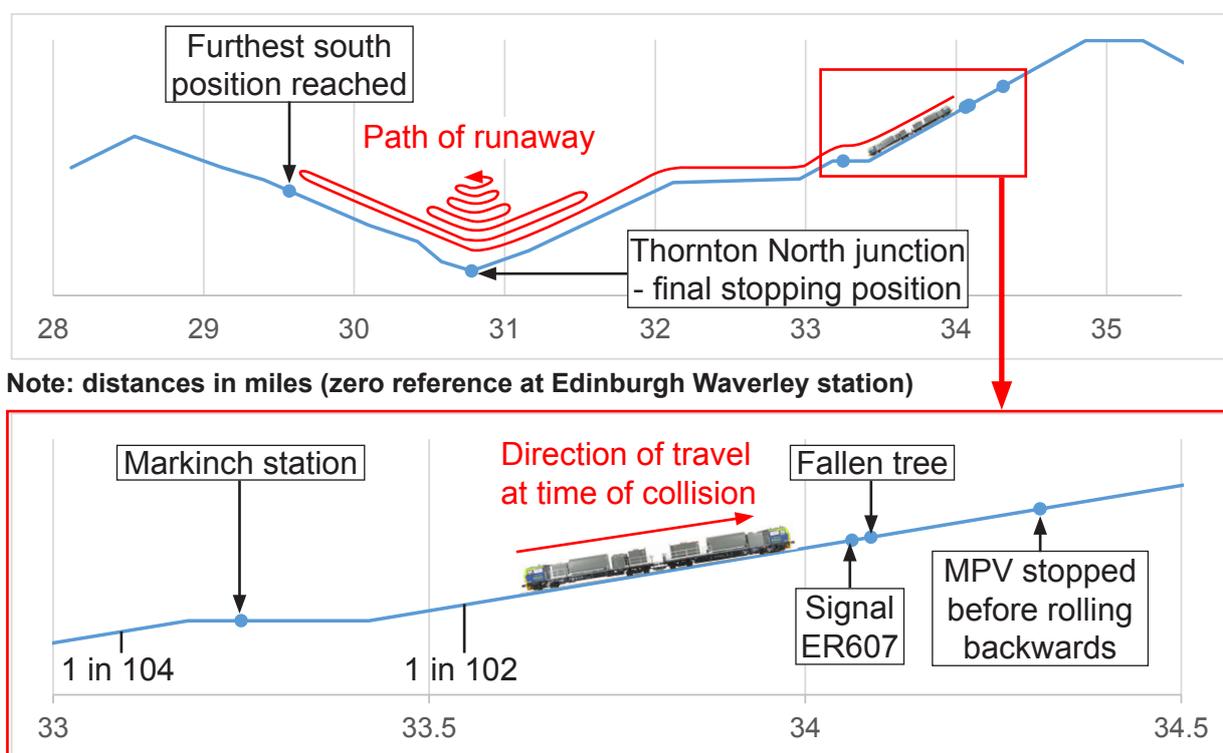
Figure 3: Diagram showing approximate locations of events (Not to scale)

- 10 The MPV had left Slateford depot in Edinburgh just before midnight, with the driver and treatment operator on board, and had treated the lines to Tweedbank, Dunfermline and Kirkcaldy before passing through Markinch en-route to Ladybank. At approximately 04:25 hrs, when approximately 0.8 miles (1.3 km) north of Markinch station, the driver saw the outline of the top of a tree across the track ahead. At this moment the MPV was travelling at about 43 mph (70 km/h) (figure 3).

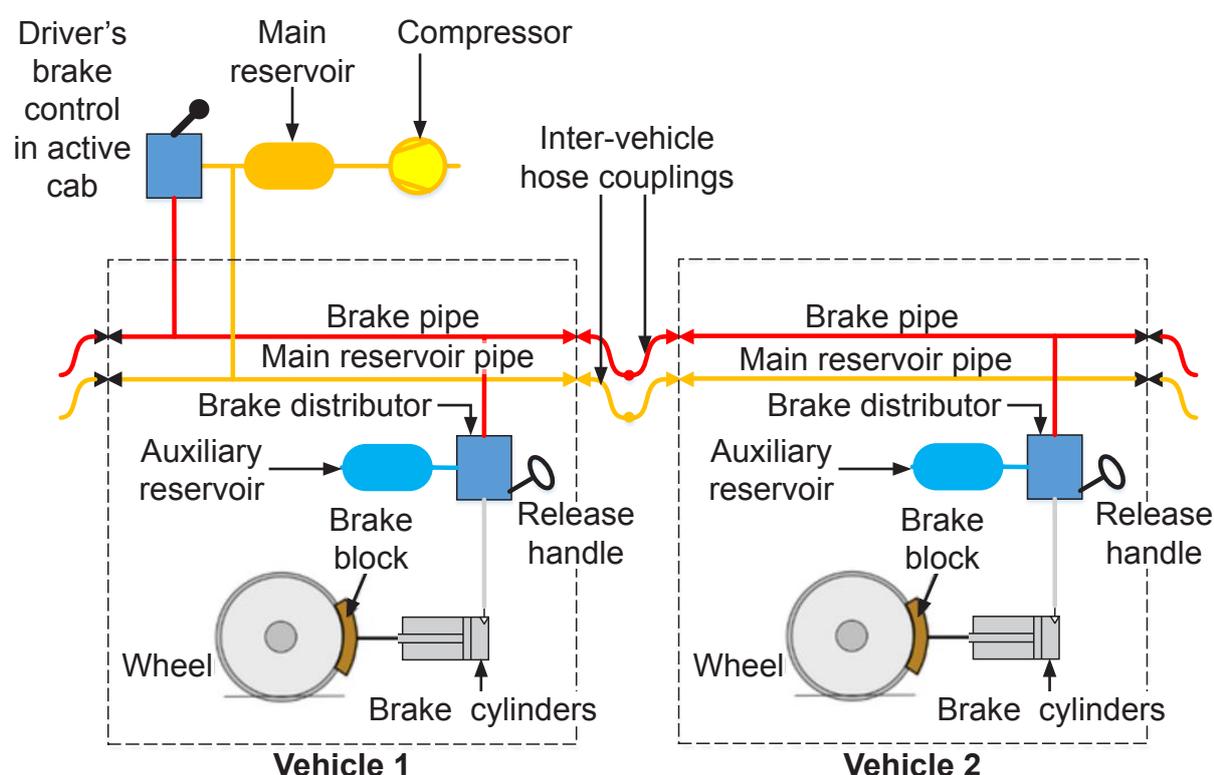
Figure 4: Simplified diagram of MPV braking system (direct brake omitted – see paragraph 22)

- 19 Figure 4 shows a simplified diagram of the *air brake system* on the MPV. It operates very similarly to that of a modern *two pipe freight wagon*. A main reservoir pipe and a brake pipe run the length of the MPV, with hose couplings in each between the two vehicles. The main reservoir pipe keeps the auxiliary reservoirs topped up from the main reservoir and compressor. The driver's brake control modulates the air pressure in the brake pipe. Each vehicle has a *brake distributor* that controls the air from its own auxiliary reservoir to apply the *brake cylinders* on that vehicle.

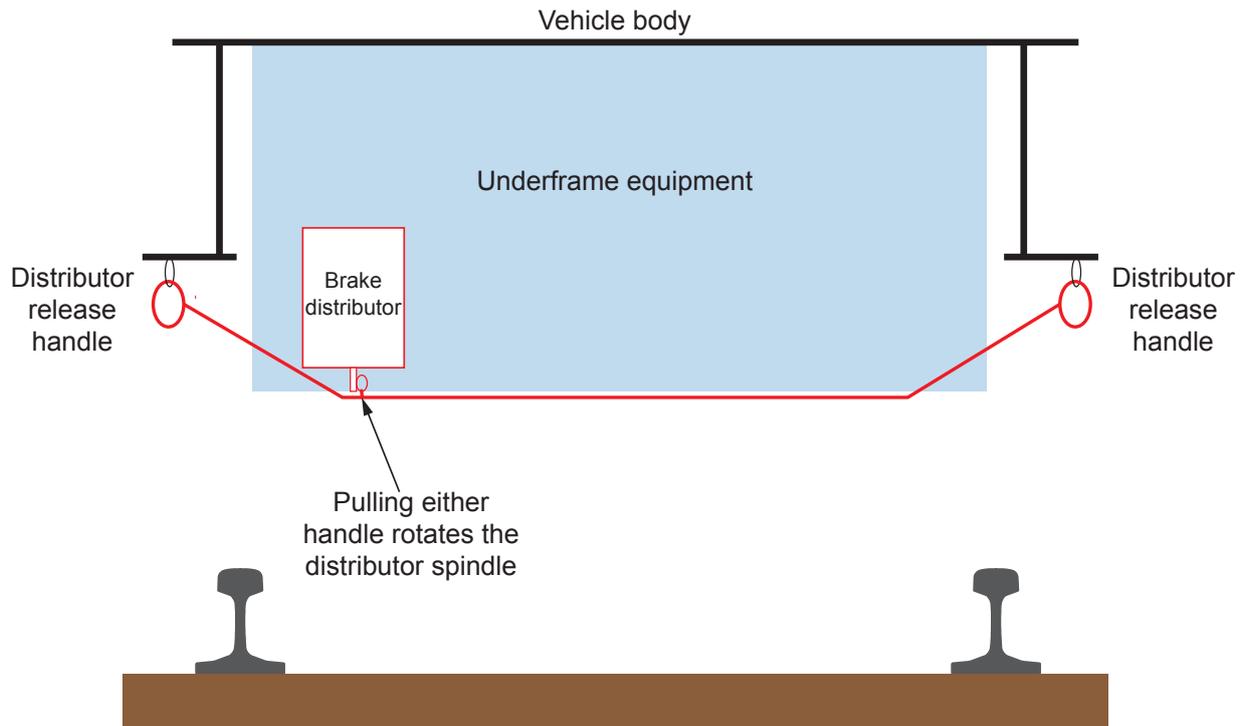
Figure 5: Diagram of brake distributor release mechanism

- 20 When the brakes are not applied, the brake pipe pressure is at its highest, and this pressure reduces as the driver requests more braking. In an emergency brake application, the brake pipe is vented to atmosphere, so that all the pressure is released.
- 21 The distributor senses the brake pipe pressure and modulates the air pressure applied to the brake cylinders in response. A reduction in the brake pipe pressure results in an increase in the pressure to the brake cylinders, and thus the amount of braking applied. The manual release handle, when pulled, rotates a spindle on the distributor, which releases a control pressure chamber in the distributor, thus venting the brake cylinder pressure, and releasing the brakes (figure 5). The control pressure chamber is re-pressurised from the brake pipe when the release handle is no longer operated, allowing braking to be re-established.

- 32 Examination of the front and rear vehicle distributor release mechanisms indicates that both had been distorted towards the rear of the train, as it was travelling at the time of the collision with the tree (figure 6). This is consistent with them having been hit by the tree debris. It is likely that the release spindle (figures 5 and 6) on each brake distributor was rotated briefly during the impact, causing the air pressure to be vented from the brake cylinders for each vehicle and the brakes to be released.
