# ***AAIB Bulletin***

***3/2018***

<b>Aircraft Type and Registration:</b>	Cessna 402C, N603AB
<b>No &amp; Type of Engines:</b>	2 Continental TSIO-520-VB piston engines
<b>Year of Manufacture:</b>	1997 (Serial no: 402C0603)
<b>Date &amp; Time (UTC):</b>	11 February 2017 at 2004 hrs
<b>Location:</b>	Virgin Gorda Airport, British Virgin Islands (BVI)
<b>Type of Flight:</b>	Commercial Air Transport (Passenger)
<b>Persons on Board:</b>	Crew - 1                      Passengers - 8
<b>Injuries:</b>	Crew - None                      Passengers - None
<b>Nature of Damage:</b>	Extensive damage to the landing gear and aircraft structure
<b>Commander's Licence:</b>	Commercial pilot's licence (FAA)
<b>Commander's Age:</b>	29 years
<b>Commander's Flying Experience:</b>	5,458 hours (of which 809 were on type) Last 90 days - 225 hours Last 28 days - 80 hours
<b>Information Source:</b>	AAIB Field Investigation

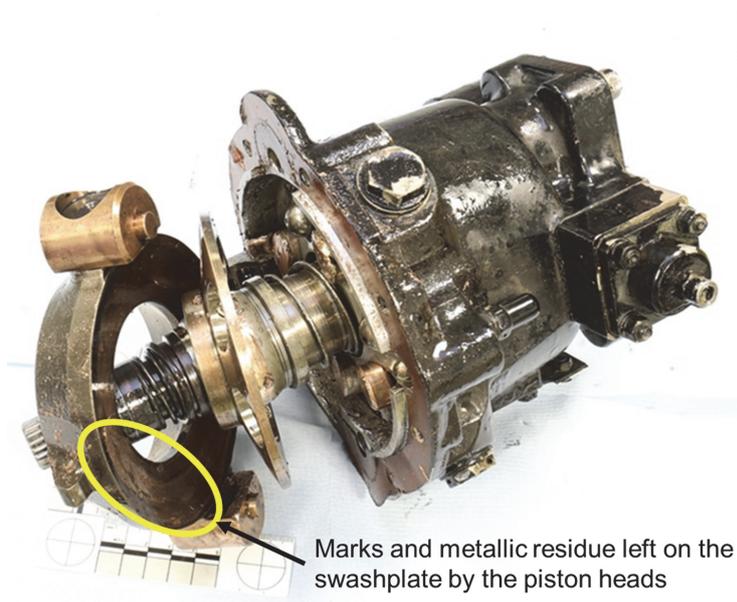
**Figure 3**

The Red pump was disassembled first and although it showed no outward signs of damage or malfunction, there was metallic debris present in the supply and return pipe connections. The disassembly revealed that the outer casing, cover plate and piston carrier were damaged internally with substantial amounts of non-ferrous material of various sizes throughout the pump. All seven of the pistons were present, but most of them were seized in the piston carrier. The swashplate piston track had significant metal scuffing and pick-up from the piston heads on its surface (Figure 3). Otherwise the swashplate, its pivot blocks and piston

synchronising plate, were free to move and were undamaged. The servo piston and linkage to the swashplate was also seized. All the piston head collars had fragmented leaving just the ball and socket at the top of each piston (Figure 4).

The Red pump shown with its cover plate removed

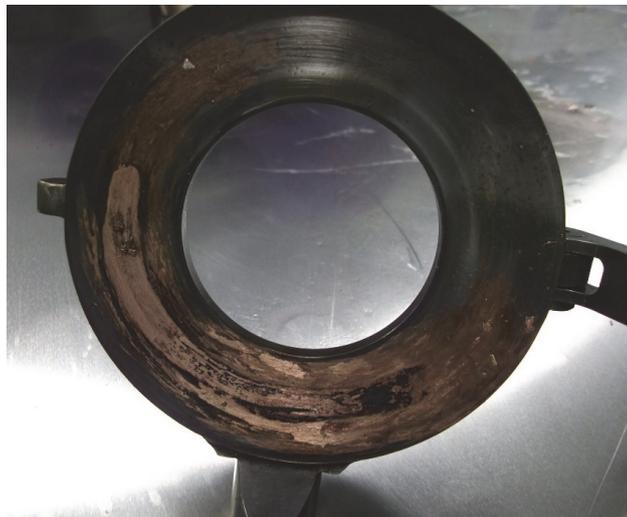
**Figure 6**

where they contacted the swashplate but were otherwise intact and correctly positioned in the synchronising plate. The servo piston was correctly attached to the swashplate and free to move. Figures 5 and 6 show the Green pump components.

Associated swashplate piston track marks

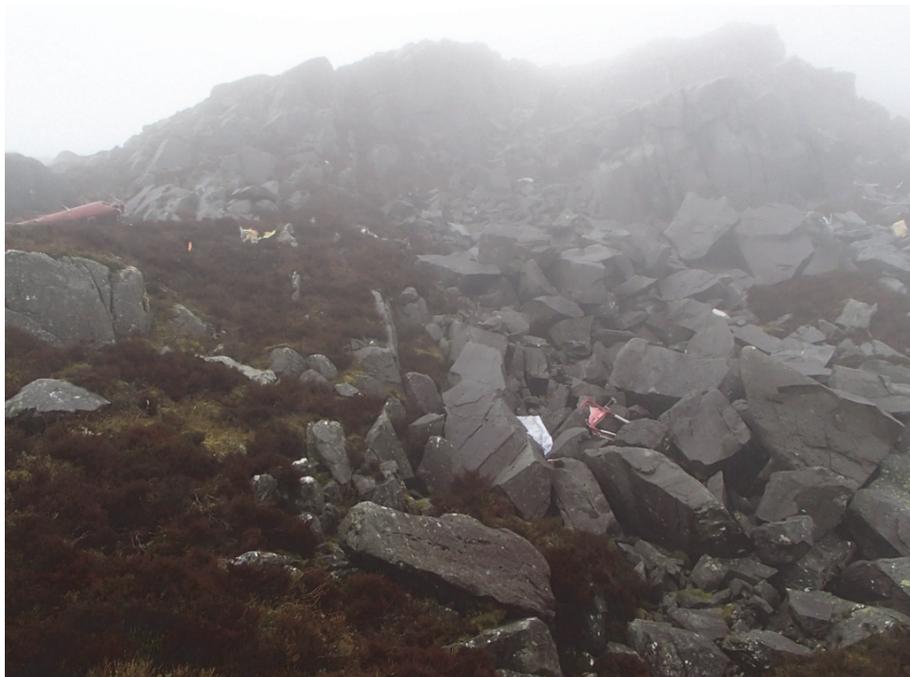
**Figure 4**

The accident site was located on the south-east face of Rhinog Fawr in southern Snowdonia, at an elevation of 2,060 ft amsl, approximately 300 ft below the summit shown in Figure 3. The helicopter had struck a rock outcrop (Figure 4), completely destroying the cabin section and depositing wreckage along a trail 150 m in length, oriented on a heading of 280°M. The helicopter's main rotor, gearbox and engines had separated from the fuselage and continued over the rock outcrop, coming to rest 140 m from the initial impact. The degree of disintegration of the cabin indicated that the helicopter had been flying at cruising speed immediately prior to impact. Witness marks made by the cabin, right skid and right horizontal stabiliser on the rock outcrop showed that the helicopter was in an approximately level pitch and roll attitude at impact.

Section of the accident site wreckage trail

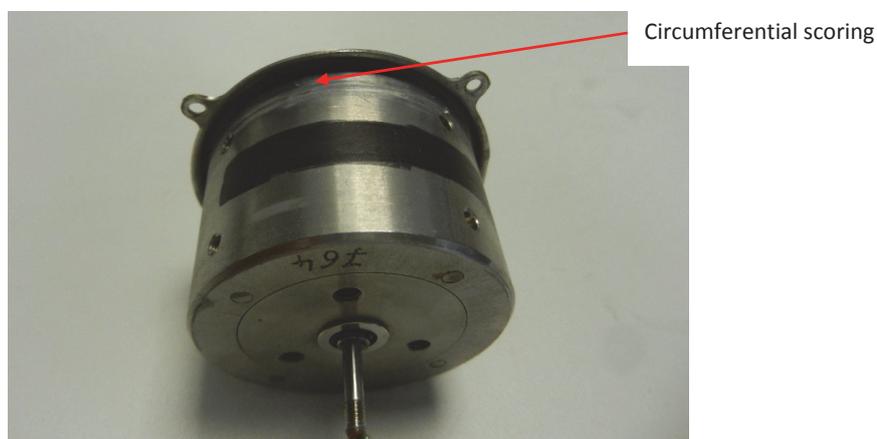
**Figure 5**

All the helicopter's flight instruments had been severely damaged during the impact sequence. The pilot's artificial horizon and the standby artificial horizon were disassembled and examined in detail. Both units had suffered from significant internal damage. Circumferential scoring was identified on the gyroscope of the pilot's artificial horizon and rotational damage was observed on the cooling fins of the standby artificial horizon gyroscope wheel (Figure 5), indicating they were both operational at the time of impact.

Pilot's artificial horizon gyroscope exhibiting circumferential scoring

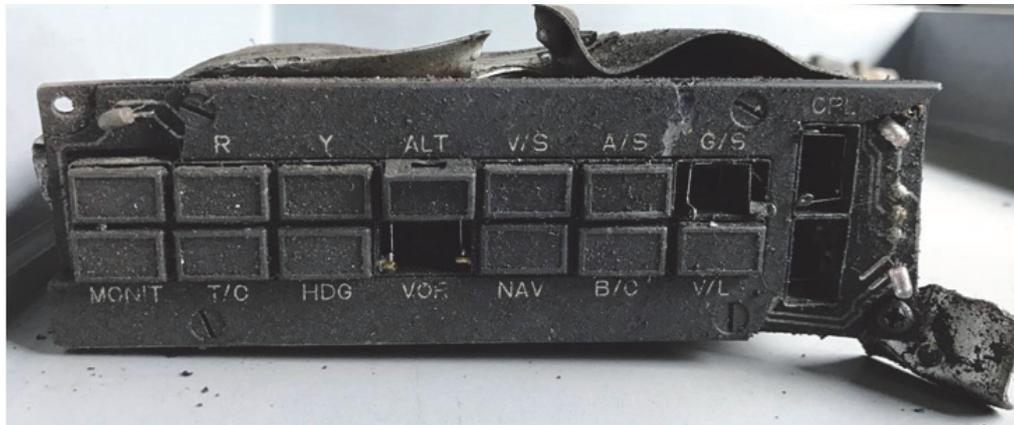
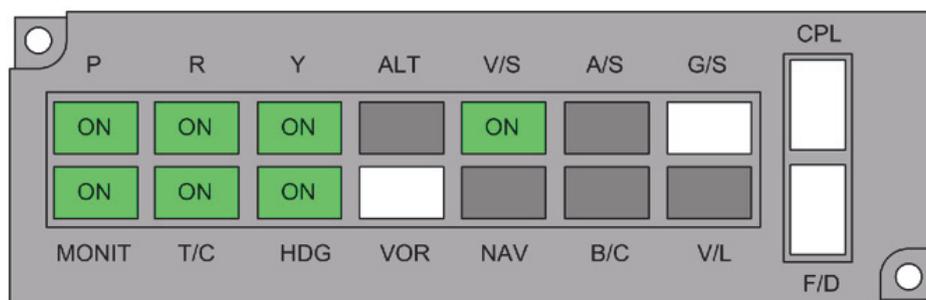
**Figure 6**

The autopilot mode control panel (Figure 6) was recovered from the wreckage trail. The control panel was substantially intact apart from the 'VOR', 'G/S', 'CPL' and 'F/D' buttons, which had separated during the accident and were not located.

Autopilot mode control panel recovered from the accident site (top), and assessment of the control panel buttons illuminated at impact by light bulb filament analysis (bottom)

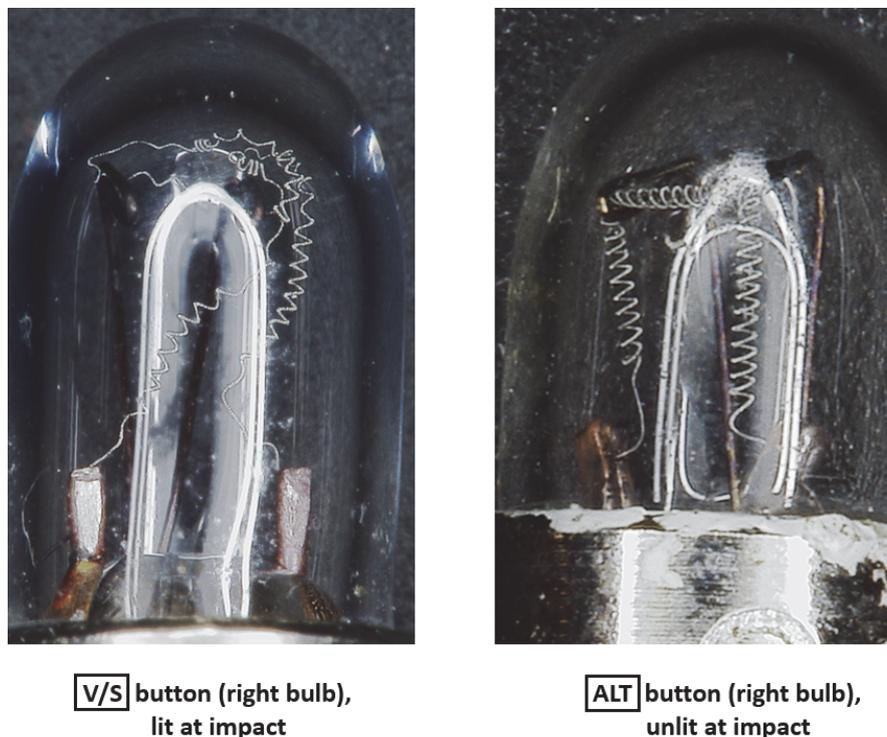
**Figure 7**

The push-button switches were disassembled and their lightbulbs removed for visual examination by microscope. This examination showed that a number of bulbs' filaments were stretched, with the double-helix coils elongated, consistent with bulb illumination at impact. By contrast, the remaining bulbs examined did not exhibit any evidence of filament hot-stretching, indicating that those bulbs were unlit at impact (Figure 7).

Example of *filament hot-stretching*, left and an unlit bulb, right, from the autopilot mode control panel buttons

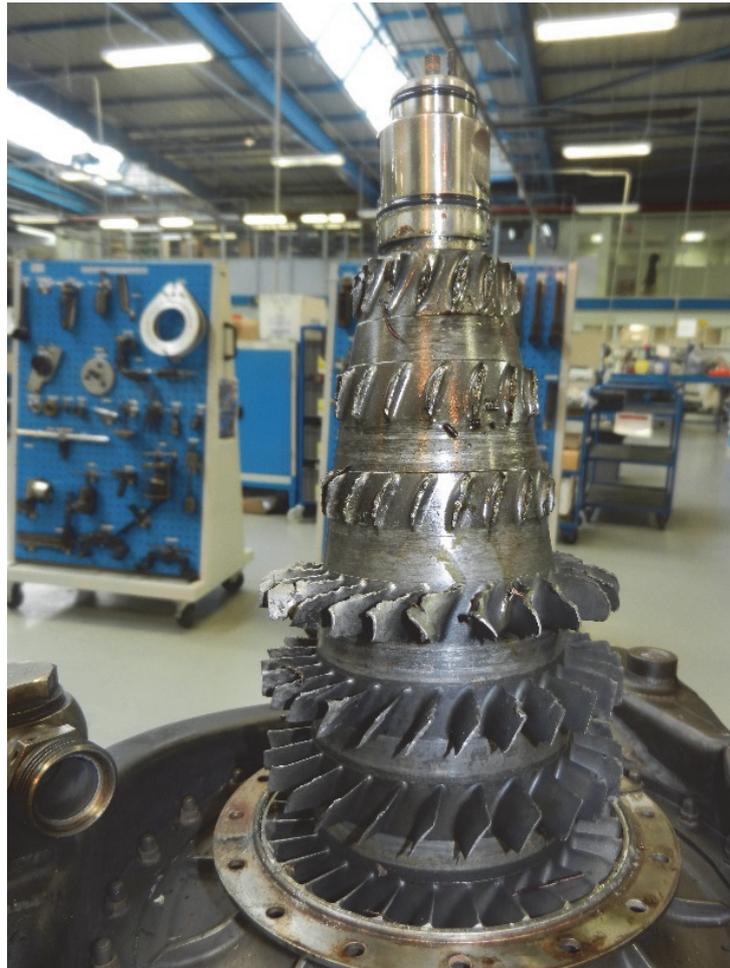
The compressor spool was heavily damaged, all the first three stages of compressor blades had been released, and the blades on the fourth stage exhibited significant impact damage (Figure 11). The impeller and impeller shroud also showed signs of rubbing. Small particles of vegetation were also found within the impeller.

**Figure 11**  
Right engine axial compressor

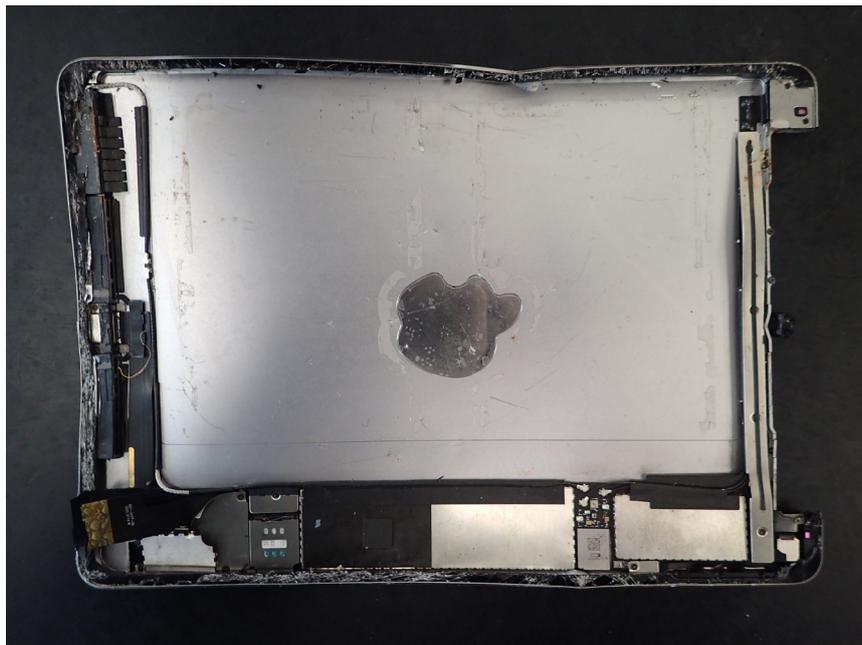
**Figure 12**

The logic board (containing the memory) and battery were still attached to the base of the iPad, which was slightly bent and dented (Figure 12). The logic board was removed from the iPad base and slaved into a similar iPad mini whose own logic board had been removed. The memory was downloaded using a commercially available data extraction and analysis software tool.

Base of iPad mini containing logic board (battery has been removed)

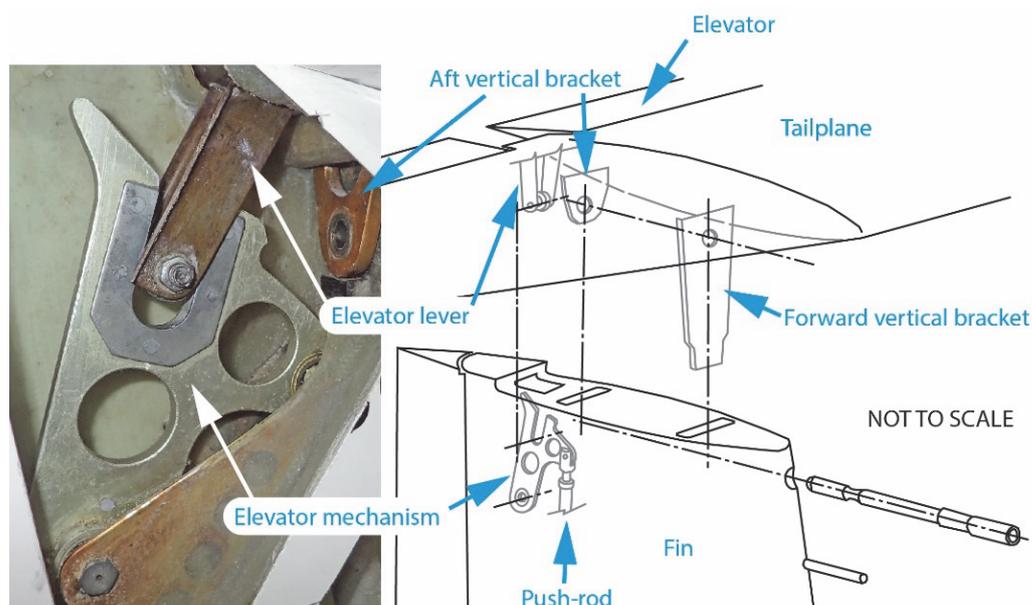
**Figure 4**

Normal connection of elevator lever and elevator mechanism on SZD-55-1

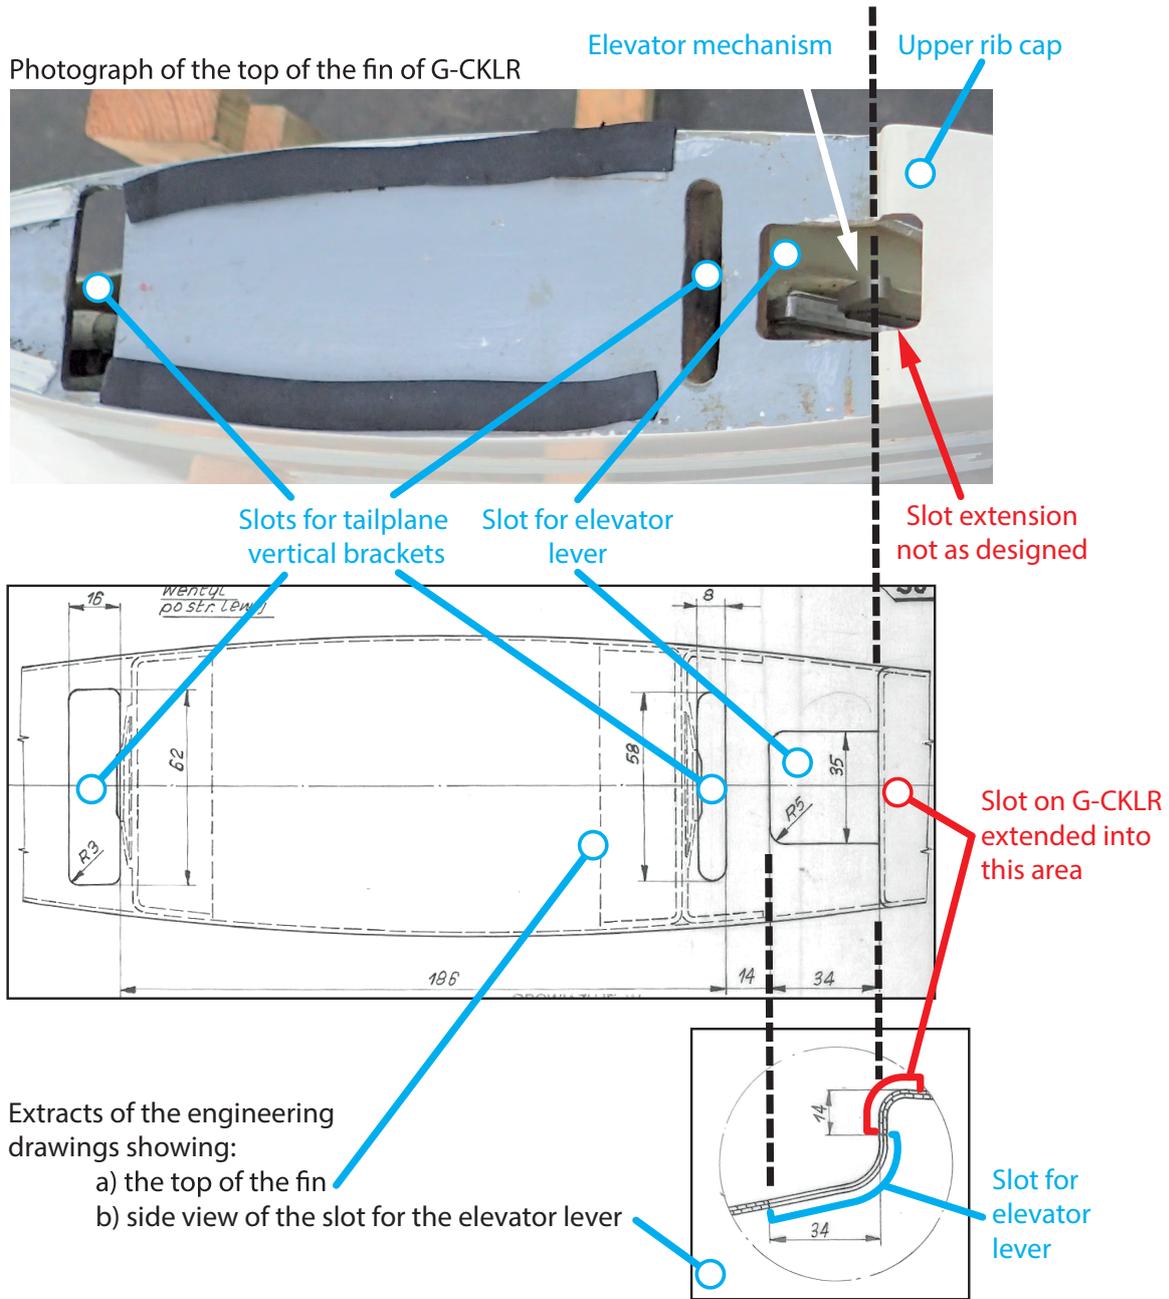
**Figure 7**

Figure 7 shows a plan view of the horizontal rib from the tail fin of G-CKLR compared with extracts from an engineering drawing provided by the manufacturer.

The design dimensions of the elevator slot in the horizontal rib of the tail fin should be 34 mm x 35 mm. The horizontal rib exhibits an approximately vertical step-change in profile towards its aft end. The design drawings indicate that the elevator lever slot should extend only partially up this vertical step, to a position which is approximately indicated by the dashed line in Figure 8. However, on G-CKLR this slot extends up the entirety of the vertical step and onto the upper rib cap.

G-CKLR tail fin horizontal rib comparison with extracts from engineering drawing showing design dimensions

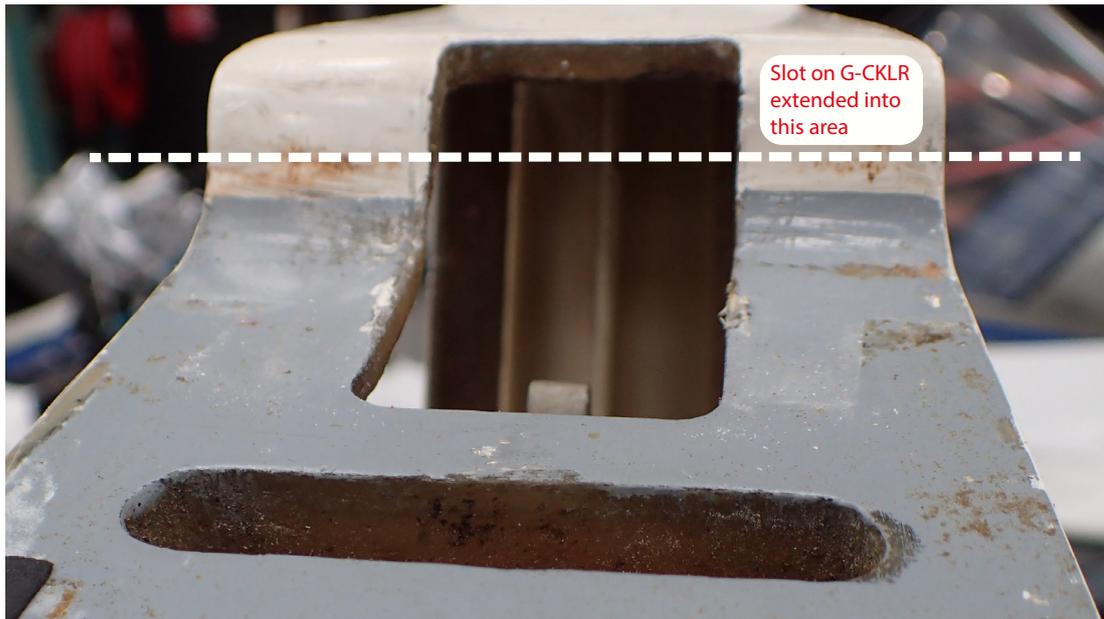
**Figure 8**

Rearwards view of elevator slot in G-CKLR's tail fin
