# ***AAIB Bulletin***

***5/2018***

<b>Aircraft Type and Registration:</b>	Boeing 737-8AS, EI-EBW	
<b>No &amp; Type of Engines:</b>	2 CFM International CFM56-7B/3 turbofan engines	
<b>Year of Manufacture:</b>	2009	
<b>Date &amp; Time (UTC):</b>	14 January 2017 at 1645 hrs	
<b>Location:</b>	On descent to Manchester Airport	
<b>Type of Flight:</b>	Commercial Air Transport (Passenger)	
<b>Persons on Board:</b>	Crew - 6	Passengers - 89
<b>Injuries:</b>	Crew - 1 (Serious)	Passengers - None
<b>Nature of Damage:</b>	None reported	
<b>Commander's Licence:</b>	Airline Transport Pilot's Licence	
<b>Commander's Age:</b>	31 years	
<b>Commander's Flying Experience:</b>	4,977 hours (of which 4,833 were on type) Last 90 days - 156 hours Last 28 days - 29 hours	
<b>Information Source:</b>	AAIB Field Investigation

<b>Aircraft Type and Registration:</b>	Piper PA-28R-201 Cherokee Arrow III, G-CEOF	
<b>No &amp; Type of Engines:</b>	1 Lycoming IO-360-C1C6 piston engine	
<b>Year of Manufacture:</b>	1988 (Serial no: 2837008)	
<b>Date &amp; Time (UTC):</b>	25 May 2017 at 1050 hrs	
<b>Location:</b>	Two miles north-east of Skipness, Kintyre peninsula	
<b>Type of Flight:</b>	Private	
<b>Persons on Board:</

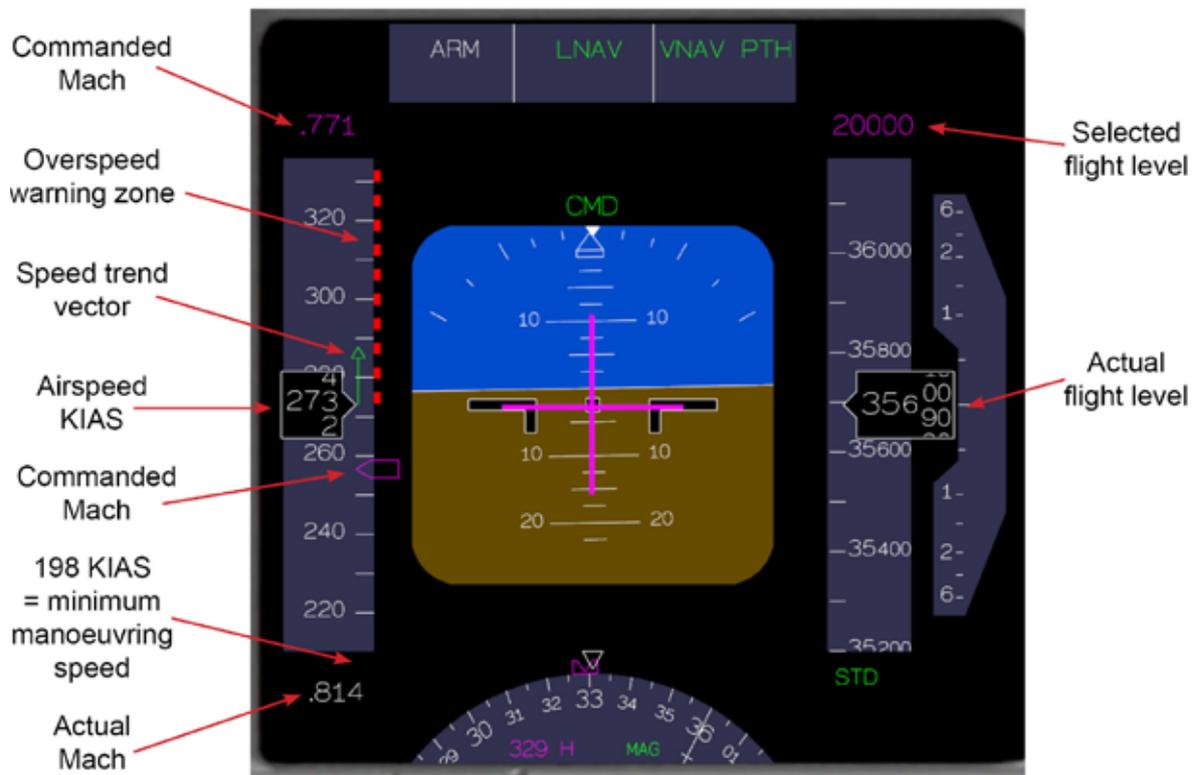
**Figure 1**

Example image of a PFD under conditions similar to EI-EBW just prior to autopilot disengagement

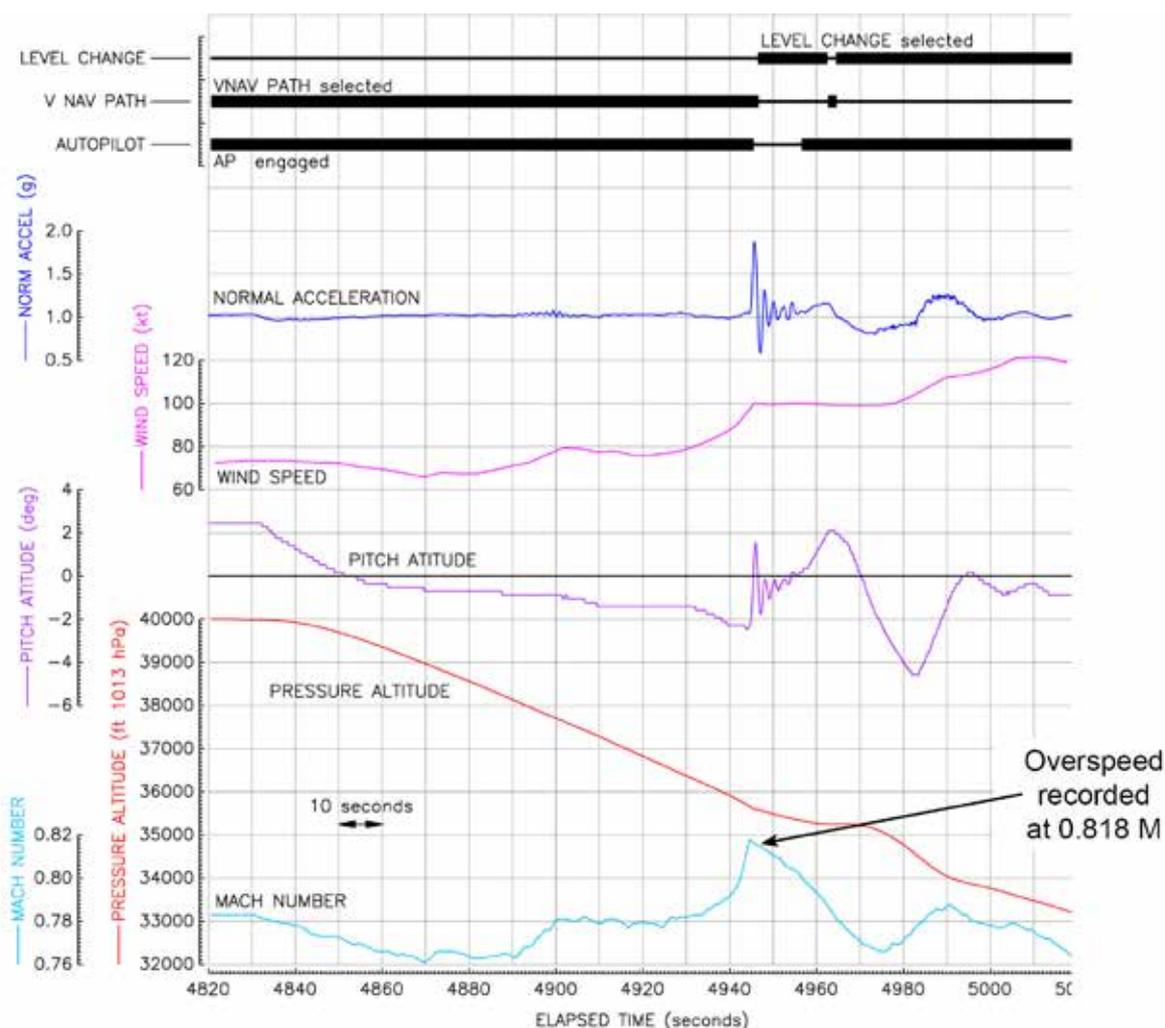
**Figure 2**  
Recorded information

The aircraft's speed rose from 0.78 M to almost 0.82 M in 28 s. If the commander only realised the severity of the impending overspeed just before it occurred – and believed that the autopilot was not correcting the condition – then he may have felt compelled to disengage the autopilot, as described in the procedure.

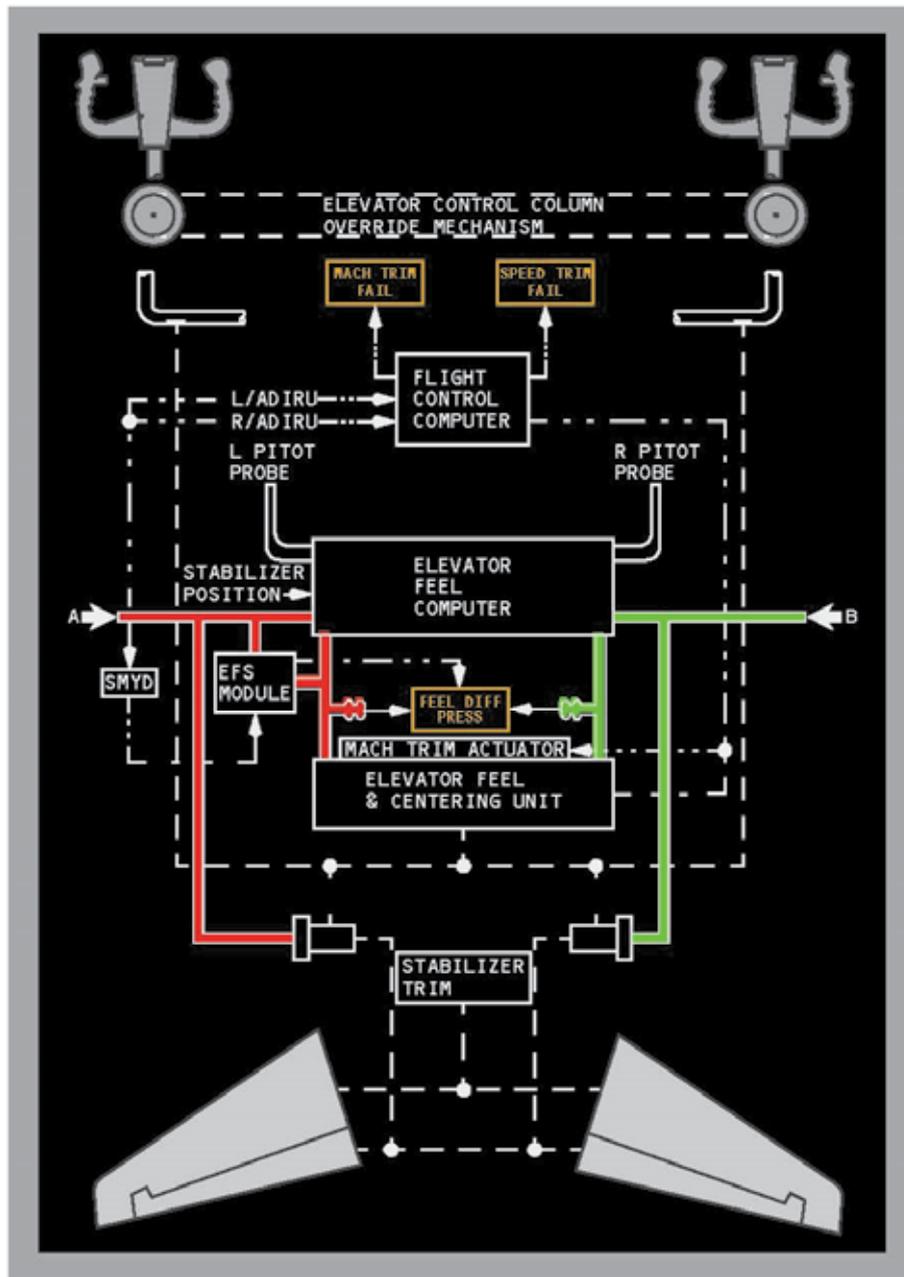
**Figure 3**

The aircraft's control column is mechanically linked to the elevator actuators and, except for small effects involving cable stretch, any motion of the control column results in motion of the elevator actuators and elevators (see Figure 3). Three forces are applied to the mechanical linkage: the feel computer, the autopilot servos and pilot control column input. The sum of these three forces will determine the position of the mechanical linkage, and thus the inputs to the elevators.

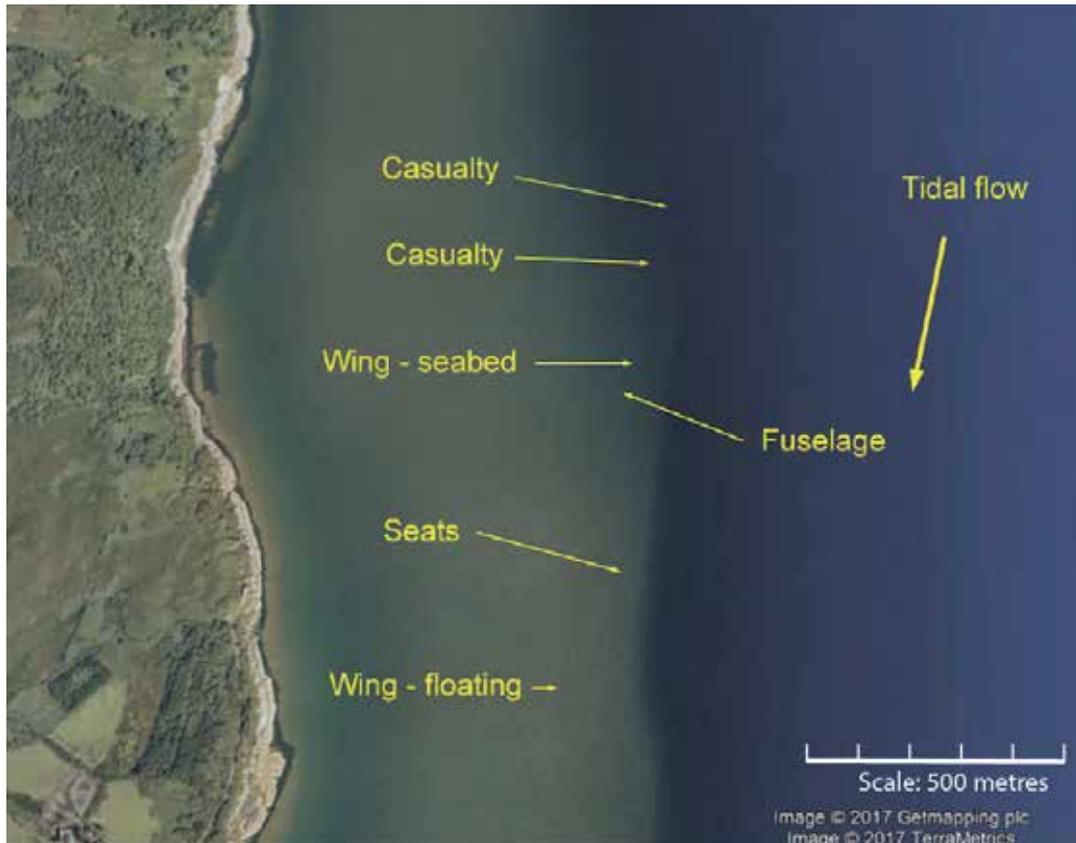
**Figure 1**

The locations of the casualties and wreckage extended over an area 800 m long and are plotted in Figure 1. It is possible that in the 12 days between the accident occurring and the underwater search beginning, some items of wreckage might have moved as a result of the extensive bottom trawling that is carried out in this area.

Reported position of casualties and wreckage

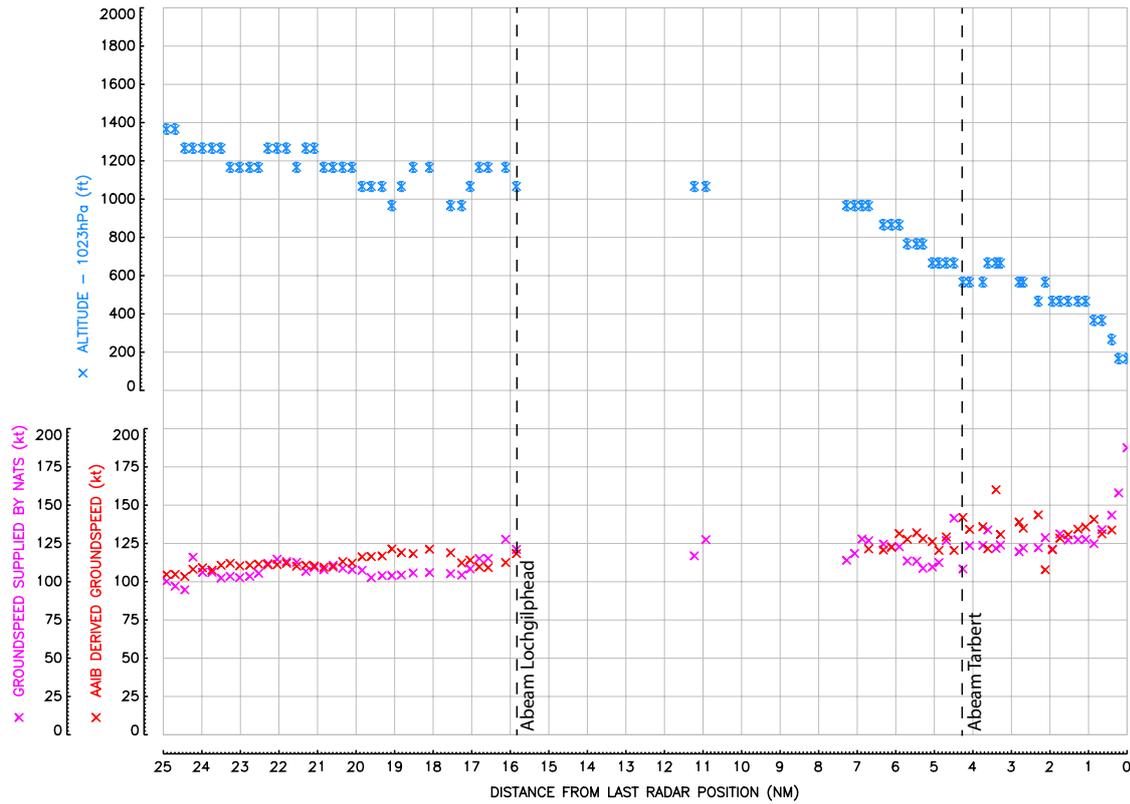
**Figure 5**

From the radar data, the AAIB was able to derive the aircraft's approximate groundspeed using a moving average calculation, which has been plotted, along with the altitude, at Figure 5 against the distance from the last radar return. There is a gap in the radar data as the aircraft passed Lochgilphead and before it was picked up by the second radar head.

Aircraft altitude and derived airspeed plotted against the distance from the last radar return

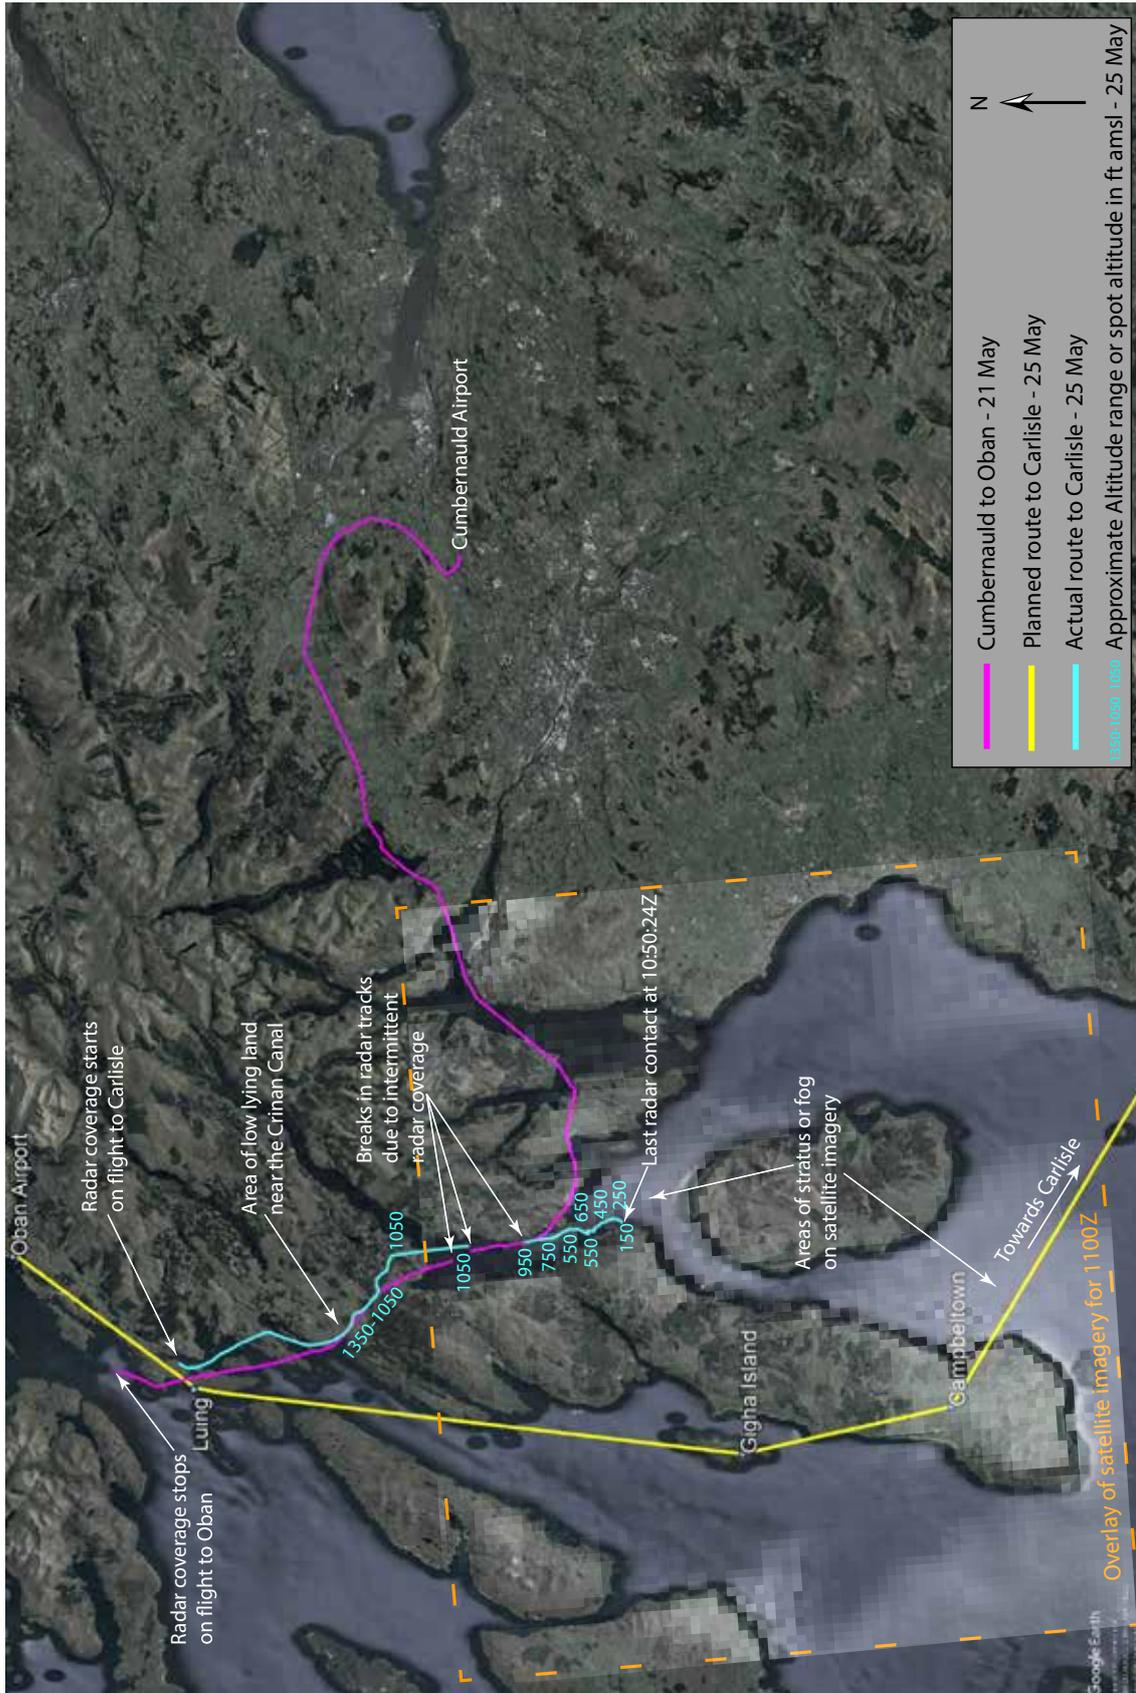
Plotted at Figure 6 are the radar tracks for the flights from Cumbernauld Airport to Oban on 21 May 2017, the accident flight, and the planned route to Carlisle stored on the company’s servers. The tracks are overlaid with the Met Office satellite imagery taken at 1100 hrs on 25 May 2017.

Radar track data and Met Office satellite imagery for 1100 hrs

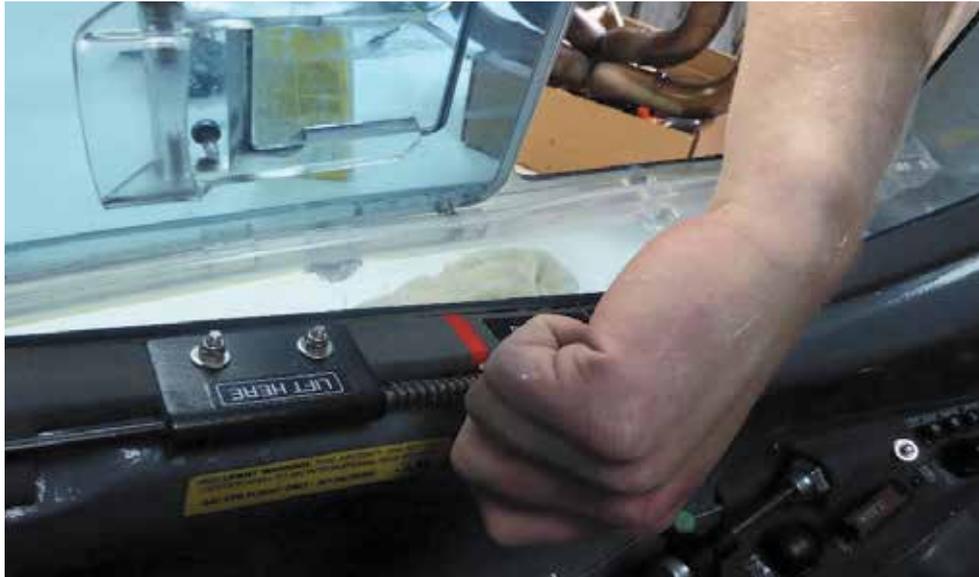
**Figure 5**

There are no canopy opening or jettison handles on the outside of the cockpit; however, it can be unlatched by reaching through the small ventilation window and operating the white handle (Figure 5). There were no instructions visible from outside the cockpit explaining how the canopy is opened.

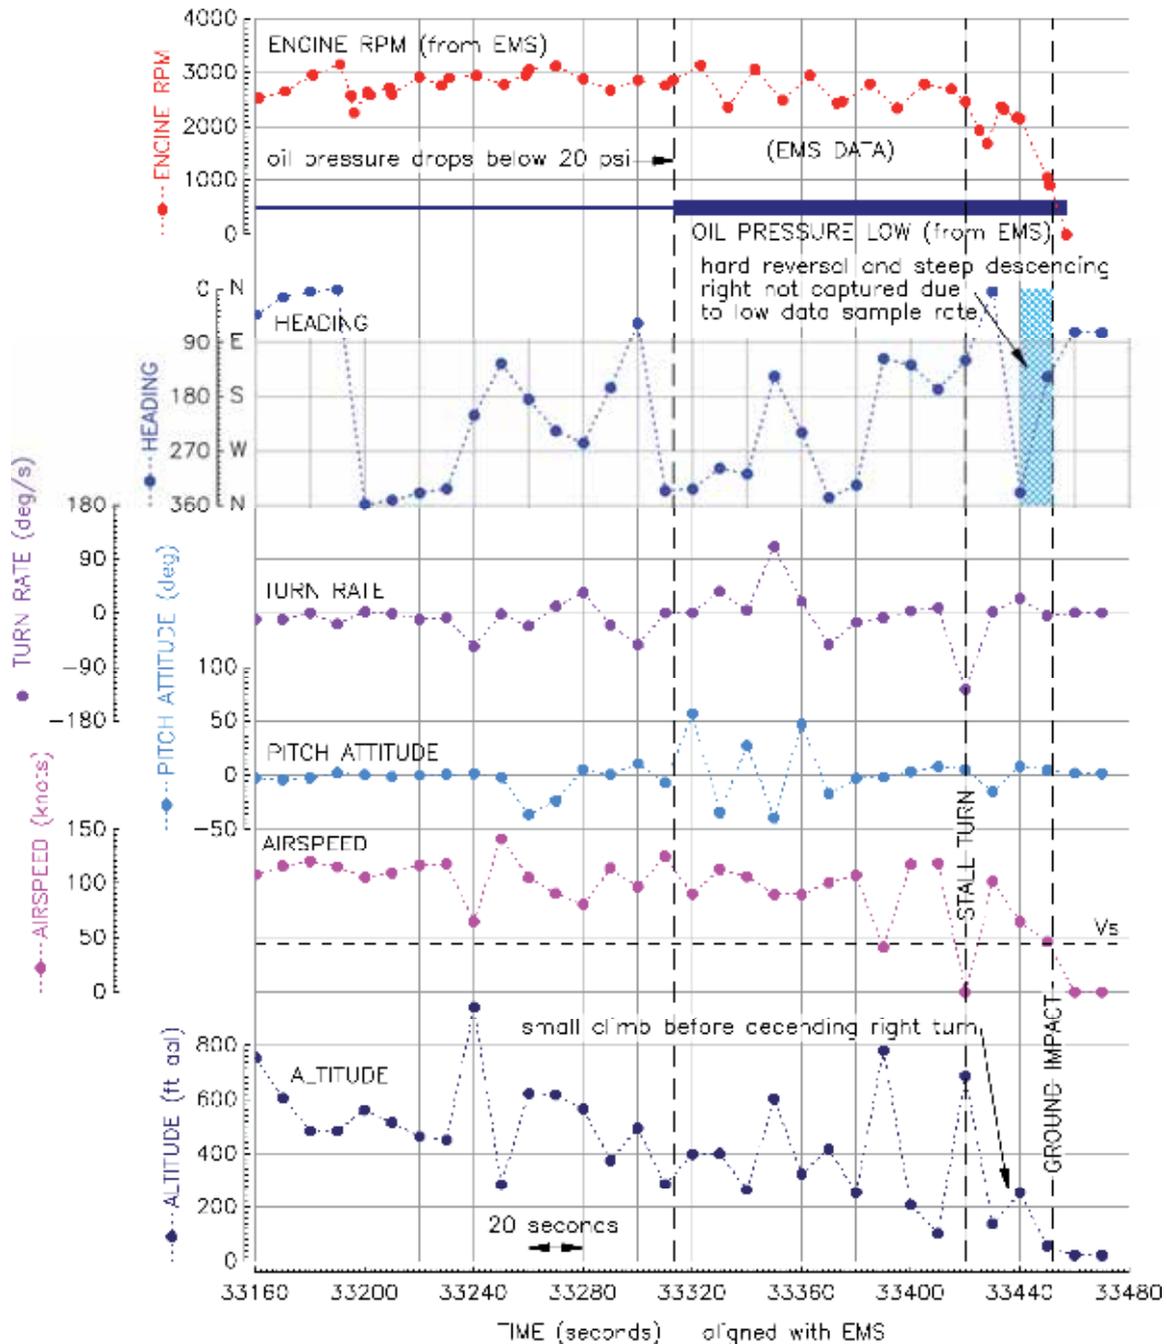
**Figure 8**  
EFIS recorded flight data – accident flight

Figure 8 shows flight data from the EFIS starting as the aircraft descended to the start the display sequence and ending with the aircraft on the ground. EFIS times have been adjusted to align them with EMS. Figure 8 shows when the oil pressure dropped below 20 psi (generating an EMS low pressure warning – also plotted with engine rpm from EMS), the point in the flight where G-JINX performs a stall turn and when (based on timing from video evidence) it struck the ground 32 seconds later.

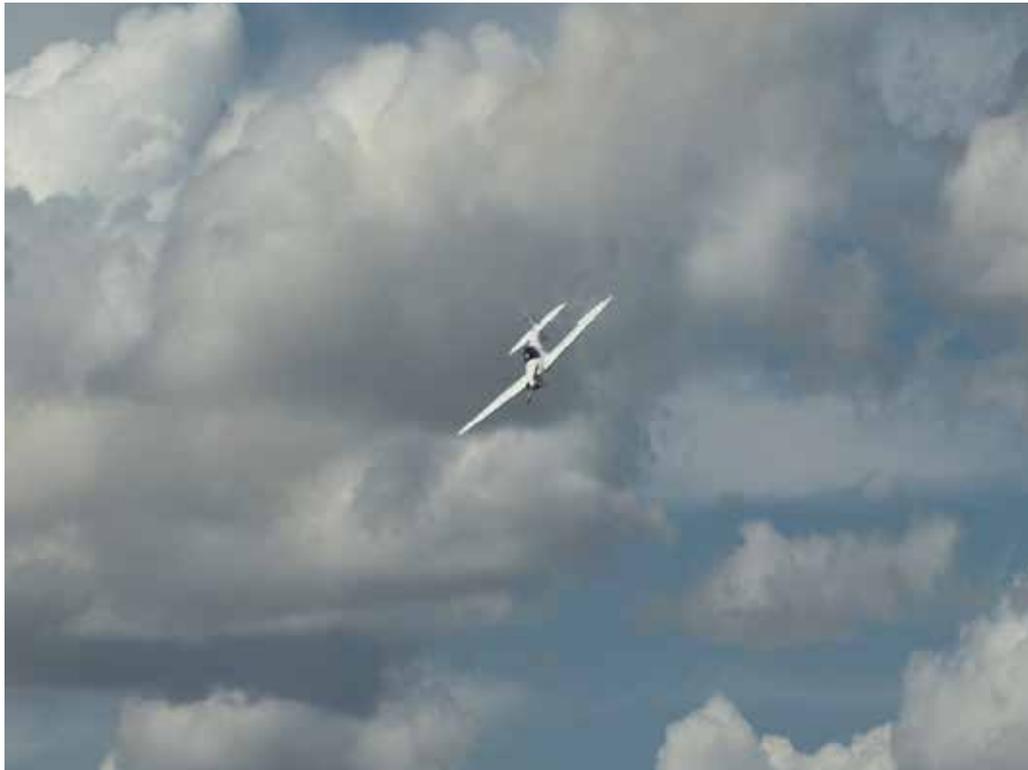
**Figure 9**

From video evidence, the right turn and descent to ground impact took 12 seconds, so are not evident in the EFIS data because of the low data sampling rate. However, the turn was through about 180° initially at 65 kt airspeed at about 250 ft aal. During the first half of the turn the bank angle was held at about 45° without significant height loss. The aircraft then began to descend as the bank angle increased and the nose dropped (Figure 9). At just under 60 ft aal the airspeed had reduced to 46 kt, after which the wings were levelled and the nose was raised to a slightly nose-down attitude at impact.

G-JINX shortly before ground impact  
(Picture courtesy of Peter Thomas)

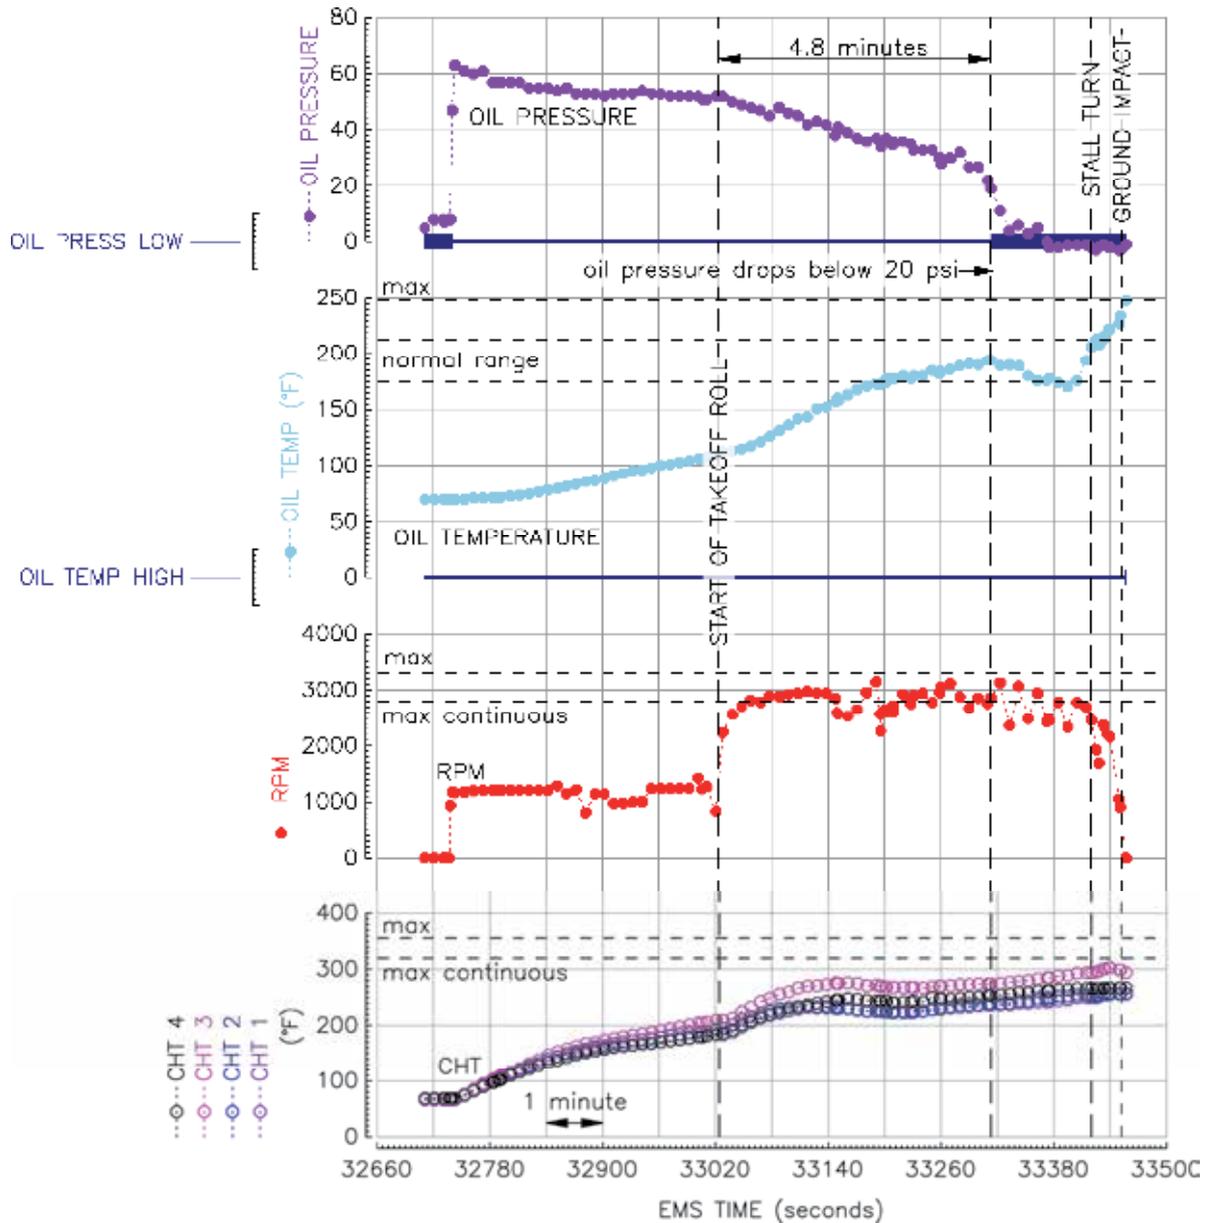
**Figure 10**  
EMS recorded engine data - accident flight

The investigation found that the engine seized following the loss of its oil during the accident flight.

Figure 10 shows relevant engine data from the EMS. It indicates that the time between the increase in engine speed (time 33030, which corresponded to the start of the takeoff roll), and the low oil pressure warning was 4.8 minutes. During this period, as the oil temperature increased and the oil pressure decreased, engine rpm varied around 2,800 rpm (maximum continuous) and peaked briefly at 3,151 rpm. The CHTs also increased with the No 3 cylinder operating between 20 and 30°F hotter than the hottest of the other three cylinders (cylinder No 4). After approximately 4 minutes, the oil pressure had decreased to 30 psi. It then continued to decrease below 20 psi, generating the low pressure warning and reaching zero one minute later. The engine continued to rotate for a further 1.5 minutes.

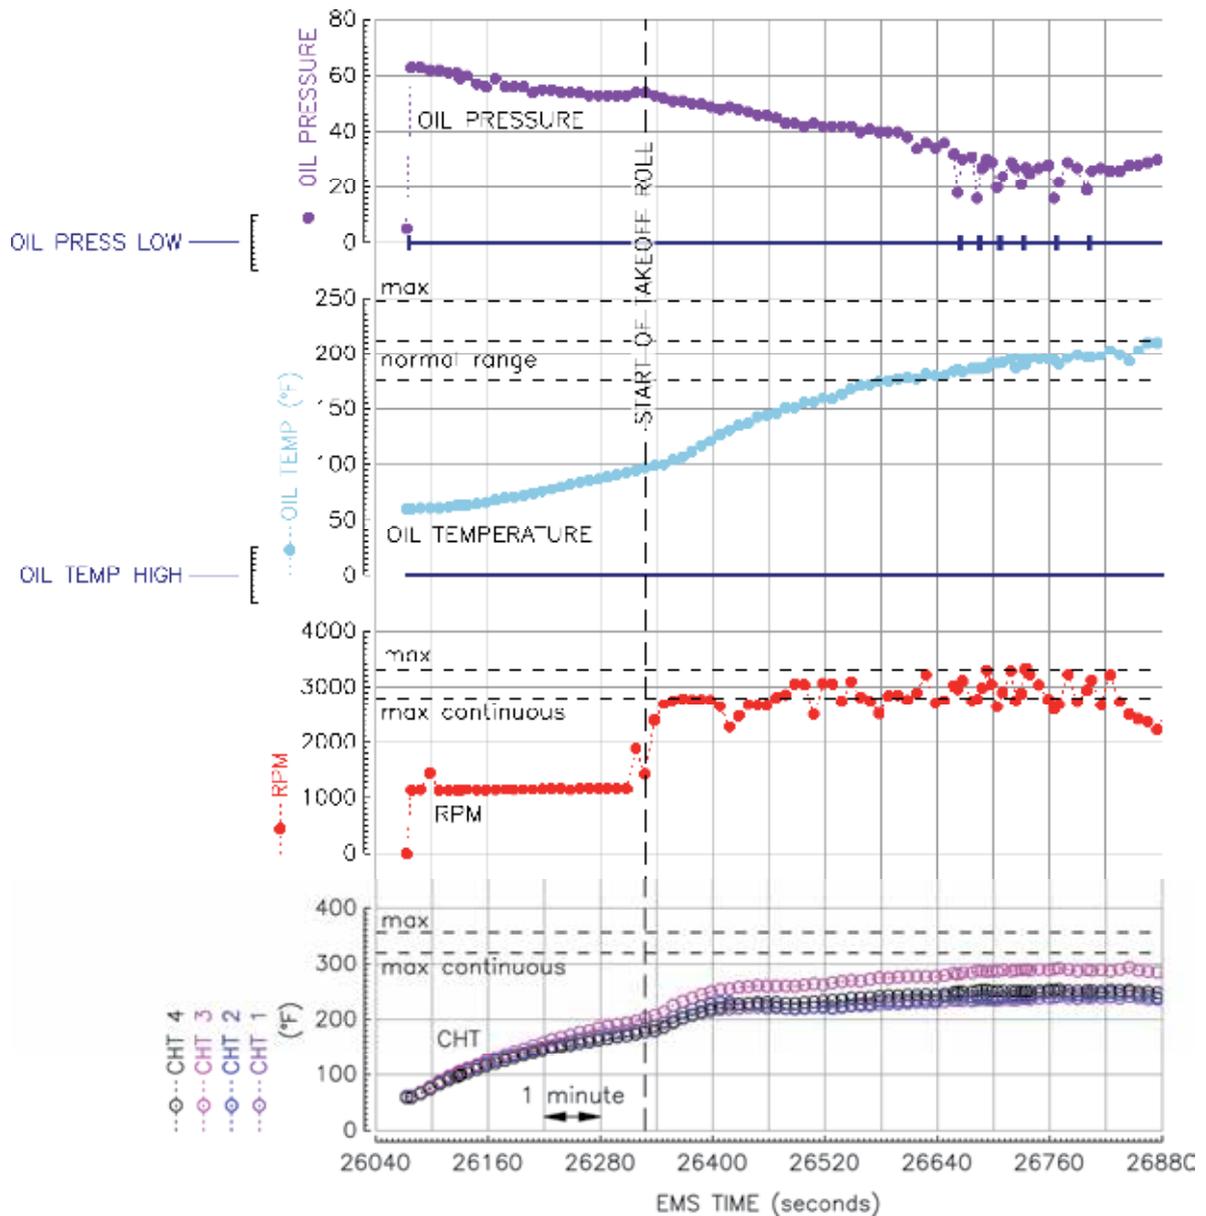
**Figure 11**

Data from the accident flight was compared with data from a previous flight during which the aircraft flew the same display routine (Figure 11). The engine rpm, oil pressure, oil temperature and CHT profiles (including the hotter running No 3 cylinder) were similar on both flights until five minutes after the start of the takeoff roll, when both oil pressures decreased to below 30 psi. During the earlier display flight there was then a 2.5 minute period in which the oil pressure fluctuated between 16 and 30 psi, causing the low oil pressure warning to activate six times.

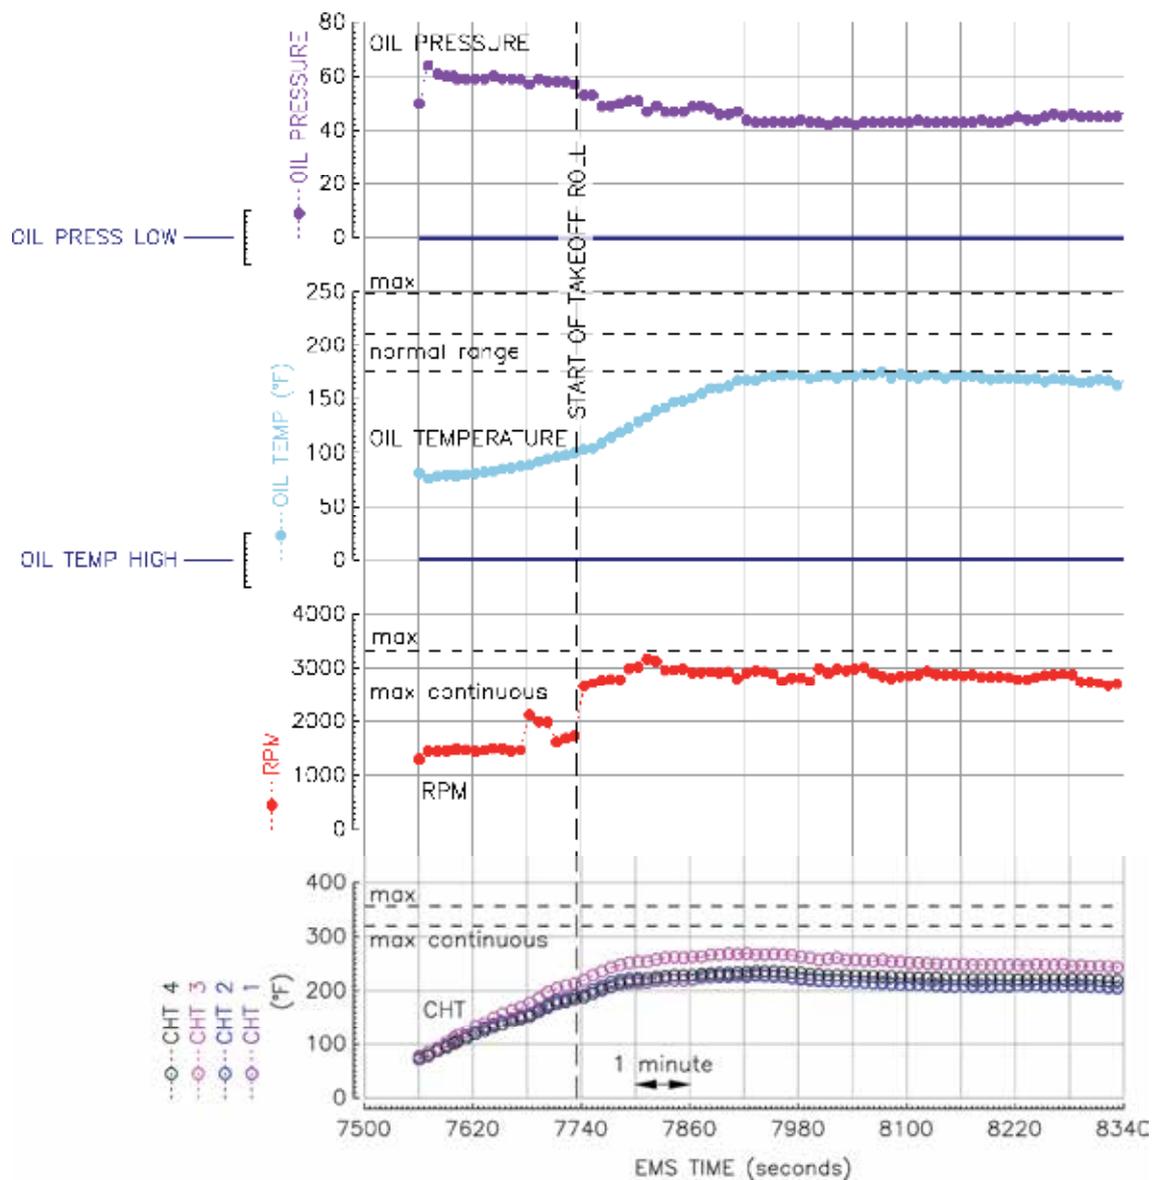
**Figure 12**

Engine data from the display flights was also compared with data from the aircraft when it was in cruising flight (Figure 12), during which oil pressure was 43(±2) psi and the oil temperature was stable at 175° F (the lower end of the normal range). The CHTs were also approximately 30° F cooler, with the No 3 cylinder again running hotter by about 20° F.
