Rail Accident Report

**Fatal accident at Trenos footpath crossing near
Llanharan, Rhondda Cynon Taf, South Wales,
1 June 2017**

Report 07/2018
May 2018

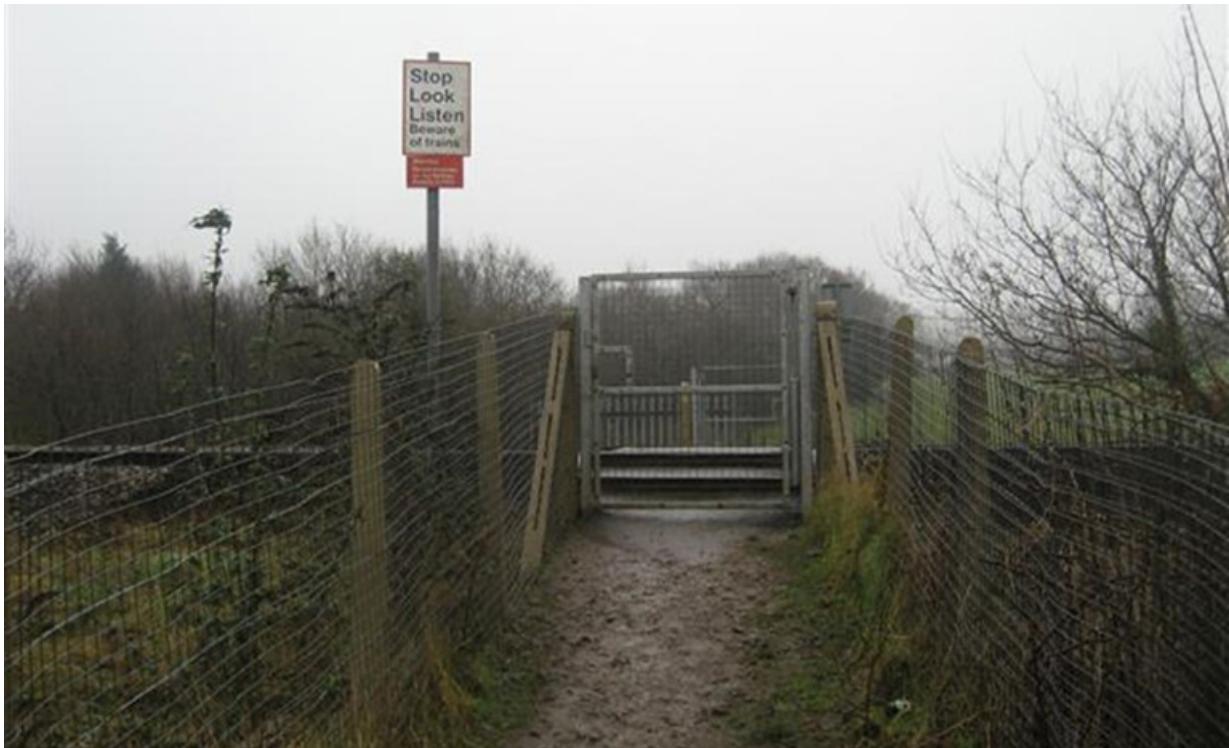
Figure 3: approach to Trenos crossing from the south

- 13 The approach from the south side is up a sloping path (figure 3 and figure 4). A pedestrian's view from this side of the railway looking towards trains approaching on the down line, the line used by the train which struck the pedestrian, is shown in figure 5.

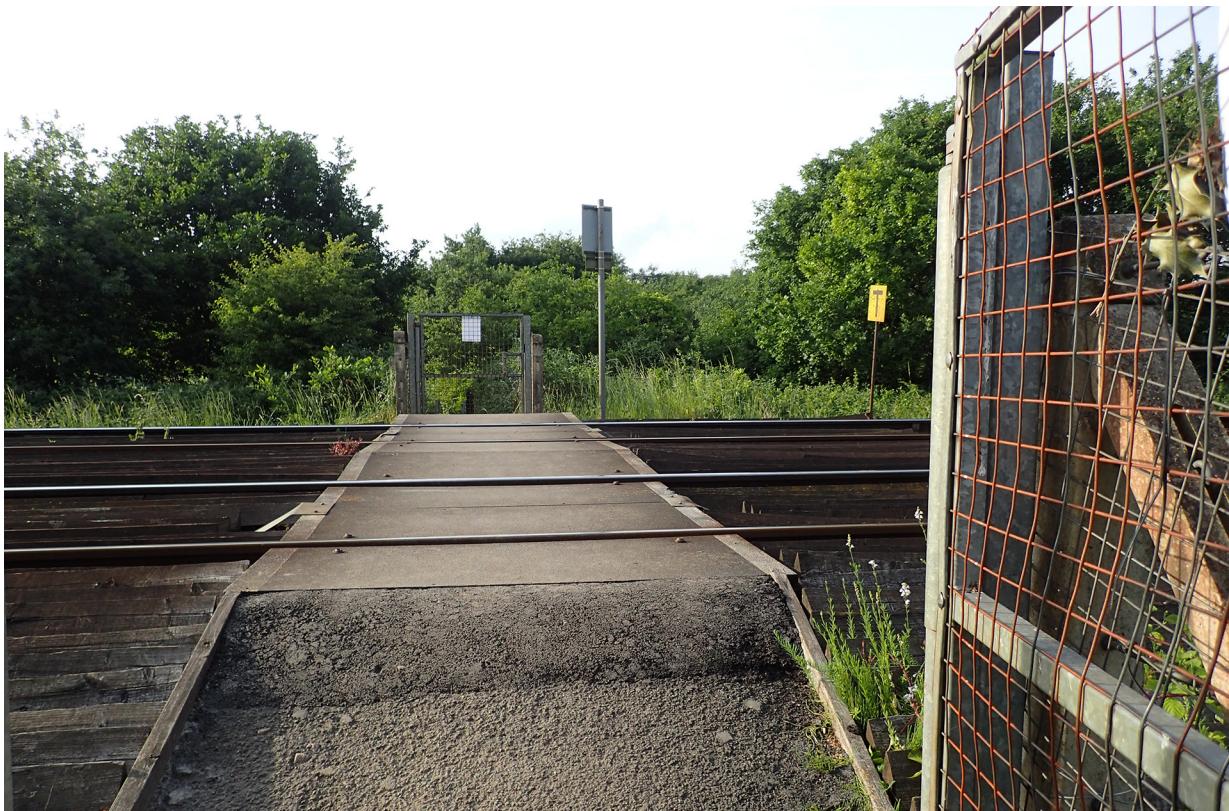
Figure 4: Trenos crossing from the south with pedestrian gate open

- 16 Trenos crossing was inspected by Network Rail operations staff while responding to the accident on 1 June 2017. These staff found no evidence that the condition of the crossing was a factor in the accident and the RAIB concurs with this view.

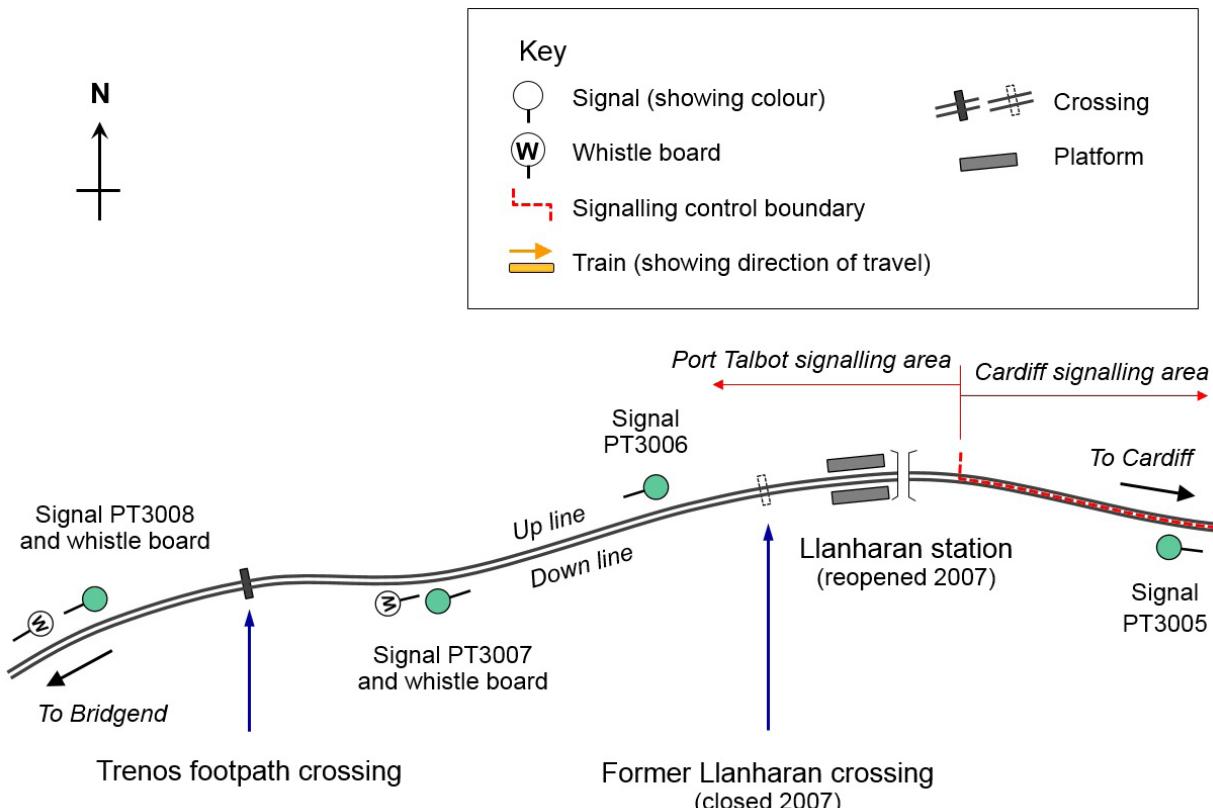
Figure 7: track and signalling layout diagram (not to scale). Note that the boundary between the Cardiff and Port Talbot signalling areas is staggered and signal PT3005 is within the Port Talbot signalling area.

- 19 Trains travelling on the down line heading west pass signal PT3005, Llanharan station, the site of the former Llanharan crossing, signal PT3007, a whistle board and then Trenos crossing (figure 7). Drivers are required to sound train horns at the whistle board as a warning to users of Trenos crossing. Both signals are controlled by the Port Talbot signaller.

- 20 Trains travelling on the up line heading east pass a whistle board for Trenos crossing and signal PT3008 before reaching Trenos crossing (figure 7). They then continue past signal PT3006, the former Llanharan crossing and Llanharan station. Both these signals are controlled by the Port Talbot signaller. Shortly after passing Llanharan station, trains travelling on the up line enter the area controlled by the Vale of Glamorgan signaller located in Cardiff.
- 21 The maximum permitted line speed on both lines is 75 mph (121 km/h). However, the up line has a long-standing temporary speed restriction which restricts trains to a maximum speed of 50 mph (80 km/h). This provides additional protection for crossing users as the sighting of trains approaching from the west is restricted because of a curve in the track.

58 The Port Talbot signaller understood, from the telephone message he received from the Cardiff signaller, that he needed to protect a crossing close to the signalling control boundary (paragraph 32 and figure 7). His display screen indicated that this was Llanharan crossing located just west of Llanharan station. He took action to protect this crossing, unaware that it was the wrong location and that the crossing no longer existed. He later dispatched emergency services to the same place.

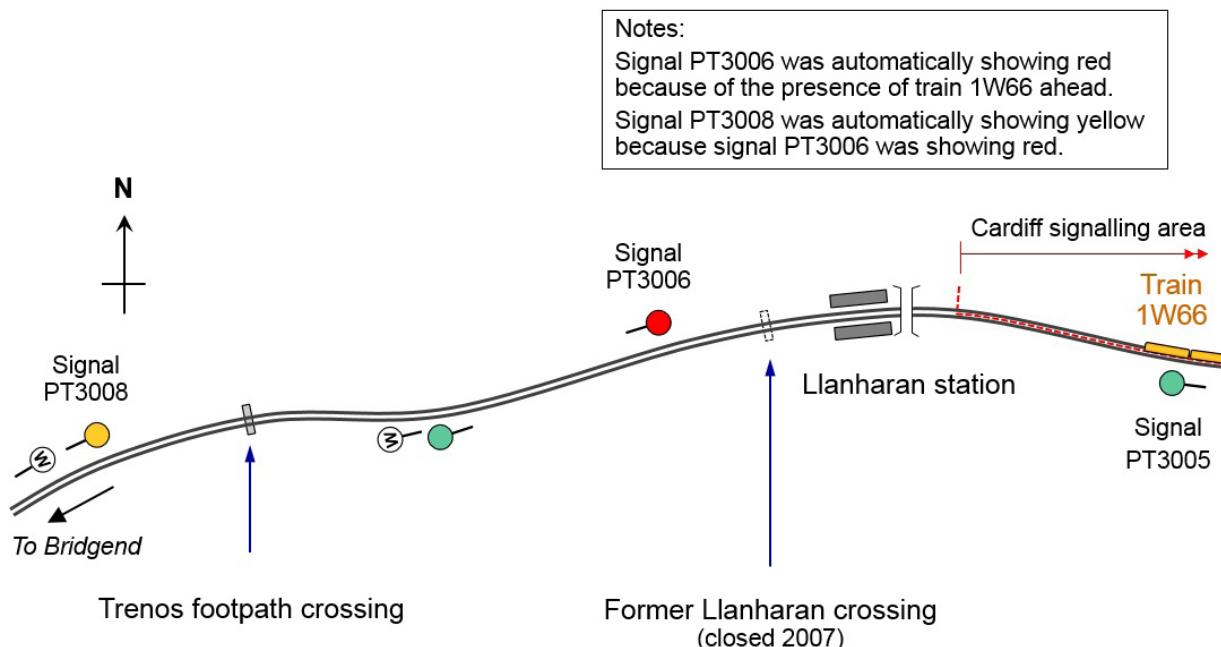
Figure 9: diagram at 15:35 hrs

- 29 The guard also used the train's cab-to-cab telephone but was unable to contact the driver. The guard ran through the 2-carriage train and entered the driver's cab. He informed the driver that he was concerned about the pedestrian's state of mind and advised the driver to report the incident to the signaller. The driver applied the brake and stopped the train for a second time east of Llanharan station at 15:35 hrs (figure 9).

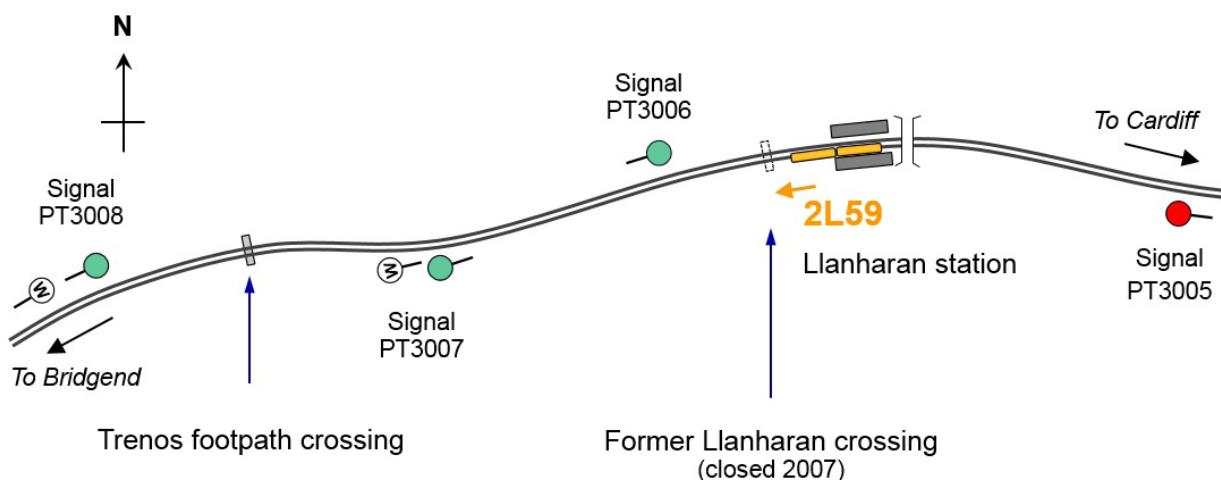
Figure 11: diagram at 15:48 hrs

- 38 At 15:48 hrs (figure 11), train 2L59 departed from its booked stop at Llanharan station and accelerated towards its next stop at Pencoed station. This service was due to depart Llanharan at 15:36 hrs, but had been delayed at Cardiff and was running about 12 minutes late.

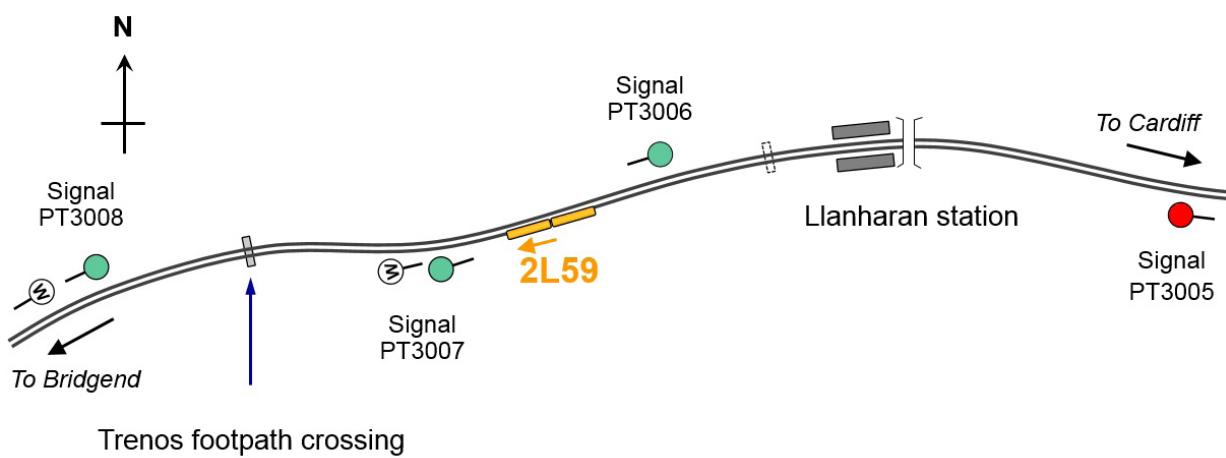
Figure 12: diagram at 15:49:30 hrs

- 39 Train 2L59's on-train data recorder⁵ indicates that signal PT3007 was displaying a green aspect as the train approached (figure 12). It also indicates that the driver then sounded the train's warning horn about 380 metres (16 seconds) from the crossing as it passed the whistle board located just beyond the signal.

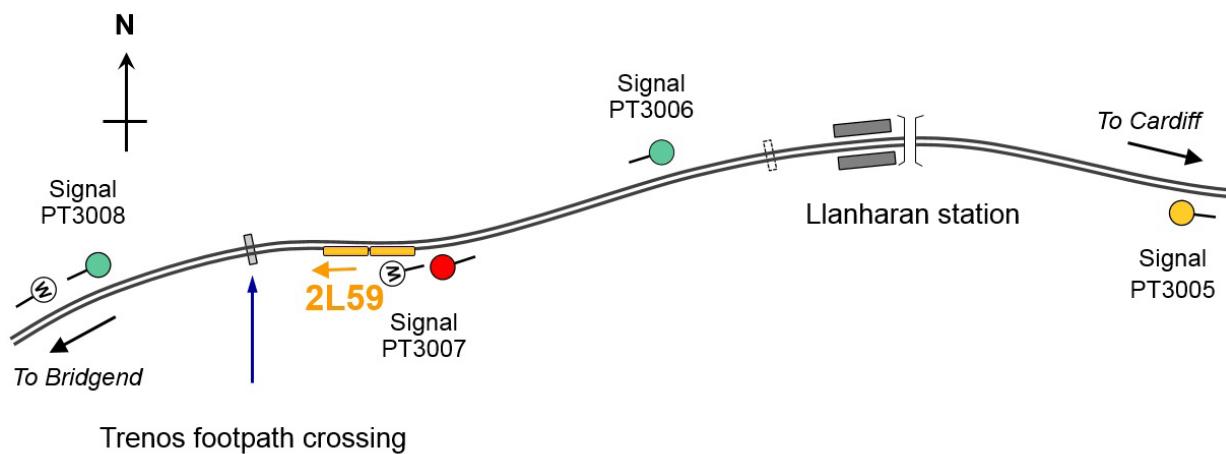
Figure 13: diagram at 15:49:45 hrs

- 40 At 15:49:45 hrs (figure 13), train 2L59's data recorder indicates that the train was 250 metres (10.5 seconds) from the crossing when its driver started to repeatedly sound the train's warning horn. The driver took this action after seeing a pedestrian walking onto the crossing from the left side of the track.

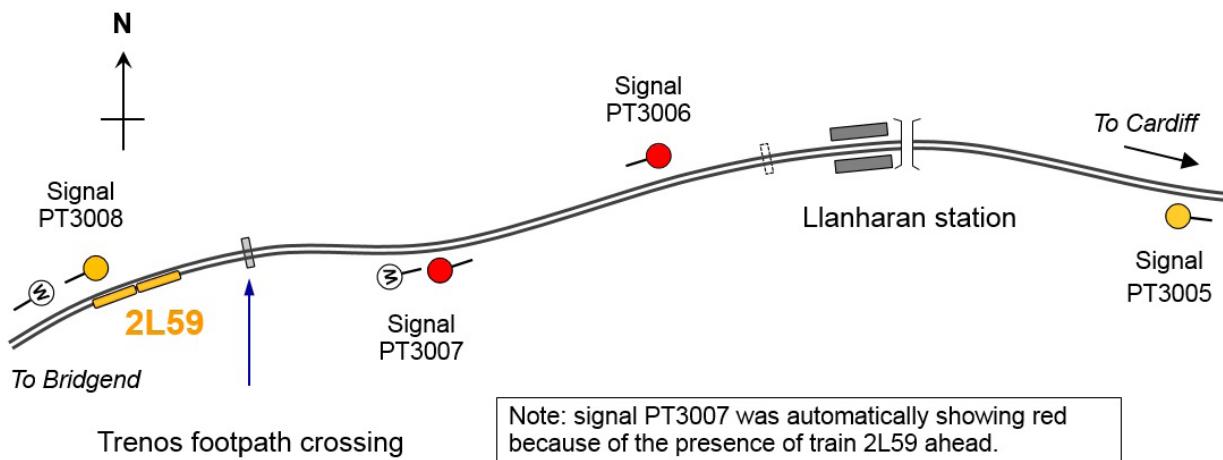
Figure 15: diagram at 15:51 hrs

- 43 The driver of train 2L59 contacted the Port Talbot signaller using the in-cab radio's emergency button. He informed the signaller that his train had struck a pedestrian on the level crossing just after Llanharan station. In response, the Port Talbot signaller put signal PT3006 to red (figure 15). This would have prevented a train approaching Llanharan crossing on the up line but would not have prevented a train approaching Trenos crossing. At 15:58 hrs, the signaller put signals PT3005 and PT3008 to red. Although the signaller still believed the accident had occurred at Llanharan crossing, this action also prevented trains approaching Trenos crossing.
