# ***AAIB Bulletin***

***6/2018***

## **AAIB Correspondence Reports**

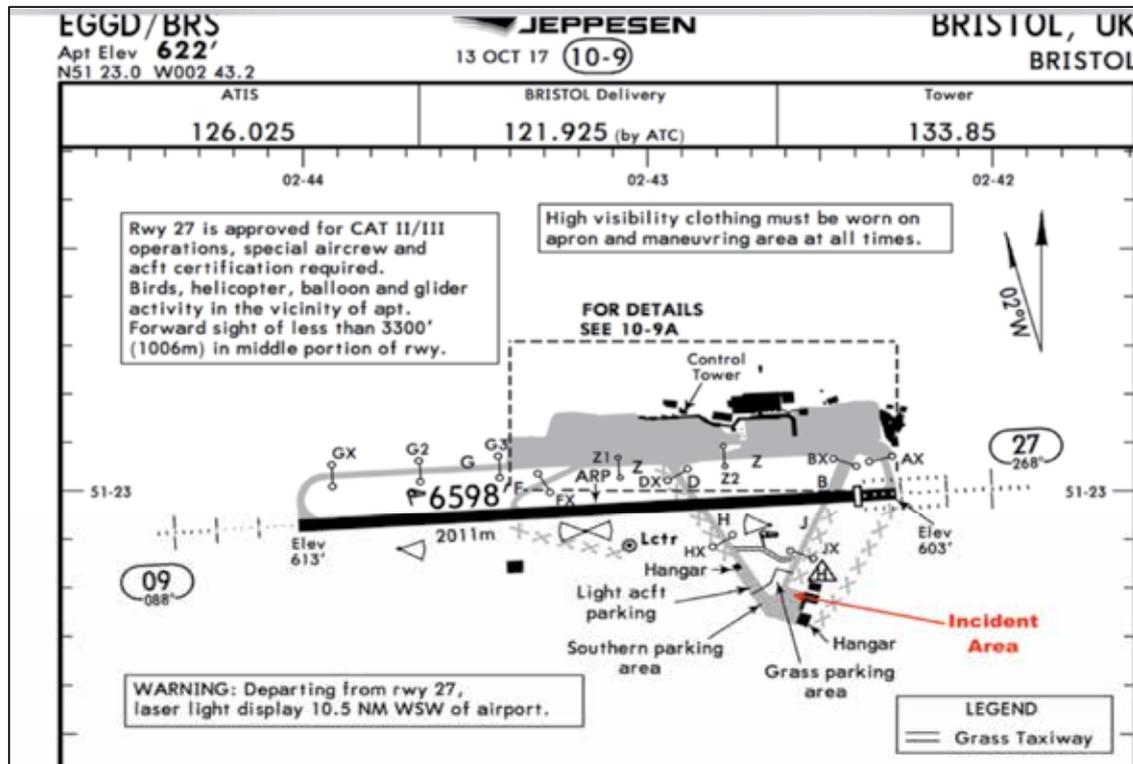
Figure 1

who provided a marshalling service. The commander reported that after crossing the Juliet X-Ray holding point (Figure 1), the aircraft was met by a wingman who stood on the left of the aircraft behind the tail of a parked Embraer 145 and a marshaller located just in front of the grass verge where the aircraft was to be parked (Figure 2). The marshaller then signalled to the flight crew to continue to move forward.

Layout of the airport showing the JX hold point and the Southern parking area

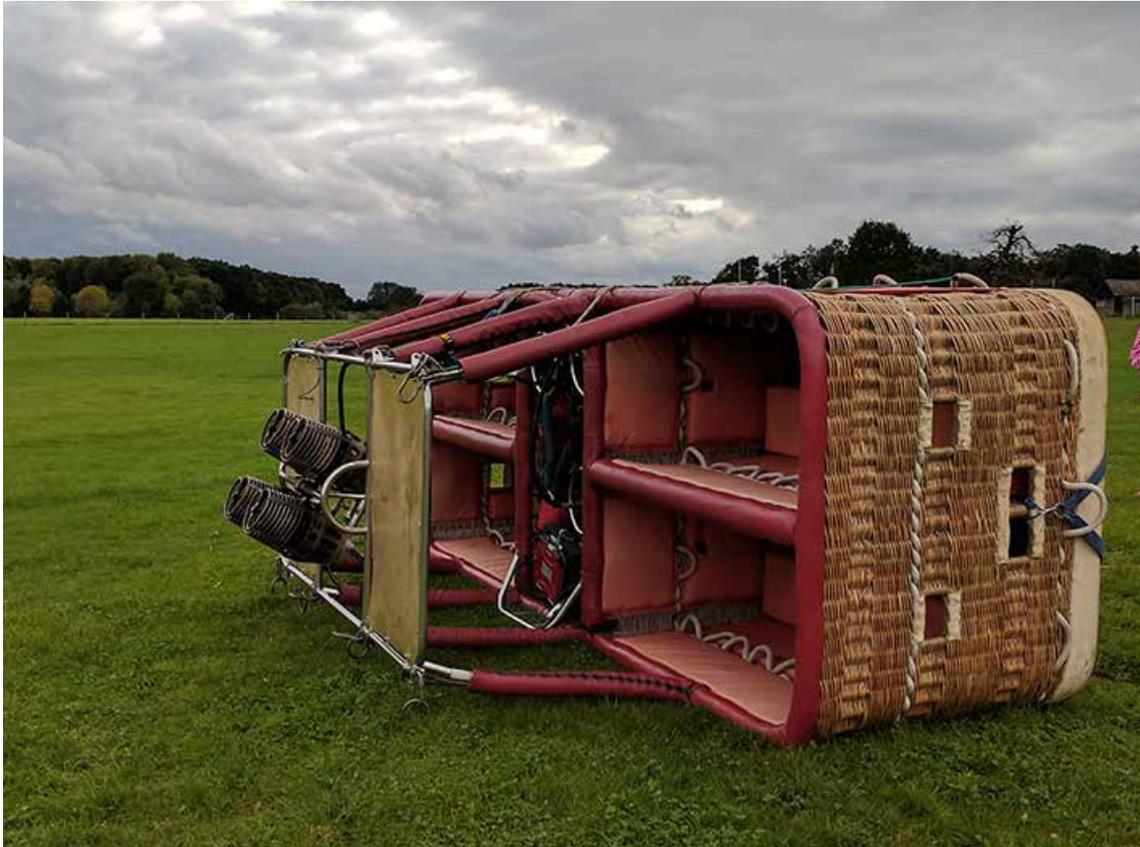
**Figure 1**

G-VBFO is a Cameron Z-375 hot air balloon. The basket has a central area for the pilot and four passenger compartments, two either side of the pilot (Figure 1). The operator's operations manual specifies that G-VBFO may carry a maximum of 18 occupants.

G-VBFO Basket before the flight
