Service Inquiry

CHALLENGER 2 Incident
at Castlemartin Ranges,
Pembrokeshire

14 Jun 17

SERVICE INQUIRY INVESTIGATION INTO THE ACCIDENT INVOLVING A CHALLENGER 2 AT CASTLEMARTIN RANGES, PEMBROKESHIRE ON 14 JUN 17

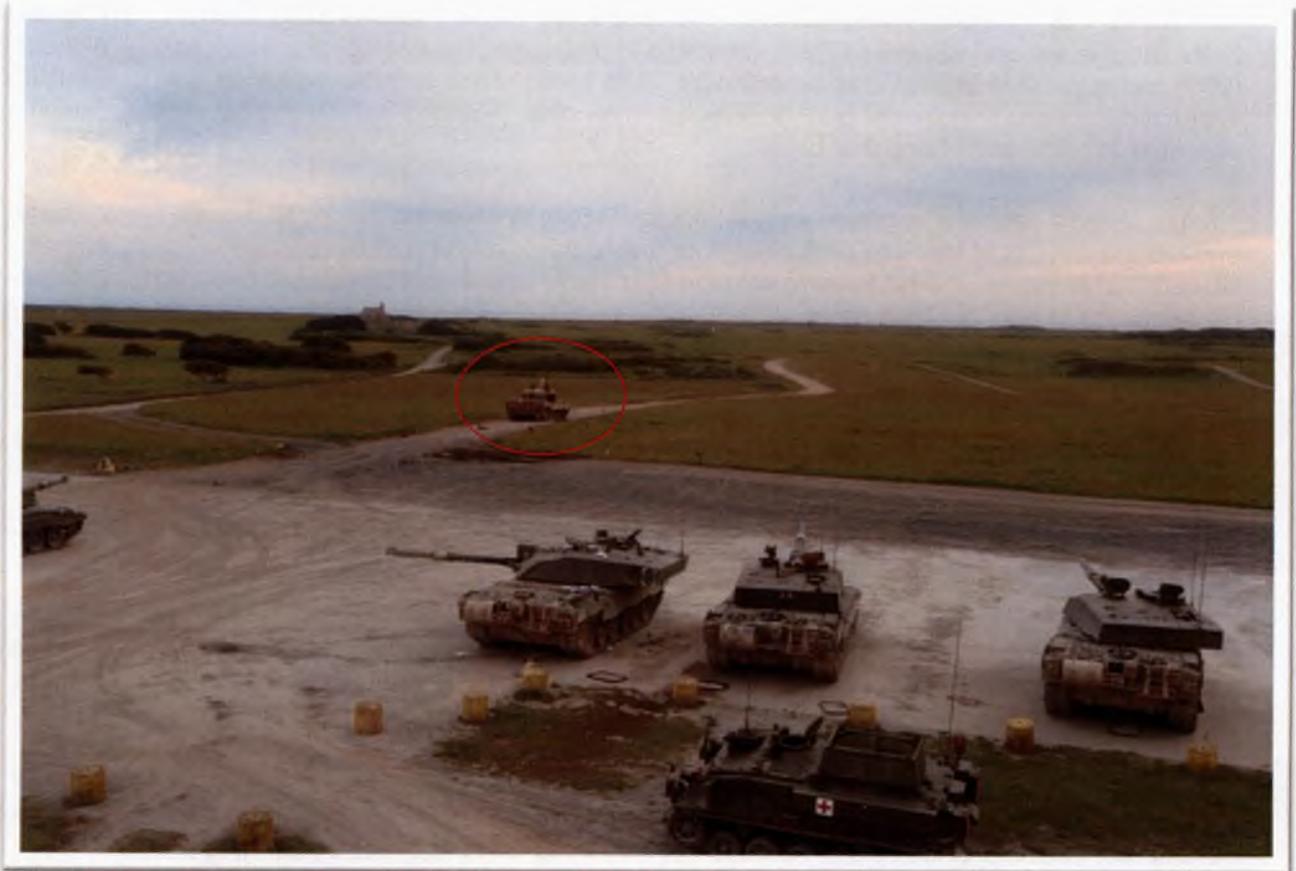
Figure 1.3.4: The Post Incident View from Range 4 Control Tower showing CR2 ERM DS39AA (circled in red) on Lane 2 Bound 1

1.3.14. At approximately 1525 white smoke was seen coming from the open turret hatches, accompanied by a loud hissing noise. Very shortly after this, the Commander was seen attempting to rapidly leave the turret from the Commander's hatch (right hand side). When his waist was level with the top of his hatch, an explosion occurred which threw him approximately 5m into the air and he landed on the grass 6m to the right of the vehicle. Immediately after this explosion, 2 large, violent jets of flame were seen coming from both turret hatches for approximately 5 to 8 seconds. The Training Safety Manger (TSM) in Range 4 Control Tower called "Stop, Stop, Stop" on the radio link to Warren Tower.

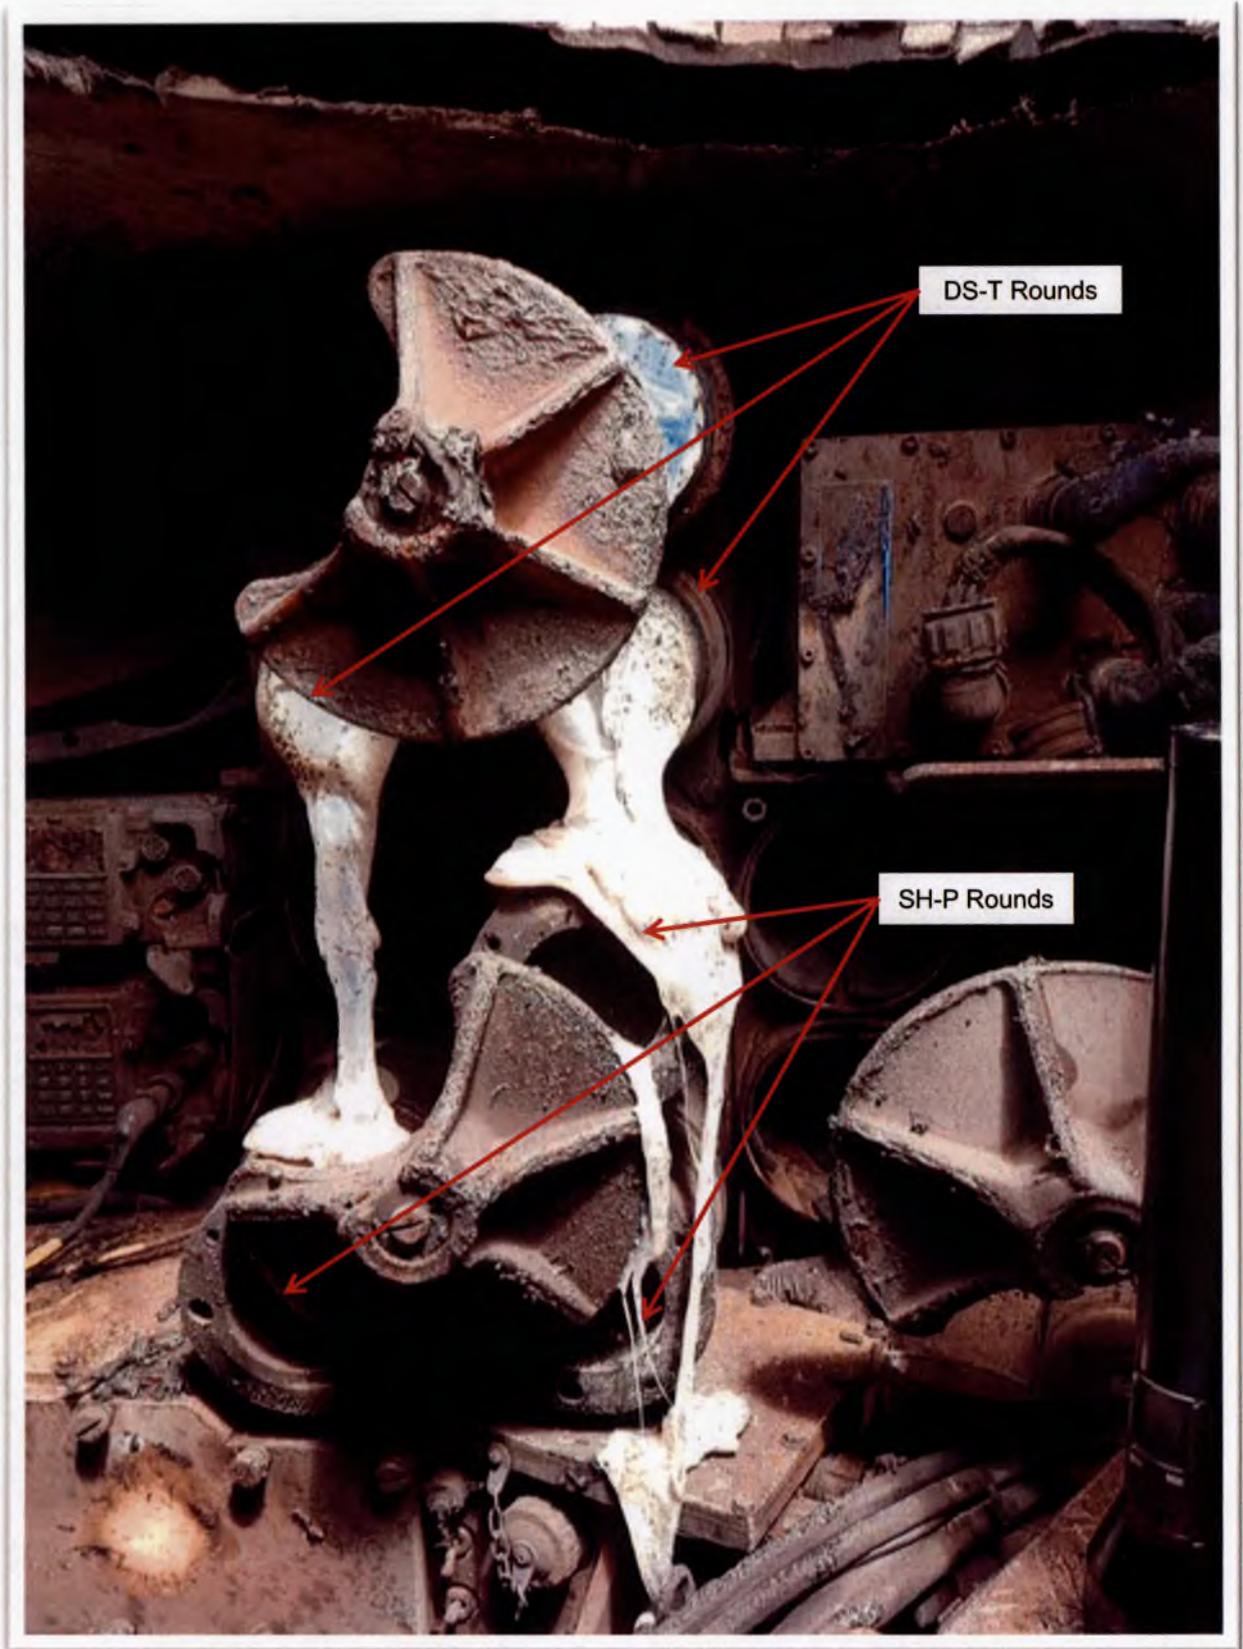
Figure 1.4.24: Projectiles in Racking

1.4.126. Seven projectiles were recovered from the tank, 3 SH-P and 4 DS-T. Therefore the missing eighth projectile, a SH-P, almost certainly was loaded into the gun as the first round to be fired, with the appropriate Propelling Charge, a CP SH, in the gun chamber. The amount of energy required to cause the catastrophic breech failure, resulting in the Upper Breech Block detaching from the Breech Ring and the lower Breech Block is significant. The Panel opined that this could only come from the ignition of this Propelling Charge in the chamber. The bore of the gun was found to be clear and therefore the SH-P must have been fired from the gun⁴⁸ with a much reduced muzzle velocity. This is consistent with the witness statements of a different noise being heard (compared to a normal firing) and the lack of recoil observed⁴⁹.

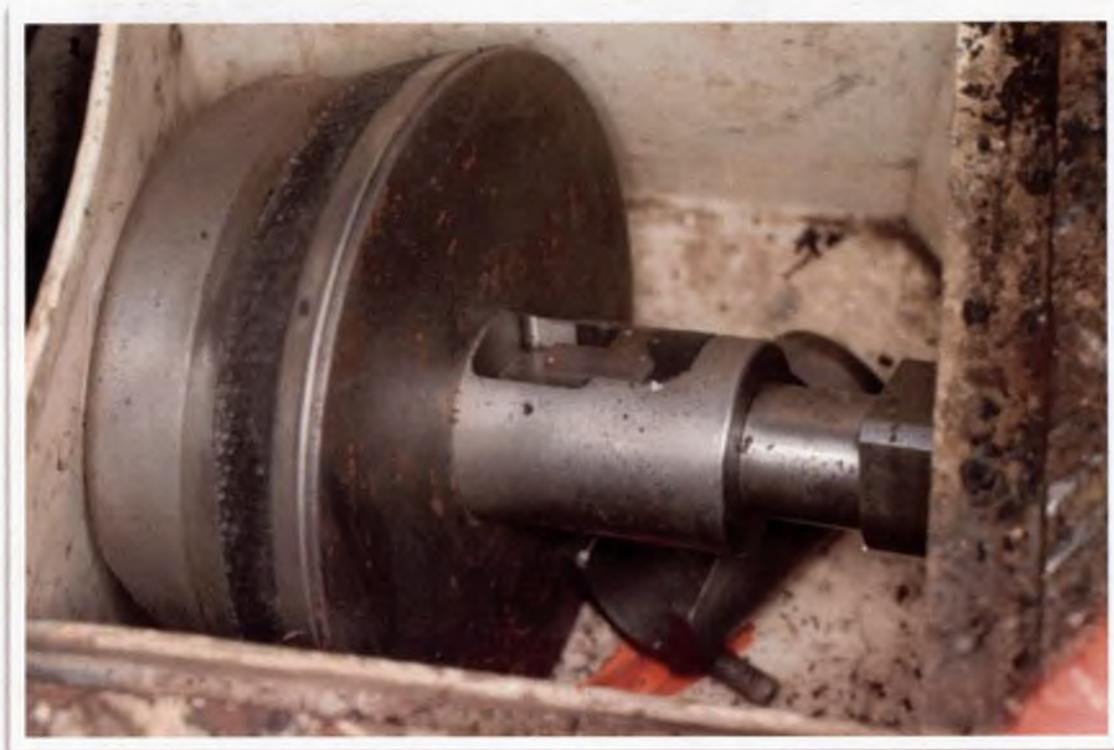
Figure 1.4.30: Ration Stowage Box with Phone, Tape, Leads, Pencil and Rag Removed

1.4.121. The serial numbers of the BVA and Obturator Pad discovered in the Rations Stowage Box matched those recorded in the DS39AA Gun Documentation Folder and only one BVA had been issued to this tank. No other BVA Assembly was found on the tank post-accident.

1.4.124. The BVA Assembly had been removed by the previous crew (C/S 30B), cleaned and placed in the Ration Stowage Box. It was recovered from this position in a clean state on 16 Jun 17. The serial number of this BVA matched the Gun Documents for DS39AA and no other BVA was found in the tank during the forensic examination.

Ration Stowage Box (Figure 1.4.30) which was later shown to belong to the Loader⁵¹. When the Loader mounted the tank he would likely have taken his mobile phone and placed it in the Ration Stowage Box to prevent it being damaged whilst he conducted the Experience Shoot. The Panel was told that the Ration Stowage Box is routinely used to store personal items. When he placed it in the Box he almost certainly did so in a manner which precluded observing the BVA Assembly, which was partially obscured by a rag and electrical leads.

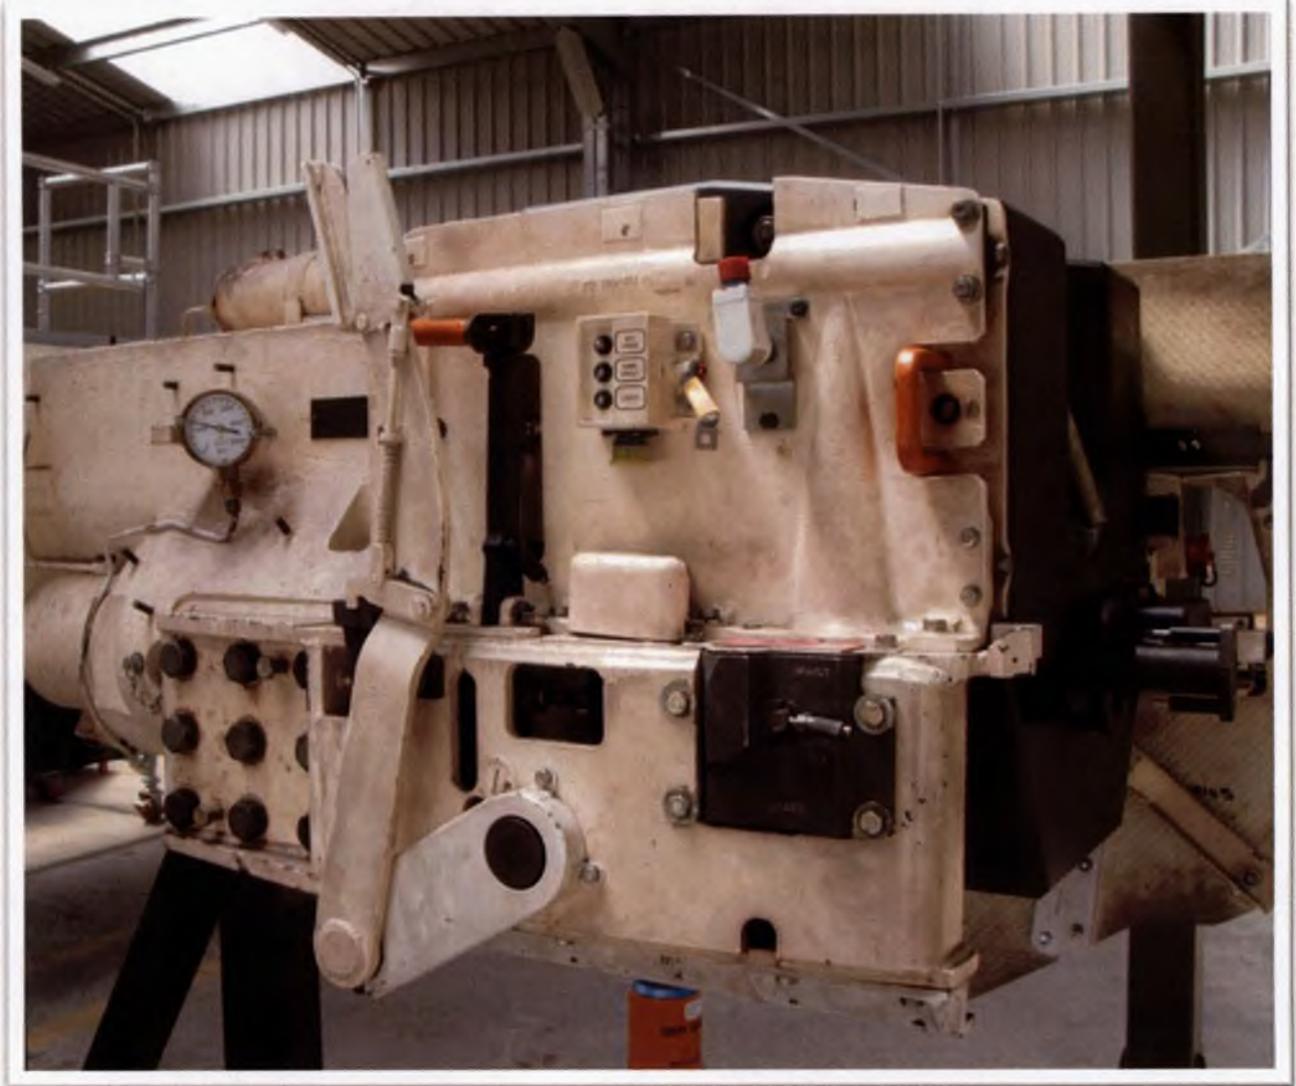
Figure 1.4.33: Classroom Instructional Model L30A1

1.4.133. In light of this conclusion, reference models were tested to discover how it was possible to complete the Firing Circuit and therefore fire the gun with the BVA Assembly removed. The BVA Assembly was removed from the Breech of a Classroom Instructional Model (CIM) of the Main Armament (Figure 1.4.33) and the following tests completed.

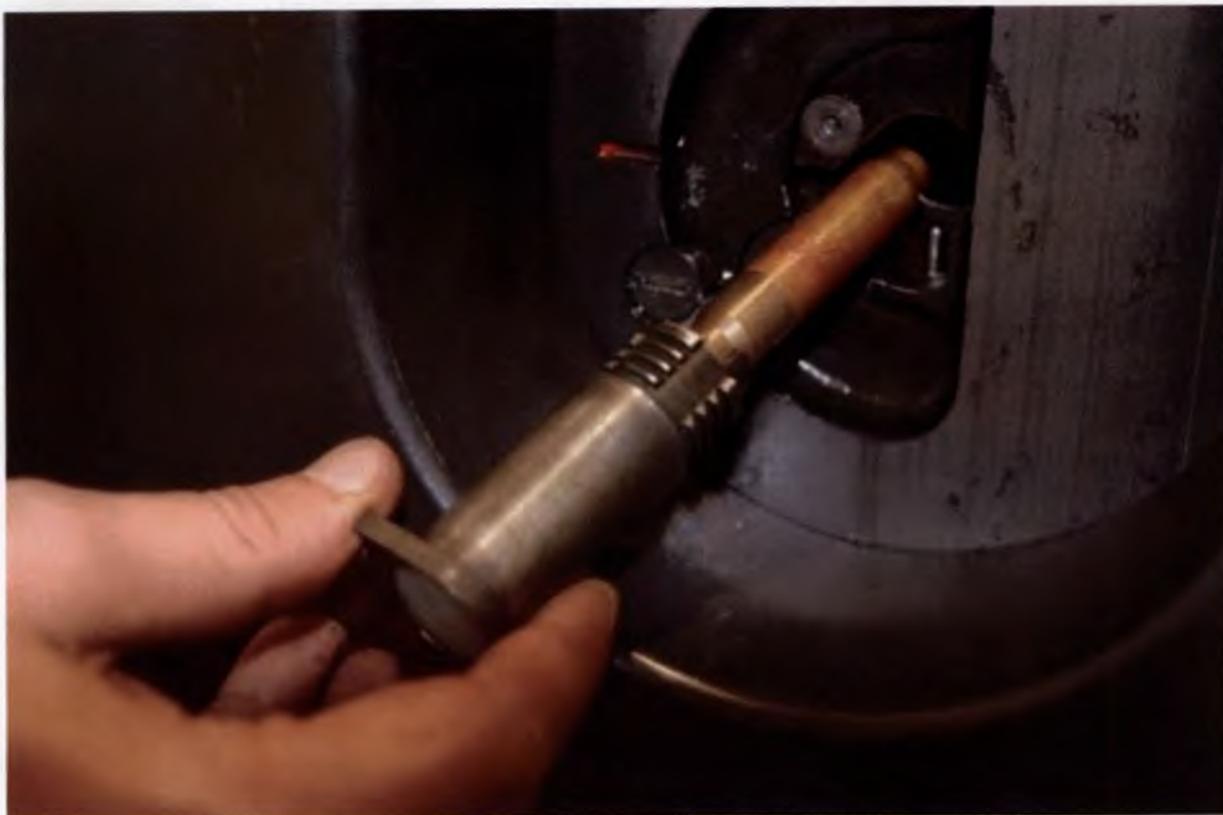
Figure 1.4.35: Hand Loading a Firing Needle Assembly with a Tube Vent Electric Fitted

1.4.134. Hand loading the FNA with a TVE fitted was the only method that the Panel and their supporting subject matter experts could establish that completed the Firing Circuit with the BVA Assembly missing.

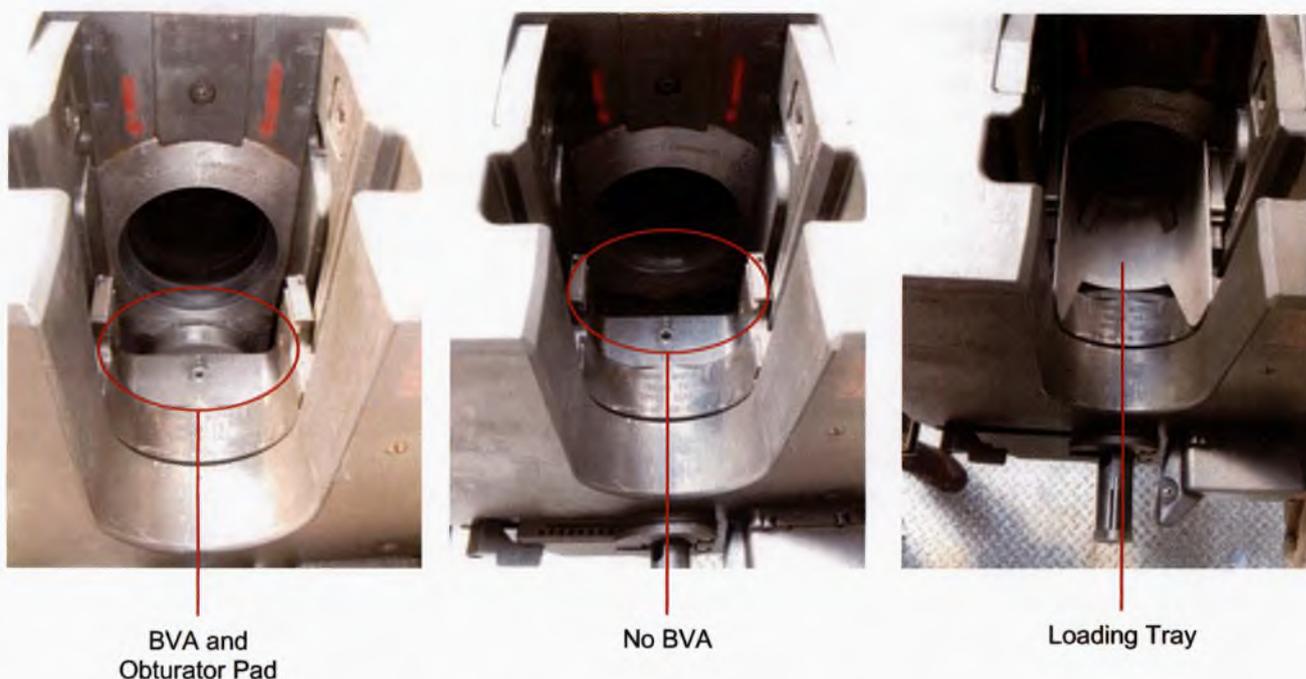
Figure 1.4.36: View of the Gun Breech⁵⁴ (Breech Open)
Left: BVA Assembly Fitted (Circled), Loading Tray Not Fitted
Centre: BVA Assembly Not Fitted, Loading Tray Not Fitted
Right: Loading Tray Fitted

1.4.146. The Panel concluded that:

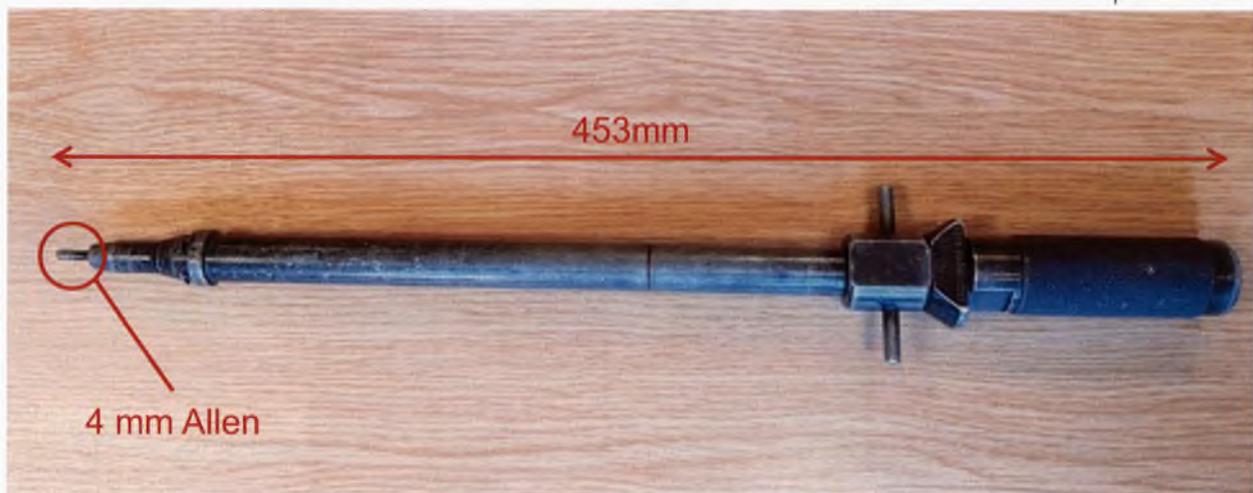
Figure 1.4.39: Combination Tool

1.4.151. When the Panel observed this drill being conducted on a CIM and in reference tanks, it was found that holding the Combination Tool with the back of the left hand flush against the FNA (holding it into the Lower Breech Block) it was relatively easy to turn the screw without realising there was no Thrust Housing in place, as the FNA is quite a tight fit. The dimensions of the tool require 2 hands to maintain any degree of control and, as such, all personnel witnessed conducting this drill placed their left hand on the FNA in this manner.

1.4.152. The Panel concluded that a loader can fit an FNA into the Lower Breech Block without realising that a BVA Assembly is absent.

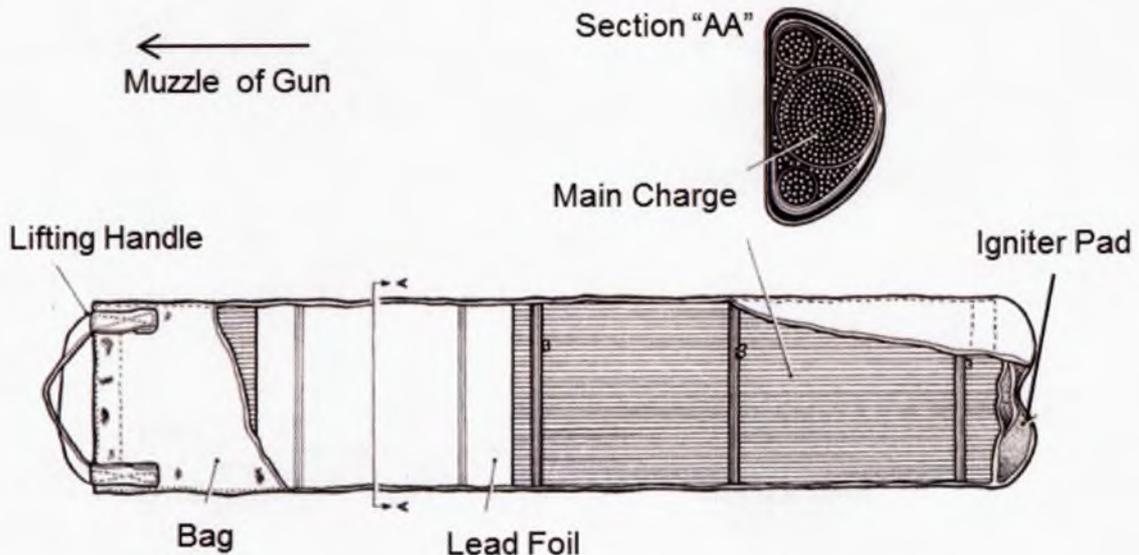
Figure 1.4.41: Detail of Charge Propelling – Squash Head L3A2

1.4.173. In its normal mode of operation, the hot products of combustion from the gun powder charge in the TVE would pass down the Flash Channel in the BVA and ignite the Igniter Pad at the rear of the CP SH (see Figure 1.4.41). With no BVA fitted there was approximately a 12cm gap between the front of the TVE and the Igniter Pad, but even without the concentrating effect of the Flash Channel, the hot gases and particles were sufficient to ignite the pad, initiating the explosive train within the Propelling Charge and igniting the Main Charge.

1.4.174. The Panel concluded that the TVE ignited the CP SH in the Chamber.

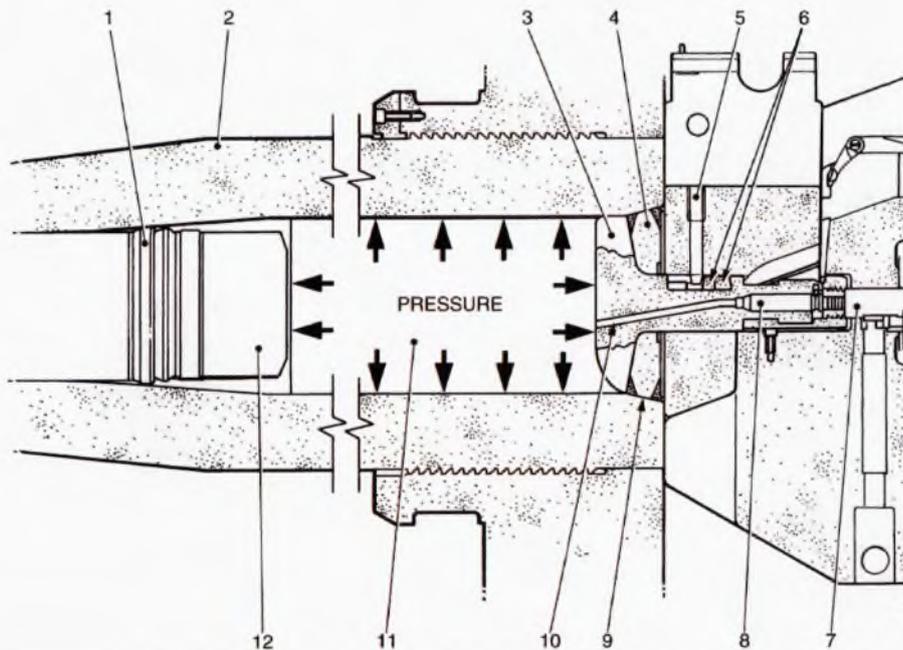
Figure 1.4.42: Obturation in the Main Armament

- a. Forward obturation is achieved by the **driving band** on the **projectile** engaging in the rifling in the gun **barrel**.
- b. Rearward obturation in the L30A1 gun is achieved by the components in the breech, principally the **BVA** and **Obturator Pad**, all held in place by the Upper and Lower Breech Blocks. As the charge burns, the pressure builds on the front face of the BVA, forcing it rearward and compressing the Obturator Pad against the Upper Breech Block. This forces the Obturator Pad radially outwards to create a gas proof seal between the Obturator Pad and the **Cone Shaped Seating** at the rear of the barrel chamber. Gas pressure is transmitted rearwards via the **BVA Flash Channel** to the brass **TVE Case**. This expands the case hard against the TVE chamber wall creating a gas proof seal, completing rearward obturation. All the components in bold are shown in Figure 1.4.42.

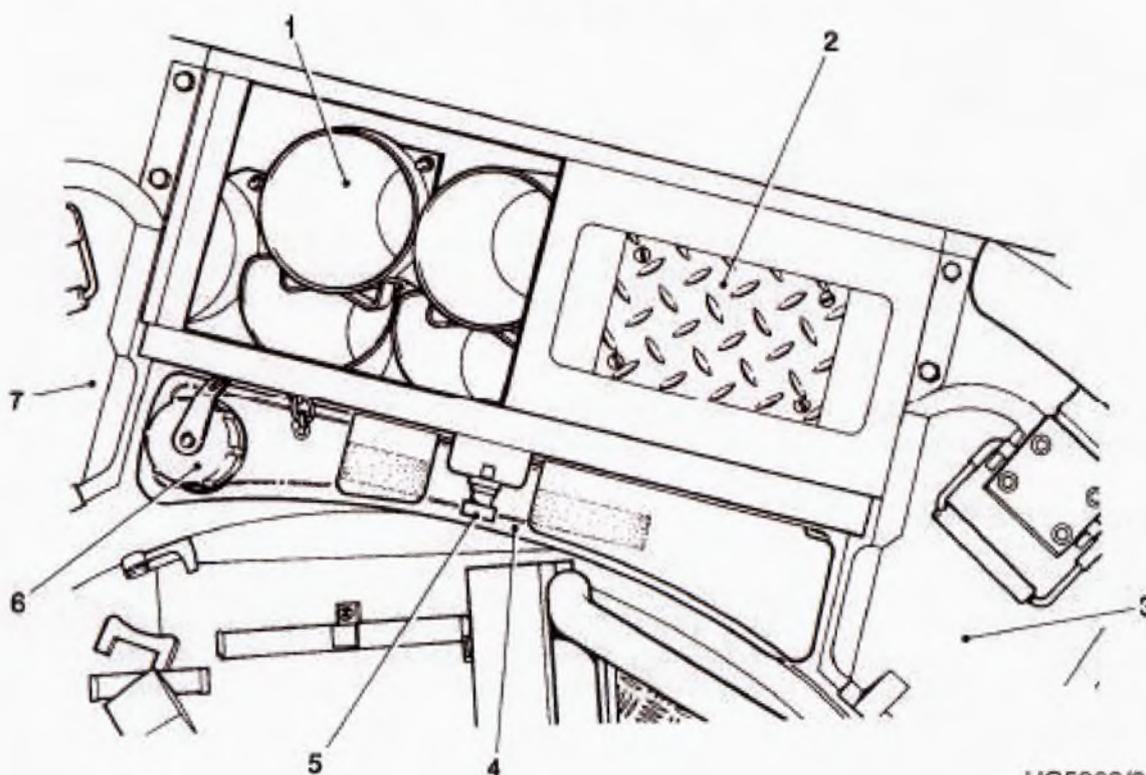
1.4.202. The armoured charge bins in CR2 are located low down around the Fighting Compartment. The majority of them are fixed to the hull of the tank and do not rotate with the turret. As such, they are not accessible at all times: the orientation of the turret occasionally prevents access. They have sliding or lifting lids which must be closed after use, to protect the charges and prevent the lids from snagging on wiring or other fittings. Figure 1.4.43 shows the Rear Charge Bin, Centre Compartment, which has sliding lids.
