AAIB Bulletin

8/2018

Aircraft Type and Registration:	Piper PA-28RT-201 Cherokee Arrow IV, G-BHAY	
No & Type of Engines:	1 Lycoming IO-360-C1C6 piston engine	
Year of Manufacture:	1979 (Serial no: 28R-7918213)	
Date & Time (UTC):	11 September 2017 at 0956 hrs	
Location:	Wolferton, Norfolk	
Type of Flight:	Private	
Persons on Board:	Crew - 1	Passengers - 1
Injuries:	Crew - 1 (Fatal)	Passengers - 1 (Fatal)
Nature of Damage:	Engine front fuselage, wings and landing gear severely disrupted	
Commander's Licence:	Private Pilot's Licence	
Commander's Age:	58 years	
Commander's Flying Experience:	1,129 hours (of which 406 were on type) Last 90 days - 15 hours Last 28 days - 10 hours	
Information Source:	AAIB Field Investigation

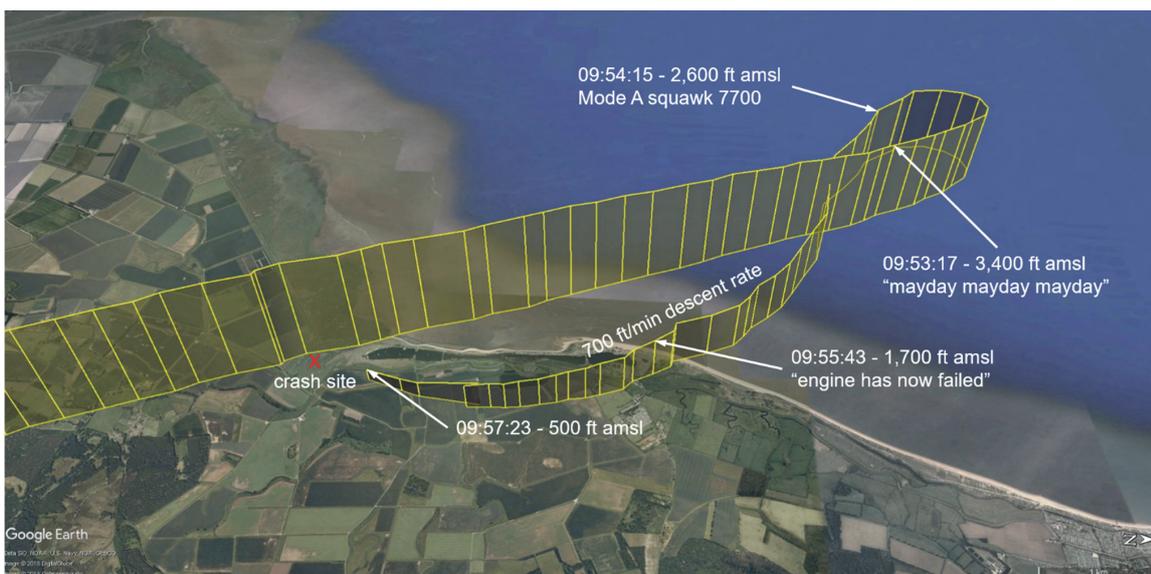
At 0953 hrs, when the aircraft was over the Wash after crossing the Norfolk coast, the pilot transmitted a MAYDAY to the Distress and Diversion Cell (D&D) on 121.5 MHz, stating he had a “VERY ROUGH RUNNING ENGINE,” that the aircraft was at 3,300 ft amsl, descending, and he would turn south towards RAF Marham. A short time later he transmitted “THAT’S SMOKE NOW I THINK WE’VE GOT AN ELECTRICAL FIRE...”. About one minute later he transmitted “ENGINE HAS FAILED”. At this point the aircraft was at about 1,400 ft amsl and D&D informed the pilot the aircraft was 13.5 nm from RAF Marham, to which the pilot replied he would not make it. The controller suggested Great Massingham 9 nm away but the pilot replied he would not make that either and, as the aircraft was passing 1,200 ft amsl, he added “IT’S GONNA BE A FIELD”. This was the last transmission received from the aircraft and was 30 seconds before the last radar contact. Figure 1 shows some of the radio transmissions relative to the radar track.

View looking to the west of last seven minutes of the radar track
(altitudes are Mode C \pm 50 ft, corrected to the QNH 988 hPa)

The aircraft crossed the coastline at 0951:30 hrs and started to descend 30 seconds later. After a further 1 minute 17 seconds (about 3 nm from the coastline crossing) the pilot made the MAYDAY radio transmission (RTF) to D&D (Figure 1).

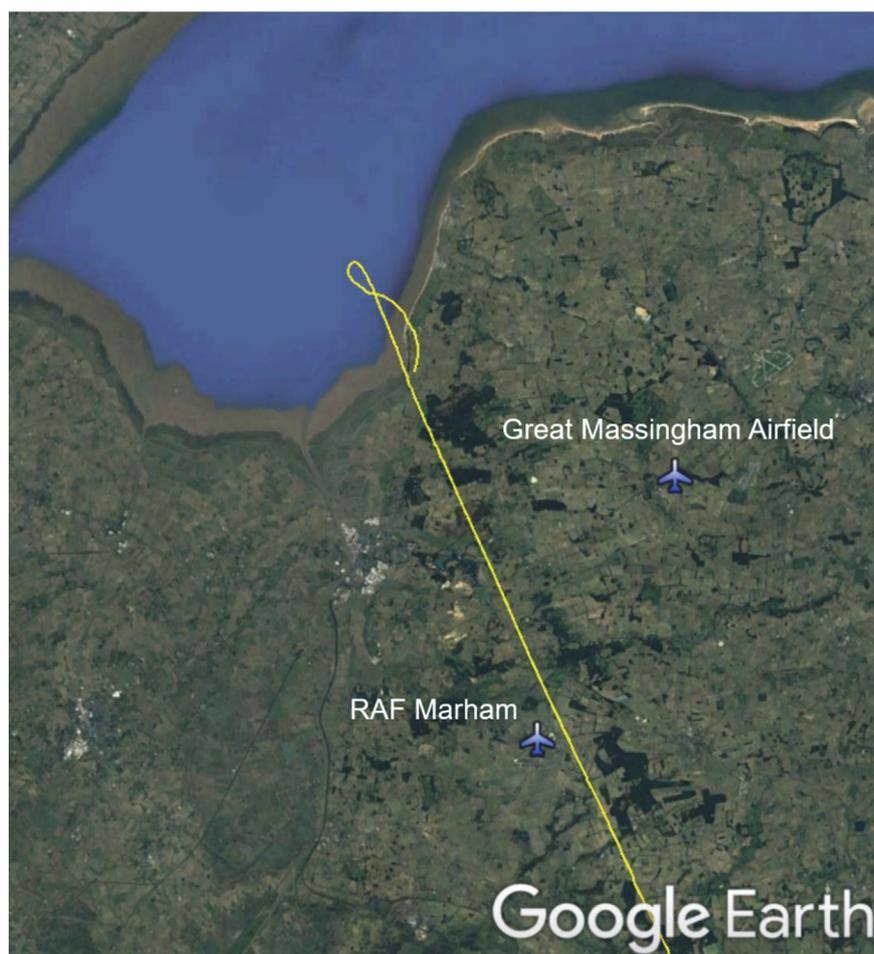
Radar returns from the aircraft were recorded for the flight starting shortly after takeoff from Southend and stopping when the aircraft was about 0.25 nm from the accident site. The returns included height information (rounded to the nearest 100 ft) and indicated that the cruise altitude for the flight was about 4,300 ft amsl. A composite radar track of the last 17 minutes of flight from the Cromer and Debden radar heads is shown in Figure 2 and an expanded plot of the final phase is shown in Figure 1.

Portion of radar track of G-BHAY – final 17 minutes

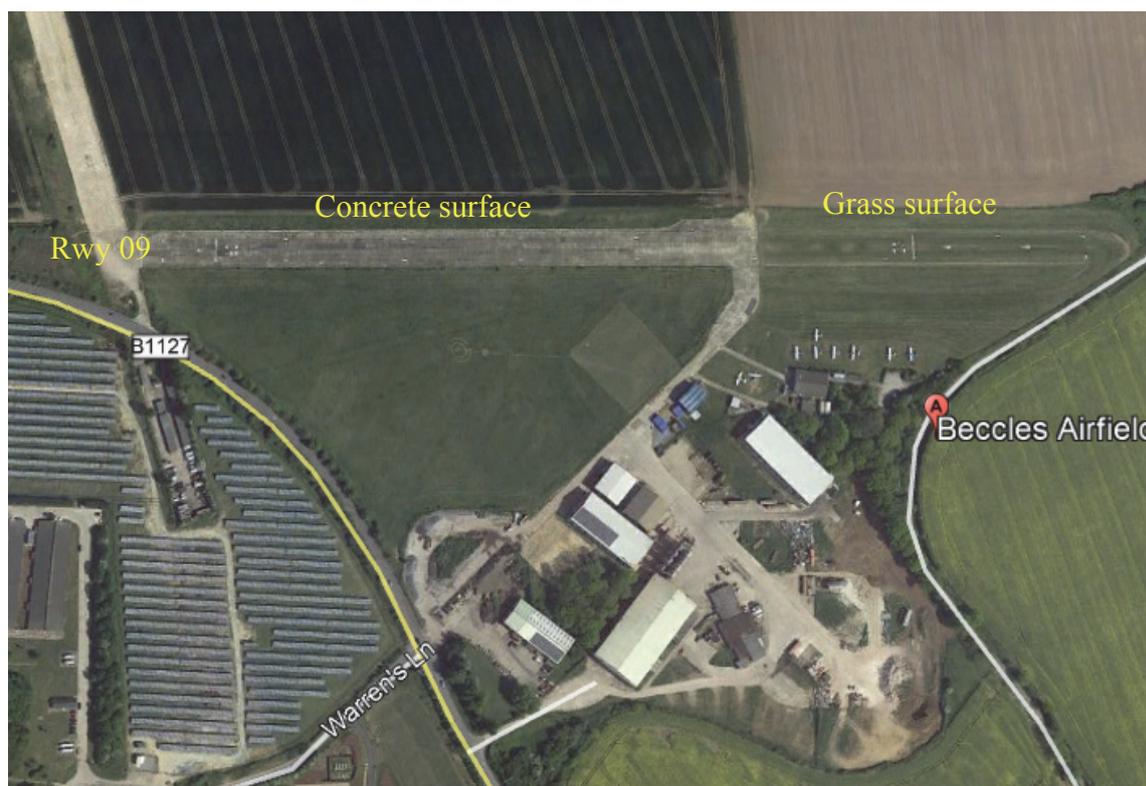
Beccles Airfield has one runway, aligned 09/27. The surface of the first 500 m of Runway 09 is concrete and the remaining 250 m is covered in grass. The LDA is 624 m. A Google Earth image of the airfield is at Figure 2.

Figure 2
Beccles Airfield
