AAIB Bulletin

7/2018

Published 12 July 2018

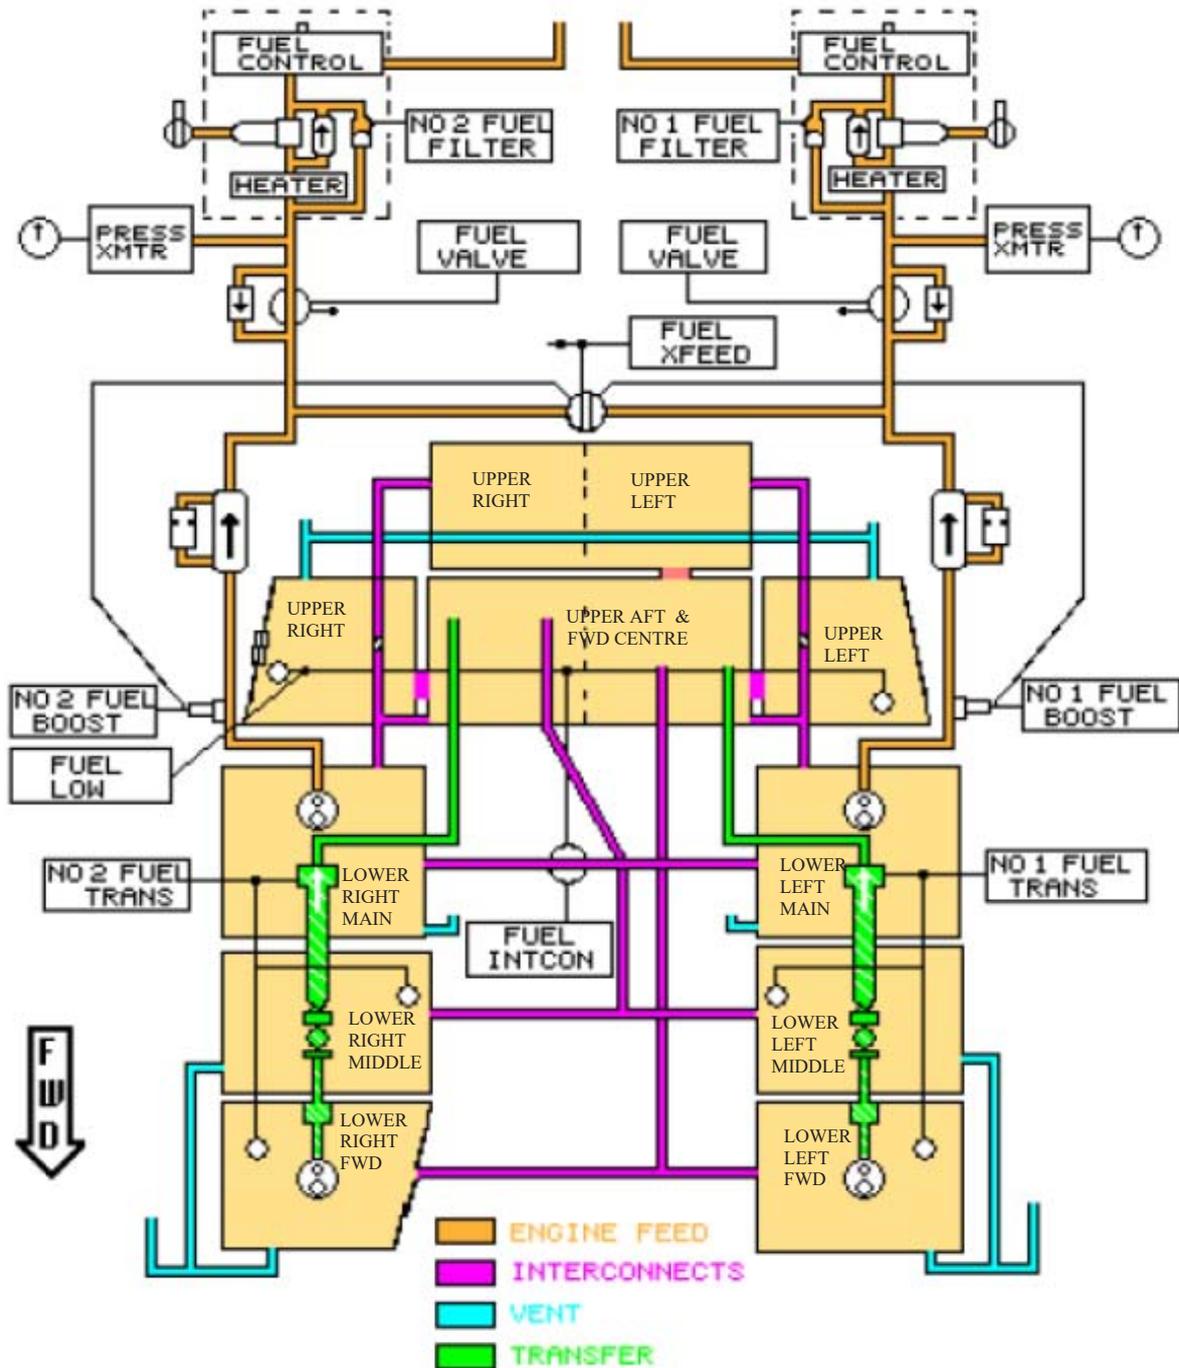
Figure 4

Bell 412EP Simplified fuel system schematic (Note: auxiliary tank not shown)

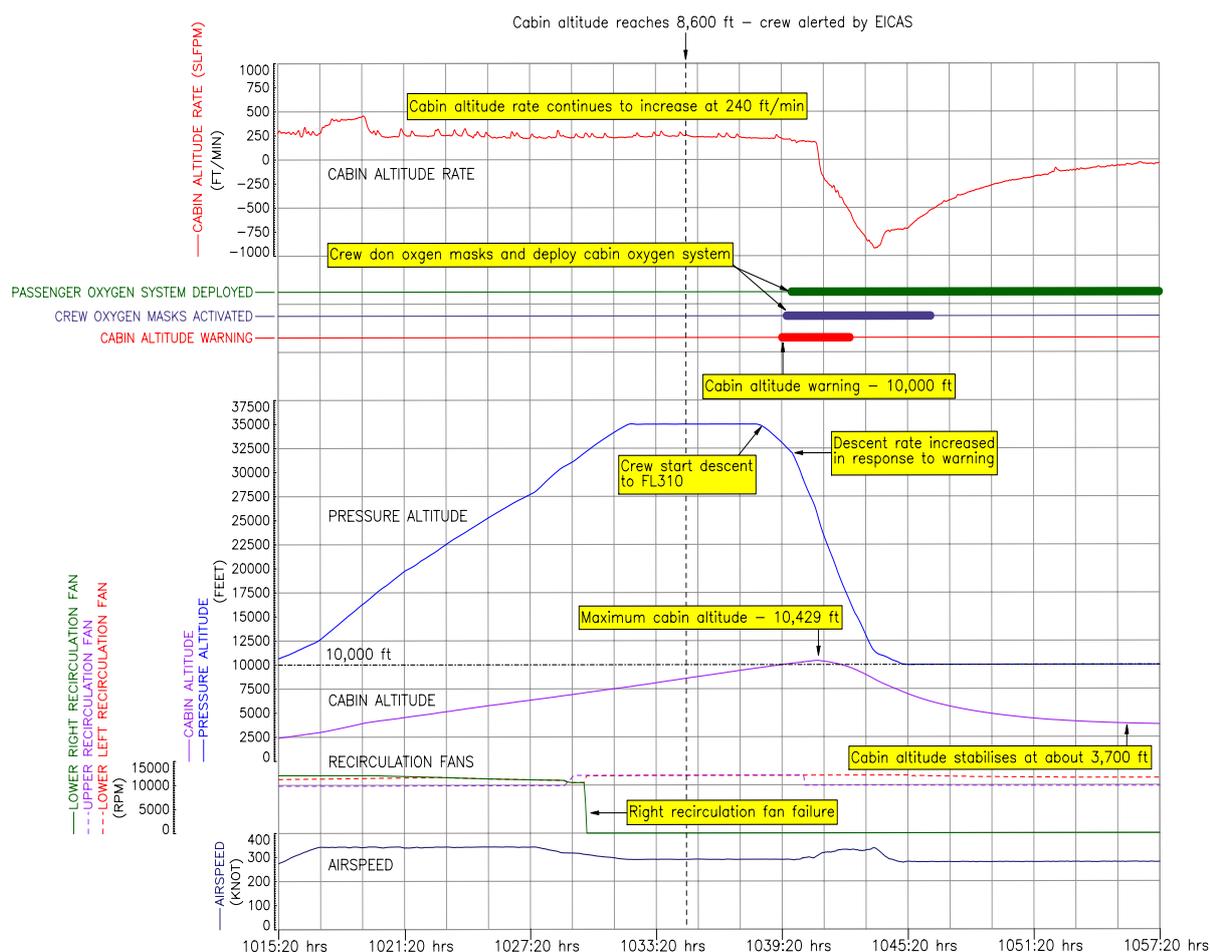
Figure 2

At 1029:54 hrs, as the aircraft was climbing through FL320, the air conditioning lower right recirculation fan stopped. The cabin altitude was 7,000 ft at this time and at 1033 hrs system status message 'RECIRC FAN LWR R' was triggered by the CMCF. This message was subsequently referred to by the crew about a minute later, after they had been alerted to the abnormal cabin pressure on EICAS.

The aircraft manufacturer later reviewed the 'RECIRC FAN LWR R' status message and its associated fault code '1031 Motor Driver Current Fault'. The manufacturer stated that the fan shut down, after which the air conditioning system attempted to restart it. After three consecutive failed attempts to restart, the status message 'RECIRC FAN LWR R' is triggered. This is a latched fault that cannot be cleared in flight. The aircraft manufacturer stated that the fault with the fan was most likely associated with it having become detached from the inner duct.

Descent from FL350 following cabin altitude warning

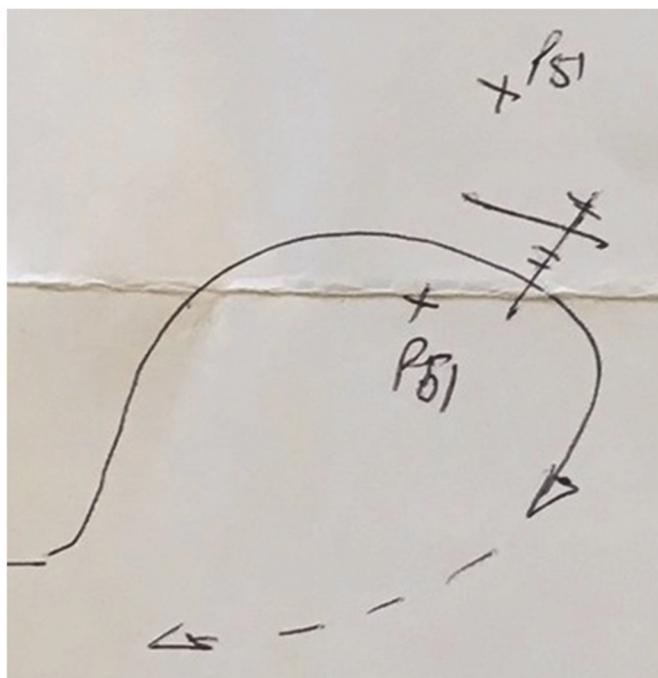
Figure 1

G-BIXL's pilot stated that when he draws a diagram of a formation display he usually annotates an aircraft symbol with 'ME' to indicate which aircraft is his in the formation. On this occasion he annotated 'P51' against both symbols representing the P-51s (Figure 1). He is "fairly sure" that had he differentiated between the two symbols, he would not have joined the B-17 on the right. He stated that he would ensure that he always does so in future.

Part of G-BIXL's pilot's annotated diagram

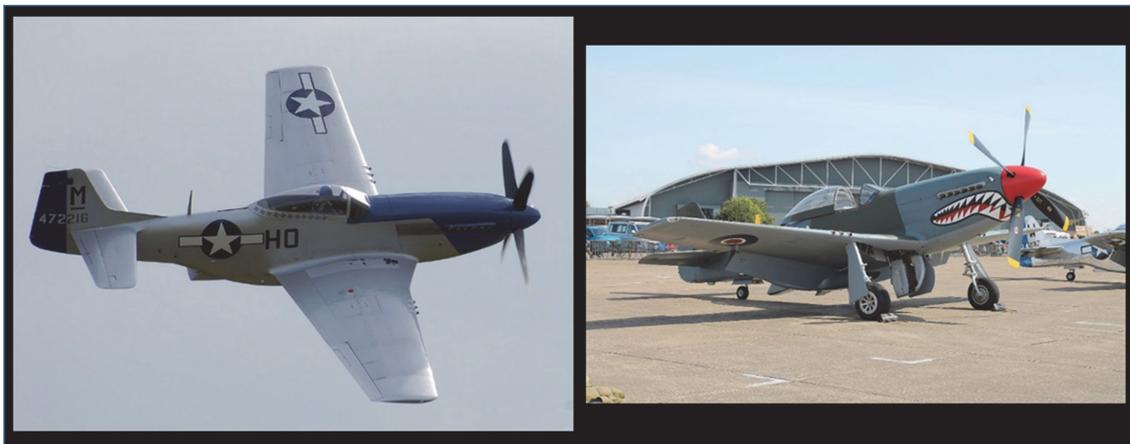
Figure 2

P-51D Mustang aircraft involved in the accident.
(G-BIXL on the left and G-SHWN on the right)

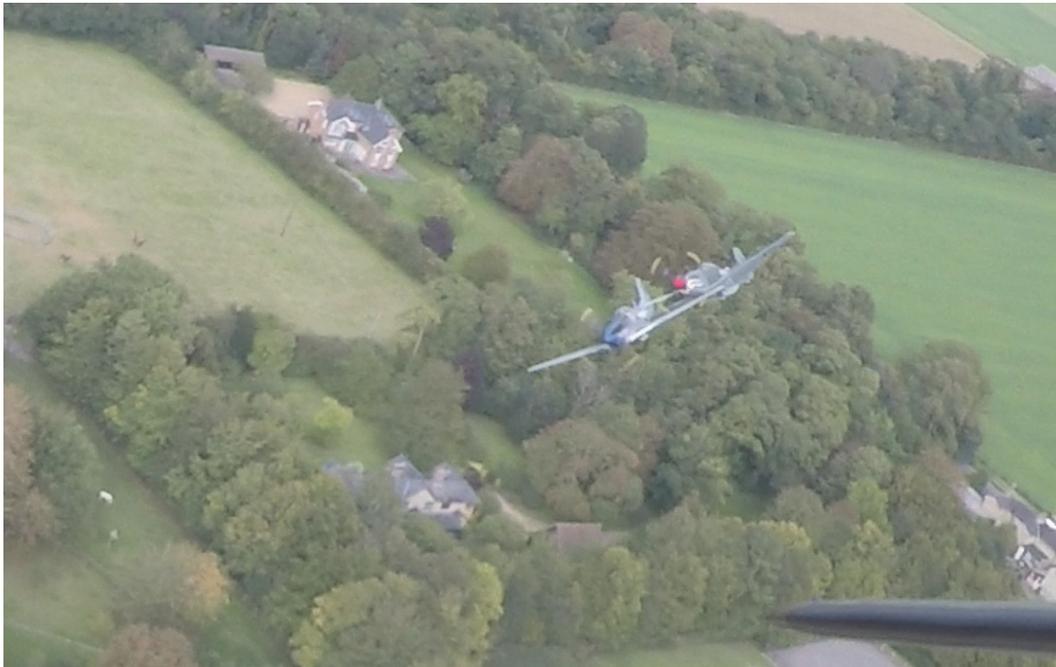
Figure 5

The collision between the aircraft was recorded by two cameras; one being operated by a witness on the ground and another fixed to the B-17, looking rearward from one of the observation windows and recording autonomously. A still from the latter is shown in Figure 5.

Video still showing the collision

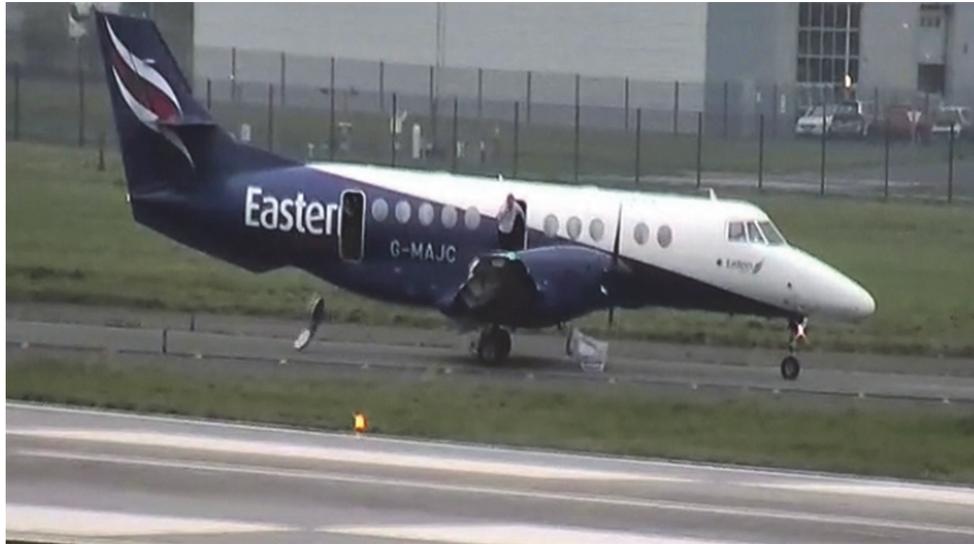
After the commander made the evacuation announcement to the cabin, the engines continued to operate at idle power for 8 seconds before they started to run down; the propellers continued turning for a further 40 seconds. The forward cabin door and the two mid-cabin over wing emergency exits were opened by the passengers. The right over wing exit door was dropped

to the ground behind the wing and blown forwards by the wind into the still rotating right propeller. The aft cabin exit door was opened by the cabin crew member; it fell to the ground and was blown rearwards by the propeller wash from the right engine (Figure 1).

Figure 1
Aircraft evacuation

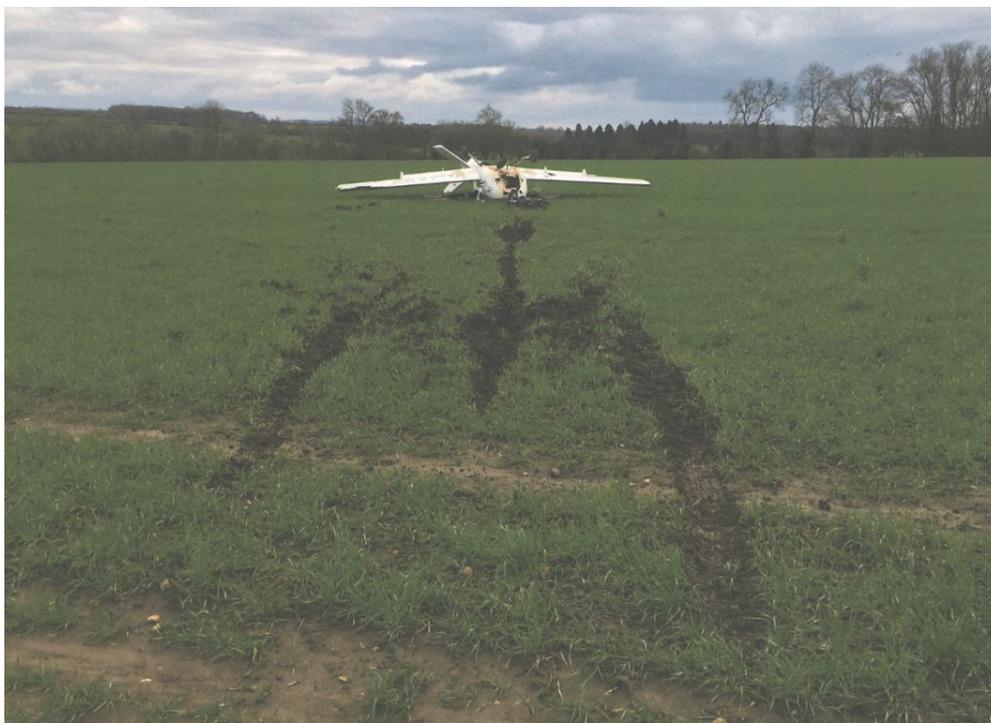
Figure 1

The pilot selected a large field to land in that was downwind, with slight downslope in the selected landing area. The aircraft touched down in the field on the main landing gear, before the nose landing gear leg dug in, causing the aircraft to nose-over and come to rest inverted (Figure 1). The pilot reported that the field was soft due to recent wet weather.

He sustained minor injuries and stated that he found egress from the aircraft difficult due to damage to the upper fuselage and the broken canopy. He recalled hearing the sound of at least one of the aircraft's electric fuel pumps running whilst he was in the aircraft, prior to his egress, and stated that all of the aircraft's switches were in the normal positions for flight.

Accident site

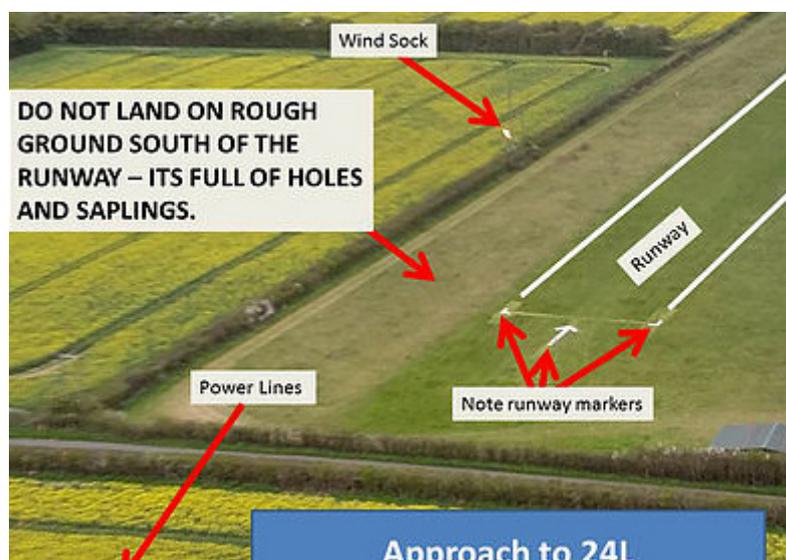
Figure 1

Chilbolton is an unlicensed airfield but the operator tries to alert pilots to the presence of the adjacent rough ground in flight guides and on its website. The pilot was aware of the website but had not referred to it prior to this flight and he had not seen a photograph, recently added and labelled, to show pilots what to look for when landing on Runway 24² (Figure 1).

Illustration from the on-line brief for Chilbolton Airfield, highlighting the rough ground beside the runway. The illustrated white parallel lines do not represent ground markings
