**PART 1.4 – FINDINGS**

1.4.1 The XZ210 Service Inquiry (SI) was convened on 5 Dec 11 to investigate the circumstances surrounding the loss of a Gütersloh based Army Lynx helicopter and to make recommendations in order to prevent recurrence and enhance air safety. While the main focus for the inquiry's determination of causal factors was on the technical aspects of the accident, a wide range of related issues were investigated to inform the Panel's findings set out in this part of the report. Although the SI Panel was dislocated from the country where the accident occurred throughout the majority of the inquiry, this did not prove a significant hurdle; particularly as the ac remains had been transported to UK for examination.

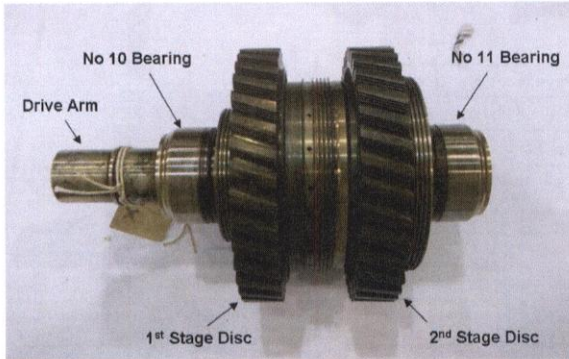
Fig 4 - Example 1<sup>st</sup> & 2<sup>nd</sup> Stage Disc (without aerofoils) and Drum Assembly

- a. **No10 Bearing Sealing Flange Retaining Bolts.** The first part of the sequence initiated within the Module 7 whereby all 11 of the No10 bearing sealing flange retaining bolts had loosened over a long period of time (up to 1530 hrs). This allowed a micro-movement of the No10 bearing sealing flange causing a significant contact rub between the sivaloy seal and seal arm. The rub led to the subsequent mechanical failure of the sivaloy seal carrier location welds and an increased frictional distress in this area. This in turn generated significant heating which manifested itself at its most intense where the seal arm was attached to the FPT drive arm in the vicinity

of the No10 bearing inner race. As a result, the seal arm and No10 bearing inner race started to slip on the FPT drive arm, generating even more heat, leading to the eventual failure of the FPT drive arm under torsional load, disconnecting it from the Module 2 FPT shaft.
