## ICOLD bulletin on internal erosion of existing dams, levees and dikes and their foundations

### Why is guidance needed?

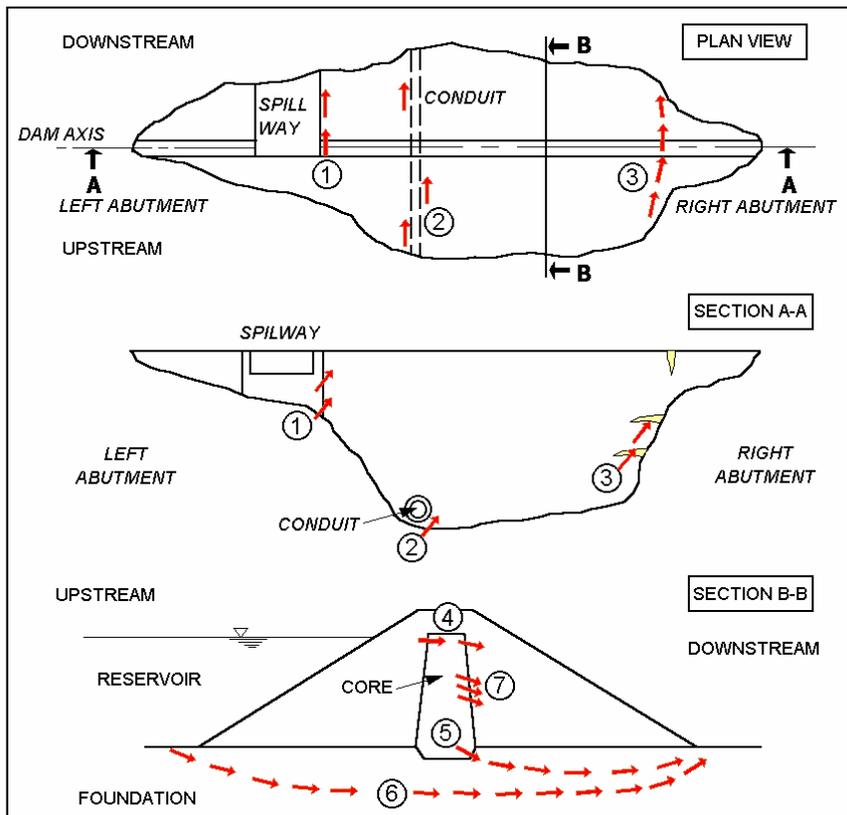
**Possible locations of initiation of internal erosion**

1. Spillway wall interface
2. Adjacent to conduit
3. Crack associated with steep abutment profile
4. Desiccation on top of core
5. Embankment to foundation
6. Foundation (if the foundation is soil or erodible rock)
7. Embankment through poorly compacted layer or crack (or by backward erosion if the core is cohesionless)

Source: Fell, R. and Fry, J.-J. (2007). *Internal Erosion of Dams and their Foundations*. Taylor & Francis, London.
