MAIB

MARINE ACCIDENT INVESTIGATION BRANCH

**Report on the Analysis
of Fishing Vessel Accident Data
1992 to 2000**

July 2002

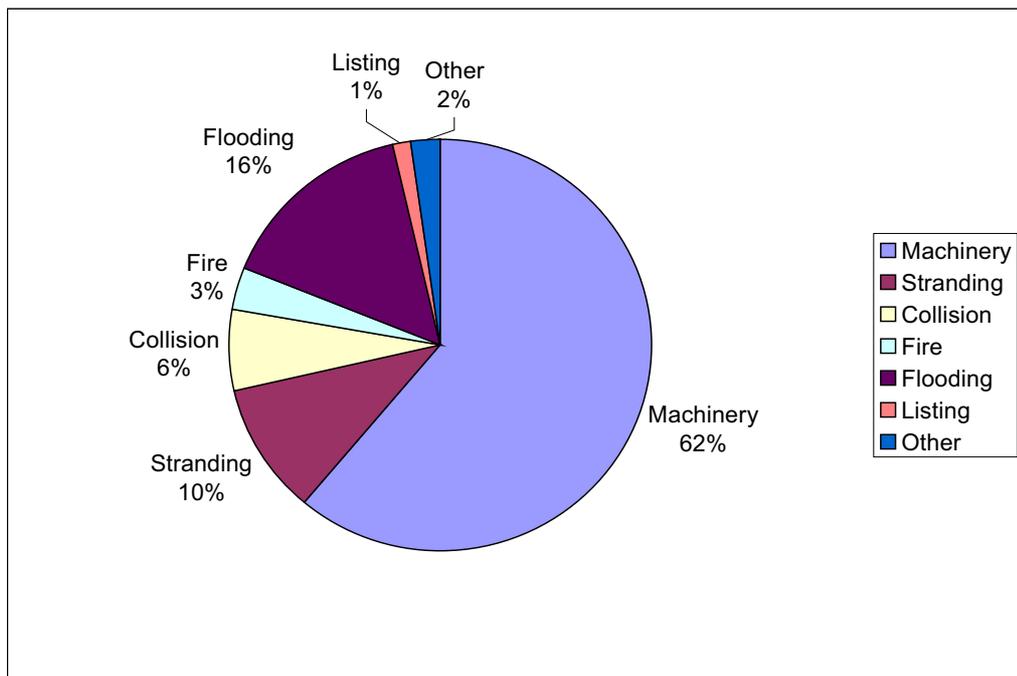
Figure 1: Accidents to vessels – initial accident categories 1992-2000

So that the more general accident figures are not masked by those accidents which were initially categorised as *Machinery*, these have been excluded from those used in Figure 1 with the result shown in Figure 5:

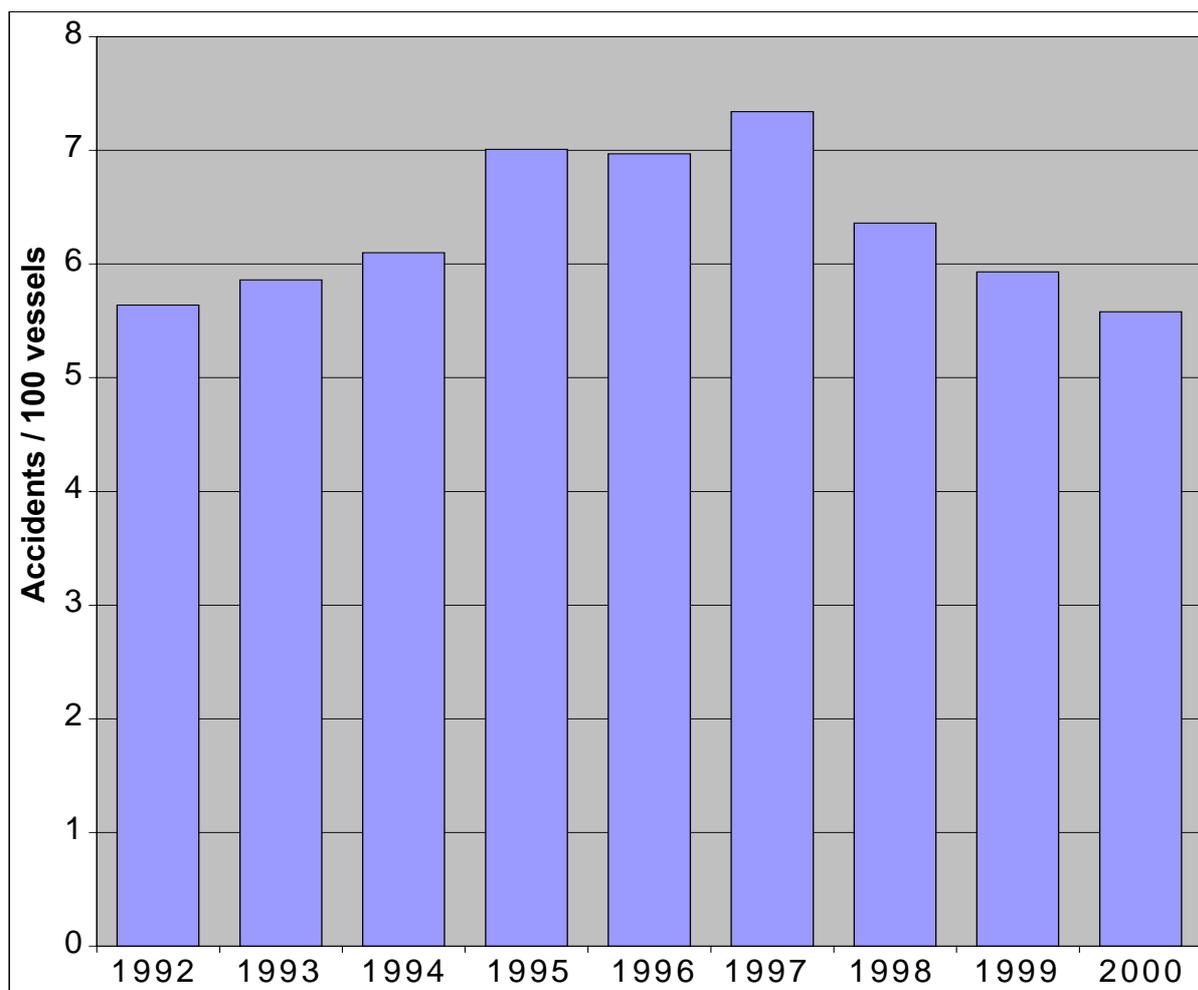
Figure 2: All accidents (vessels and persons) 1992 to 2000 per 100 registered vessels.

Figure 2 shows a gradual increase in the accident rate in the early part of the survey period, reaching a peak in 1997 at an annual rate of over 7 per 100 registered vessels. The trend shows a gradual reduction thereafter.

The trend shown in Fig 2 has been affected by the increase in machinery accidents that occurred in 1995, 1996 and 1997. When machinery accidents are not included there is little discernible rise or fall in the overall trend.

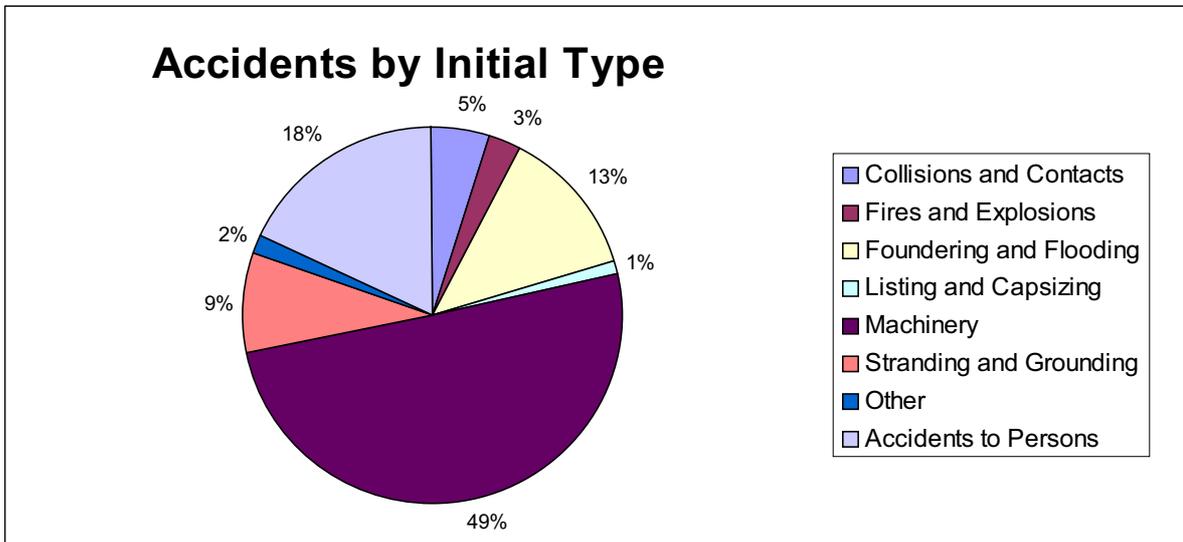
Figure 3: Pie chart showing initial accident categories 1992-2000

It can be seen from the diagram that the accident figures are dominated by those in the initial accident category *machinery*.

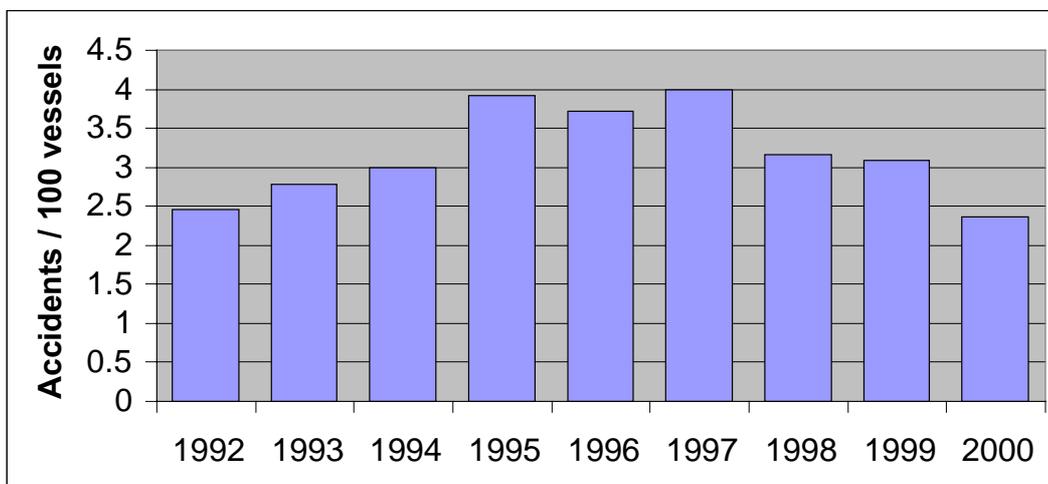
Figure 4: Machinery accidents/100 registered fishing vessels

This bar chart shows machinery accidents reached a peak in 1997 at a rate of 3.99 accidents per 100 registered vessels.

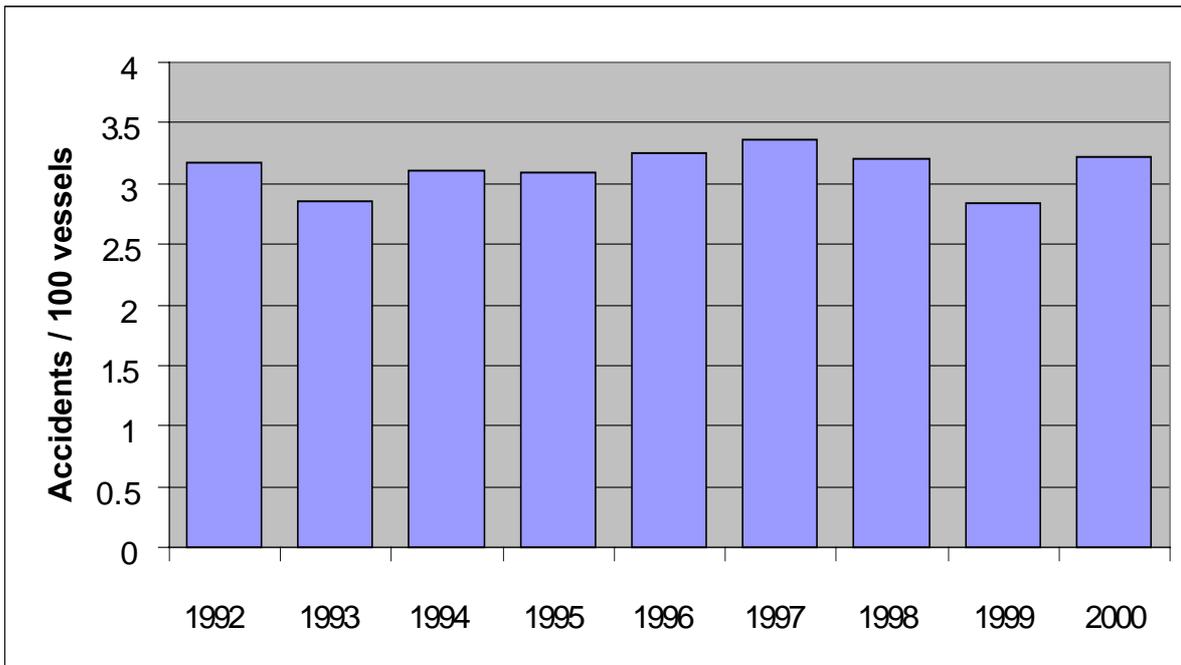
Figure 5: All accidents (vessels and persons) 1992 to 2000/100 registered fishing vessels (excluding category *machinery*).

It can be seen from Figure 5 that with machinery accidents excluded there is little discernible trend.

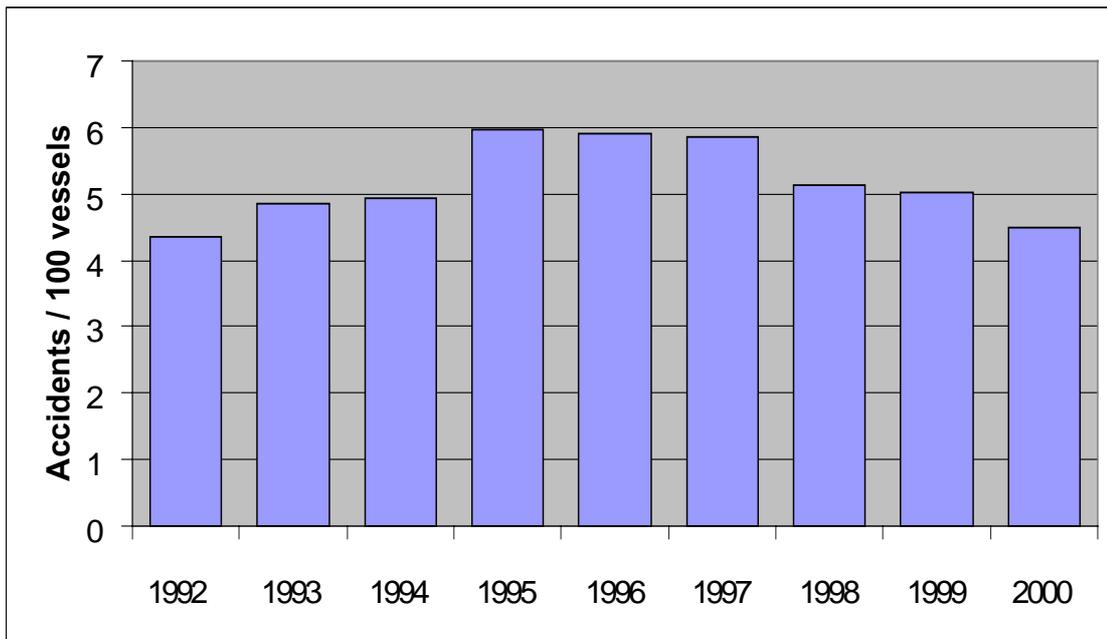
Figure 6: Accidents to fishing vessels 1992 to 2000/100 registered vessels

Figure 6 indicates a rising trend between 1992 and 1995 to peak in the years 1995, 1996 and 1997 when, in each year, 6% of the fleet reported accidents.

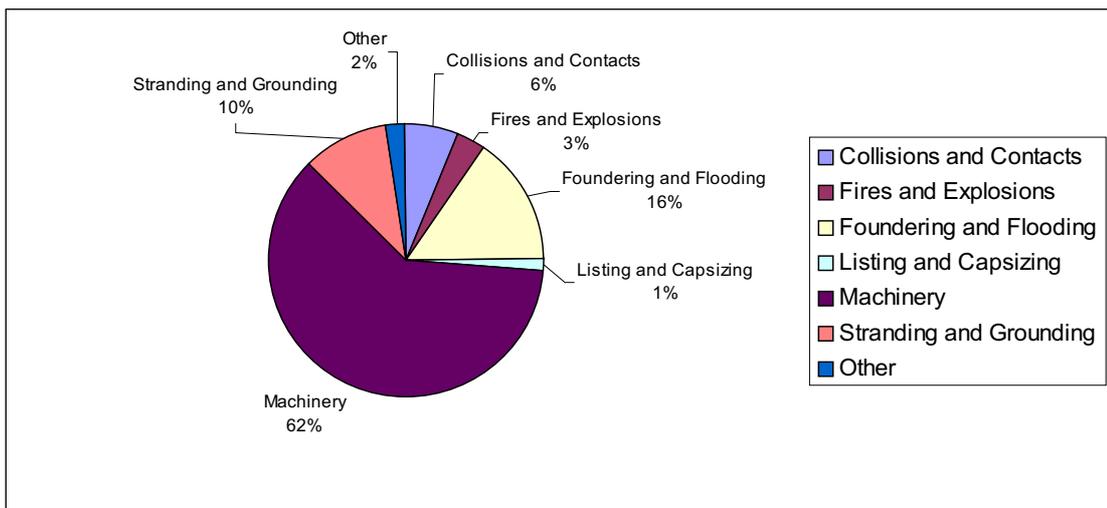
Figure 7: Pie chart showing main accident categories 1992-2000

Figure 7 shows that accidents in the category *machinery* comprised 62% of the total accidents reported.

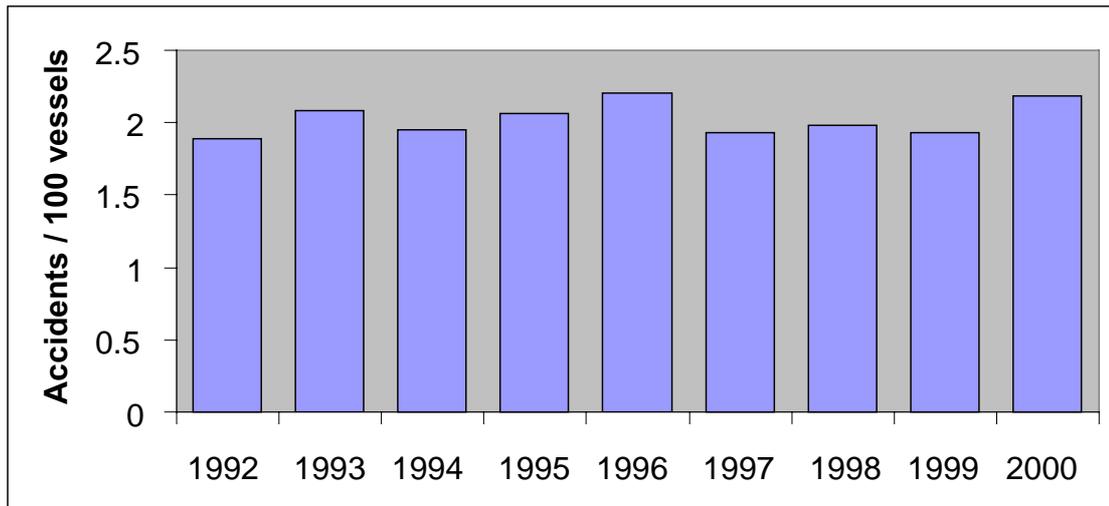
Figure 8: Accidents to fishing vessels (excluding machinery)/100 vessels

Figure 8 shows that, once again, when machinery accidents are excluded, no discernible accident rate trend is apparent for the 9-year period of the survey.

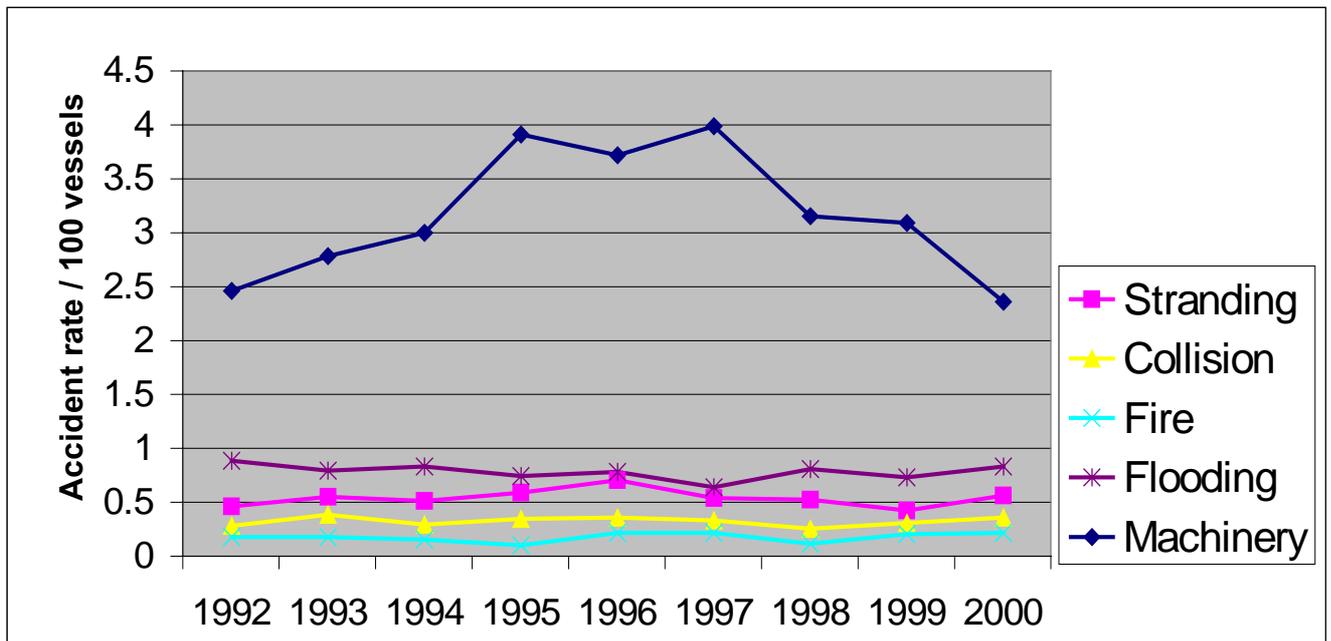
Figure 9: Accident rate - initial incident category/100 registered fishing vessels

Figure 9 shows the accident rate trends for each of the main initial incident categories. It can be seen that while the machinery accident rate rose to a peak in the years 1995, 1996 and 1997 the accident rate for other categories showed only minor fluctuations. A probable explanation for the rise in machinery accidents has been discussed in the preceding section.

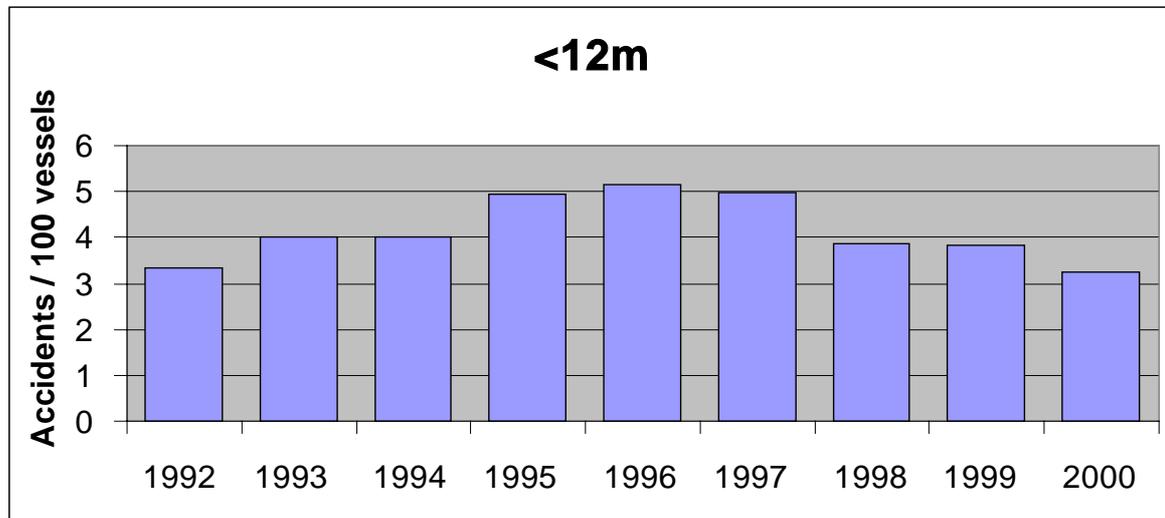
Figure 10.1 shows the accident rate for <12m vessels rising from 3.35% per annum in 1992, to 5.15% in 1997. It then gradually reduces to 3.24% in 2000.

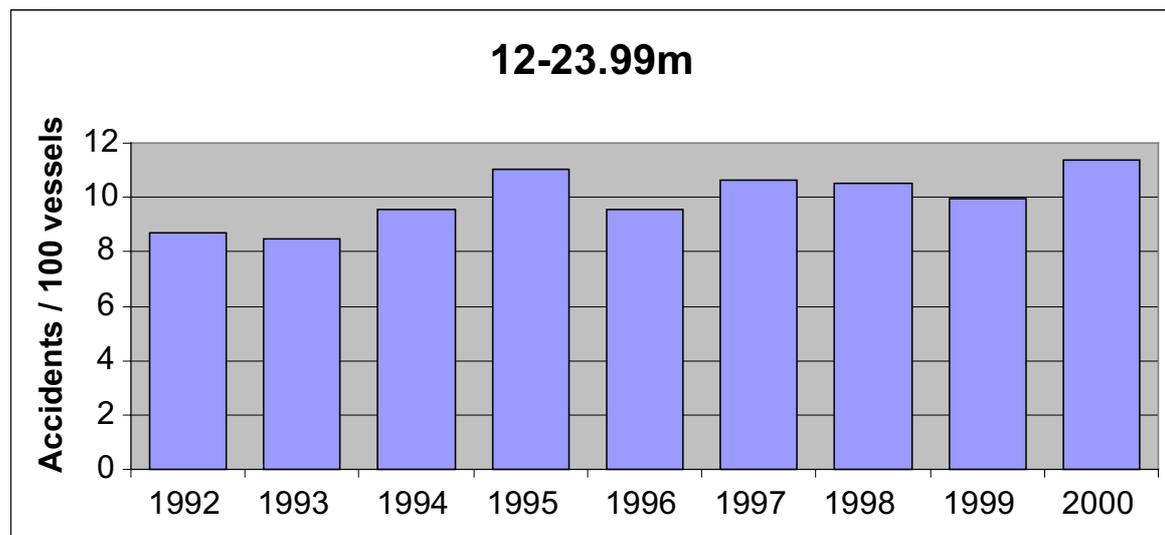
Figure 10.2 shows the rate for vessels between 12m and 24m in length increasing from 8.62% per annum in 1992 to 11.02% in 1995, and then remaining fairly steady until the end of the study period in 2000. It will be noted that the accident rate for this length range (and for >24m vessels) is generally considerably higher than for <12m vessels. This may be attributed to a number of factors, including that the <12m accident rate is influenced by a larger fleet size, and that many only operate part-time and in good weather. According to figures estimated by the MCA² <12m vessels spend on average 1200 hours at sea each year, as opposed to 4800 hours for the >12m vessels.

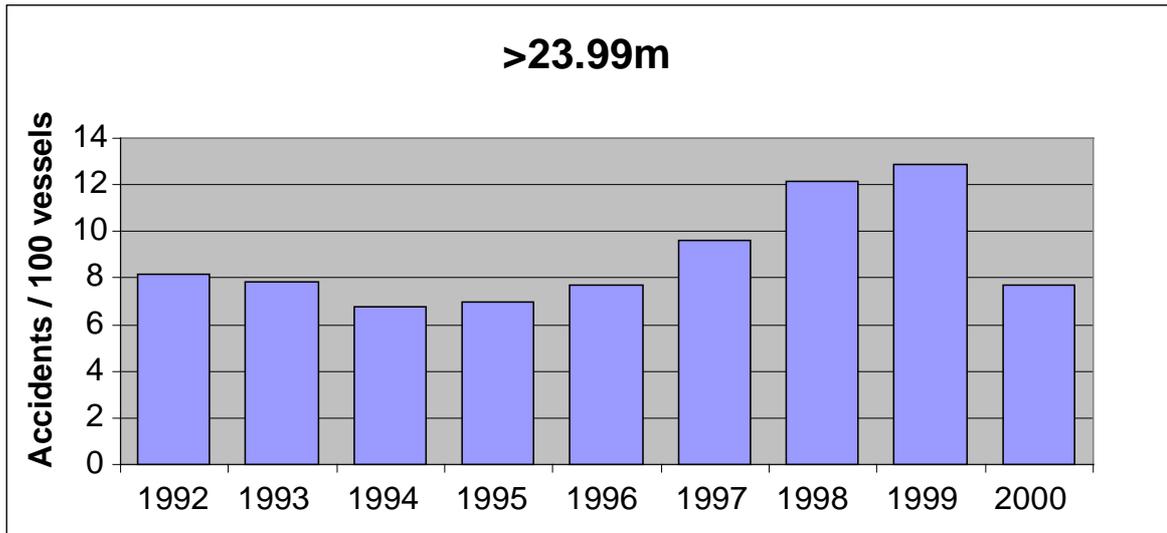
Figure 10.3 shows the rate for >24m vessels indicating a slight fall from 8.13% in 1992 to 6.8% in 1994, and thereafter a sharp increase to 12.86% in 1999. The year 2000 rate of 7.67% represents a very sharp reduction from the high of 1999, but this may be an anomalous year made possible by the relatively small numbers involved. There were 40 reported accidents to >24m vessels in 1999 and 22 in 2000.

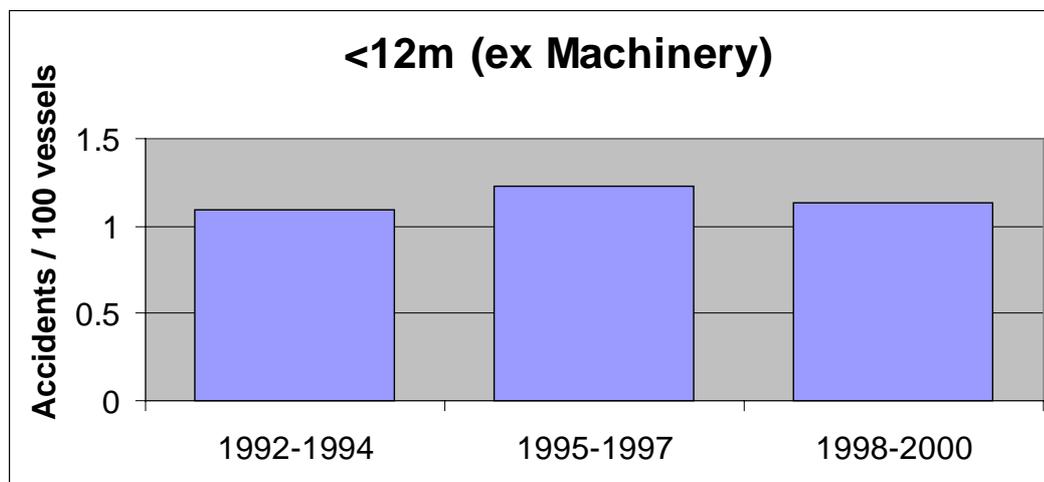
Figure 11.1 shows only a slight rise in the accident rate (excluding category *Machinery*) for <12m vessels in the years 1995 to 1997. Comparing this with Figure 10.1 (which includes *machinery*) it can be seen that a majority of accidents that contribute to the sharply rising trend in 1995, 1996 and 1997 can be attributed to *machinery*. By analysing these figures further, and comparing them with those for >12m vessels, it is concluded that the rising trend in fishing vessel accidents in general shown in Figures 1 and 2 can be attributed to *machinery* accidents in <12m vessels.

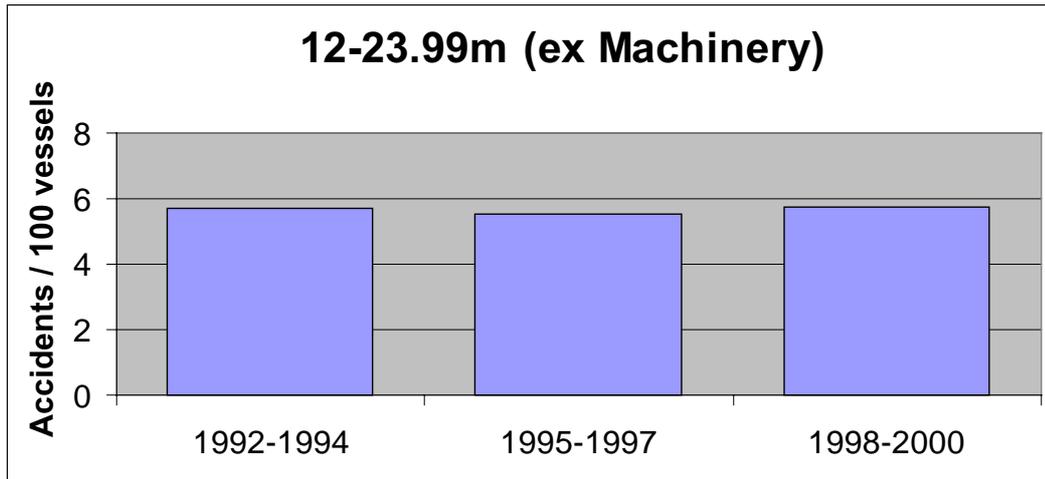
Figure 11.2 shows little or no discernible trends in the accident rate for vessels of between 12m and 24m in length (excluding *machinery*).

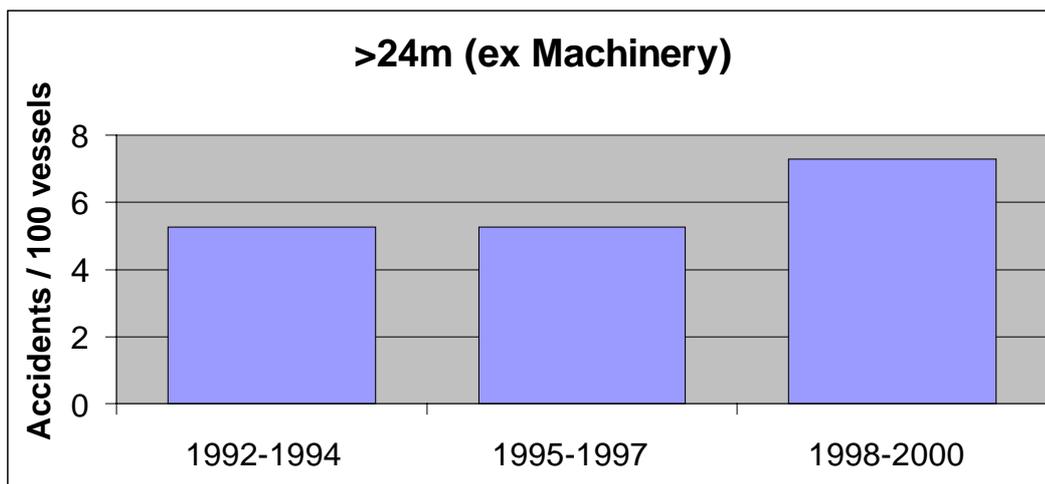
Figure 11.3 shows a steep rise in reported accidents in >24m vessels (excluding *machinery*) for the three year period 1998 to 2000. Owing to the small >24m fleet size this may not necessarily be indicative of an accident trend.

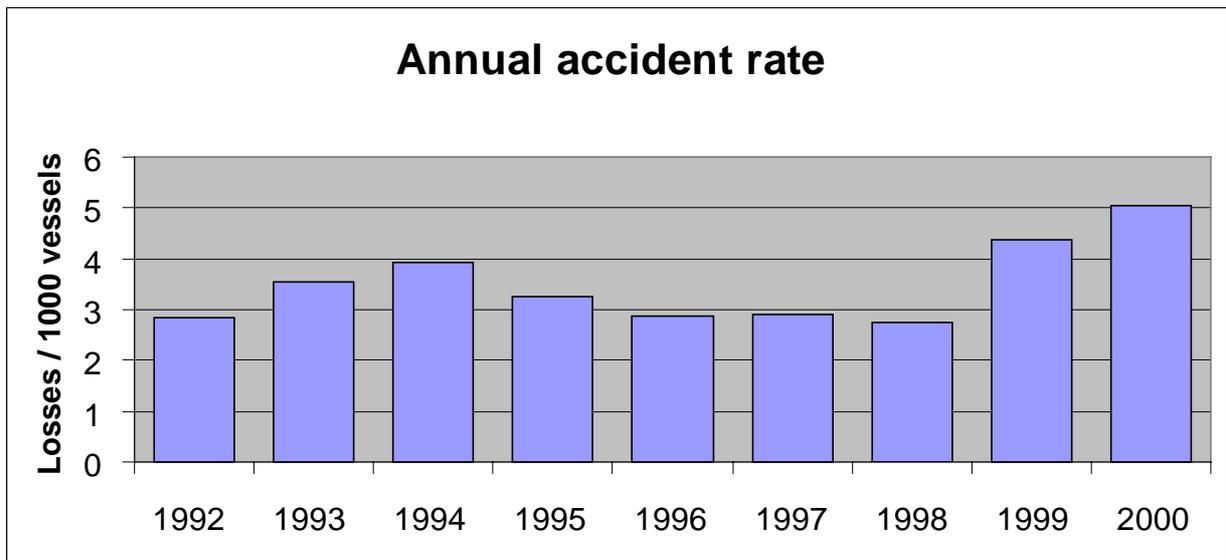
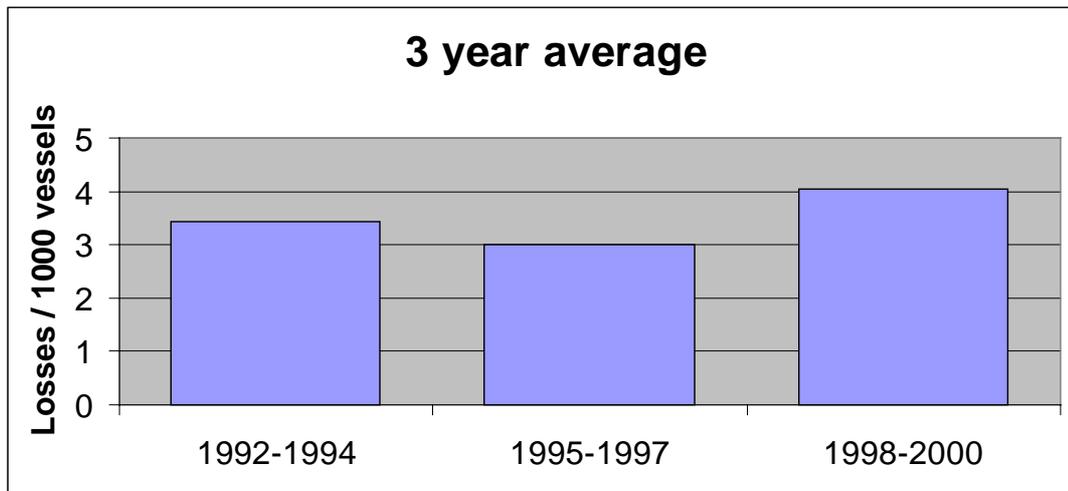
Figure 12.1: Fishing vessel losses/1000 registered vessels, annual accident rate

Figure 12.2: Fishing vessel losses/1000 registered vessels, accident rate averaged over three year periods

Figures 12.1 and 12.2 show the vessel loss rate rising from 0.28% in 1992 to 0.39% in 1994 before falling again to reach a steady rate of about 0.28% during 1996,1997 and 1998. It then rose sharply to reach 0.51% in 2000.

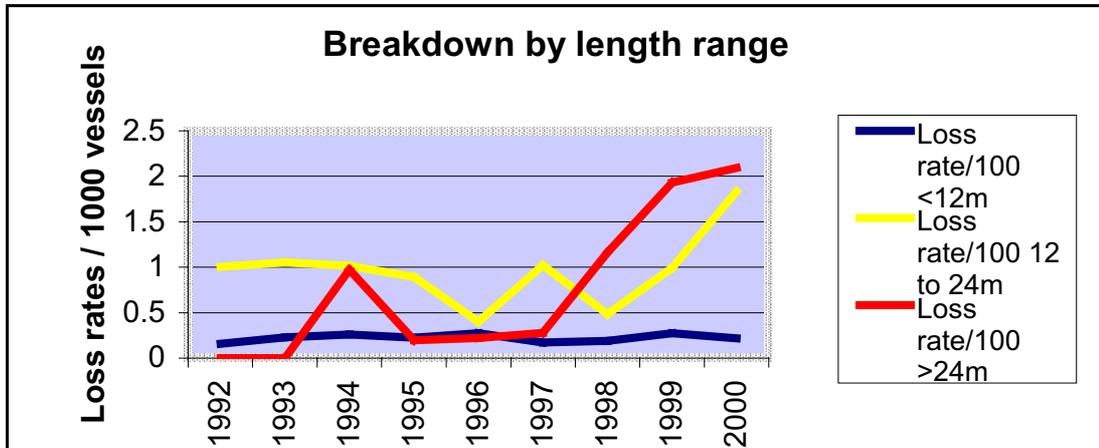
Figure 13: Fishing vessel loss rate/1000 registered vessels in length ranges

This figure clearly indicates that the rise in the loss rate during 1999 and 2000 was entirely due to accidents to vessels over 12m. There were 40 >12m fishing vessels lost during 1999 and 2000. In 2000 alone, about 2% of the whole >12m UK fleet was lost.

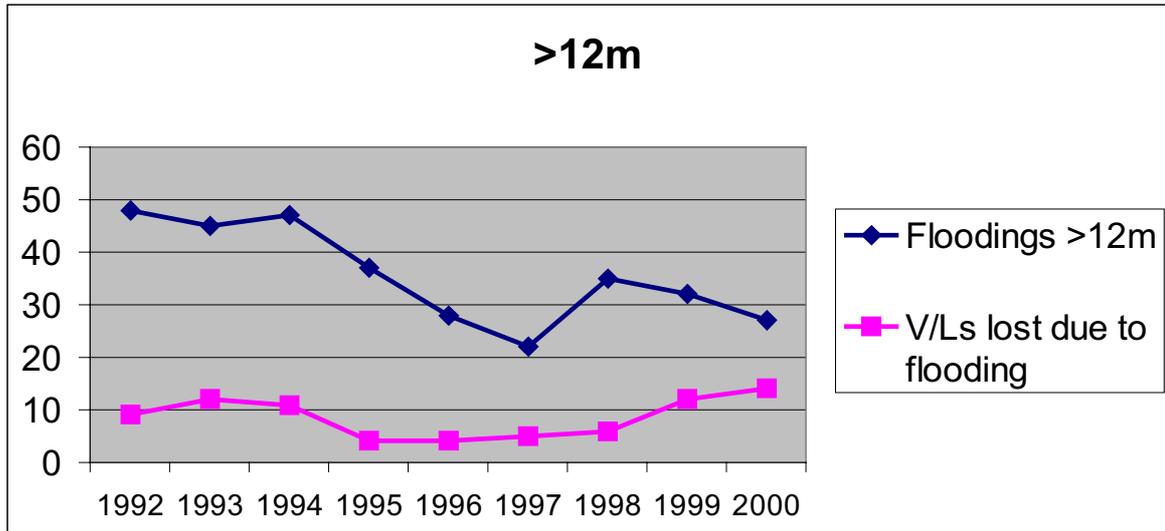
Figure 14: Reported flooding accidents and vessel losses due to flooding for >12m vessels between 1992 and 2000

It can be seen from this figure that the number of losses caused by flooding appears to be converging with the number of reported flooding incidents in vessels of >12 m. The overall trend is apparent throughout the period, but is most marked in 1998, 1999 and 2000. In 1998 there were six losses from 35 incidents, in 1999 there were 12 from 32 incidents and, in 2000, 14 from 27 incidents.

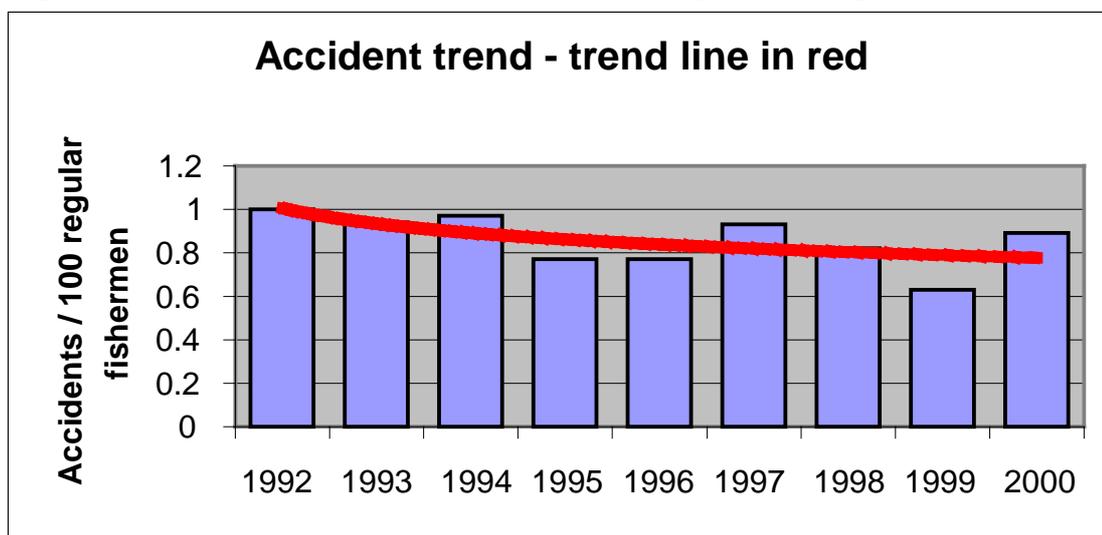
Figure 15: Accident rate trend, 1992 to 2000 per 100 regular fishermen

The accident rate for injuries has reduced steadily during the period 1992 to 2000.

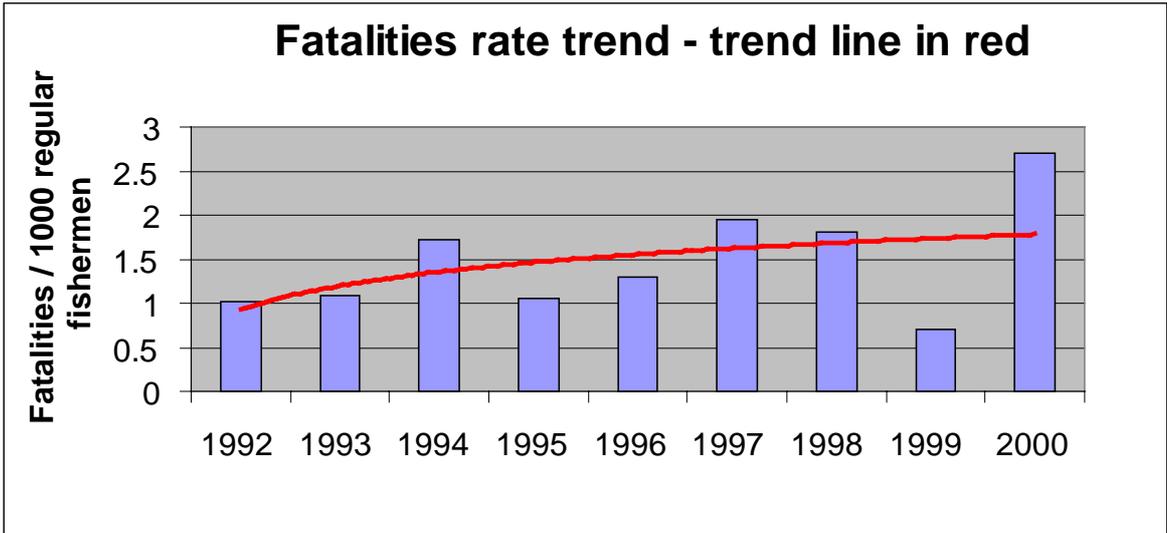
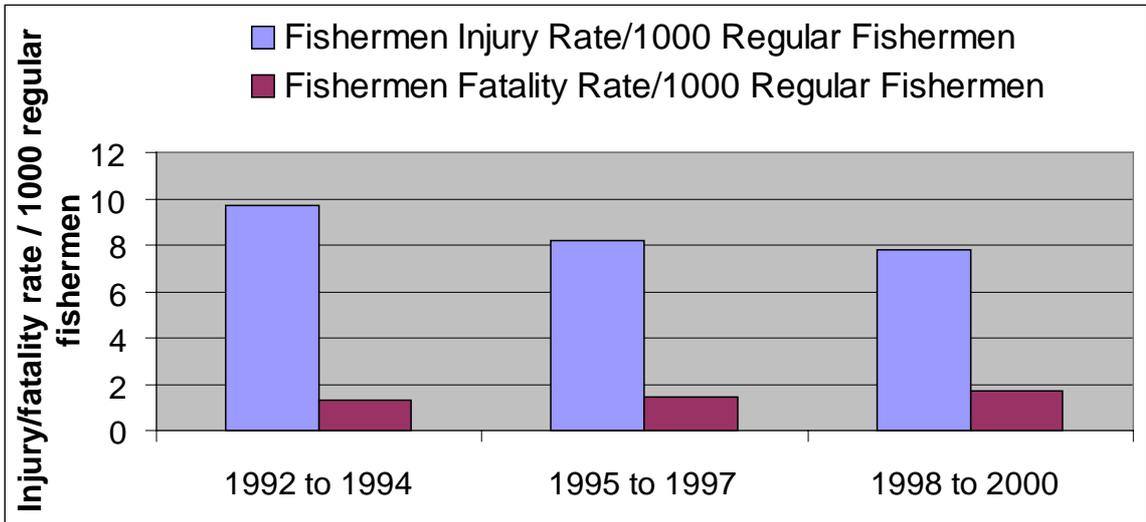
Figure 16: Fatality Rate Trend / 1000 Regular Fishermen for 1992 to 2000

Figure 17: Three year averaged injury rate and fatality rate per 1000 regular fishermen

The fatality rate for fishermen, which has been adjusted to account for the number of Regular Fishermen employed, has been steadily increasing. This rising trend is opposite to that recorded for injuries, which is decreasing.

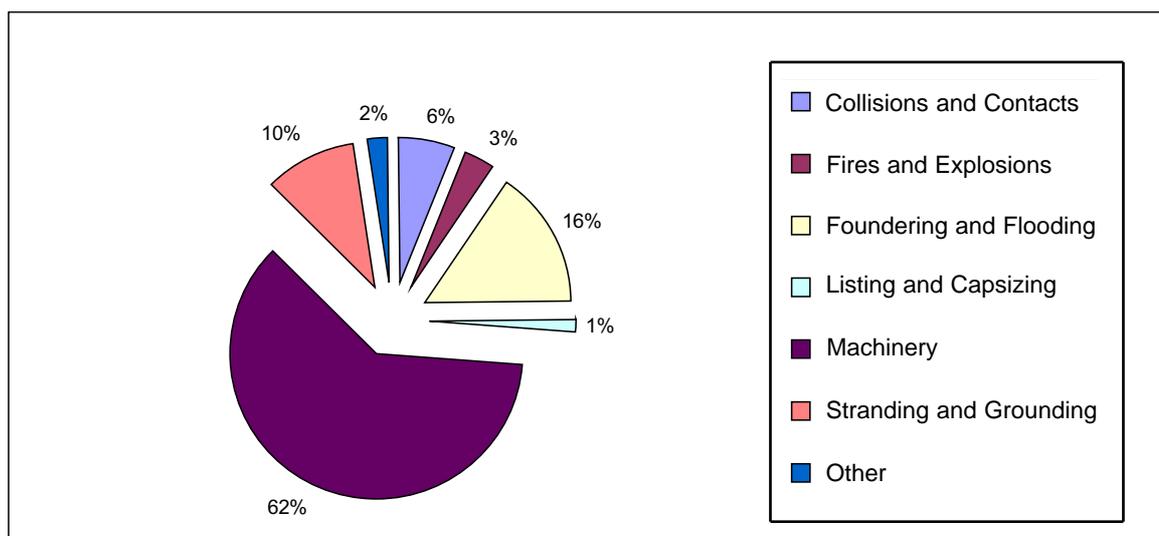
Figure 18: Accidents to vessels - initial incident types 1992-2000

Figure 18 shows a breakdown of the initial incident types recorded and are analysed separately below.

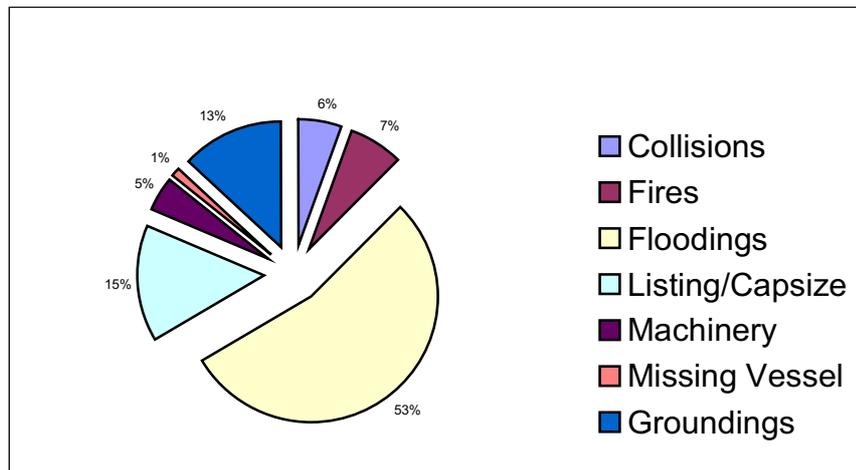
- 16 were collisions
- 20 were fires
- 153 were foundering/floodings
- 43 were listing and capsizes
- 13 were machinery
- 1 was a “missing vessel” accidents
- 37 were stranding and groundings

Figure 19: Vessel losses by initial incident category 1992-2000
