Permitting decisions

Part surrender

We have decided to accept the surrender of part of the permit for Alderley Park Energy Centre operated by Veolia Energy & Utility Services UK Plc.

The permit number is EPR/XP3139BM.

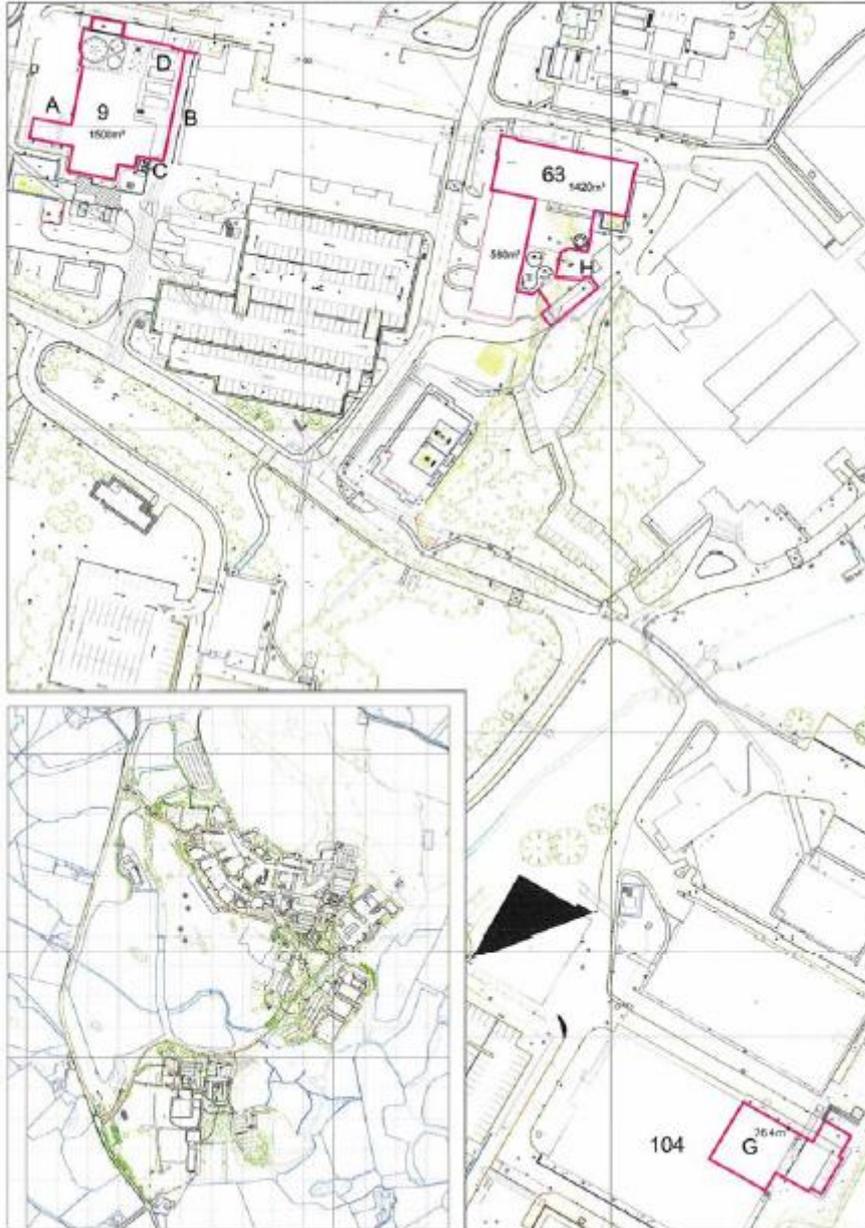
Alderley Park Energy Centre is located at Alderley Park at Alderley Edge, approximately five kilometres northwest of Macclesfield. Prior to the development of the combustion plant the site was a green field site. The original installation boundary within which the boilers were located was obtained from the permit. See map below for site layout plan.
