Case Study Reference: IEM/2012/006

### Usk Carbon Reduction Case Study

The South Wales, Usk Town Flood Wall project adopted an innovative approach to refurbish 120m of existing flood walls that was in danger of collapse during a 1 in 20 year event. The new wall was designed to protect 38 properties from a 1 in 100 year flood event.

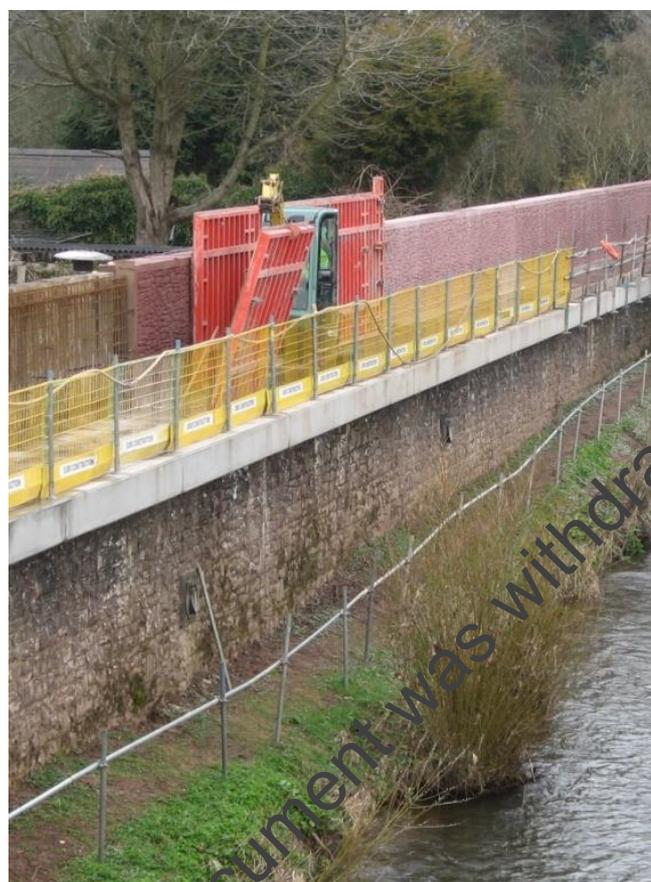
Instead of replacing the old walls with a new wall, the project team applied innovative design and construction techniques to identify a way to reuse the failing existing walls by structurally tying them together. This avoided requirement for additional new materials and waste removal on site.

To address the risk of wall failure, the overall weight of the combined structure was reduced by replacing fill material with polystyrene fill (low carbon-footprint lightweight material).

The historic setting dictated a high quality finish to the upper wall. A coloured, textured concrete finish was selected (using a form liner) to mimic adjacent stone features. This solution was also cost-effective in comparison to masonry.
