Construction noise and vibration Monthly Report – September 2017

London Borough of Camden

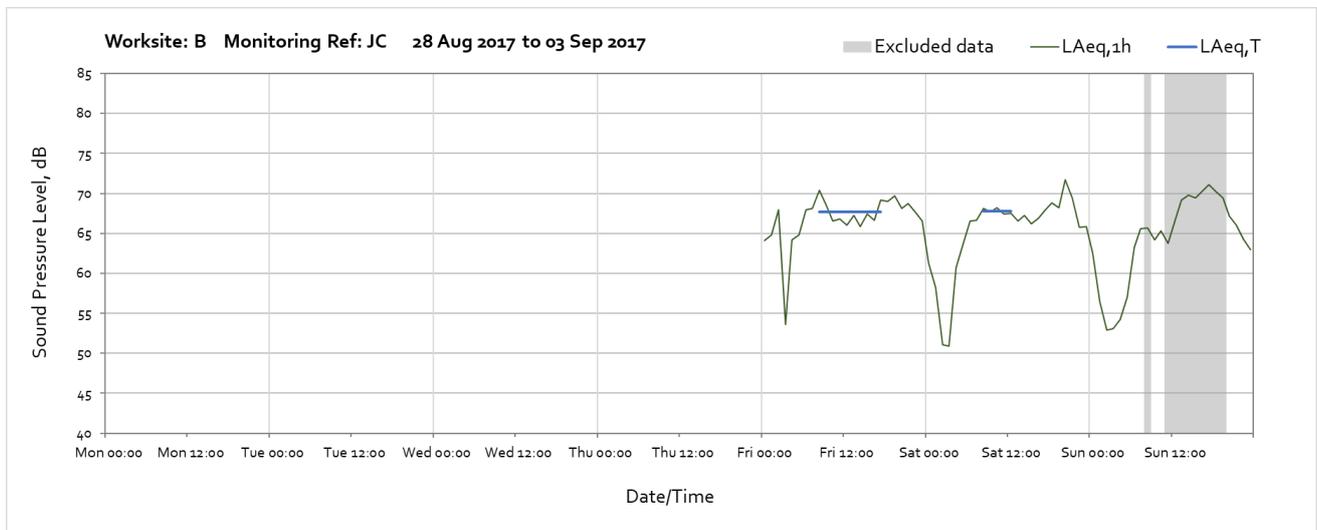
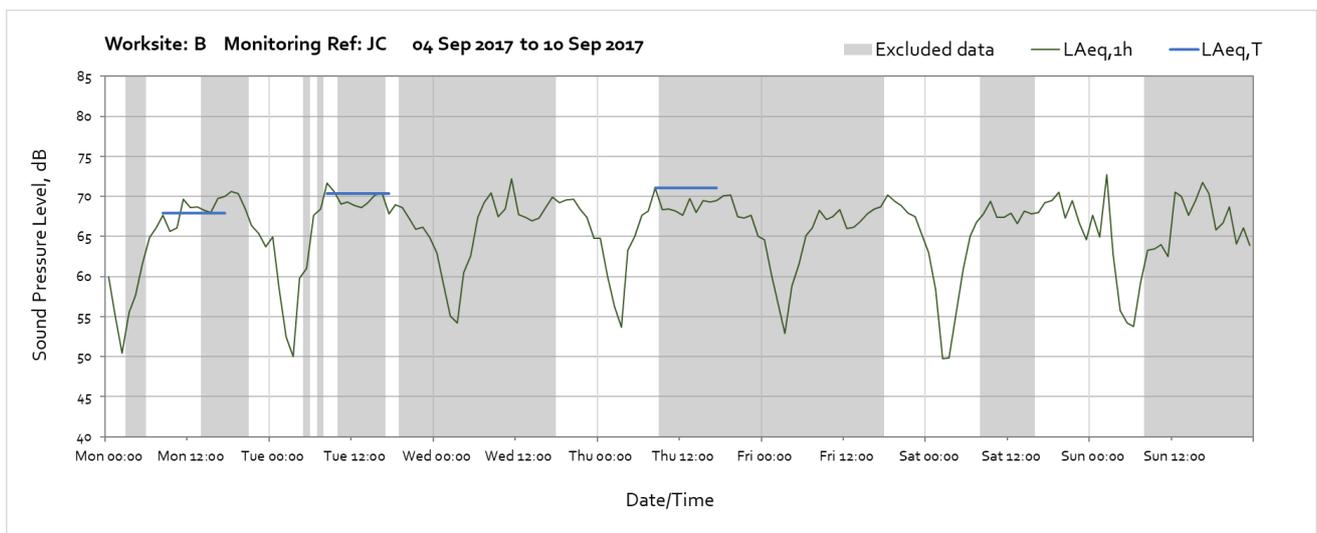
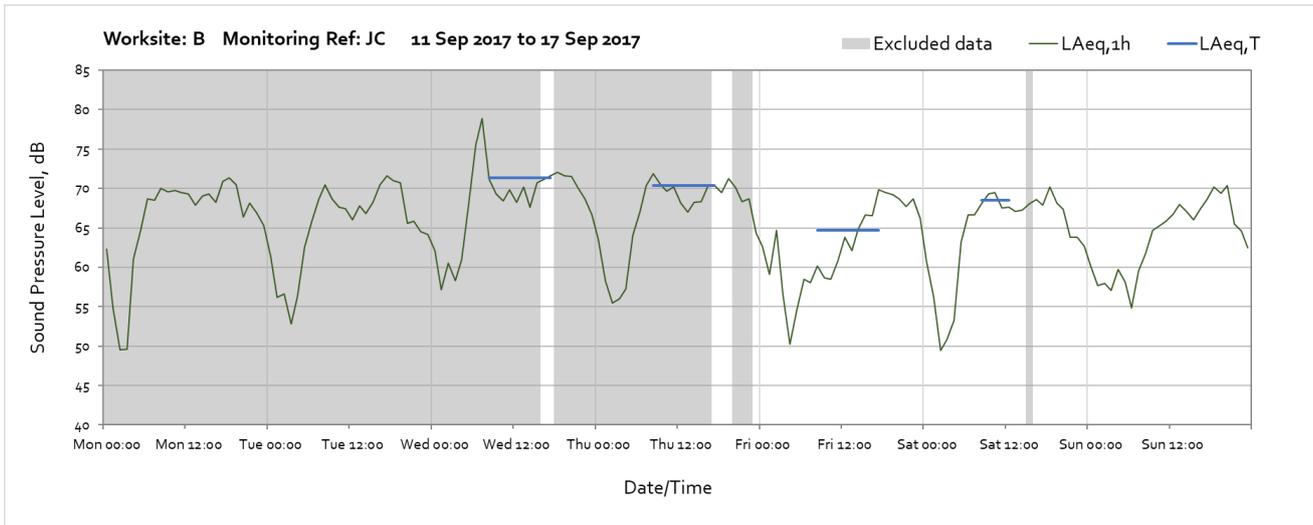
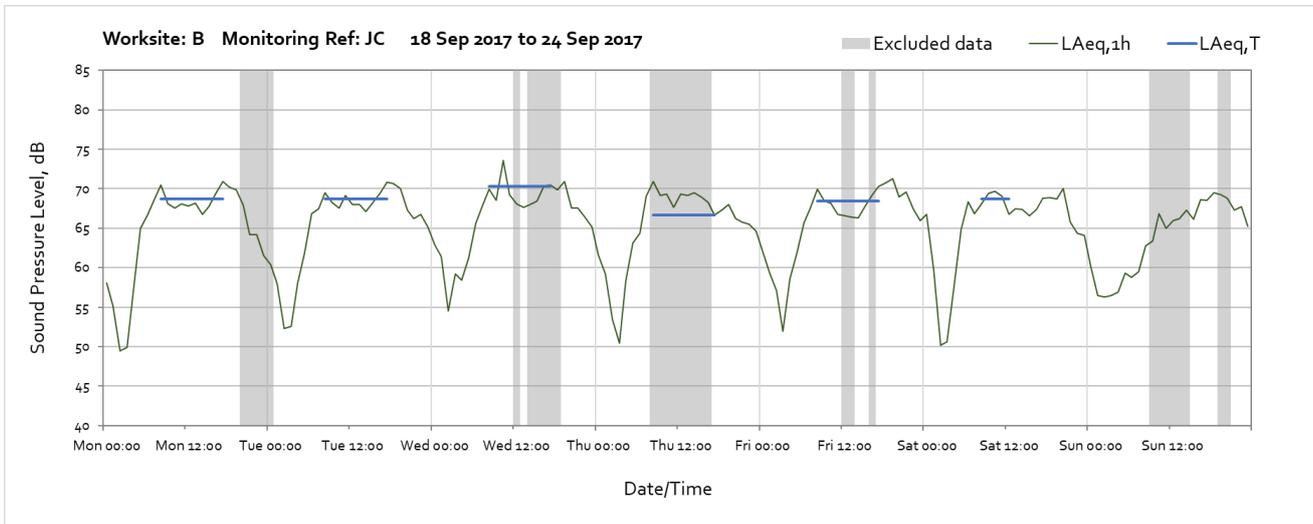
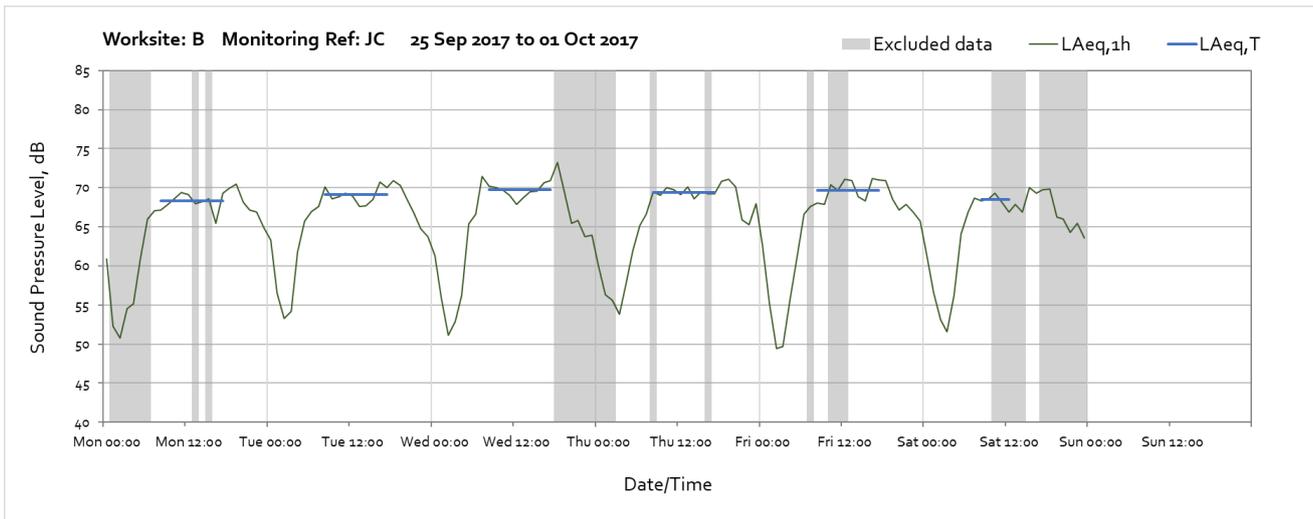
Worksite: B – Monitoring Ref: JC

The following graphs show the hourly measured ambient noise level $L_{Aeq,1h}$ and, where relevant, the averaged noise level $L_{Aeq,T}$ values, where the time period T is as specified in Table 1 of HS2 Information Paper E23. Periods with adversely weather affected noise levels are greyed out and have been excluded from the calculation of the $L_{Aeq,T}$ values in Table 5.

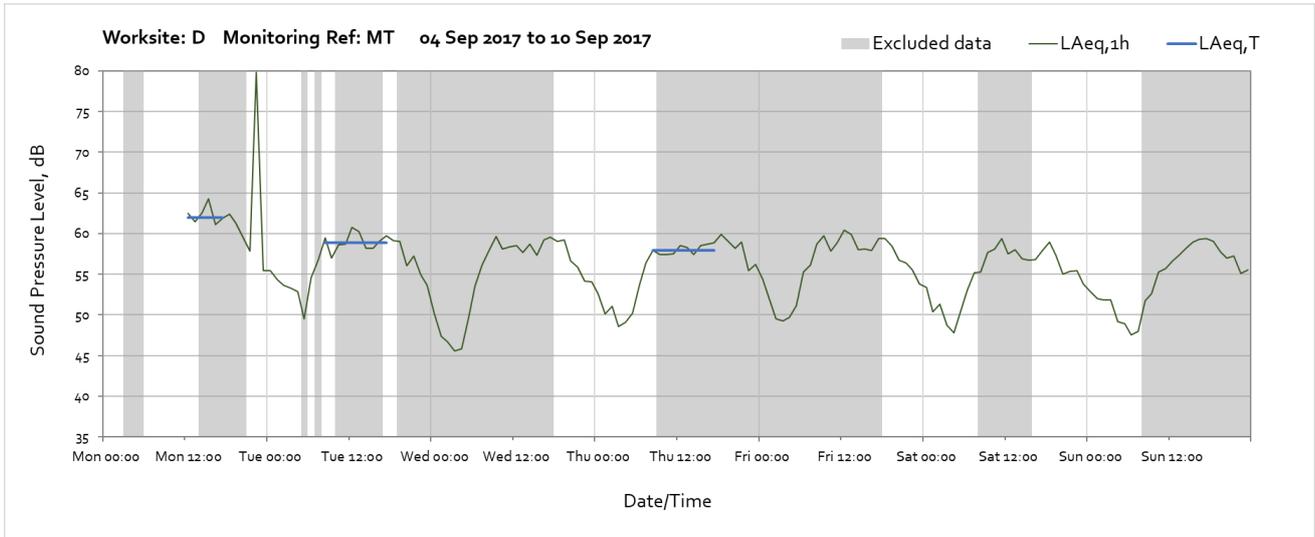
Worksite: D – Monitoring Ref: MT

Note – Missing data between the beginning of month and 12:00 on Monday 4th due to a loss of power at the noise monitor.

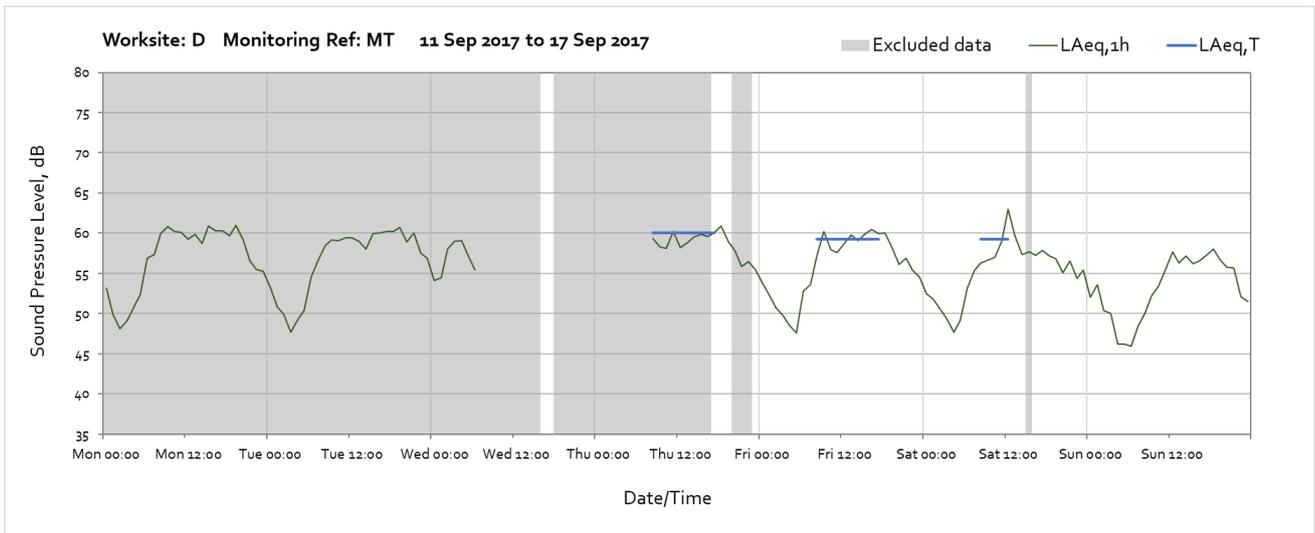
Note – Missing data between 06:00 on Wednesday 13th and 09:00 on Tuesday 14th due to a loss of power at the noise monitor.

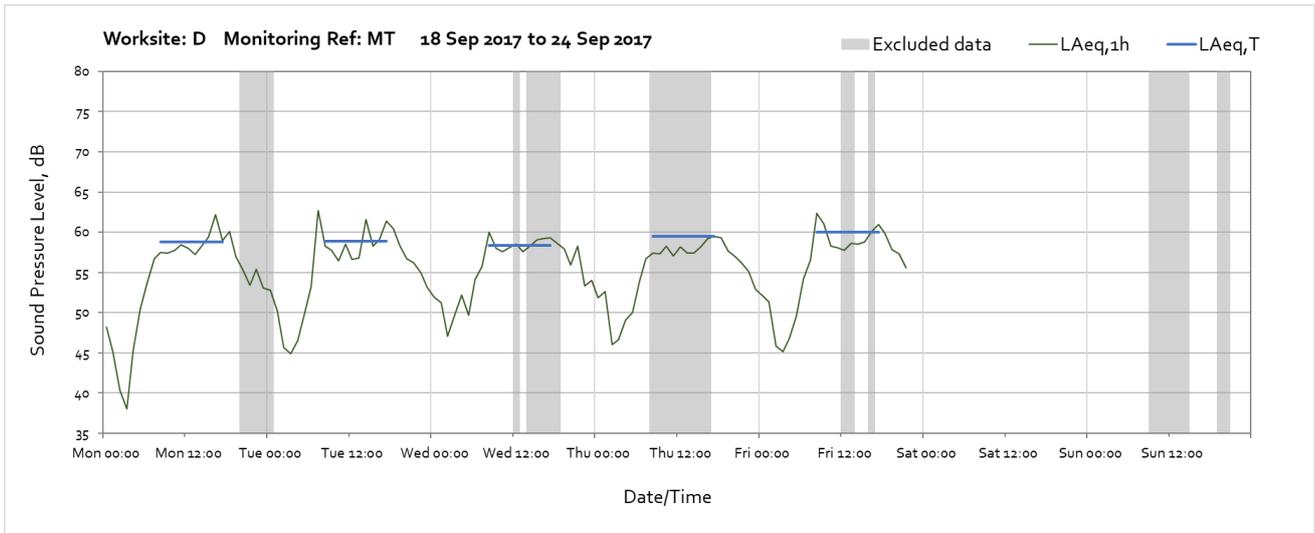
Note – Missing data between 21:00 on Friday 22nd and 11:00 on Thursday 28th due to a loss of power at the noise monitor.

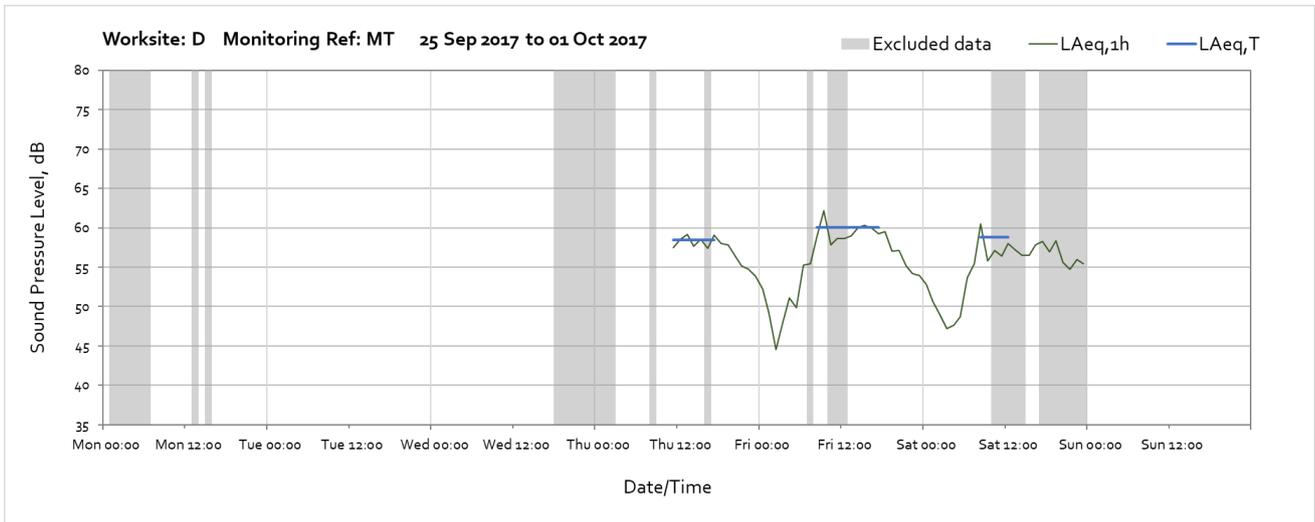
Note – Missing data between 21:00 on Friday 22nd and 11:00 on Thursday 28th due to a loss of power at the noise monitor.

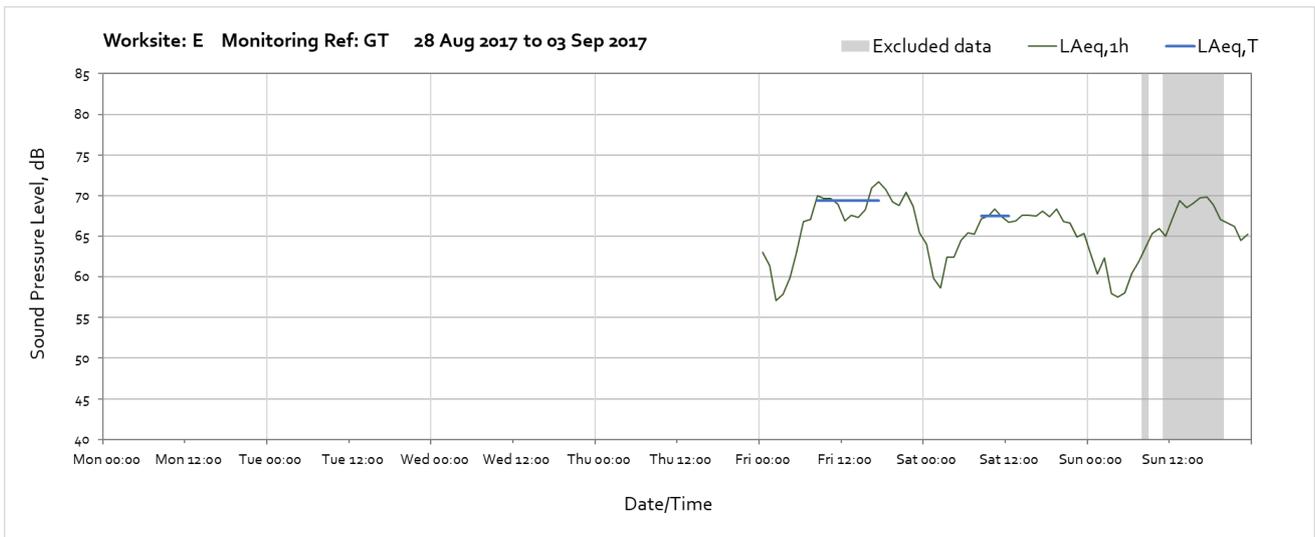
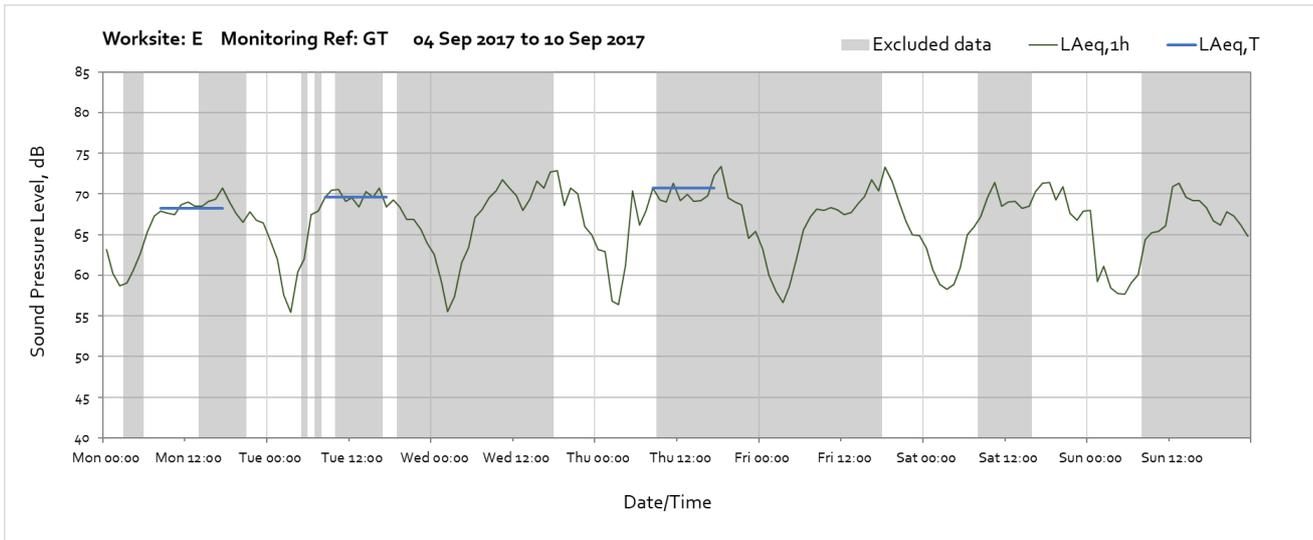
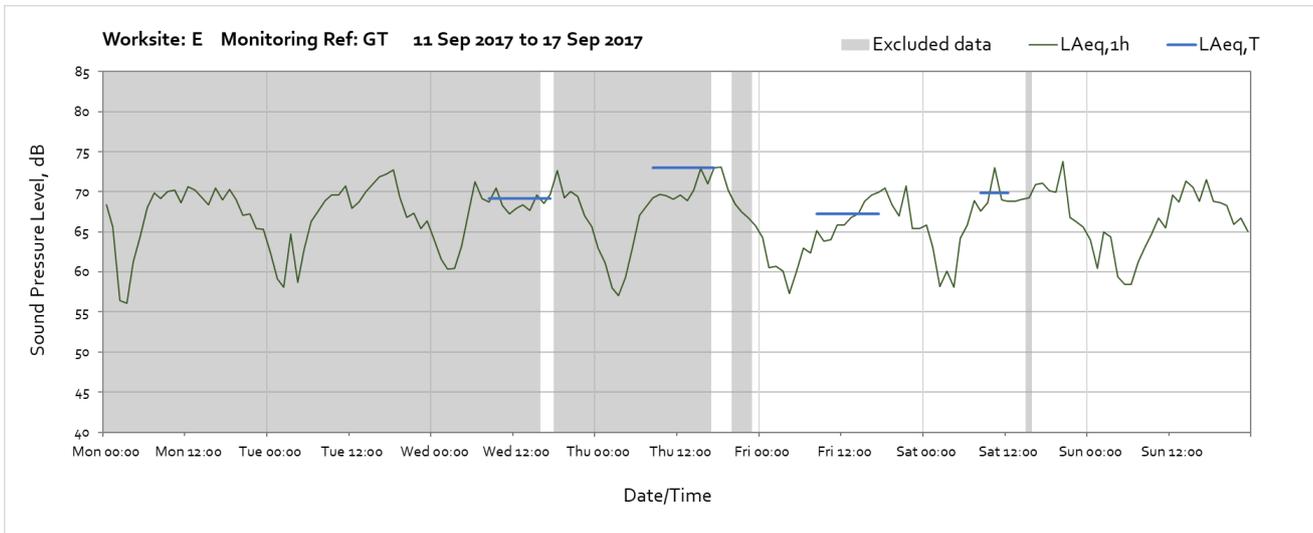
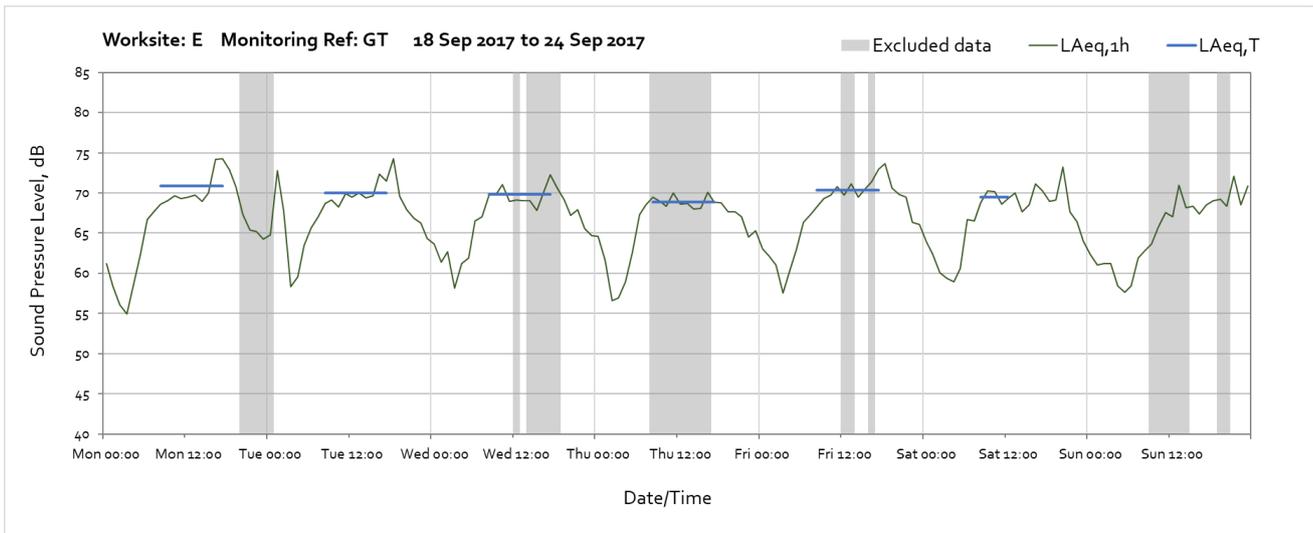
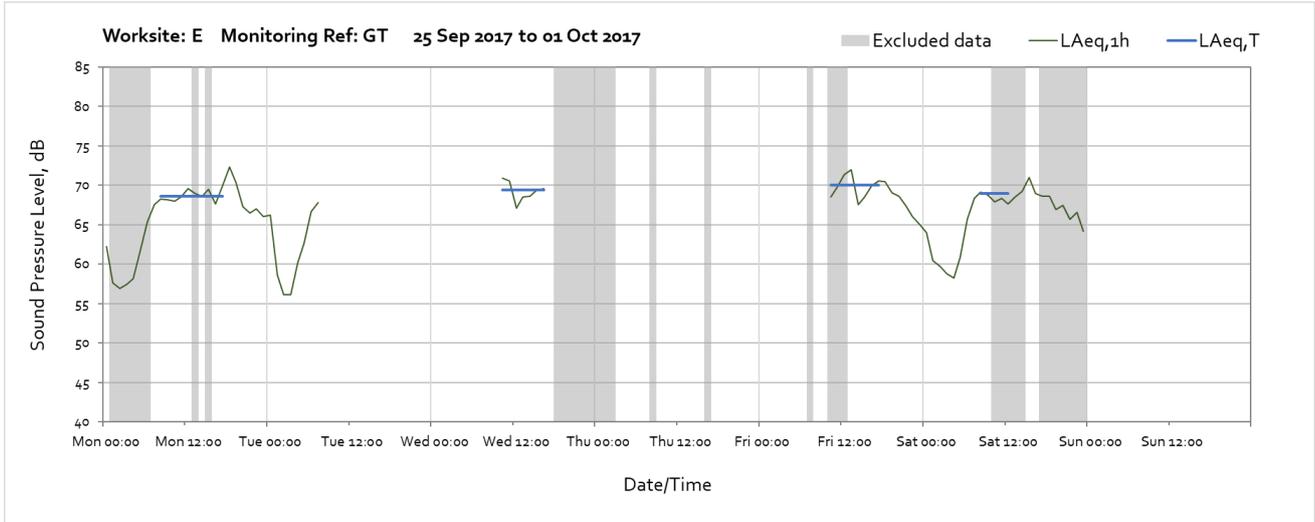
Worksite: E – Monitoring Ref: GT

Note – Missing data between 07:00 on Tuesday 26th and 10:00 on Wednesday 27th and between 16:00 on Wednesday 27th and 10:00 on Friday 29th due to a loss of power at the noise monitor.
